Feasibility Study for

Village of Saranac Lake Emergency Services Facility

Saranac Lake, NY

October 11, 2023

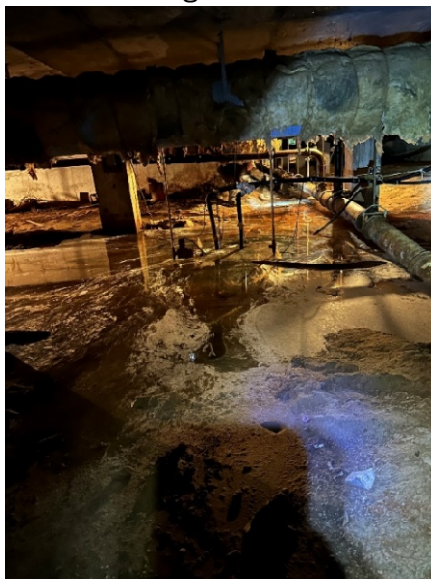
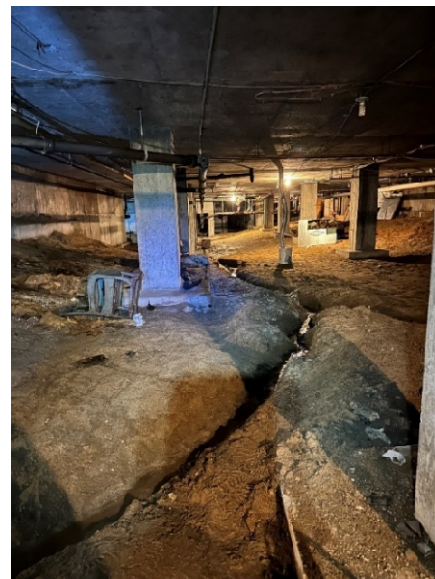
3. Water infiltration was noted in the crawl space on the west side (minor), south side (moderate), and east side (severe). Water is actively flowing from the west side to the east side of the existing crawl space, with erosion of the sub-base material. A large pool of standing water is currently located in the north-east corner of the existing crawl space. Further investigation is required to determine the source of the water, but leaking pipes were noted in the field on the south-west corner. An existing sump pump appears to be in the north-east corner but is currently not functioning. Structurally, this standing water is a concern to the long-term stability of the existing foundations. Wendel recommends further investigation and installation of a sub-drainage system tying into a new sump-pump; in the meantime, we recommend the existing sump-pump is repaired and actively running to eliminate the standing water.

Figure 3 & Figure 4 Water Infiltration in Crawl Space

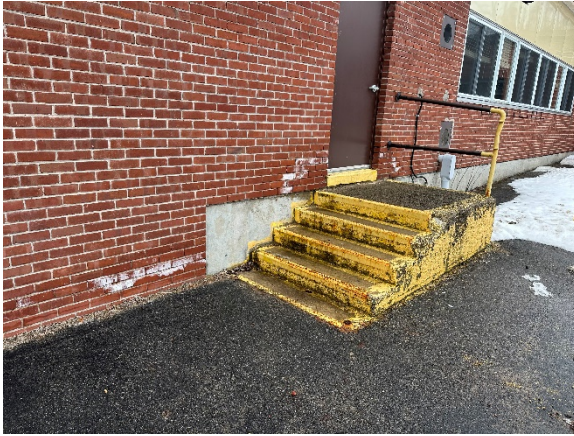
5. Minor concrete deterioration was noted on the exposed concrete surfaces at all entrance slabs due to chloride exposure. Deterioration noted in the field includes spalling, delamination, and cracking. Wendel recommends the existing slabs are removed and replaced in their entirety.

Figure 7 North Entrance Concrete Damage

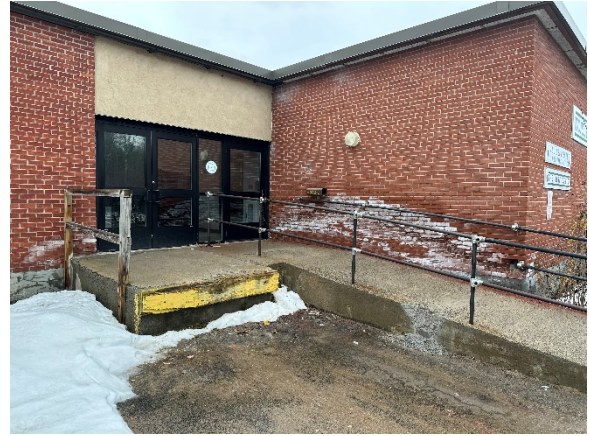
Figure 8 East Entrance (1993 Addition) Concrete Damage

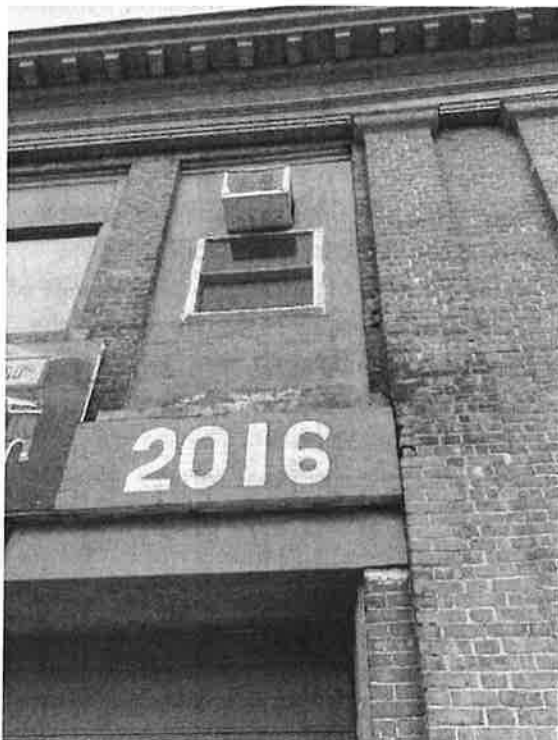
Second floor door & window openings infilled with painted plywood, replacement units & a/c

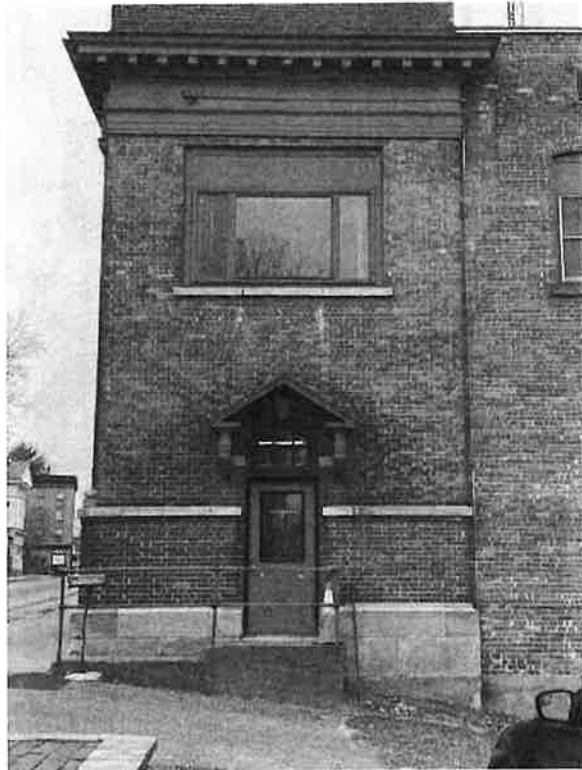
Original side entry with replacement door and framed down and altered 2nd floor window.

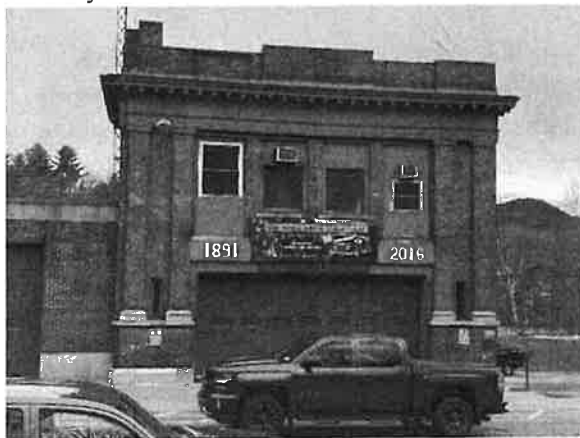
Front elevation with altered 2nd floor window/door openings and missing balcony.

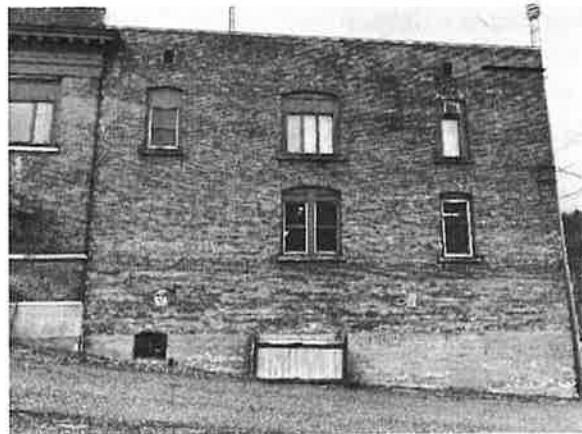
South elevation with altered window openings.

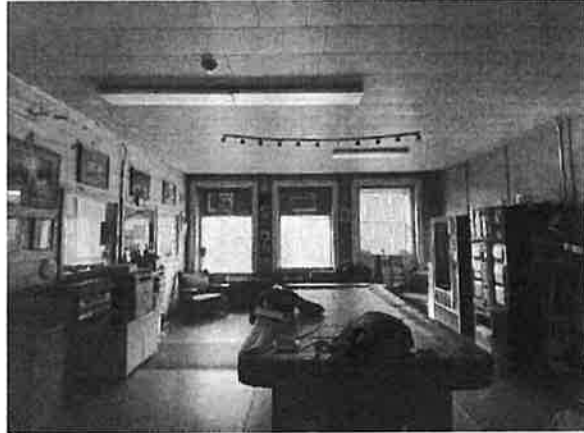
View to west (front) wall in Day Room where orig. windows and doors to former balcony have been infilled & replaced.

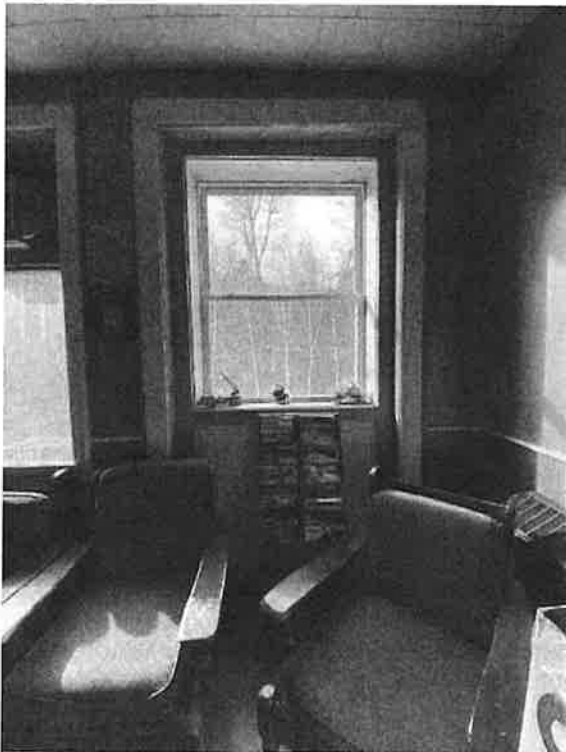
Detail view of orig. doorway opening to front balcony, now infilled with a small window unit.

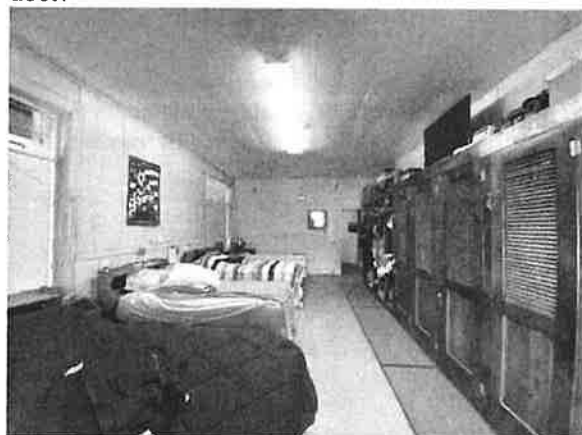
Historic wall, ceiling and floor finishes covered with layers of vinyl tile, acoustical tile and Masonite sheet paneling.

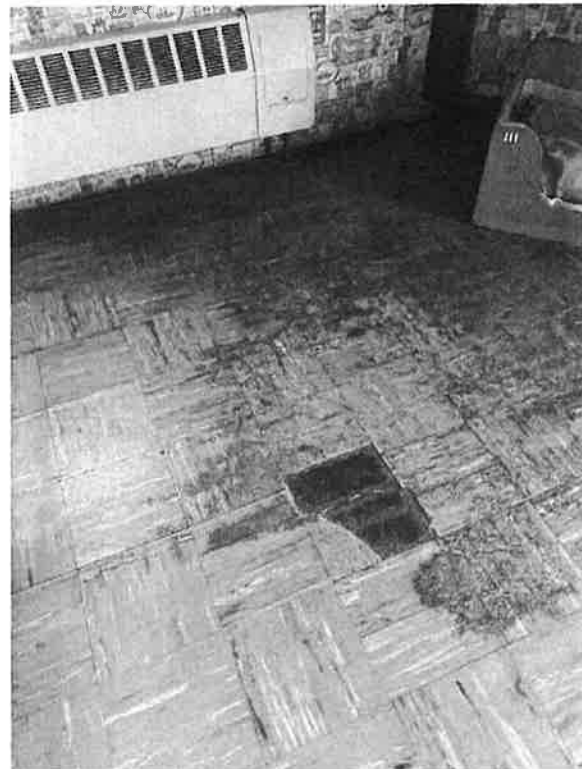
Vinyl composition tile (VCT) on floor is in poor condition in many locations. 9" square VCT typically contained asbestos & is considered a HAZMAT.

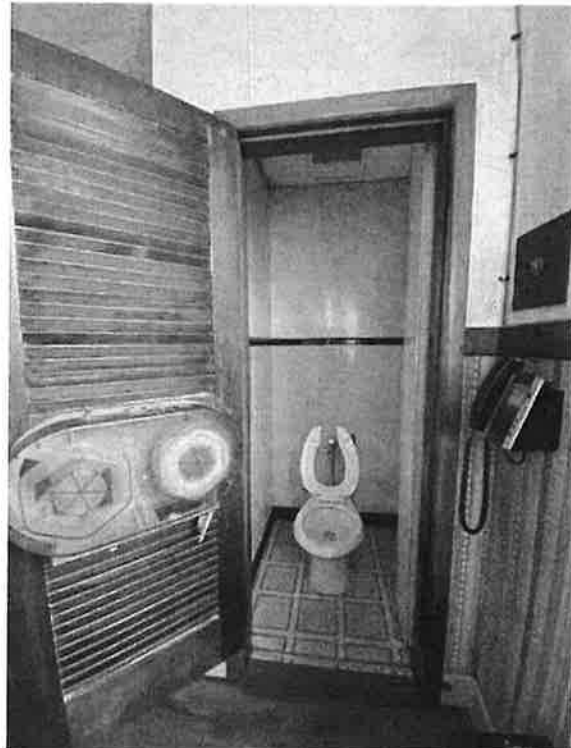
Mid/late 20th century fixtures and finishes are showing age and wear.
