Town of Alta

Tom Moore Restroom Historic Structure Report

FFKR ARCHITECTS

JUNE 2025

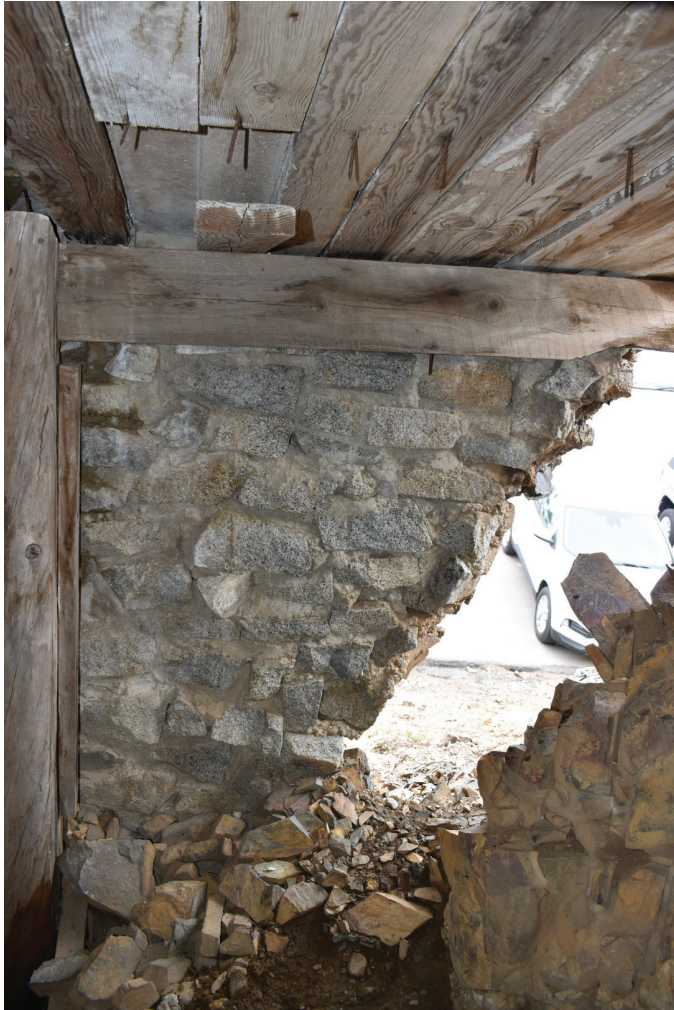
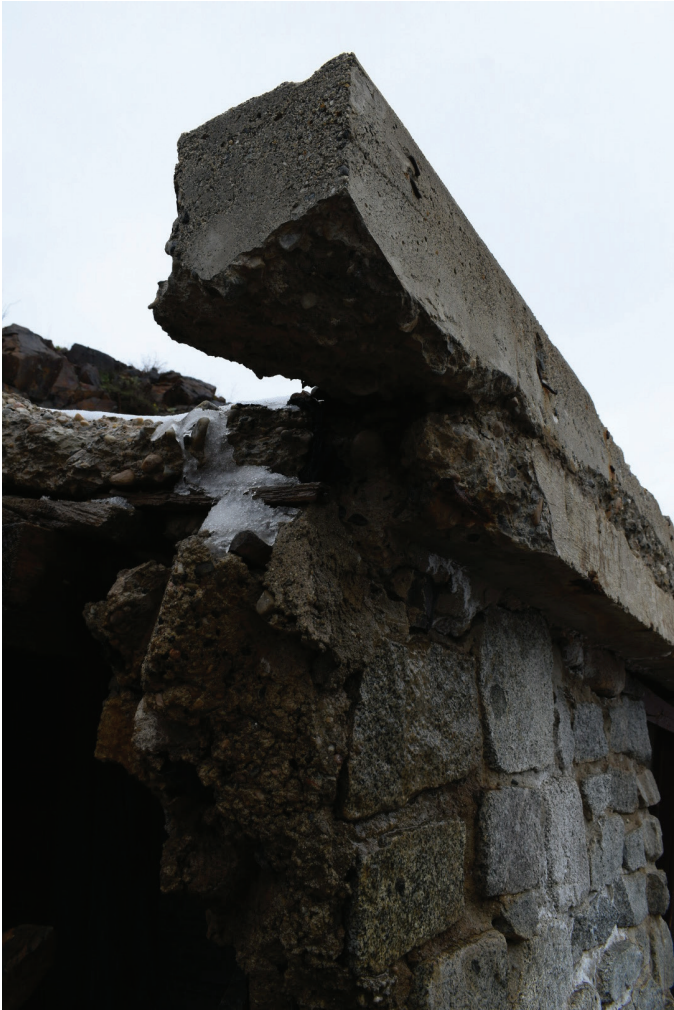
There is heavy deterioration in the concrete structure of the roof.. The rebar is exposed on the face of the slab and is rusting out. There is significant deterioration of concrete on the eaves of the slab. In addition, there is significant deterioration on the top of the slab where initially there was likely minor spalling which began to pool and collect water which exacerbated the spalling. Despite the sloped roof, this condition appears to be ongoing. At some point in time, a curb wall was installed at the south edge of the eave to prevent water and snow from dripping off the edge, and a short section of it still sits atop of the roof, though in poor condition, and due to heavy damage to the curb, parts and pieces of it are lying on the ground.

In addition, there is a cast iron vent pipe that extends through the roof that has a significant amount of rust.

a. First, the entire roof should be cleaned off. Stabilization of the roof will require a fair amount of concrete restoration to further arrest the cyclical freeze thaw damage now underway. Any failing concrete should be removed down to sound concrete. The entire concrete roof structure should be sounded with a hammer to determine the integrity of the existing structure. Any detectable hollow areas in the slab should be hammered out and removed. Rusted rebar should be removed by chipping out the concrete around it and exposing the damaged rebar. New rebar can then be installed adjacent to the existing by epoxy in the new rebar. New concrete can then be reinstalled where removed. The surfaces of the concrete should be rough enough to provide an adhesible substrate for the new concrete. Any cracks in the concrete should be scraped out with a small V-shaped chisel to a depth of at least ½ inch and patched in with new concrete.

b. The vent pipe should be outfitted with a metal cover which prevents water from infiltrating inside the building.
2. **Better** (Code Compliance)

a. In addition to the recommendation stated above, this category requires that the water running off the south end of the roof be collected and directed away from the building to a proper storm water runoff system, which could be connected to the city's stormwater system or could be detained on site. The gutter system is really intended to be functional first and foremost, therefore a K-style aluminum gutter, painted to match, or approximate the color of the concrete, can be installed with a matching downspout.

b. Also, because the roof is bare, exposed concrete, a membrane roof should be installed. Again, because this is a functional requirement, a white TPO roof can be installed.
3. **Best** (Restoration)

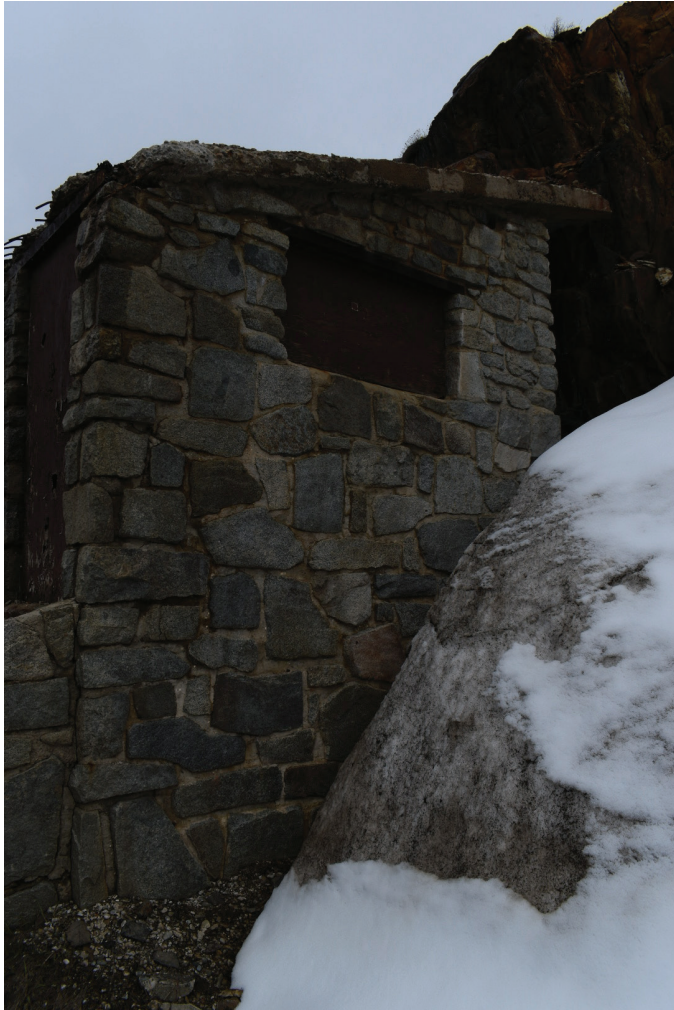
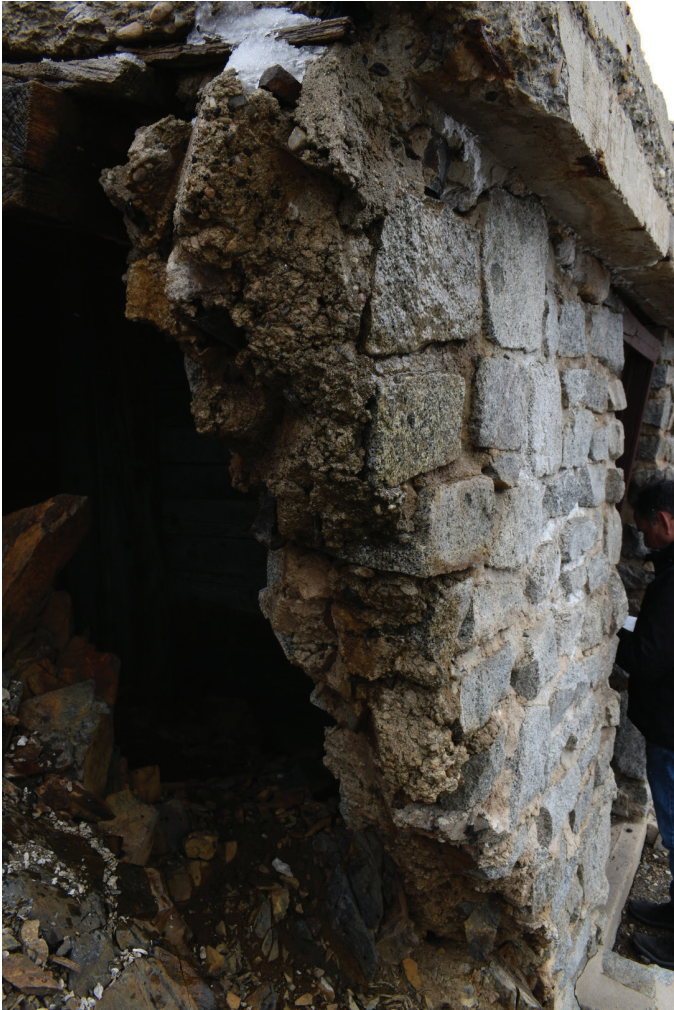
The stacked stone walls on the south and east facades are themselves in fairly good condition. There does not appear to be any significant step cracks in the mortar joints, and the stones themselves appear to be intact. There is however a significant amount of mortar deterioration between the stones, as would be expected of a building of its age. Namely, the mortar has eroded away from the face of the wall thus providing a shelf for the water to pool on. Additionally, there is a significant amount of mortar deterioration between the stone wall and the concrete roof. Lastly, on the south wall as the wall extends to the west and meets the rock, there has been significant ruination of the wall due to erosion.

- a. Stabilization will require that the mortar be repointed as necessary. This will involve raking out the damaged mortar with hand tools, cleaning out the joints, and repointing the joints with a mortar that matches, the color, the texture, the profile, and aggregate mix. The mortar should be a lime-based mortar that is softer (lower compressive strength) than the surrounding stone. Because the mortar is largely set back from the wall due to erosion, this should be raked out to at least a depth of 2x the width of the joint. Then the appropriate mortar can be installed flush with the stone.

- b. Soils should be sloped away from the base of the wall at a minimum of 2%.
 - c. A non-growable medium (drainable fill) should be installed 18 inches out from the wall for a minimum depth of 12 inches around the base of the building to eliminate plant growth at the base of the building.

- a. Same as above
 - b. There is a significant amount of erosion on the face of the south wall as it extends to the west. It appears that this wall would have originally been mortared into the rock. In order to properly stabilize this portion of the wall, it should be rebuilt. To properly do this, rebar should be drilled and epoxied into the rock substrates and likewise into the base of the rebuilt stone wall. New stone can be stacked and mortared into place above this base wall and up to the roof. A non-shrinkable grout should be placed between the top course of stone and the roof structure. Likewise, as the base of the wall was embedded into the rock, rebar should be drilled and epoxied into the roof and the uppermost stone coursing. This section of wall should extend all the way to the rock west of the building and a non-shrinkable grouch should be installed between the rock and the wall.

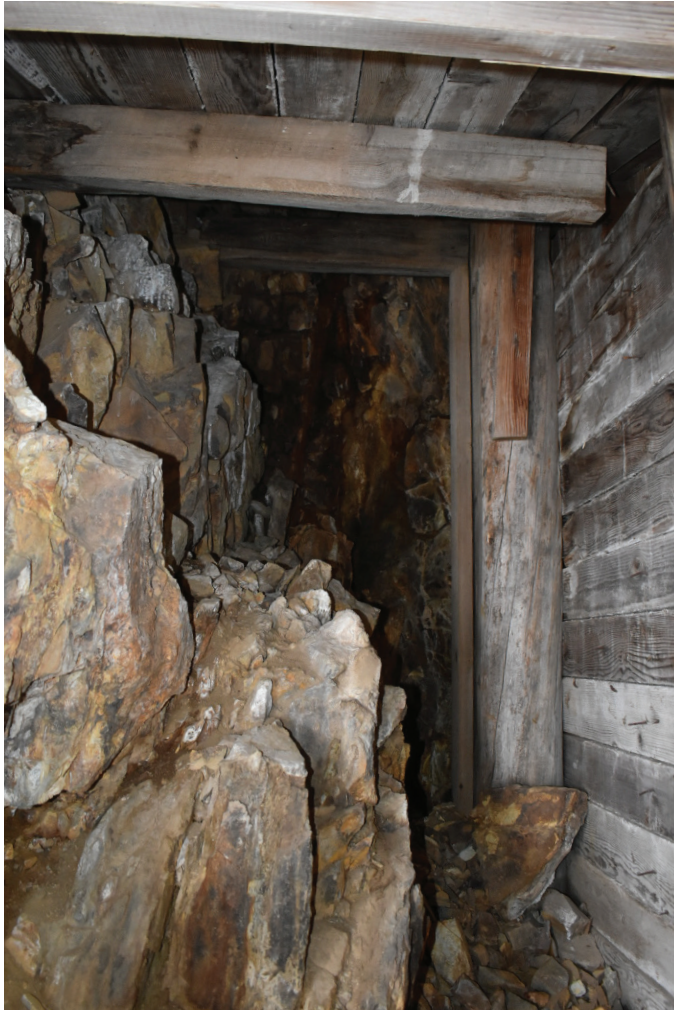
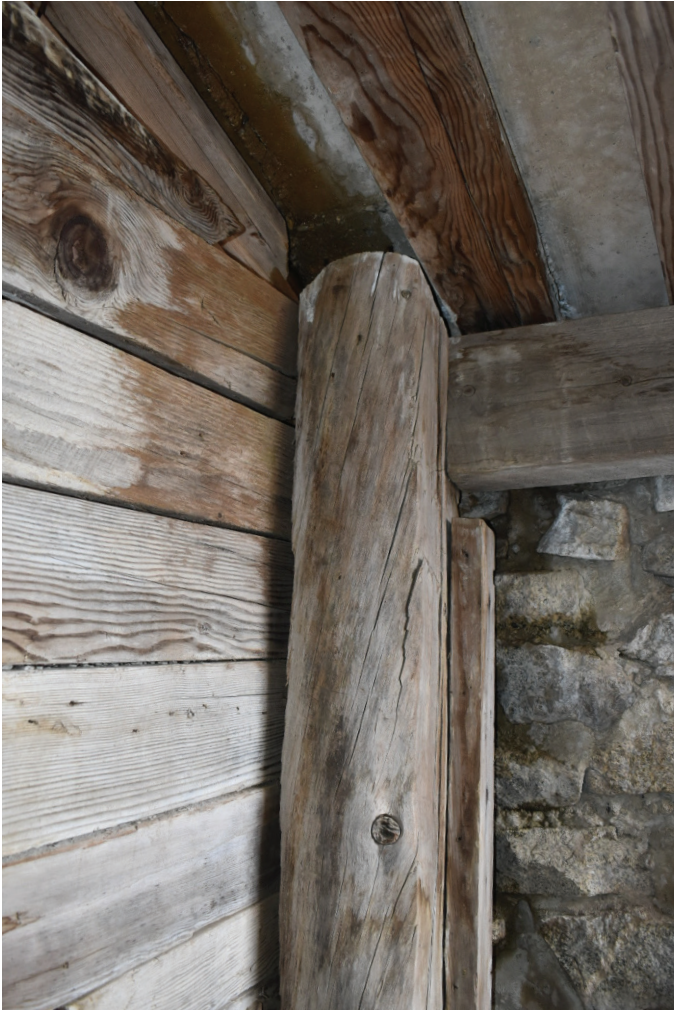
The logs are embedded in the dirt and extend up to the roof, but rest most likely on a reinforced concrete foundation, or pier in this case, though the below grade condition was not observed. Wood beams are carried by the logs and extend about two feet to the edge of the roof. The beams run through the interior to the opposite side. In some cases, there is a stud on the outside face of the log to provide additional support for the beam above. Its not clear if this is original or was added later. The wood-framed walls are highly under-structured. The logs carry the weight of the roof and transfer that weight to the foundation system. The 1x4 wood slats between the logs are simply infill and not load bearing. It is unclear if the logs have the structural capacity to carry the roof loads. The logs appear to be in good condition, however the wood infill wall between the logs is in very poor condition. In addition to being coated in a lead-based paint, there is heavy deterioration in the wood itself. In addition, as stated above there appears to be a thin wood veneer over the 1x4's but this has entirely failed.

- 1. Good** (Stabilization)
 - a. Not applicable
- 2. Better** (Code Compliance)
 - a. To better carry the roof loads, the infill wall between the logs should be removed and rebuilt. The best way to accomplish this is to pour a new foundation wall between the logs (see section on vault). Once that is complete, a new wood stud wall can be built on the new foundation wall. This wall can be sheathed and should be protected on the outside of the wall with a house wrap and covered in new treated 1x4's. The inside should also be finished in the 1x4 slats. This wall should be extremely breathable. Water will infiltrate this system, and the intent is that it will dry out passively. The walls should be painted on the inside. If reasonable, the piers, if they exist, should be supplemented structurally. Ideally, the logs should be painted to protect them from further weathering.

- 3. Best** (Restoration)
 - a. Same as above
 - b. In addition to the recommendations listed above, any detailing on the interior should be restored.

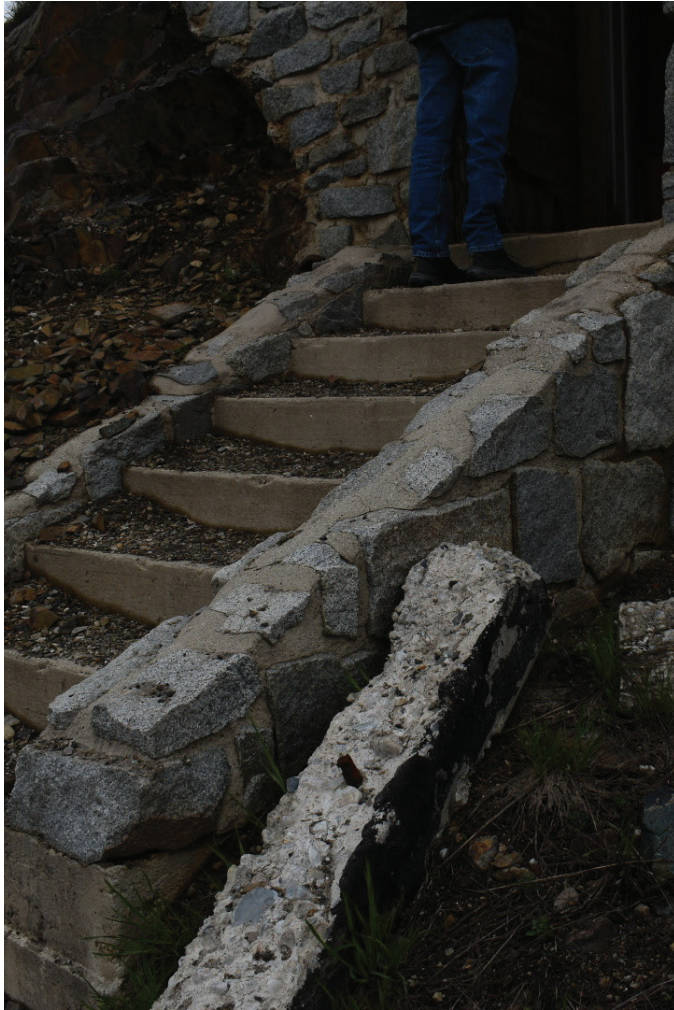
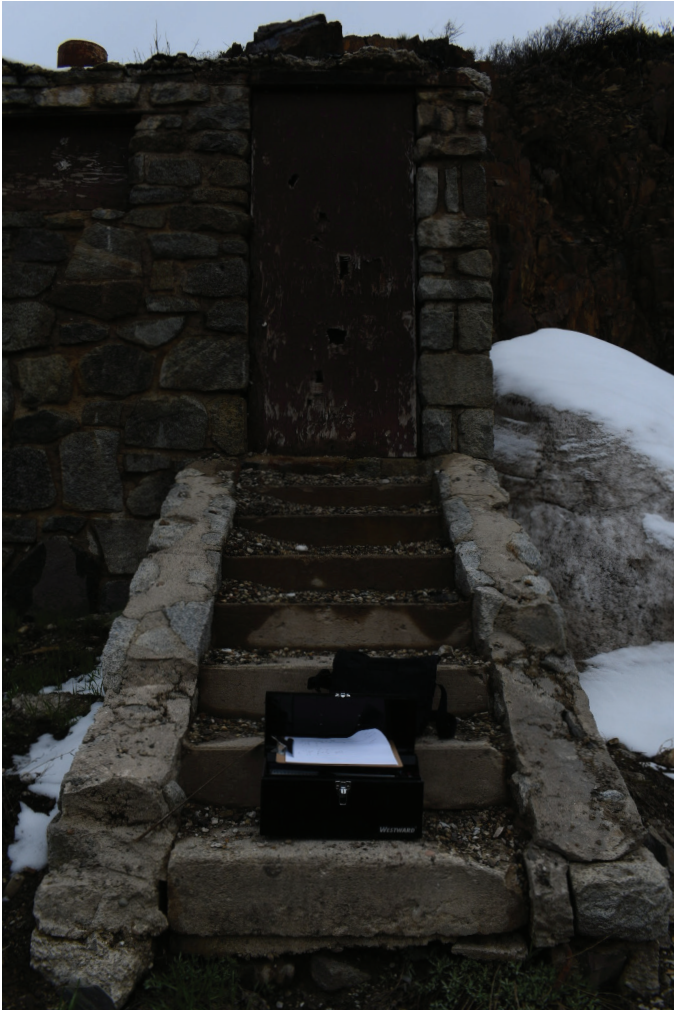
The stone stoops situated along the south face of the building are in good condition structurally speaking. Though they provide access to the elevated structure, current code requirements dictate that a landing be present outside the doors and that a landing is at level with the floor. Furthermore, code requires accessible entry to the building. This is not the case with these stoops. As one exits, the building one steps directly down one step from the door. The steps appear to meet current code with regard to the rise and run, however, there are no handrails or guard rails associated with this component. The final step down to grade is about 18 inches and is. due to erosion.

- 1. **Good** (Stabilization)
 - a. not applicable
- 2. **Better** (Code Compliance)
 - a. To better meet accessibility code and to ensure that these restrooms are usable the stoops should be disconnected from the building and shifted 5 feet away, if this does not encroach in the right of way. Rather than moving them, or relocating them, they should be reconstructed. The stone that is currently on the Stoops should be reused on the new stoop and it should be reconstructed in the exact manner. The intent of this is that the finished look of the stoop will be the same. Because this is new construction it will require a reinforced masonry or concrete wall supporting the stoop. In the gap between the stoop and the building a new landing should be constructed on level with the finished floor of with the structure.

- b. New guardrails and handrails should be installed the reconstructed stoops. Because the stoops rise more than 30 inches vertically a 42-inch guardrail is required by code. This guardrail should be as light as possible, so it does not conflict with the primary architecture of the structure. This may be achieved by utilizing one by two steel bar stock with aircraft cable strung tightly between. The handrails should hang off the guardrail structure.

- c. Again, to enhance accessibility, one of the restrooms should be wheelchair accessible. Because the stoops were shifted 5 feet this allows for a ramp structure to be constructed. The ramp should be as light as possible, similar to the guardrail. This can be constructed of steel and will require both a handrail and a guardrail and cannot exceed a 5% slope.

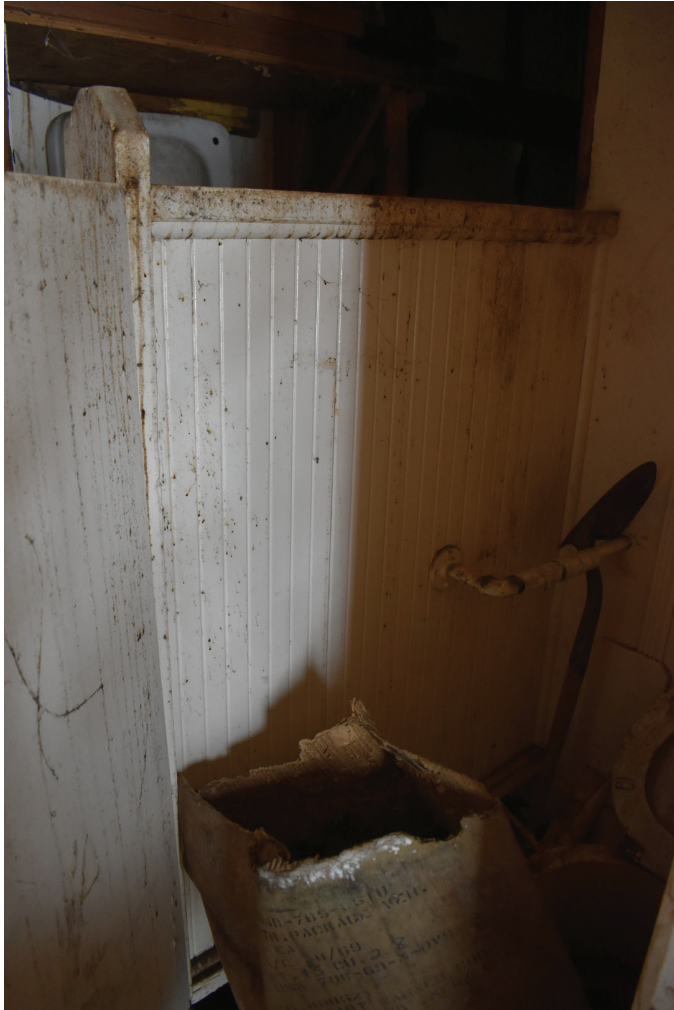
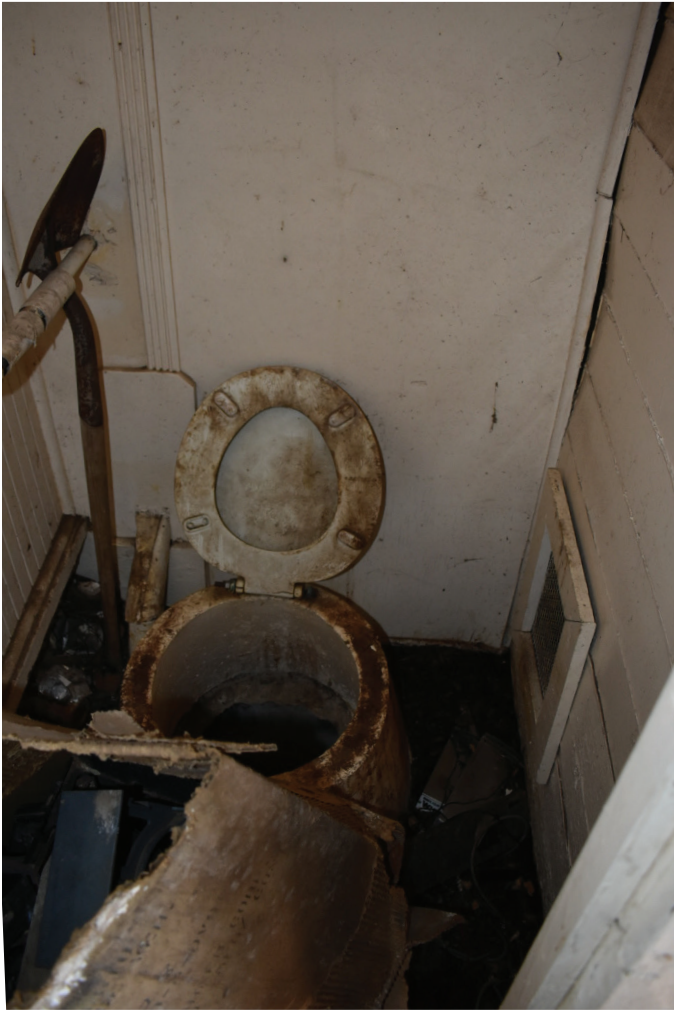
As is the case of the interior walls, the interior furnishings, which includes the toilet partitions and the toilets, of the structure are in very poor condition as well. The toilet partitions are made of wood and are highly damaged. Apart from being in poor condition, part of the dividing wall is missing as are two of the toilet partitions. The toilet fixtures are in extremely poor condition. Nothing on the interior meets modern building code. In addition, there is a significant amount of hazardous material on the interior.

- 1. **Good** (Stabilization)
 - a. Removal of all interior furnishings including partitions and toilets.
 - b. Abatement of all hazardous material.
- 2. **Better** (Code Compliance)

- a. Same as above.
 - b. In addition, and to better meet modern building codes, a new partition wall should be constructed between the two halves of the building. Each of these spaces should be unisex restroom. Each of these spaces should also only be a single user facility.

- c. The holes in the slab should be infilled with new concrete and a new hole should be introduced in a location that meets current code (see section on Vault).

- d. The slab should be thoroughly cleaned and sealed with an epoxy floor finish.
 - e. New pit toilet fixtures should be installed above the holes.
 - f. New toilet roll paper holders and sanitizing hand stations should be installed in each of the rooms.

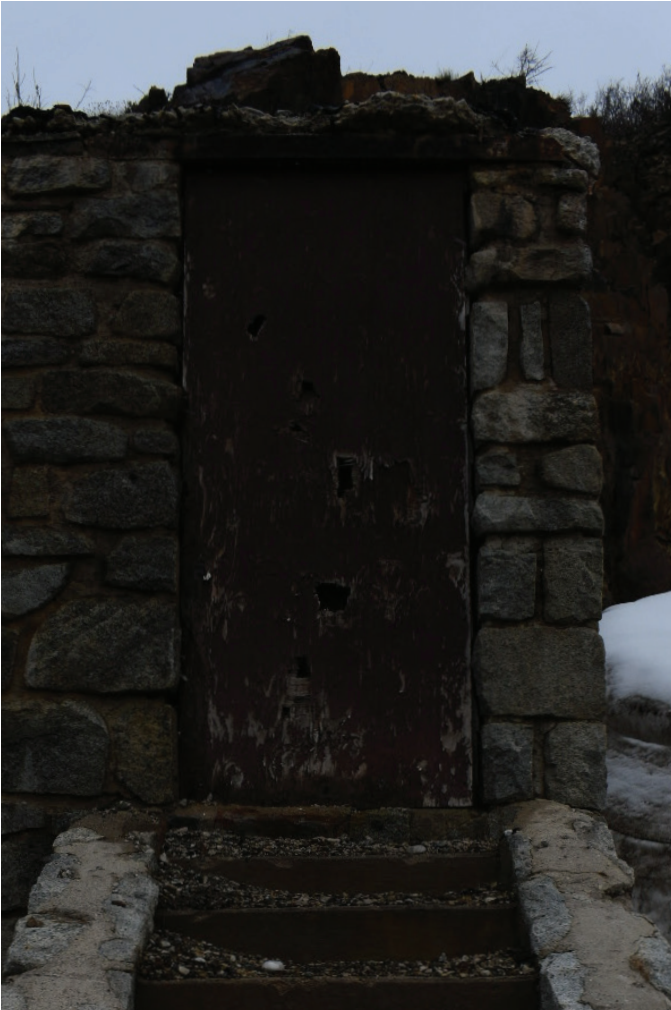
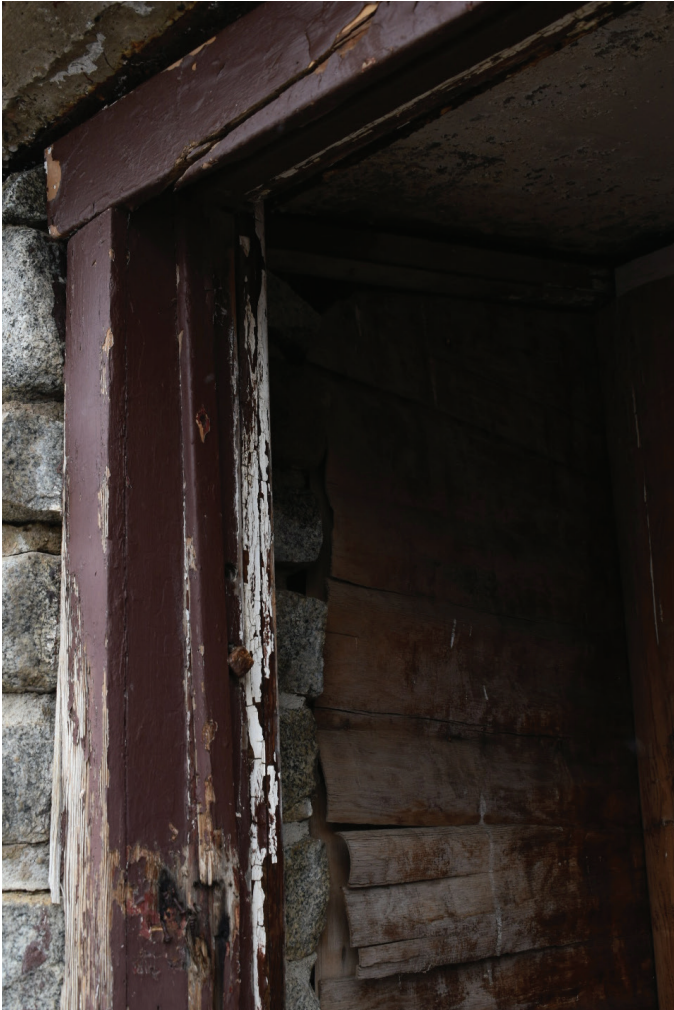
Both doors are currently missing. Each of these doors has been covered with a plywood sheet. There is a door on the interior of the building which has a wood panel below and a single light above. This may be the original door. However, because it is in such poor condition it is likely not usable. The door frame is one of the more interesting features of the building. It is a simple door frame, about three inches wide, but it is scribed to the stone jamb surrounding it.

- 1. **Good** (Stabilization)
 - a. Replace the one of the existing plywood sheets with a new painted plywood sheet that is secured with a lock and is set on hinges to allow easy access in and out of the building.
- 2. **Better** (Code Compliance)
 - a. Remove the plywood sheets.
 - b. The wood frame should be salvaged and reinstalled.
 - c. Install 2 new hollow metal doors in each of the openings.
- 3. **Best** (Restoration)
 - a. In addition to the recommendations above, instead of two new hollow metal doors, a new door based on the existing door inside the building should be constructed. However, rather than having an upper glass panel, this should be a solid wood panel To enhance the security of the building.

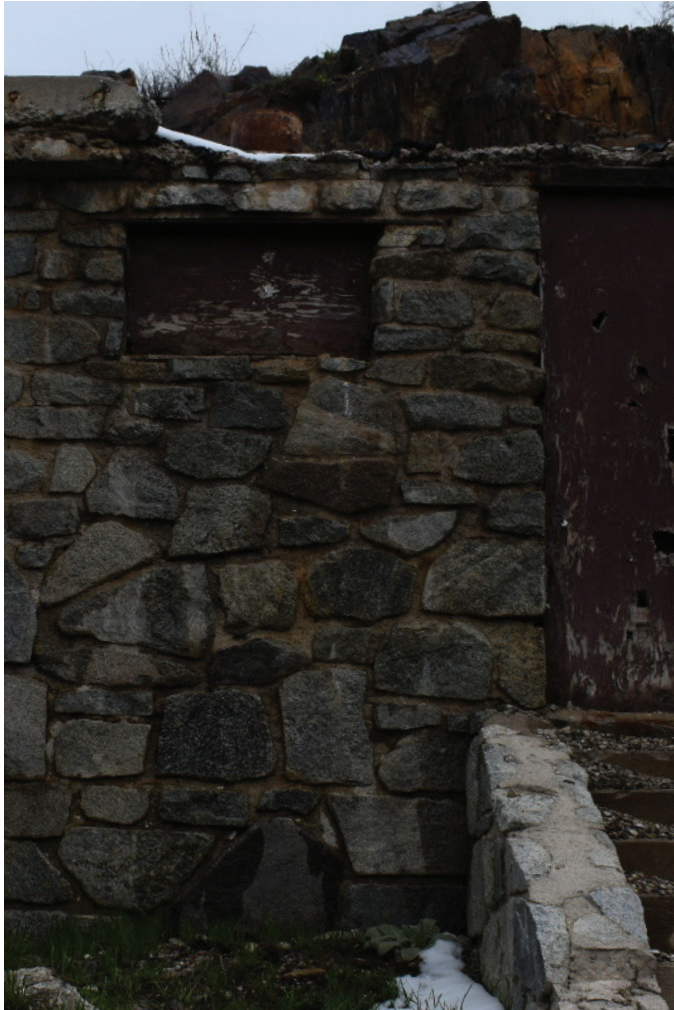
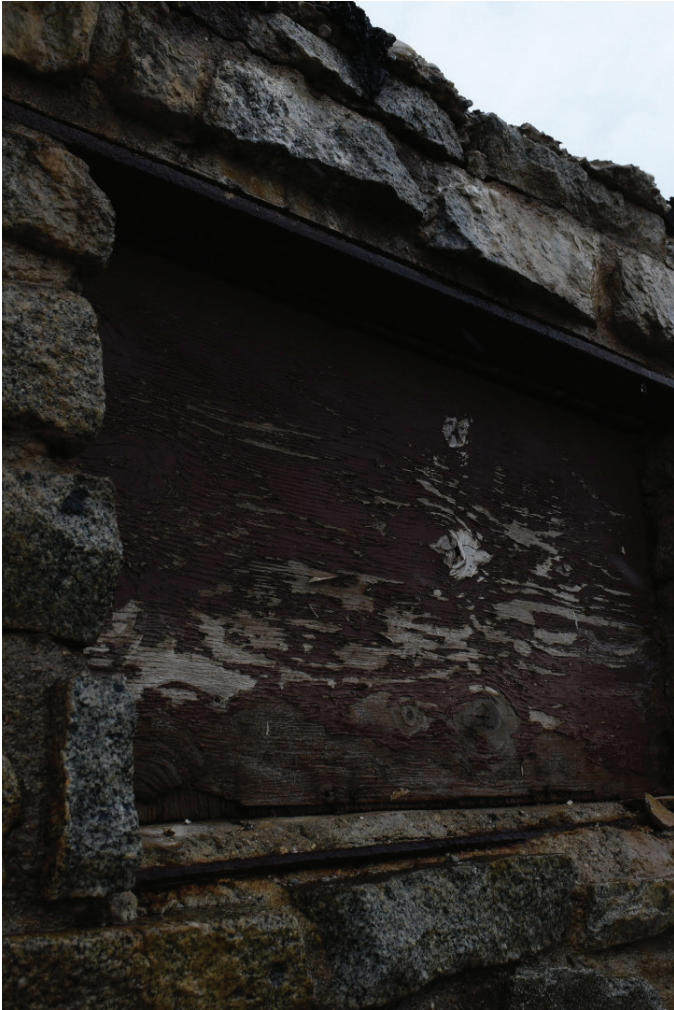
The two windows in the building are extant. They are currently covered in a plywood sheet on the outside. Both windows appear to be in fairly good condition.

- 1. **Good** (Stabilization)
 - a. Not applicable.
- 2. **Better** (Code Compliance)
 - a. Remove the plywood sheets.
 - b. Restore the windows.
- 3. **Best** (Restoration)
 - a. Same as above

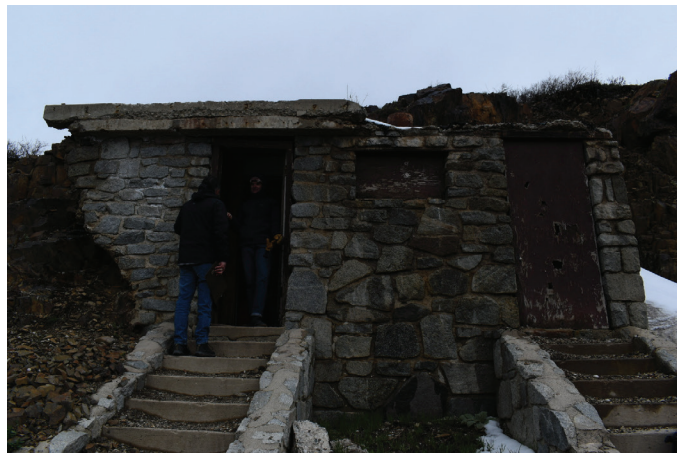
The type of construction is unreinforced stone exterior walls on two sides (south and east walls) with a six-inch thick poured-in-place, board formed concrete roof slab. The two other sides are enclosed with wood framed walls with spaced timber columns placed for support of the roof slab. The floor appears to be a concrete slab on grade. It is unknown if there is a concrete foundation or just stone rubble.

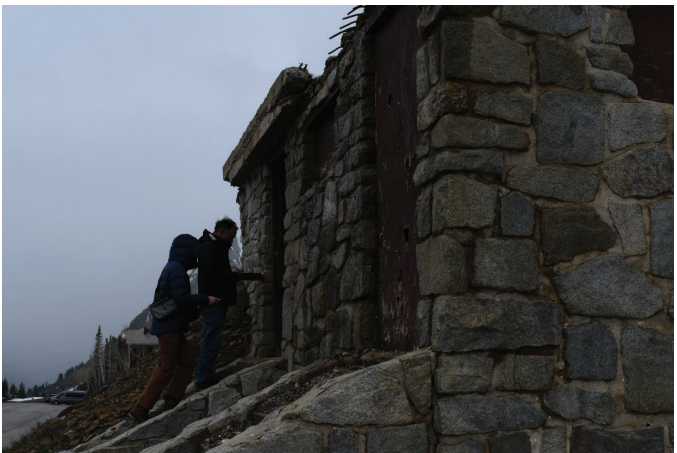
The stone walls appear to be in excellent condition with no signs of settlement or cracking. Mortar used for construction of the walls is a Portland cement mix that shows no signs of significant deterioration. The west end of the south wall has not been finished straight but has a jagged edge. It is assumed that this edge of wall was placed against the existing rock hillside, but that the rock is fragmented and has spilled away from the wall forming a rough gap between building and hillside.

The top of the concrete roof slab has been exposed to weather and snow melt for many years and shows significant signs of deterioration on top with exposed aggregate and spalling of concrete. However, observation of the underside shows the concrete in good condition with no significant signs of cracking, water damage, or spalling of concrete. Steel lintels placed over the doors for support of the roof slab show signs of rust due to the water run-off from the roof.

The timber support posts appear to be in good condition and have not been adversely affected by moisture and appear to be supporting the roof adequately at the present time.

1. Due to the excellent condition of the stone walls, no re-pointing of mortar or repair work is recommended. However, if the jagged edge of the south wall needs to be improved for aesthetic reasons, this area can be rebuilt or natural stone from the hillside can be placed to fill the gap.

2. The rusting steel lintels should be cleaned and sealed to inhibit further deterioration. Replacement may be required if field investigation indicates that the steel has been compromised.

3. The timber posts supporting the roof slab appear to have no positive connection with the slab. Steel brackets should be placed with bolts into the timber posts and drill and epoxy anchors into the roof slab. This will help ensure stability in the event of lateral ground motion induced from a significant earthquake event.

4. Even though the concrete roof slab has supported heavy snow loading for many years, repairs are recommended to prolong the longevity of the structure. The following repair options are recommended based on cost.
