# Town of Alta

## Facilities Master Plan

AUGUST 2025

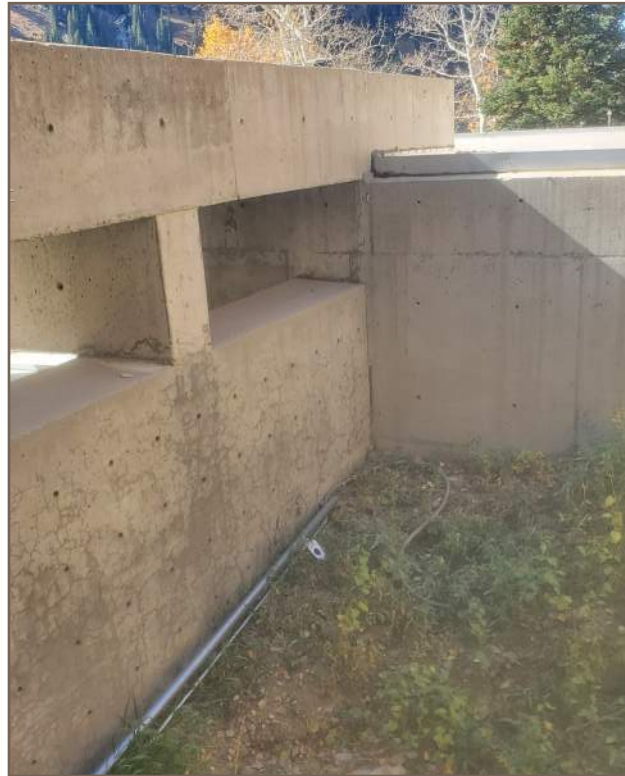
The concrete foundation and retaining walls are in good overall condition and do not exhibit areas of spalling, honeycomb or significant cracking.

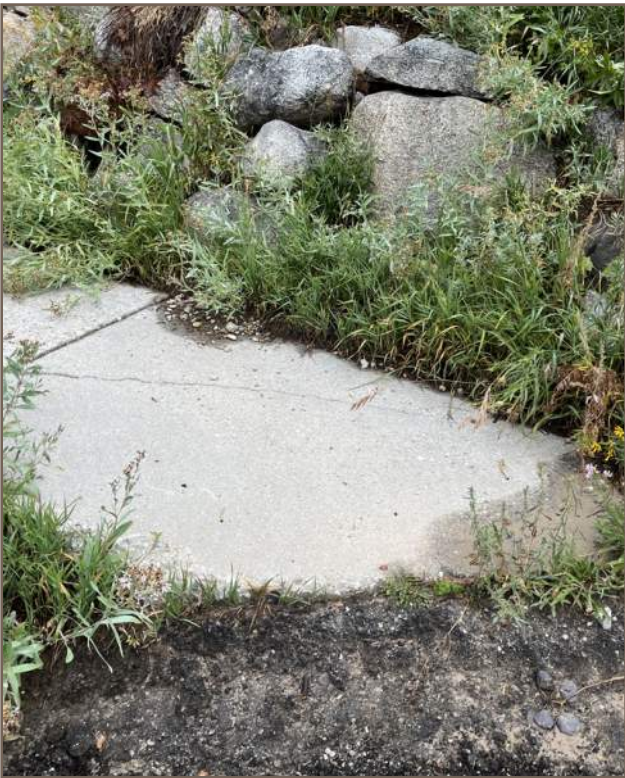
Because the building is built into a steep hill, the building does not have an accessible path from a parking area. The two sidewalk approaches to the entries are both close to being accessible but have glaring failures. Despite the accessibility failures, the walks are comfortable to navigate, and most visitors will likely have no issues gaining access to the building. Of the two walks, the first-level entrance is the closest to an accessible path, but the sidewalk stops short of the road and has a short section of vegetation interrupting the path. The second-level walk has a step at the bottom that also interrupts the walk from the road. Both approach walks appear to be close to the 5% maximum slope, but likely exceed that limit.

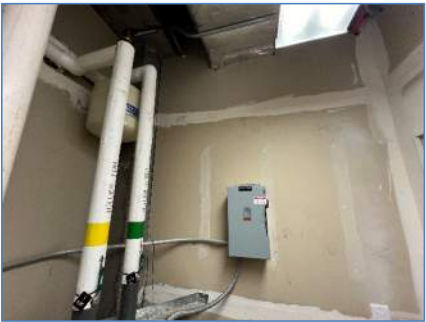
- i. A large mechanical duct is located above the boiler disconnect switch which not in compliance with NEC 110.26 (E). This should be fixed in by relocating the duct or the disconnect.
- j. The wiring devices (light switches, receptacles, etc.) appear to be in good conditions.
- k. The women's restroom receptacle outlet is not GFCI protected as required in NEC 210.8 (B)(1). It is unknown if the outlet is protected by an upstream GFCI outlet. This should be further investigated and a proper GFCI protection should be provided.

Exhibit 7 – Mechanical duct above the boiler disconnect

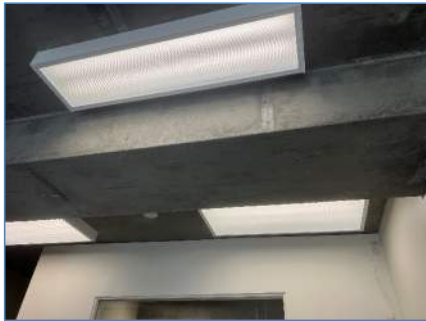
- c. The as-built drawings indicate the presence of the egress lighting fixtures with the integral battery packs. We were not able to field verify the egress light levels (1 fc average, and 0.1 fc minimum). If the lighting upgrade is considered in the future, the egress lighting should be completely upgraded at that time.
- d. Existing lighting controls consist almost solely of the toggle switches. A couple of wall mounted occupancy sensors are observed in the restrooms.
- e. Significant upgrades to the interior and exterior lighting control systems are needed to meet the latest energy codes. There are opportunities for energy savings by installing lighting controls such as occupancy sensors and timed relay controls.

Exhibit 9 – Fluorescent surface troffers

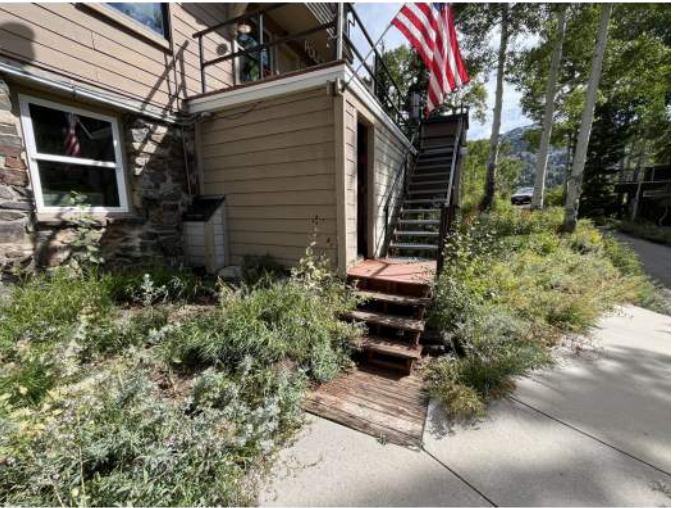
Other basic accessibility provisions such as hall width and door hardware are completely missing. The building does not have an elevator or wheelchair lift to provide an accessible path between floors.

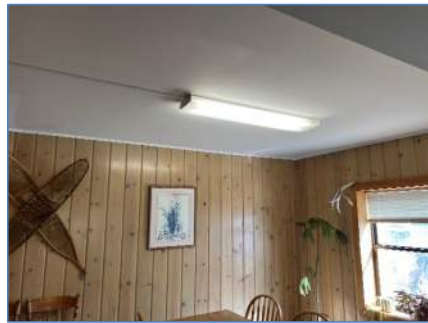
- a. Most of the building has florescent lights. The existing light sources are outdated and inefficient. All existing light fixtures and bulbs are recommended to be replaced with new LED lighting. Each space will need to be evaluated individually to determine the extent of the upgrade needed.
- b. The egress lighting is provided using emergency bug-eyes. We were not able to field verify the egress light levels (1 fc average, and 0.1 fc minimum). If the lighting upgrade is considered in the future, the egress lighting should be completely upgraded at that time.

Exhibit 11 – Fluorescent surface light fixture

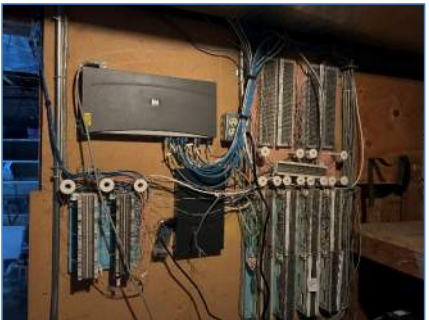
- a. The telecommunication equipment is located at the lower level and in one of the offices at the upper level (equipment rack with the radio equipment, etc.).
- b. A dedicated A/C system and telecommunication ground bus bars were not observed at these locations.
- c. Abandoned data and telephone wiring is scattered throughout the building.

Exhibit 13 – Lower-level telecom equipment

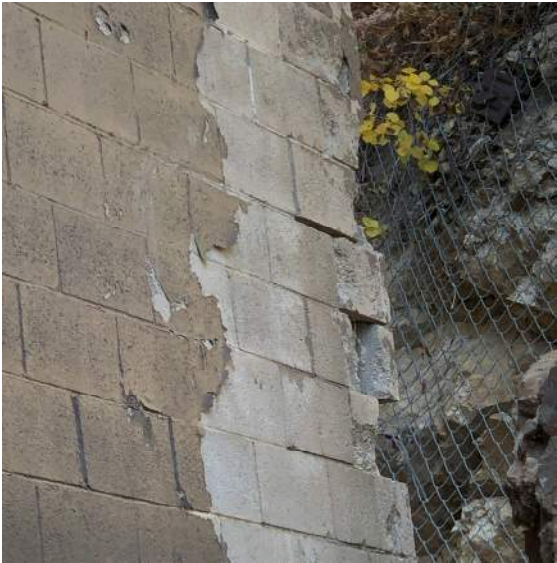
Photo #3 – Damaged CMU Walls

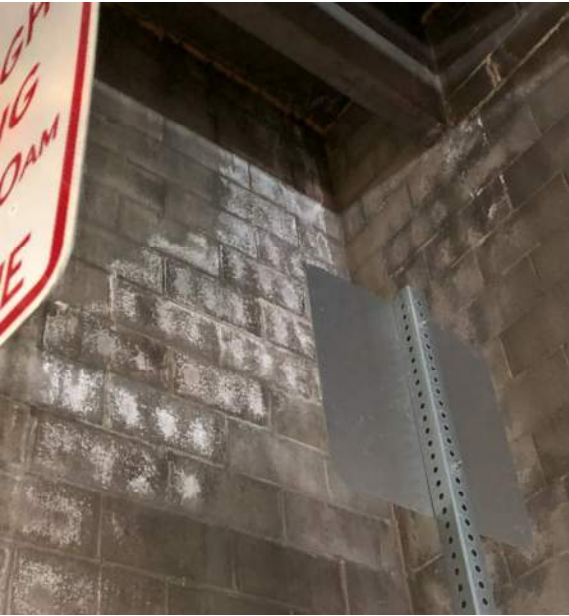
Photo #4 – Moisture Infiltration in CMU Walls

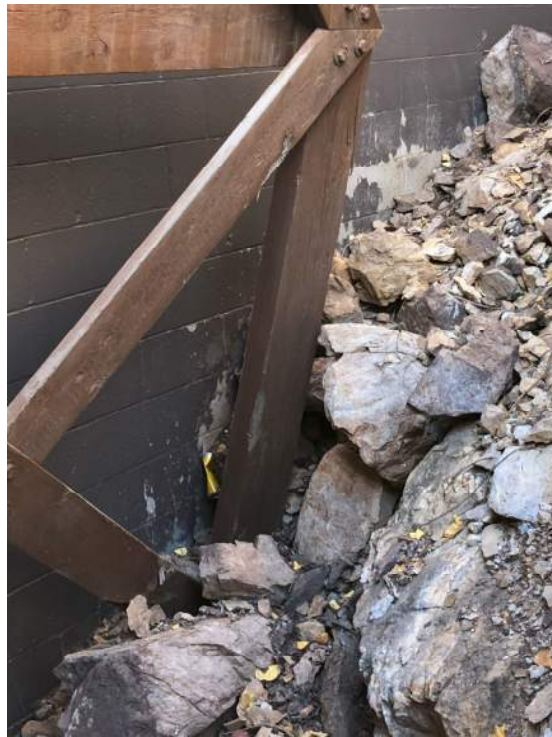
Photo #5 – Rock Fall Damage to Framed Addition Base

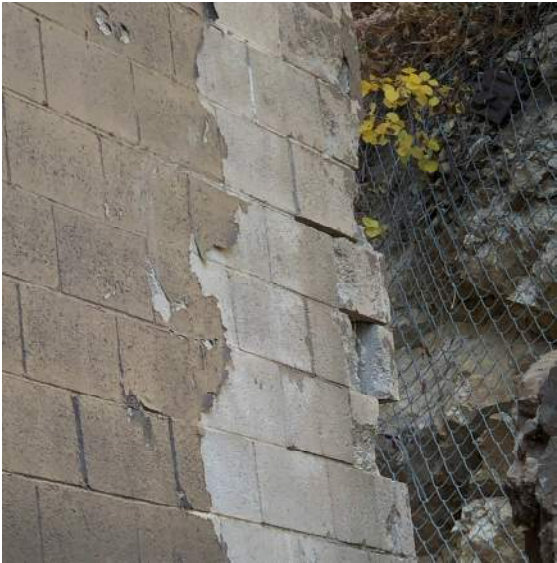
Photo #3 – Damaged CMU Walls

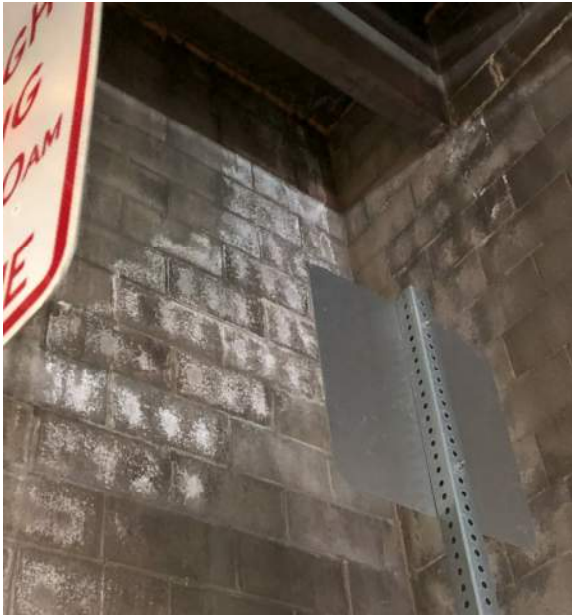
Photo #4 – Moisture Infiltration in CMU Walls

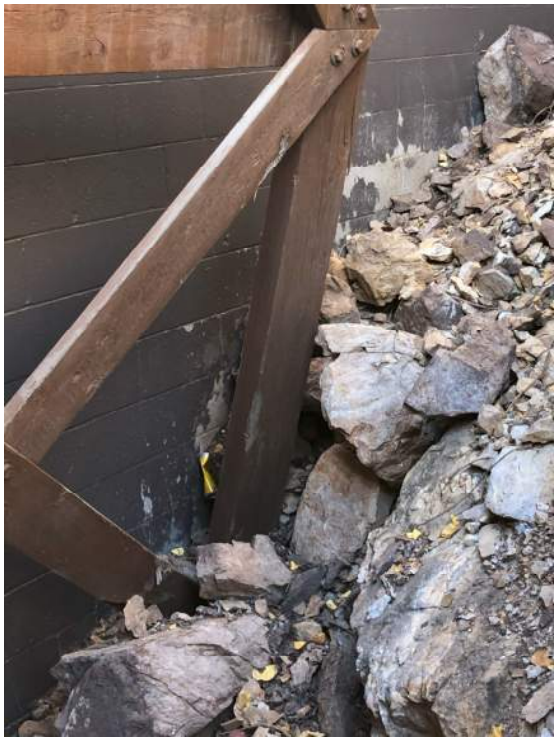
Photo #5 – Rock Fall Damage to Framed Addition Base

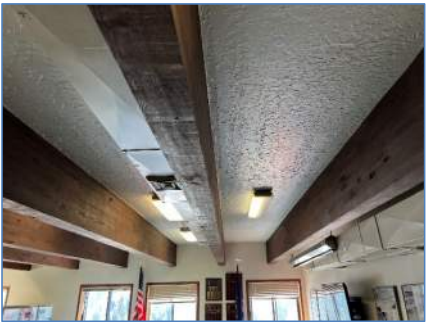
- a. Most of the building has florescent lights. The existing light sources are outdated and inefficient. All existing light fixtures and bulbs are recommended to be replaced with new LED lighting. Each space will need to be evaluated individually to determine the extent of the upgrade needed.
- b. The egress lighting is provided using emergency bug-eyes. We were not able to field verify the egress light levels (1 fc average, and 0.1 fc minimum). If the lighting upgrade is considered in the future, the egress lighting should be completely upgraded at that time.
- c. Existing lighting controls consist solely of the toggle switches.
- d. Significant upgrades to the interior and exterior lighting control systems are needed to meet the latest energy codes. There are opportunities for energy savings by installing lighting controls such as occupancy sensors and timed relay controls.

Exhibit 7 – Fluorescent troffers – upper level

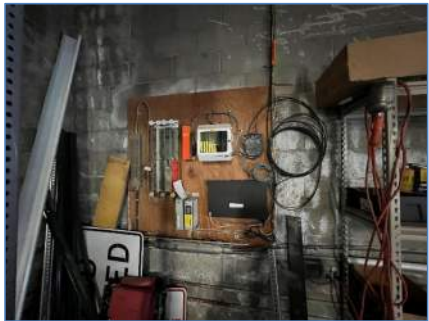
- a. The telecommunication demarcation equipment is located at the lower level in the high bay area.
- b. This environment is not suitable for telecom equipment, it's not properly conditioned. The telecommunication ground bus bar was not observed at the demarc location.
- c. A telecommunication pedestal is located in front of the building. The purpose of this pedestal is unknown.

Exhibit 11 – Telecom backboard in the high-bay area

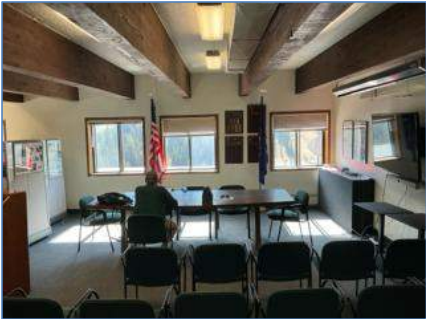
- b. The council chambers AV system consists of a wall mounted display, video conference bar, and connection cables connected to the back of the display.
  - 1) VC bar is inadequate for the space. Its current location limits the camera site lines for both council members, and public presenters, showing only profile views of presenters, and the council members.
  - 2) Requires the city manager to site next to the display to run the meeting.
  - 3) VC bar limits remote viewers to only see whomever is speaking the loudest.
- c. An old 4x3 projection screen hangs from the ceiling at the same location as the as the display.
- d. There is no in-room voice lift system, limiting speaker to their own voices.

Exhibit 13 – Council chambers.
