TOWN OF WHEELOCK  
REQUEST FOR BIDS  
FALL BROOK ROAD BRIDGE

## PA Mitigation Site Inspection, Virtual and In-Person (Template)

**Table 23: PA Mitigation Site Inspection (Template)**

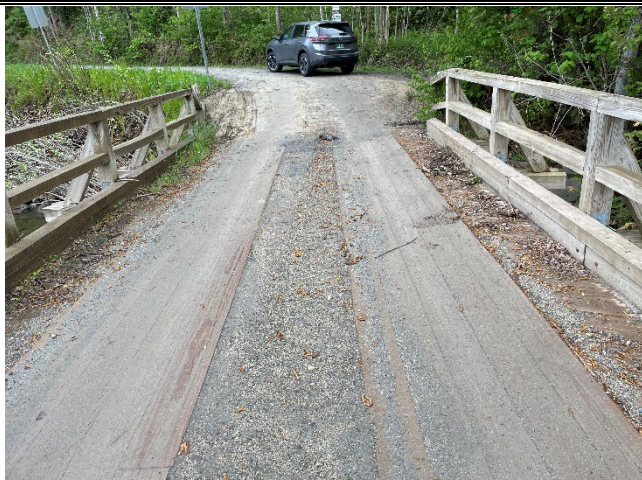
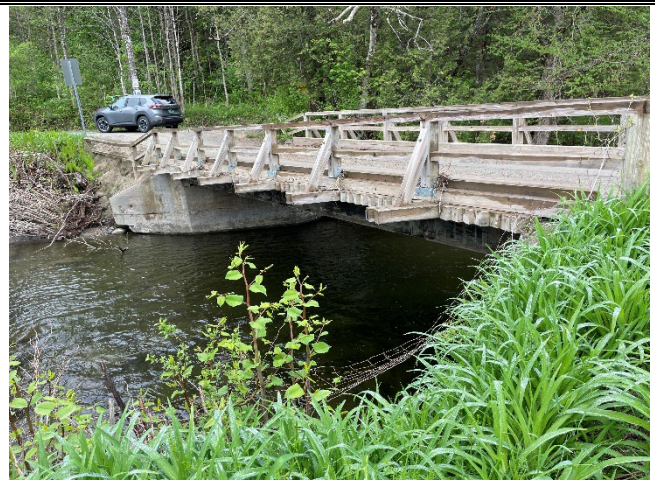
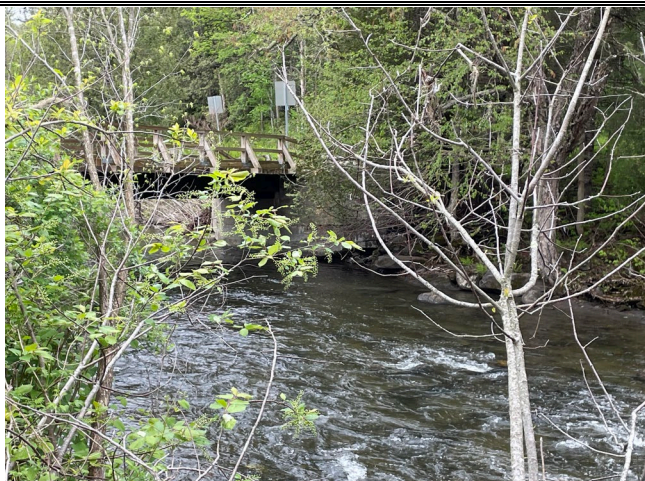
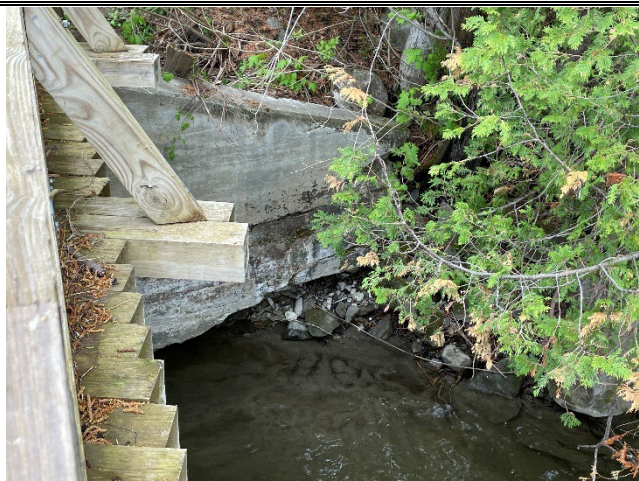
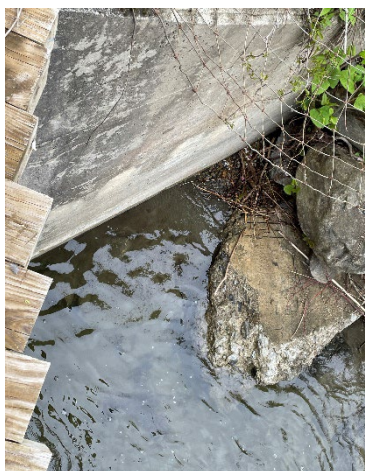
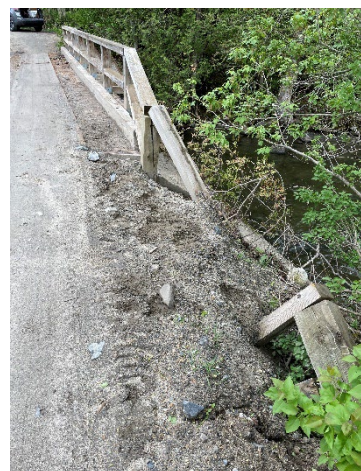
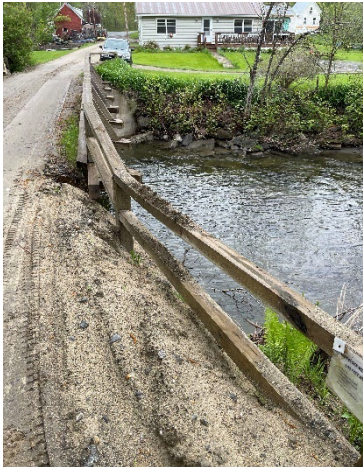
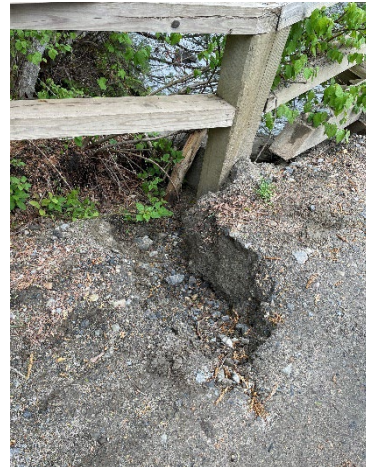
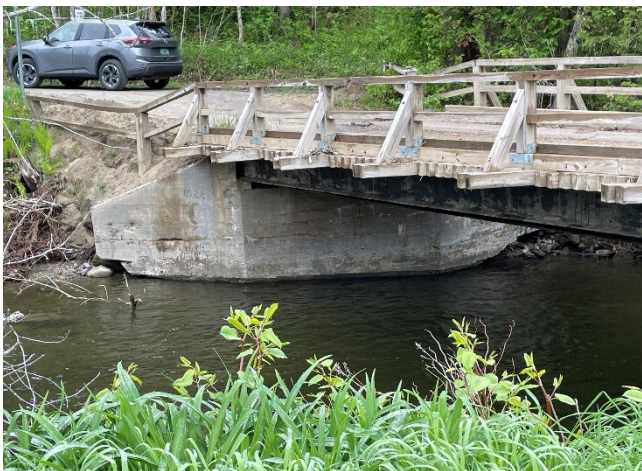
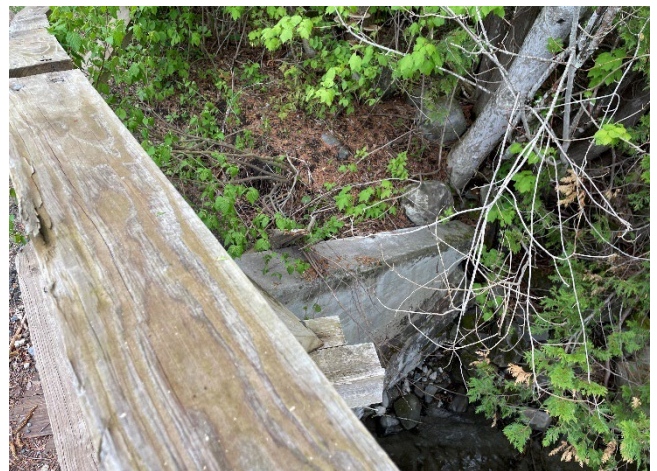
- **Damage #1494374** Category C (Roads and Bridges) Fall Brook Road Bridge #00023, Wheelock, Vermont 05851 Latitude: 44., Longitude:44.587140, -72.085130, Work order dated -03.17.2025 stated: "Flood waters (Miller's Run) rose above deck of bridge eroding approach road and fill at north and south sides of bridge: Location: 44.48714N, 72.08513W. South: 20-ft x 15-ft. x 3-ft. to 8 ft. depth. North: 30-ft. x 12-ft. x 1-ft -5-ft. depth. The material of the deck for the south side and north side appears to be fine gravel. What will be the method of repair for the deck approach is to be determined pending river engineer visit. Requested new site inspection for abutments and guard rails."

\* Applicant indicated on original work order dated 03.17.2025) that work is 50% work complete in reference to temporary infill work that has since subsided or been washed out without fulfilling its structural support intention. The bridge abutment appeared to be substantially damaged as noticed during the 05.20.202 site inspection. The Applicant will be consulting with a structural engineer to confirm whether the bridge should be replaced with a longer span pending on a hydrologic and hydraulic evaluation by the Vermont Agency of Transportation and Agency of Natural Resources.

- **Damage #1494374** Fall Brook Road Bridge #00023. Riverine flooding (Miller's Run) over-topped bridge damaging the North and South approaches, guar rails, abutments, and wing walls.
- **Damage #1494373** Boulay Road (Town Highway 47). Heavy precipitation caused Miller's Run to flood causing erosion to the embankment.

1. This project authorizes: Repair to in-kind dimensions utilizing type IV stone fill with 4-ft keyway.
2. The proposed activity is eligible for coverage under the VT ANR Stream Alteration General Permit.
3. The proposed activity will meet the terms and conditions of the General Permit provided:
  - a) The work is constructed to in-kind dimensions.
  - b) Material removed from site is not deposited within a mapped Flood Hazard Area or River Corridor.

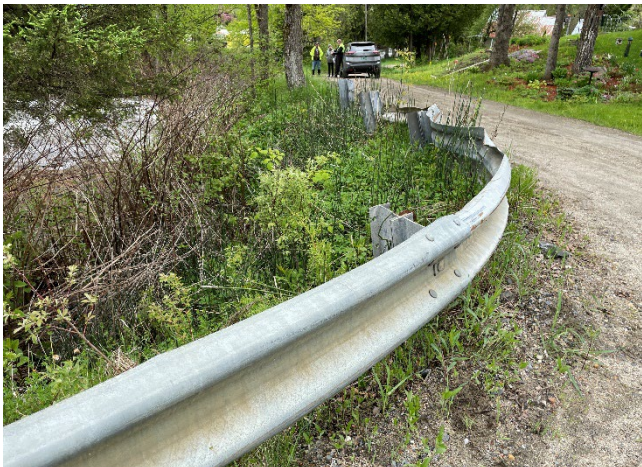
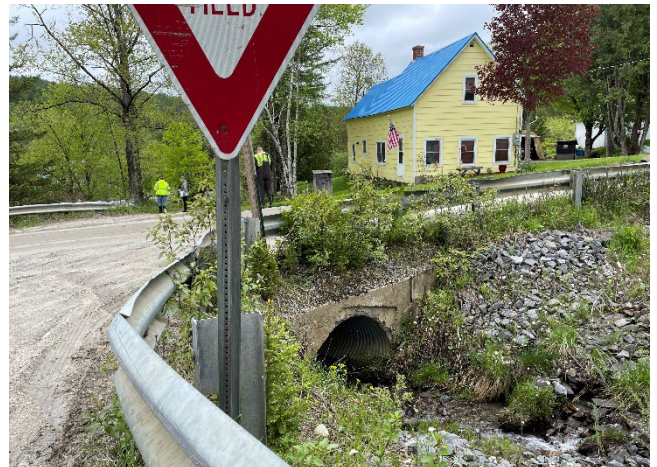
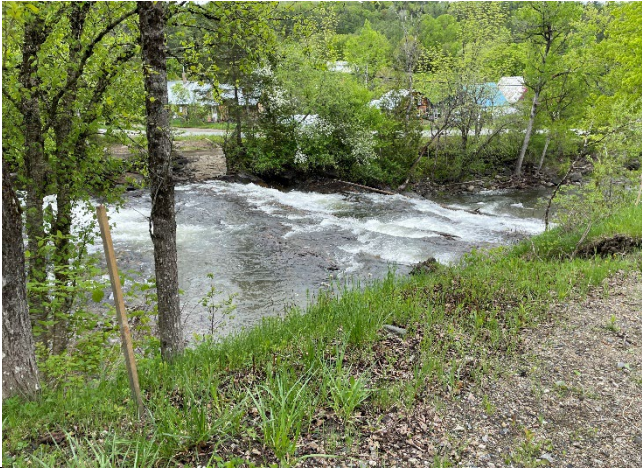
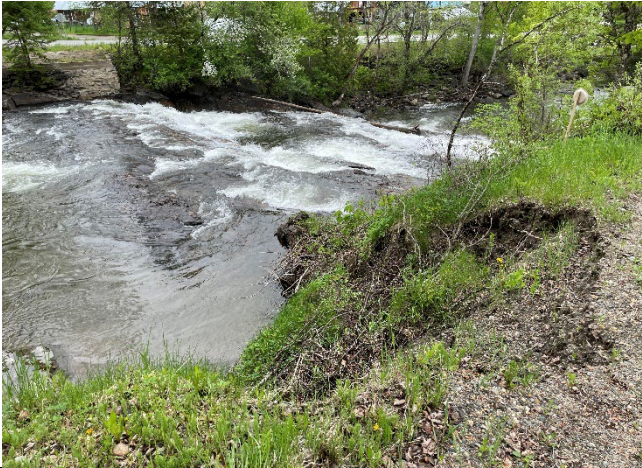
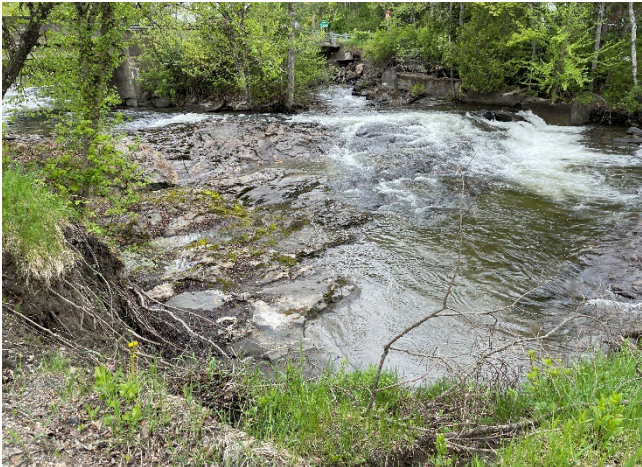
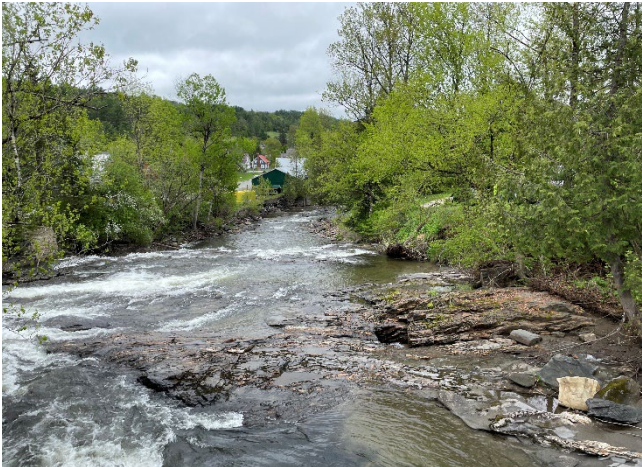
- **Damage #1494373** Category C (Roads and Bridges), Boulay Road (Town Highway 47), Wheelock, Vermont 05851 Latitude: 44.665840, Longitude: -72070870, "Heavy prescription caused problems with embankment. Embankment: 20-ft to 50-ft L x 10-ft to 20-ft W x 12-ft. H = CY. The damaged material of the embankment consists of natural materials, rocks, and soil. The method of repair for the embankment: we need guidance and permit from the river engineer. Spoke with Jason Borg, regional river engineer and Patrick Ross to set up visits." \*\*

\*\*Applicant indicated on site that the collapsed embankment was due to rising Miller's Run flood levels and an undersized an/or clogged culvert at the top of Boulay Road.
