# TOWN OF CLARKTON - SEWER ASSET MANAGEMENT PLAN

October 2025

NC DEQ Project No. AIA-W-ARP-0065

WR Project No. 02200415.02

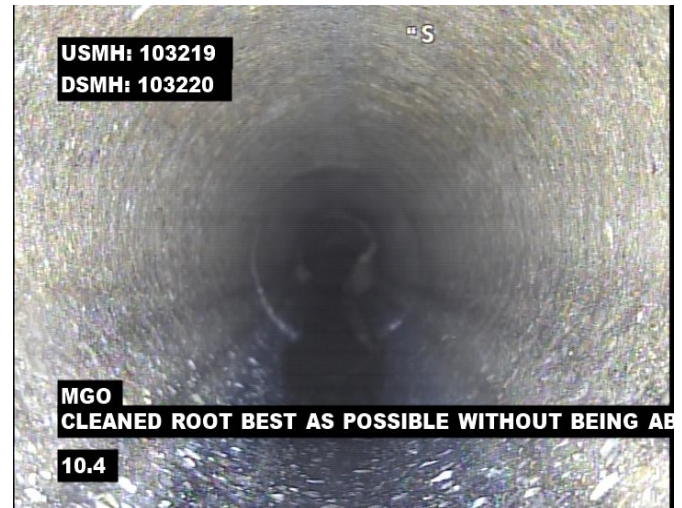
Distance: 8.0 ft. Grade: 1  
 Condition: RFJ-Roots Fine Joint  
 Remarks: N/A

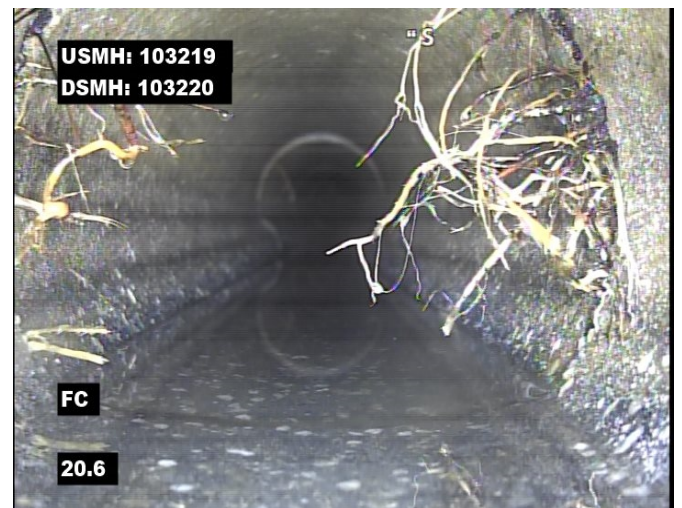
Distance: 17.6 ft. Grade: 3  
 Condition: RMJ-Roots Medium Joint  
 Remarks: N/A

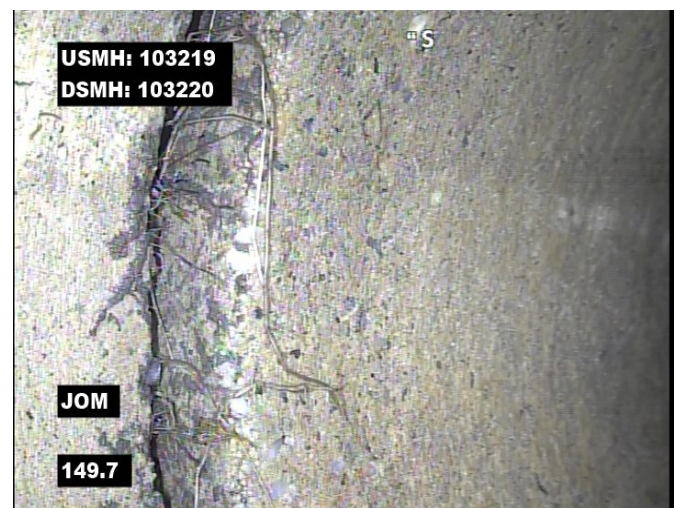
Distance: 149.7 ft. Grade: 3  
 Condition: JOM-Joint Offset Medium  
 Remarks: N/A

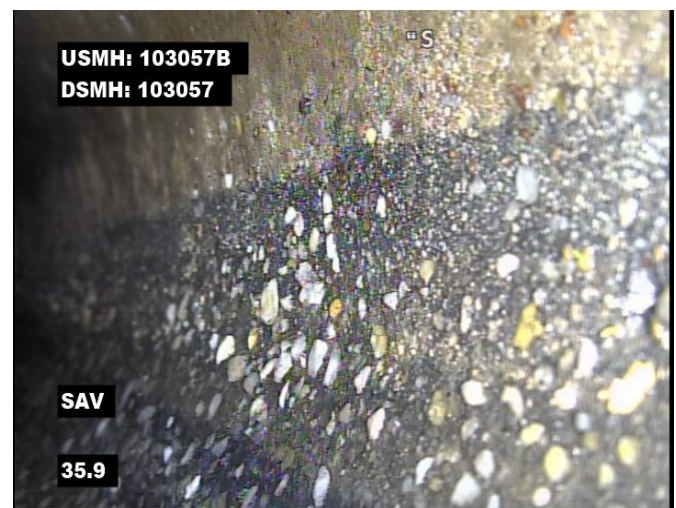
Distance: 35.9 ft. Grade: 2  
 Condition: SAV-Surface Damage Aggregate Visible  
 Remarks: N/A

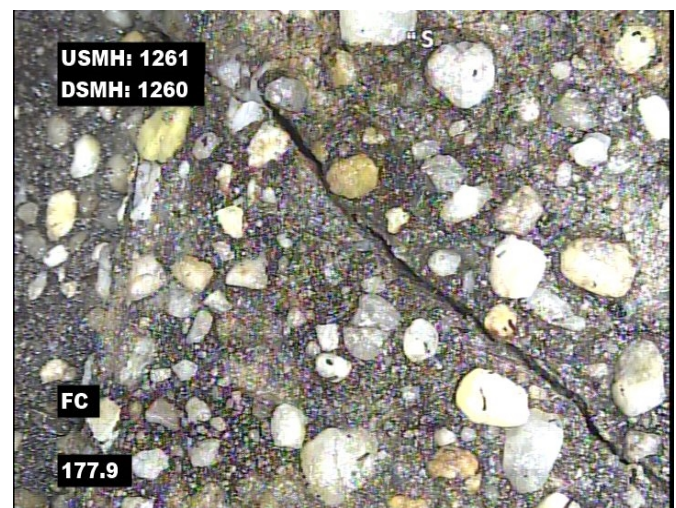
Distance: 177.9 ft. Grade: 2  
Condition: FC-Fracture Circumferential  
Remarks: N/A

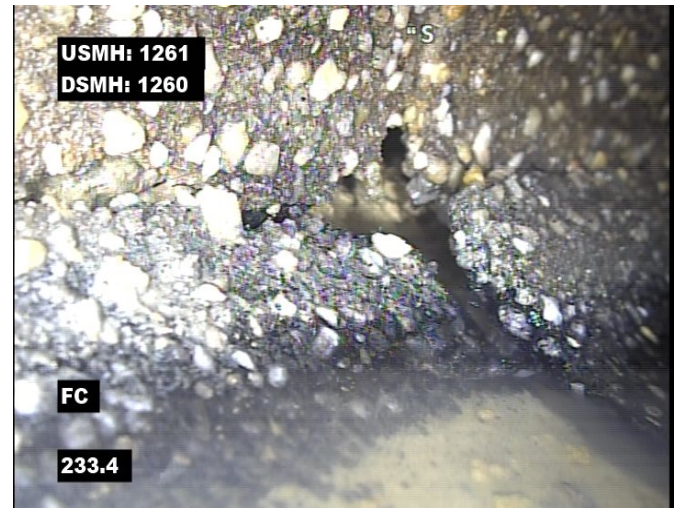
Distance: 233.4 ft. Grade: 2  
Condition: FC-Fracture Circumferential  
Remarks: N/A

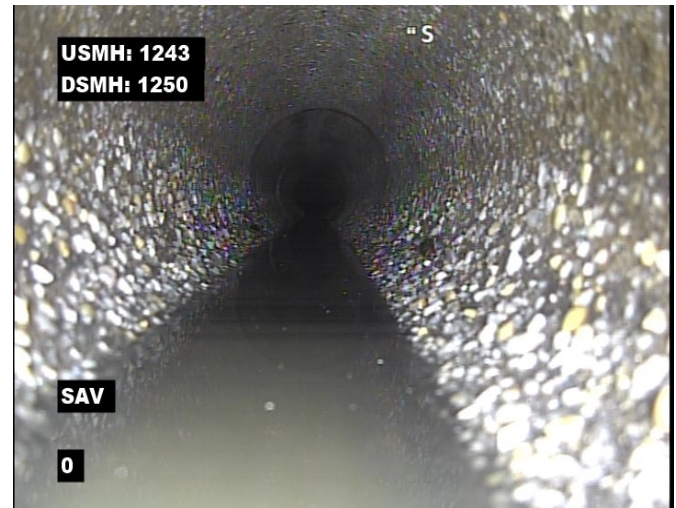
Distance: 0.0 ft. Grade: 2  
Condition: SAV-Surface Damage Aggregate Visible  
Remarks: N/A

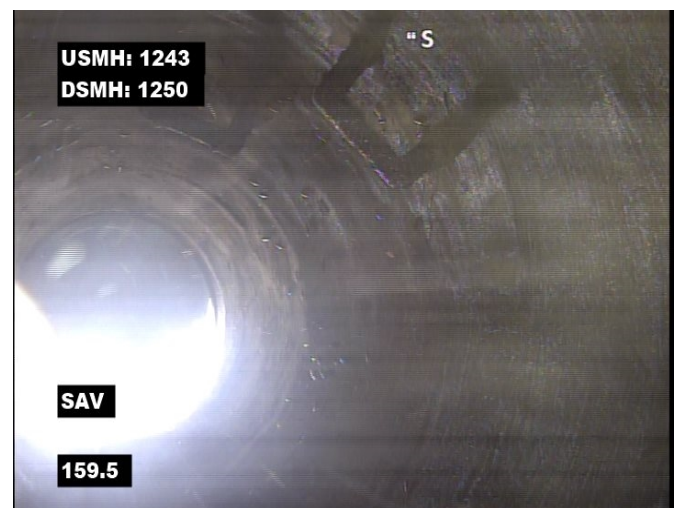
Distance: 159.5 ft. Grade: 2  
 Condition: SAV-Surface Damage Aggregate Visible  
 Remarks: N/A
