Town: 110 - JOHNSON

Team Lead: Martin Kelley, Inspection Date: 09/10/2023

IDENTIFICATION	
(1) State Names	50 - Vermont
(8) Structure Number	100806000508061
(5) Inventory Route	1
(2) Highway Agency District	8 - District 8
(3) County Code	15 - LAMOILLE

(4) Place Code	37000
(6) Features Intersected	GIHON RIVER
(7) Facility Carried	C2001
(9) Location	0.03 MI TO JCT W VT15
(11) Mile Point	0 mi
(12) Base Highway Network	No

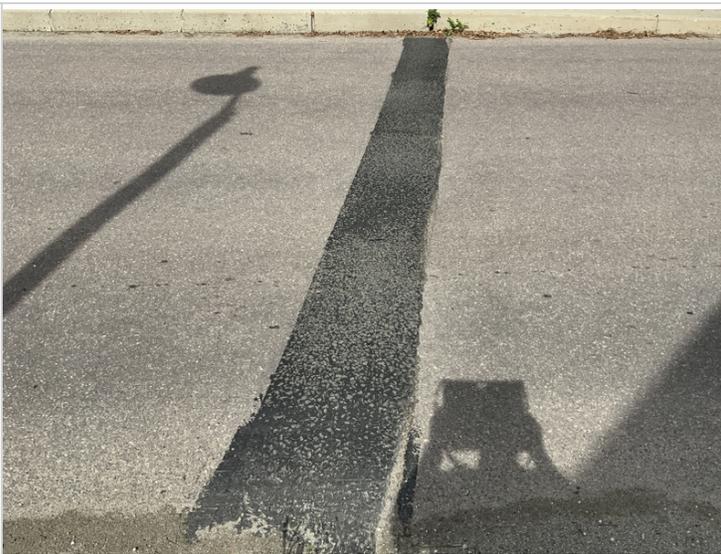
Joint 1

Some minor wear and separation along plug joint saw cut line abutment 2

Some minor leakage getting through abutment 1 curb line causing minor rust scaling along beam 4 and 5 downstream end. Plug joints have separated some along cut line and should be resealed.

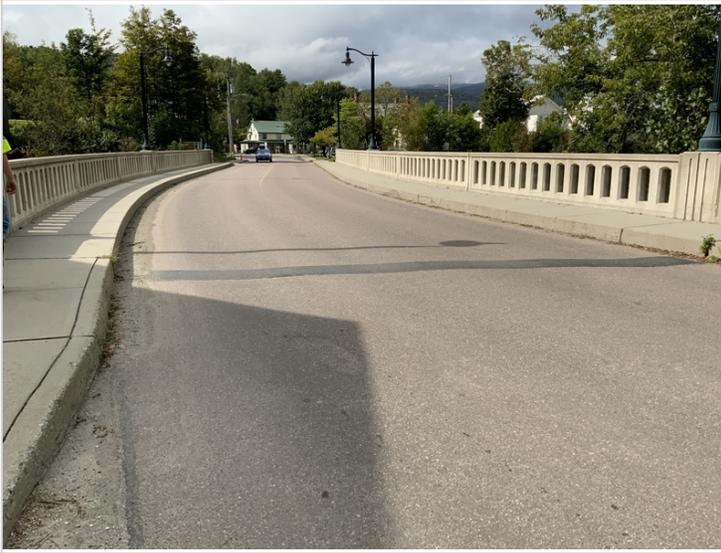
Minor wheel track wear

Concrete decorative rail with concrete baluster with fine cracks

Wearing surface and rail

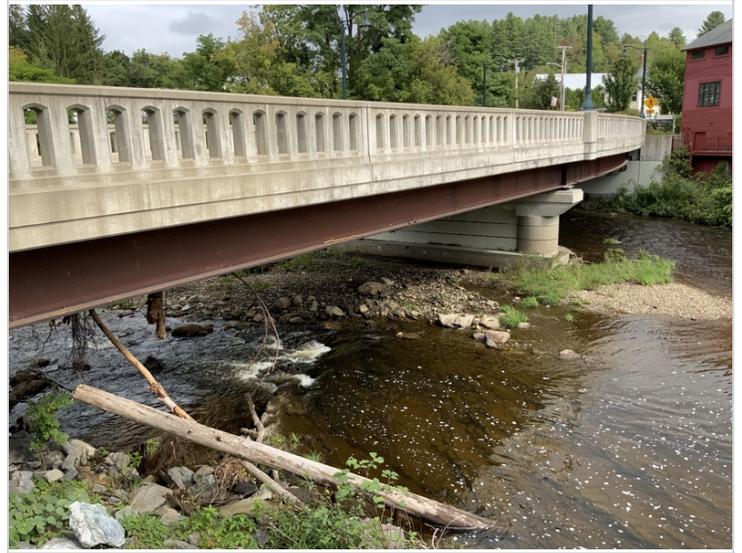
Upstream fascia

Fine cracks

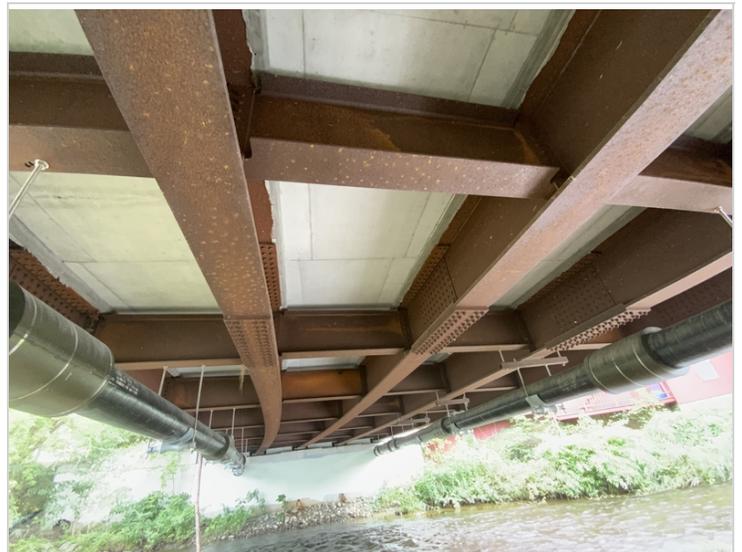
Soffit has a few flexure cracks near pier in both spans

5 A588 curved girders with light rust scaling beams 4 and 5 abutment 1 downstream with 5 most notable.

Span 1 soffit and beams

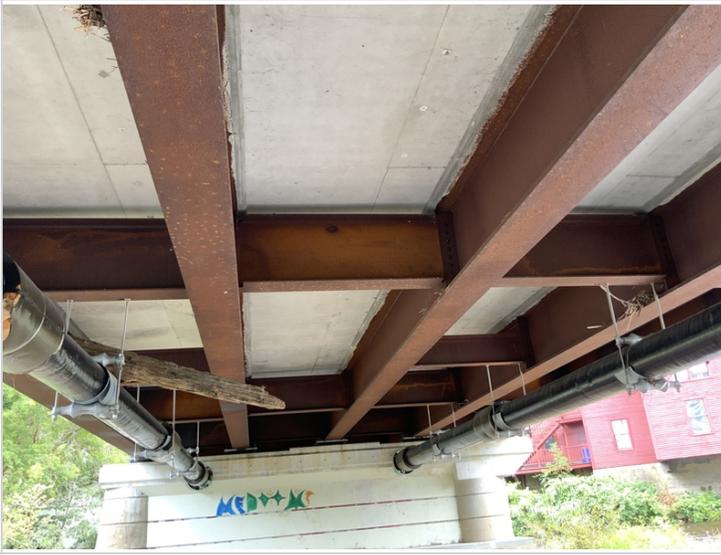
Span 2 soffit and beams

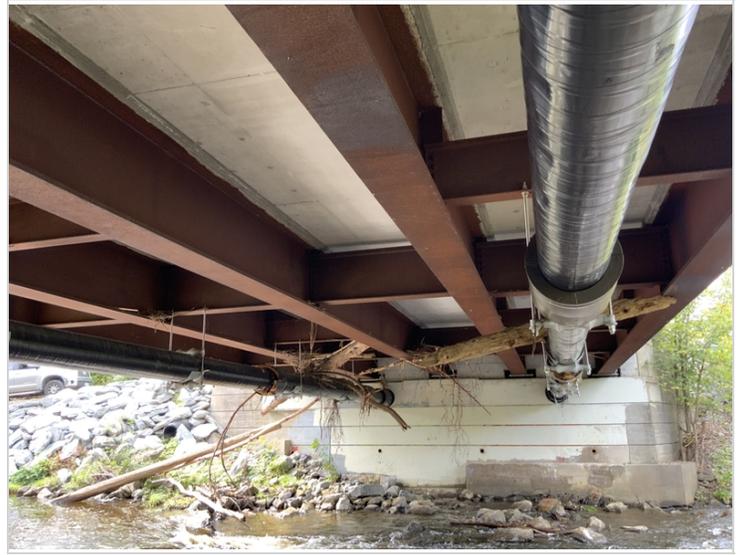
Structure is in relatively good shape with some tree debris caught up along utility pipes

Span 2 debris

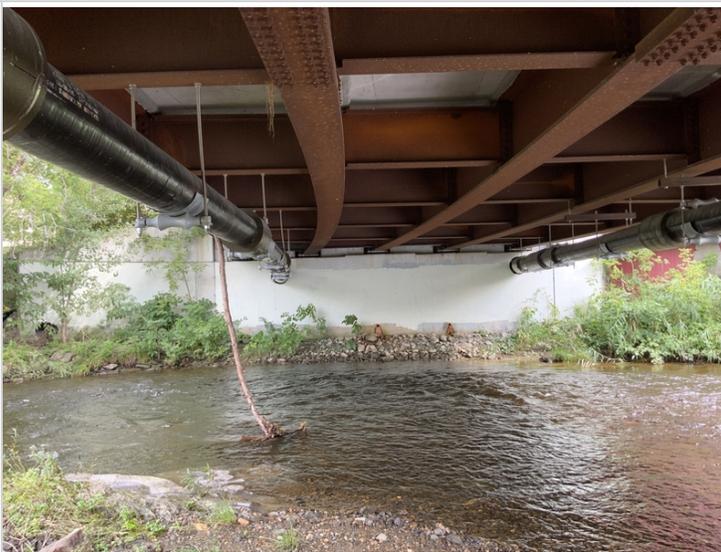
Abutment 1 is newer and relatively clean, abutment 2 was recon with new concrete cap and older portion has some minor cracks and light scaling.

Some minor cracks in older section abutment 2 and recon with new cap. Abutment 1 are newer with fine cracks

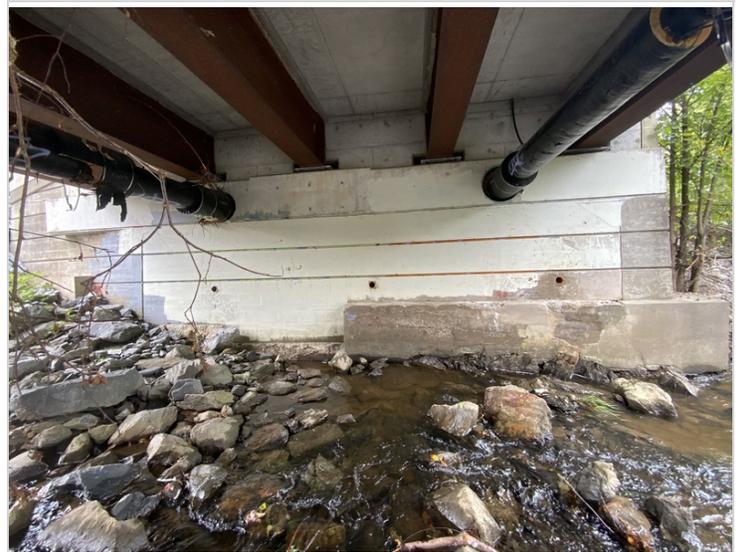
Abutment 2

Minor high water debris abutment 2

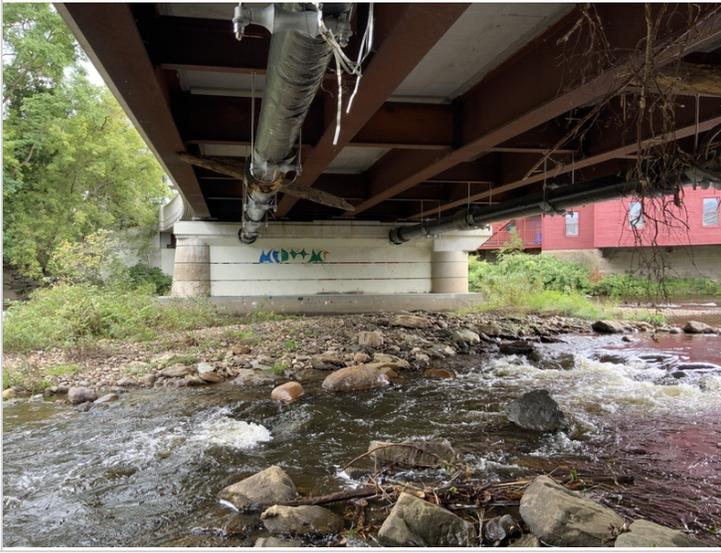
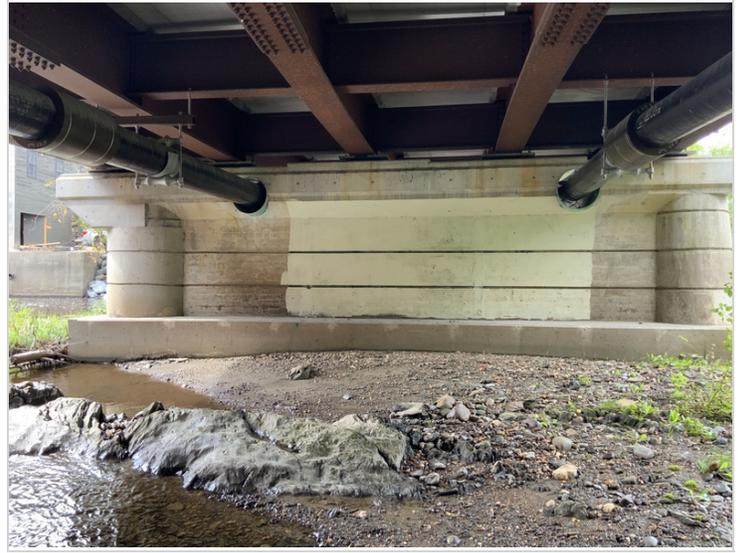
Pier

Recon with new columns and concrete cap. Minor cracks in older portion

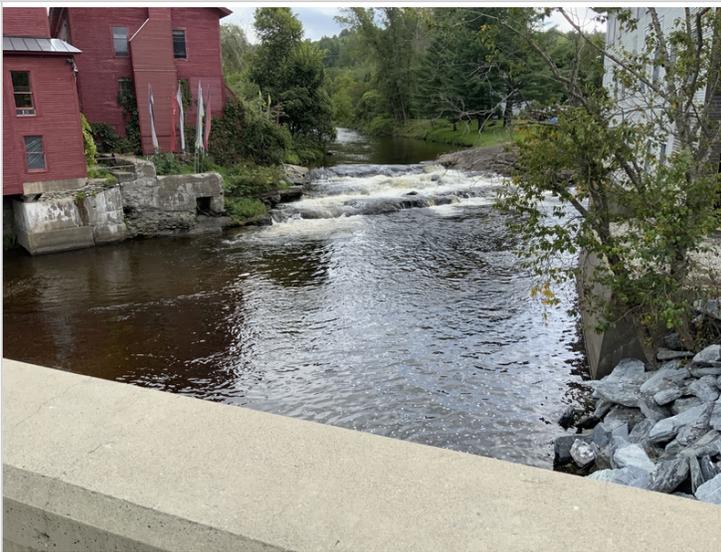
Upstream channel

All ledge and stone
