C3 PROPERTY INSPECTIONS INC.

INSPECTION REPORT

58 Lower Main Street Johnson, VT 05656

> Town of Johnson 10/16/2025

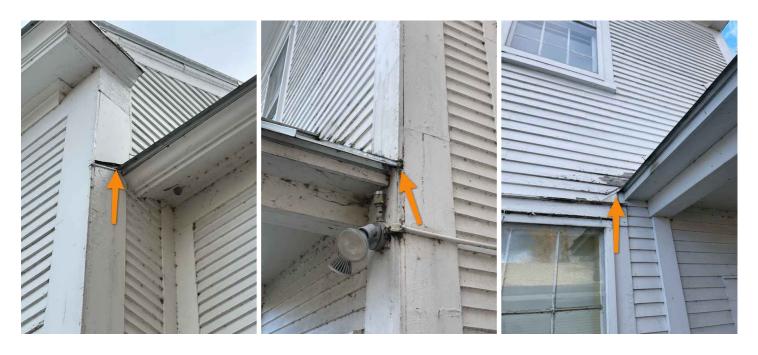
MISSING DIVERTER FLASHING

Diverter flashing was missing along the eaves of the lower roofs where intersecting the exterior walls of the building. Water run-off should be diverted away from the finishes to prevent water infiltration and damages the adjacent building materials. It is recommended to have a qualified contractor install diverter flashing where missing and repair/replace any damaged building materials.

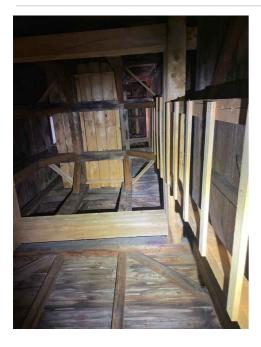
CUPOLA - NOT EASILY ACCESSIBLE

The wood ladder leading to the cupola is not considered safe means of access, preventing the inspector from fully viewing the space. It is recommended to have a qualified contractor install a safe means of access and further assess the condition and integrity of the cupola.

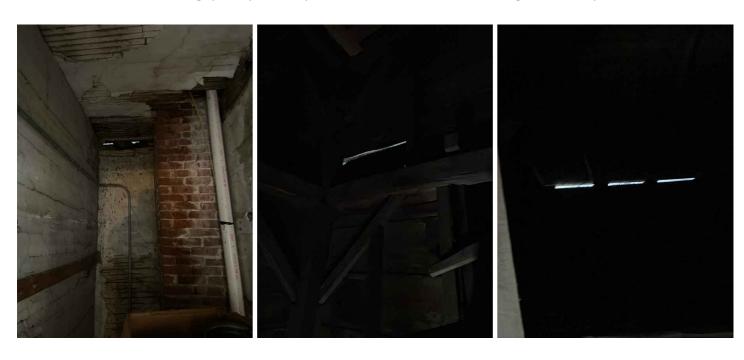
2.5.2 Roof Structure and Attic

DAYLIGHT VISIBLE

Daylight was visible through the exterior finishes in multiple places around the attic space. It is recommended to infill the gaps to prevent pests and water from infiltrating the attic space.

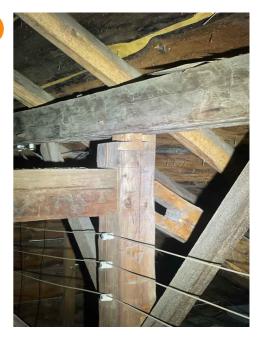
STRUCTURAL SEPARATION

One of the post-to-beam connections on the south-west side of the attic space showed signs of separation, which could put uneven stress on the adjacent structural assemblies. It is recommended to have a qualified contractor and/or structural engineer further assess and advise on permanent repairs.

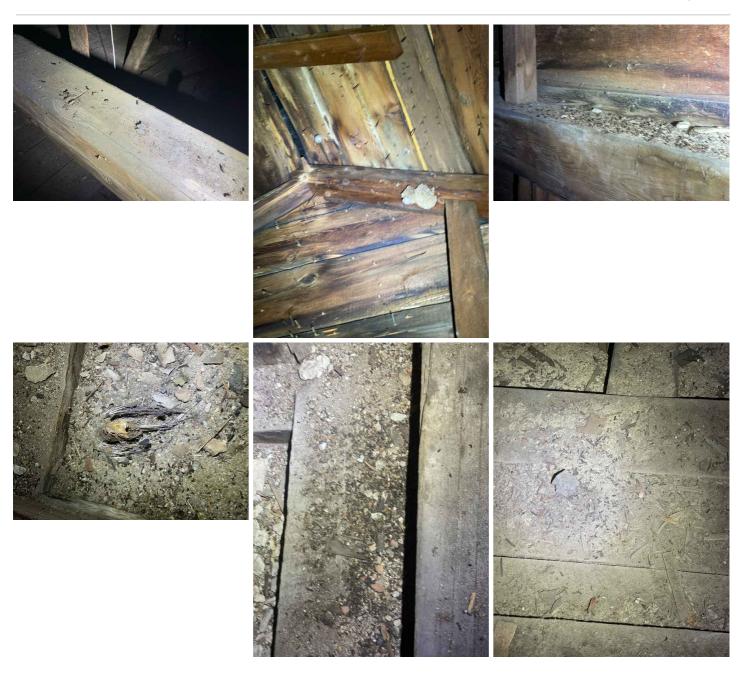
2.5.4 Roof Structure and Attic

PESTS

Evidence of pests was observed in the attic space. It is recommended to take steps in eliminating and discouraging pests from living in the home, as they can cause damage to finishes and utilities.

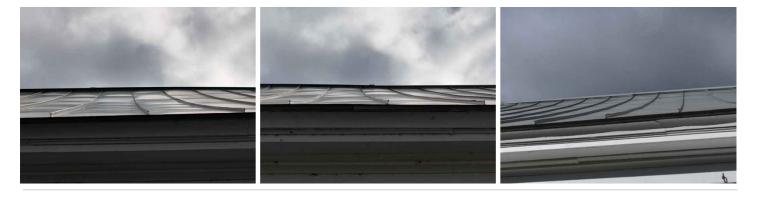
2.5.5 Roof Structure and Attic

SAG IN RAFTERS

The roof showed signs of sagging mid-span between the ridge and eaves. While this is a common characteristic of old buildings, a sag in the roof could result in stress to the adjacent framing and finishes. It is recommended to have a qualified contractor and/or structural engineer further assess and advise if any structural supplementation is necessary.

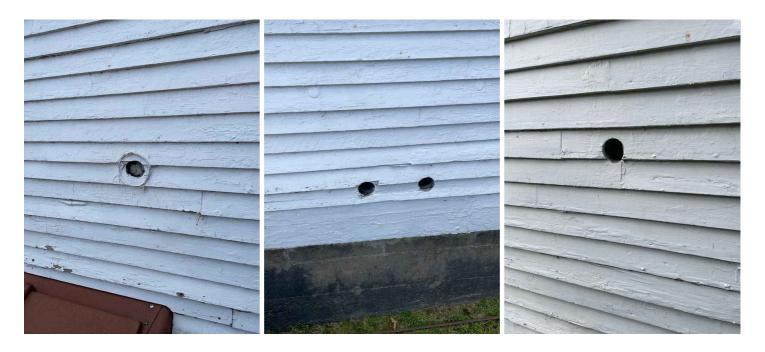
ABANDONED PENETRATIONS

Multiple abandoned penetrations were observed around the building which could allow water run-off and/or pests to infiltrate the exterior finishes. It is recommended to permanently infill the exterior finishes as needed to provide a uniform weather barrier.

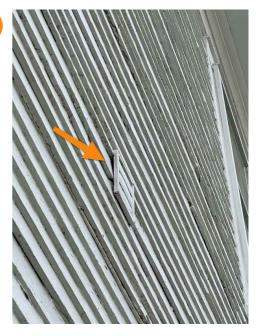
MISSING TRIM BLOCK

The vent for the bathroom exhaust fan was installed directly to the wood siding which could lead to water infiltration through the utility penetration. Typically with clapboard siding a trim block is installed for utility penetrations so there is a solid connection between the utility and the structure of the building. Flashing installed over/around the trim block will prevent water from infiltrating the exterior finishes. It is recommended to have a qualified contractor install a trim block and flashing behind the vent.

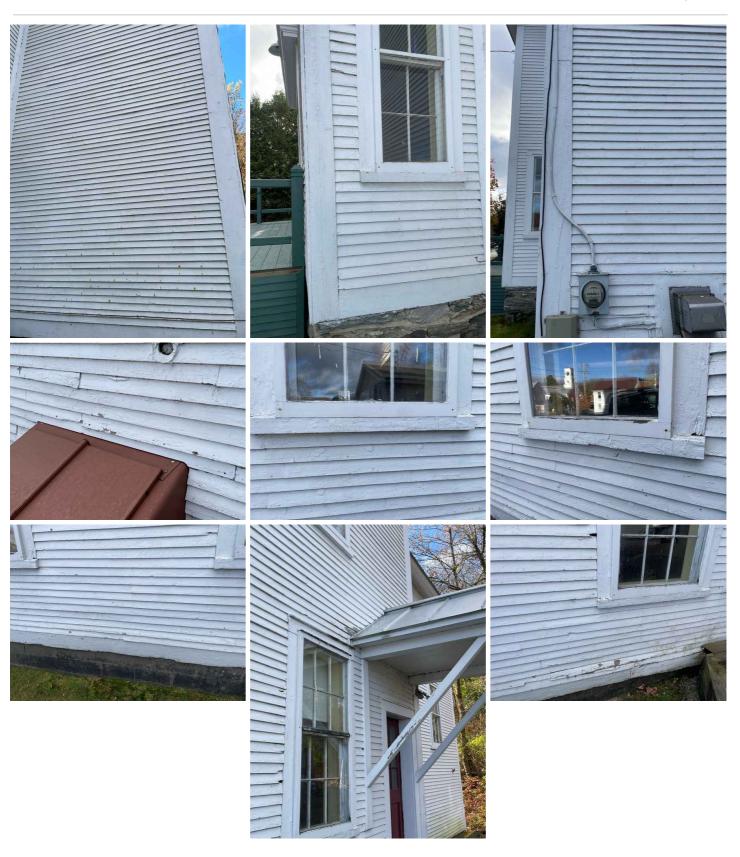
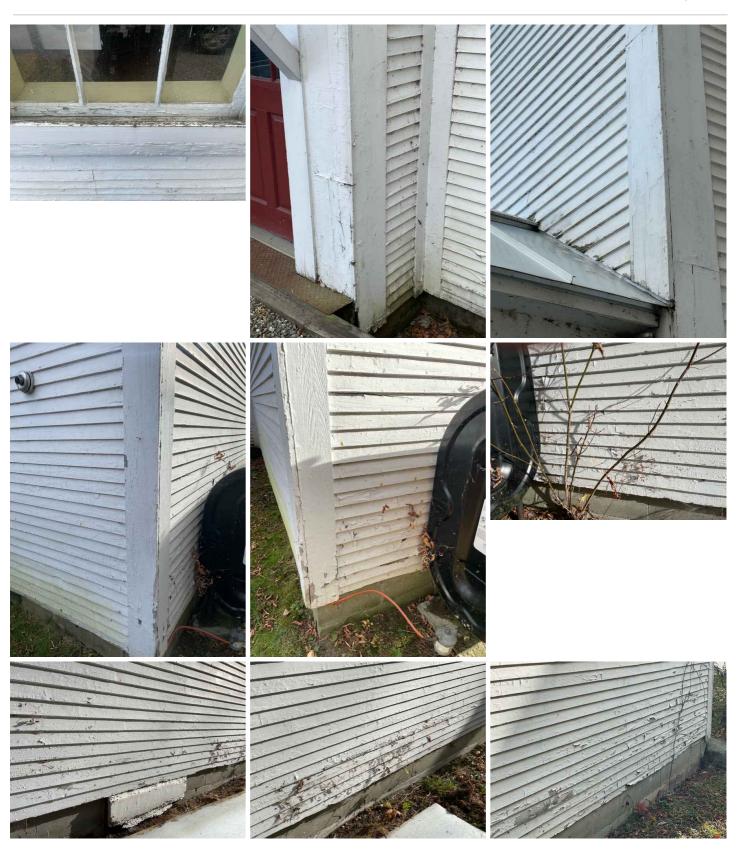
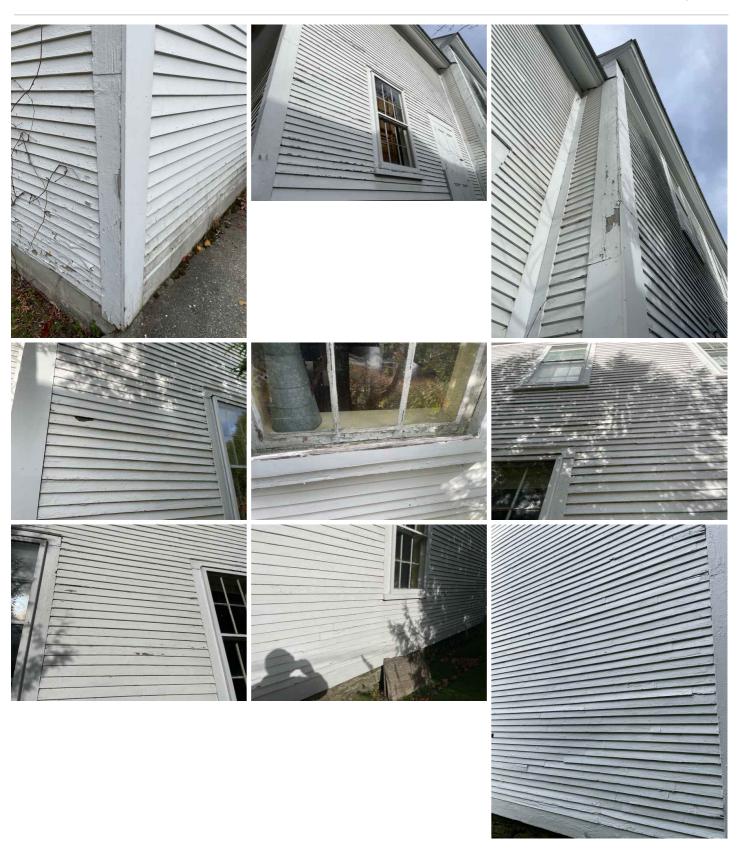
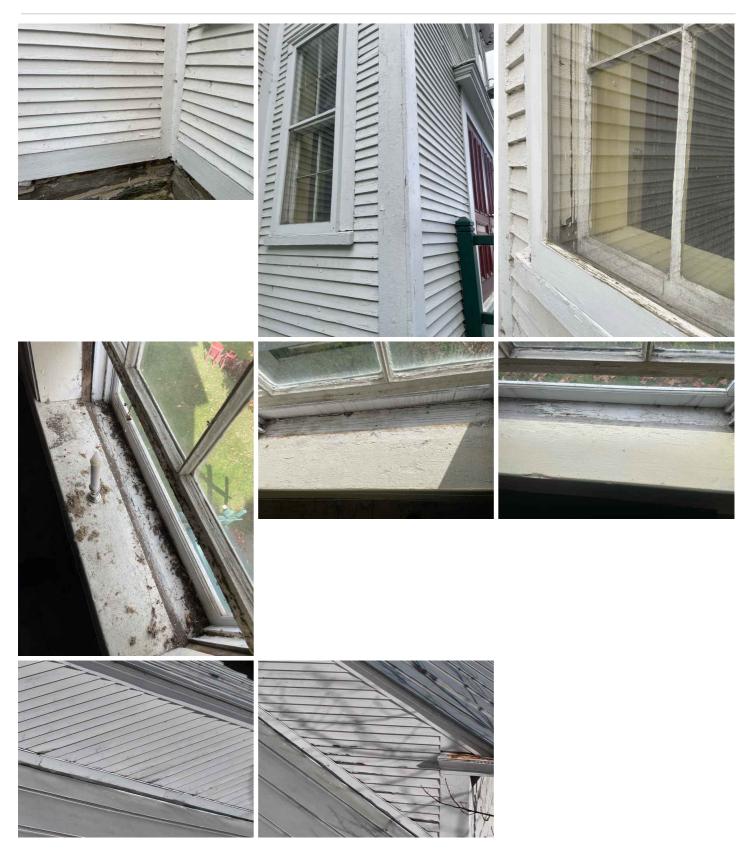
3.1.4 Wall Covering, Flashing, and Trim

PEELING PAINT - UNDERLYING LEAD PAINT

Peeling paint was observed on some of the wood finishes around the building. Bare wood will retain water and cause the adjacent building materials to deteriorate at an expedited rate. It is recommended to scrape all loose/peeling paint and re-coat the exterior finishes to prolong the integrity of the building materials.

Be advised: Some of the underlying paint has characteristics common with lead-based paints. Lead paint should be tested and removed (if present) by certified/licensed professionals to prevent environmental and/or health impacts.

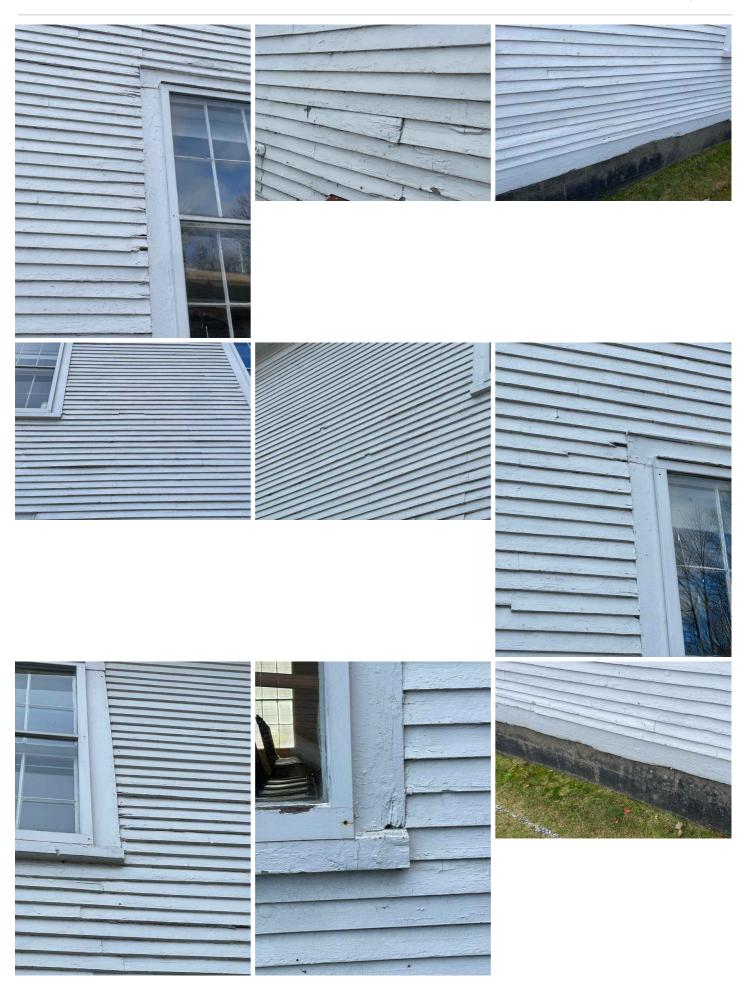
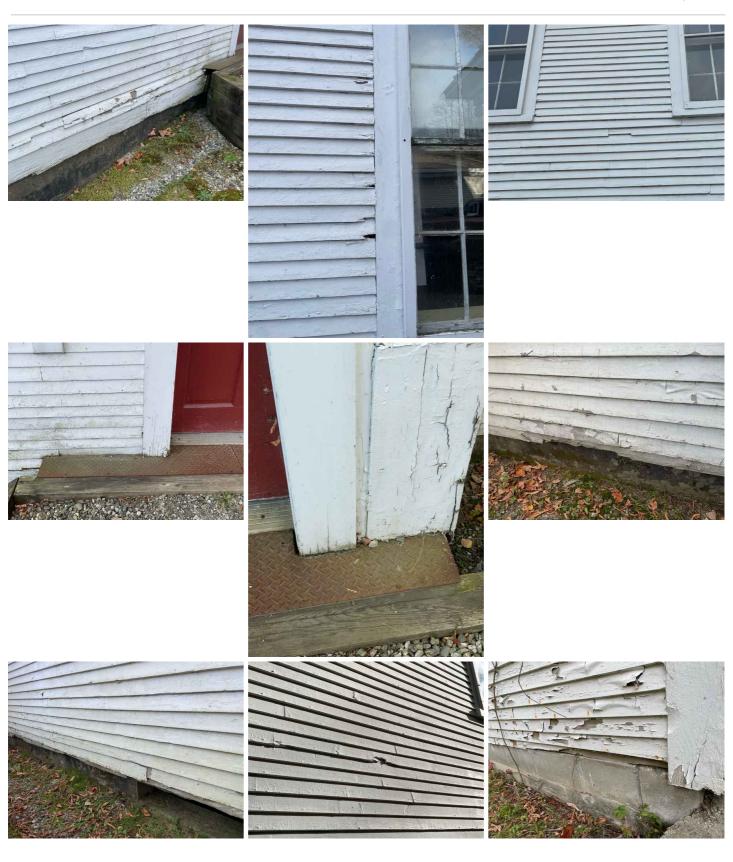
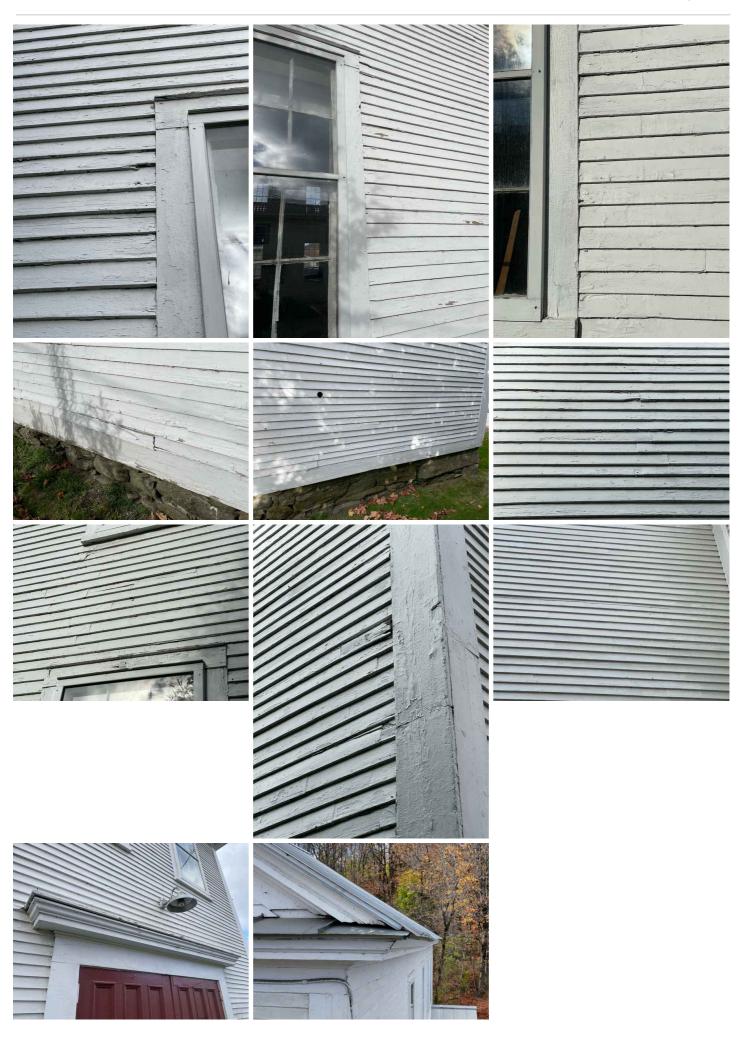
Multiple sections of the exterior walls showed signs of rot behind the finishes. Rotted wood attracts wood destroying organisms and compromises the structural integrity of the materials. It is recommended to have a qualified contractor further assess the materials and substrates behind the exterior finishes and repair/replace any rotted building materials.

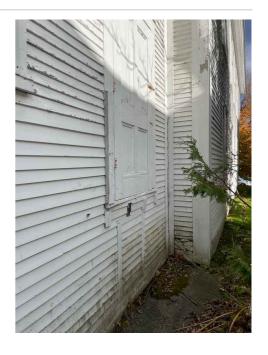
MISSING STAIRCASE

The exterior door on the east side of the stage did not have a platform or steps to grade. The height difference between the finished floor and the exterior grade is tall enough to cause serious injury to the occupants or guests without a platform, steps, etc. It is recommended to install permanent steps where missing.

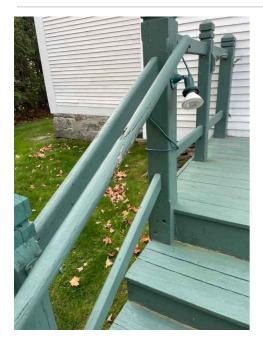
ROTTED HANDRAIL

One of the handrails along the exterior staircase on the north side of the building was rotted and should be replaced.

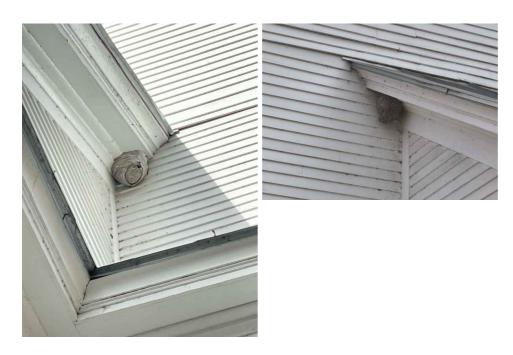
Multiple nests for stinging insects were observed under the soffit around the building. It is recommended to remove the nests to prevent damage to the building materials and injury to the occupants.

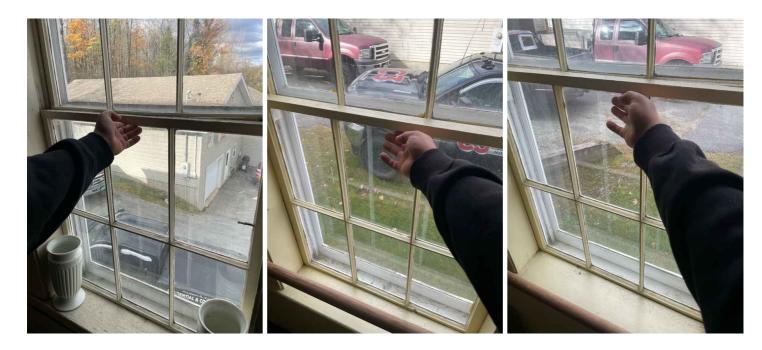
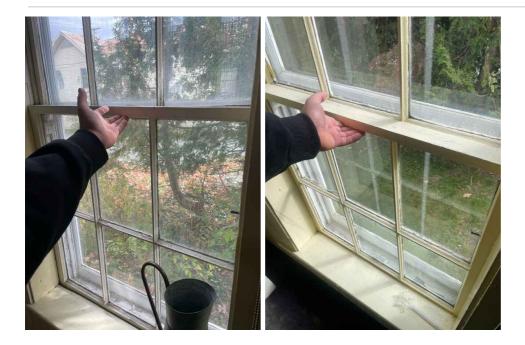
3.8.4 Windows (a representative number)

SEIZED SASHES

Multiple windows did not open when tested due to the sashes being stuck in the jambs. This could be due to incorrect installation, building settlement, paint, and/or swelling of the building materials. It is recommended to have a qualified contractor further assess and adjust, correct, or repair the windows so they operate as intended.

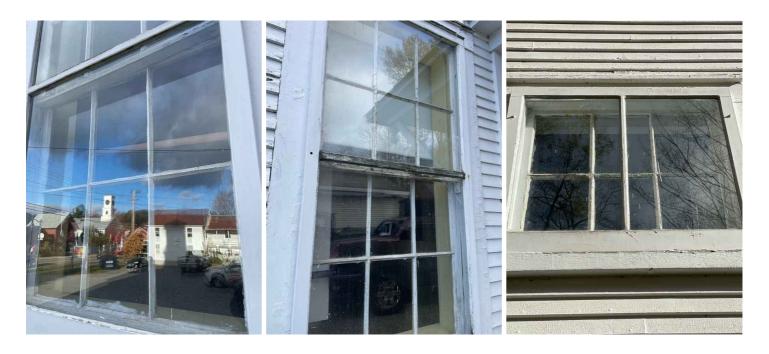
Some of the glazing around the single pane windows was missing or deteriorated, leaving little support for the glass. It is recommended to remove the existing glazing material, repair any deteriorated wood, and re-glaze around the glass with a suitable flexible sealant.

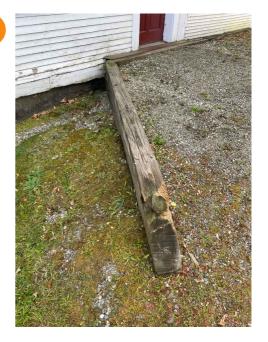
The wood retaining wall on the west side of the building showed signs of leaning and failure. Water saturation on the backside of the wall has likely caused damage from long-term hydraulic pressure and/or frost heaving. It is recommended to have a qualified contractor repair/replace the retaining wall and mitigate water runoff and soil saturation with a sub-surface drain assembly.

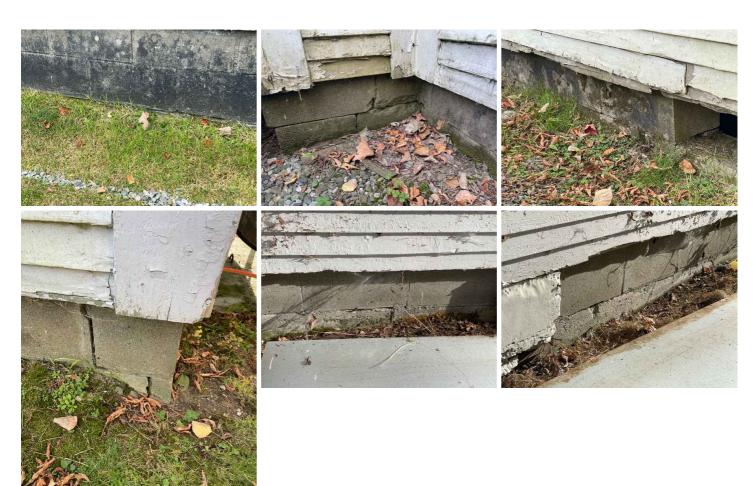
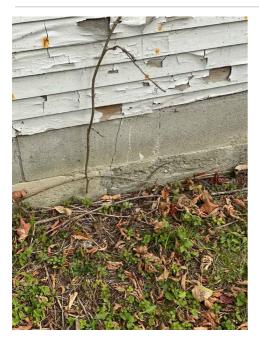
Some of the foundation had deteriorated blocks and mortar joints, likely due to long-term water exposure and/or infiltration. Masonry block foundations should provide a uniform drainage plane to prevent water intrusion and deterioration of masonry materials. Water infiltration and/or absorption will soften mortar between blocks and cause spalling of block faces when absorbed water freezes. It is recommended to have a qualified contractor replace any deteriorated/cracked masonry blocks and re-point mortar joints as needed.

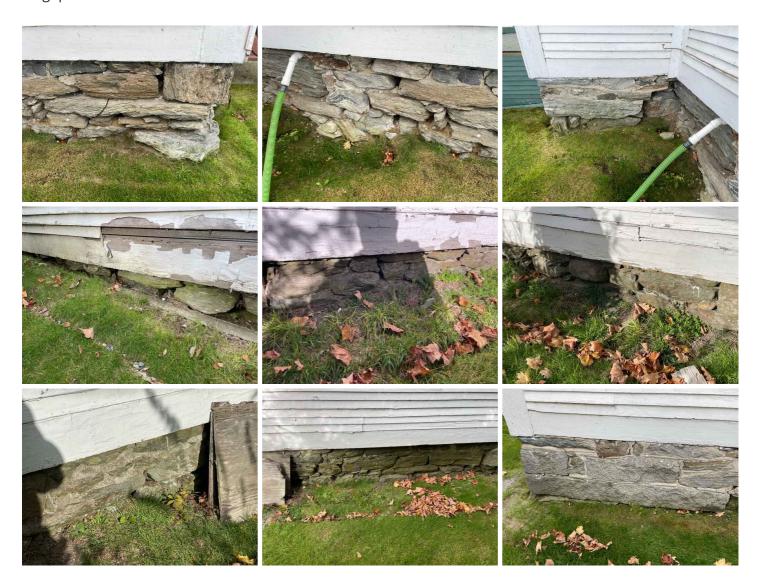
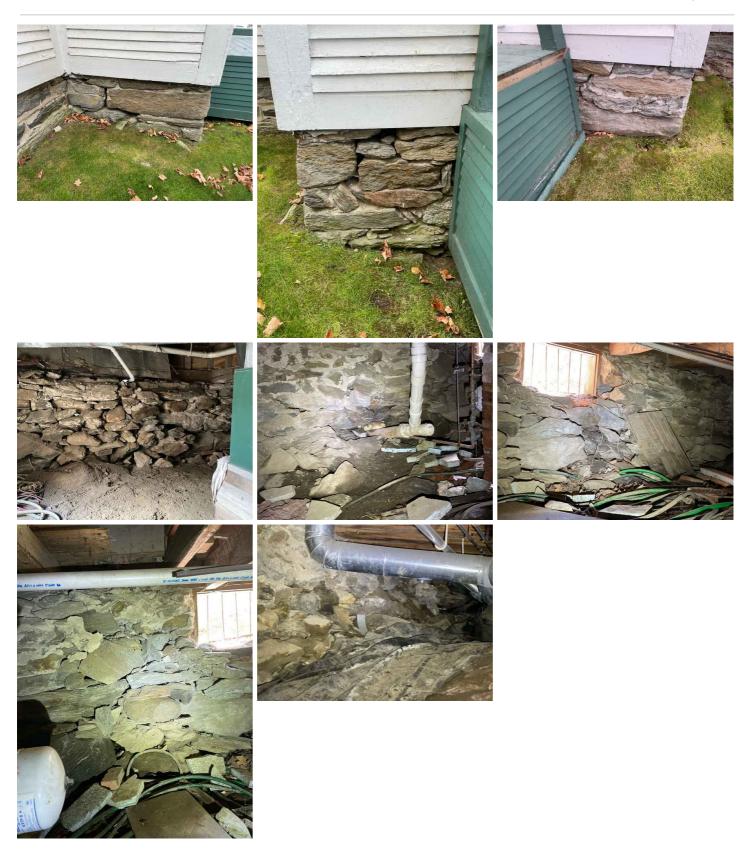
Large gaps and loose stones were observed in the foundation around the building. Foundations should provide a uniform drainage plane for water run-off to prevent water from infiltrating the crawlspaces and/or causing further damage to the foundation. It is recommended to have a qualified contractor infill all gaps and voids with suitable materials.

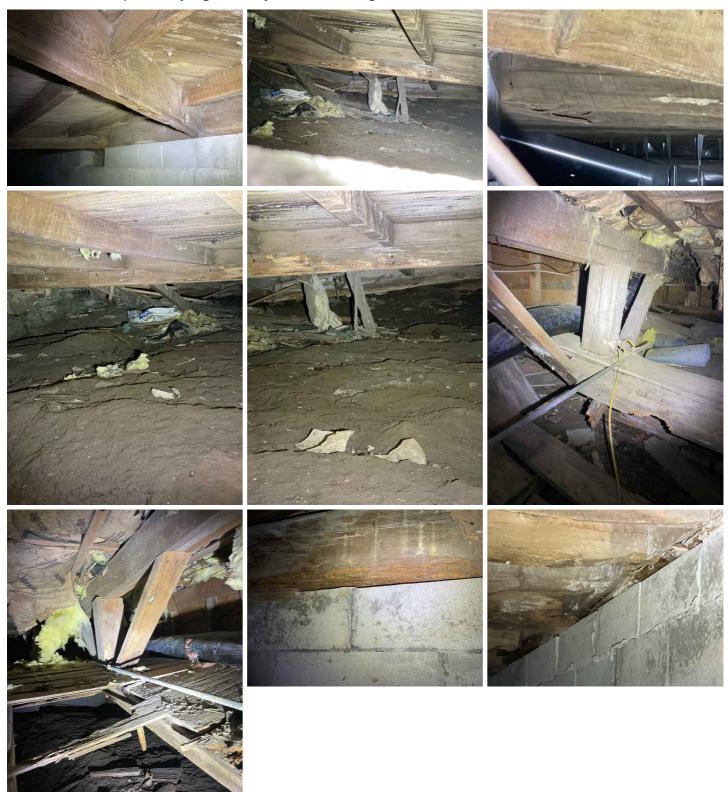
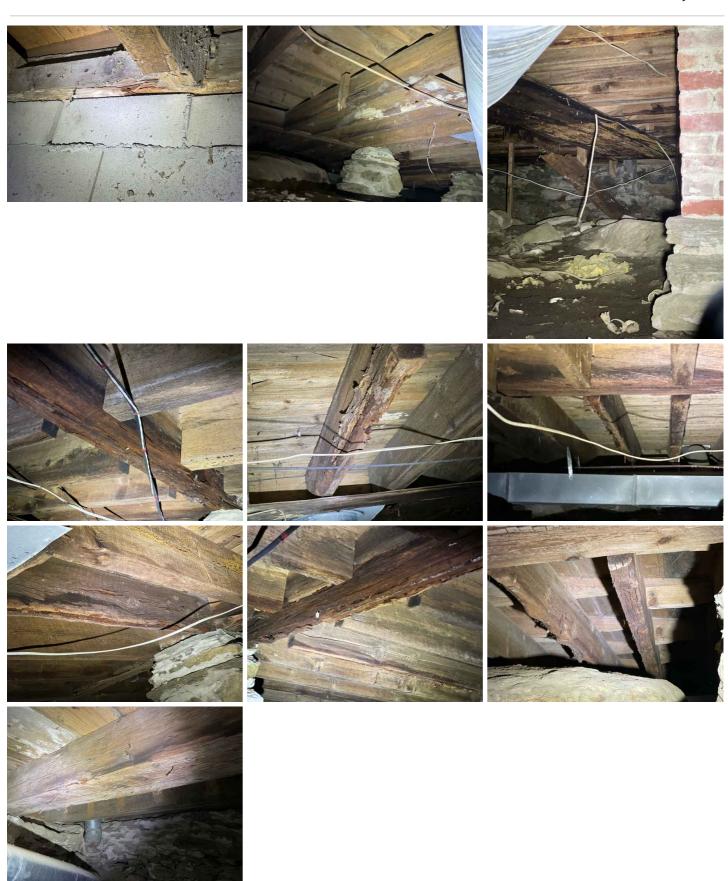
Multiple framing members in the crawlspaces showed signs of rot. Rotted wood loses its structural integrity and will retain moisture, which can advance the deterioration rate of the adjacent materials. It is recommended to have a qualified contractor repair and seal any superficial rot on the framing members or remove and replace any significantly rotted building materials.

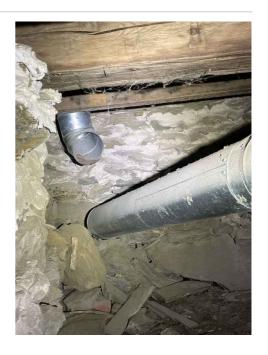
A length of ductwork on the north side of the crawlspace was disconnected which will reduce heating efficiency in the building. It is recommended to re-secure or replace the ductwork as needed.

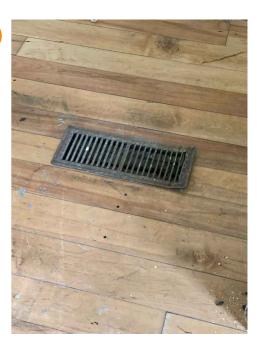
5.4.2 Distribution Systems

REGISTER - DAMAGED

A register on the south side of the meeting room was damaged and should be replaced.

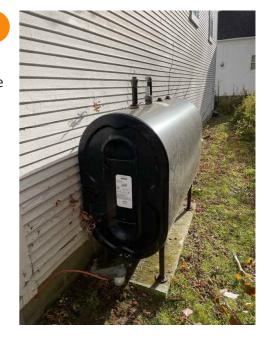
The fuel tank on the exterior of the building did not have a enclosure over it. Typically the fuel providers require a roofed enclosure over exterior fuel tanks to prolong the integrity of the tank and facilitate fuel delivery in the winter. It is recommended to have the fuel provider further assess and advise on options for a compliant tank enclosure.

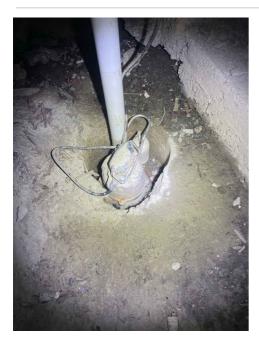
6.6.1 Sump Pumps

DRY PIT - PUMP APPEARED TO OPERATE

The sump pump pit was dry at the time of the inspection. The inspector operated the float valve and the pump appeared to operate when tested. It is recommended to confirm the pump efficiently discharges water accumulation from the crawlspace.

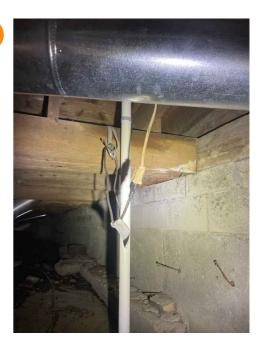
6.6.2 Sump Pumps

EXTENSION CORD

The sump pump appeared to be powered by use of an extension cord instead of having a dedicated outlet. It is recommended to have a licensed electrician install a dedicated GFCI outlet for the sump pump.

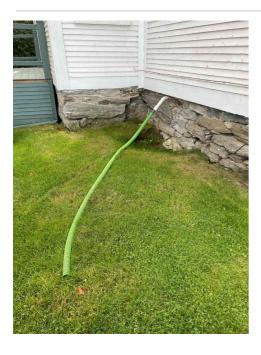
6.6.3 Sump Pumps

PERMANENT DISCHARGE ASSEMBLY RECOMMENDED

The sump pump discharge piping was not considered a permanent or efficient assembly. The discharge pipe should be solid PVC with a check valve and terminated in a manner that will prevent erosion of the grade and saturation of the soils adjacent the foundation, for example, emptying into a sub-surface drain with an air-gap fitting.

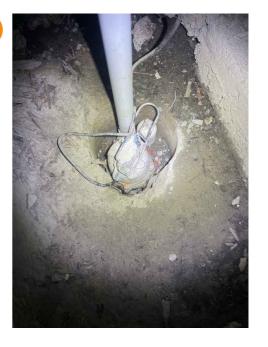
6.6.4 Sump Pumps

SEDIMENT/FILL IN SUMP PIT

Sediment was observed in the sump pump pit which could obstruct the pump and affect the discharge of water. It is recommended to clean the sump pit and install a means of preventing further fill from entering the pit.

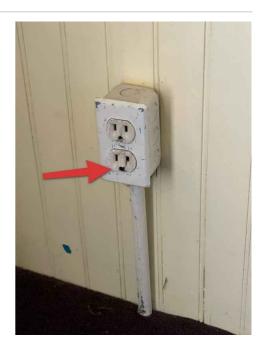
A first floor outlet on the north-west side of the building was damaged which presents an electrical hazard. It is recommended to have a licensed electrician replace the outlet.

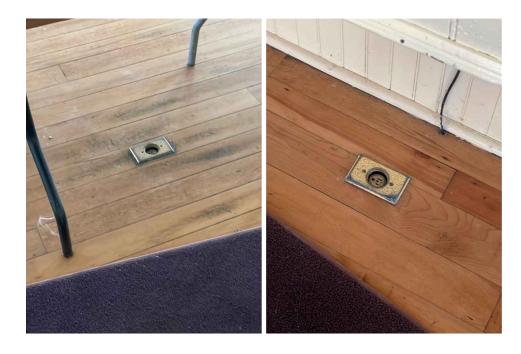
Multiple floor mounted receptacles were missing covers which could allow dust and debris to enter the outlets when not in use and result in defects. It is recommended to replace the outlet covers as needed.

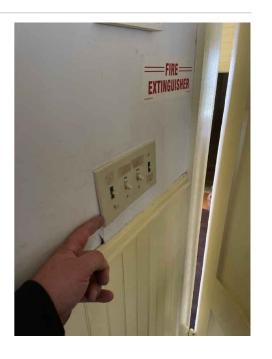
The light switch receptacle on the first floor of the meeting room was loose which can damage wiring in/around the receptacle. It is recommended to have a licensed electrician re-secure the receptacle to framing or solid blocking.

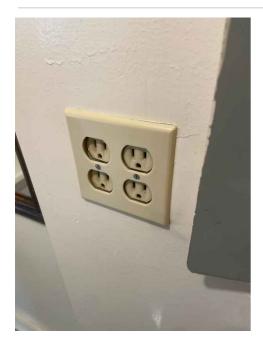
The outlet receptacle in the bathroom was recessed behind the wall finishes. This can present an issue for normal use and leaves an opening for direct contact of the conductors. It is recommended to have a licensed electrician correct the receptacle so it sits flush with the interior finish.

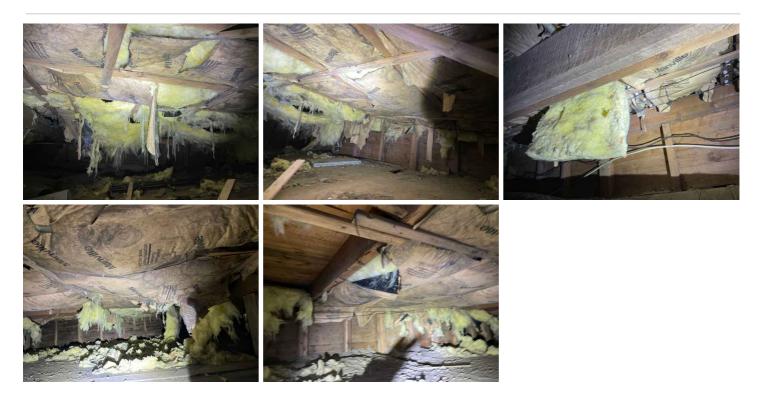
Some of the fiberglass insulation in the crawlspace was damaged, loose, and/or missing which will contribute to heat loss and may affect the adjacent building materials. It is recommended to replace insulation as needed to provide a uniform thermal envelope.

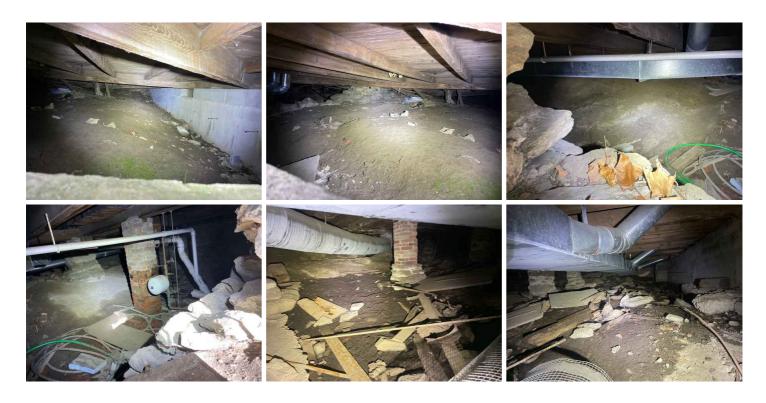
9.3.1 Vapor Retarders

DIRT FLOOR - NO VAPOR BARRIER

The crawlspaces did not have a vapor barrier on the floor. Saturation in the soils adjacent the foundation will seep through the foundation and floor and elevate moisture levels in the space, causing condensation on materials and advance the deterioration rate of building materials. Long-term elevated moisture levels without active/passive ventilation will also increase the risk of mold growth and rot. It is recommended to consult with a qualified contractor for options and pricing for installing a vapor barrier.

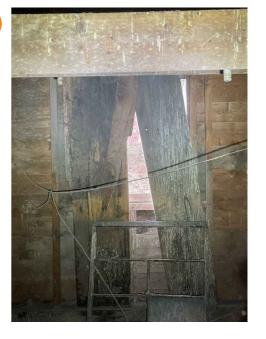
The gable vent on the south side of the building did not have a louver to help prevent wind-driven rain from infiltrating the attic space. It is recommended to have a qualified contractor install a louver and insect screen if missing.

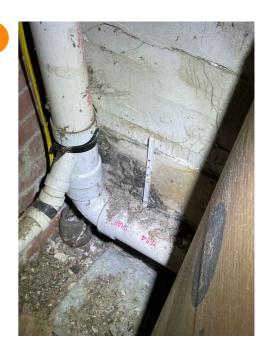
Suspect mold/mildew growth was observed on some of the interior finishes around the waste vent pipe on the upper level of the building. This is an indicator that there are or have been excessive moisture levels in the space, possibly from plumbing leaks and/or water infiltration. It is recommended to have a qualified mold remediation contractor further assess and advise on options and pricing to clean/neutralize the growth and repair or replace the affected building materials if/as needed.

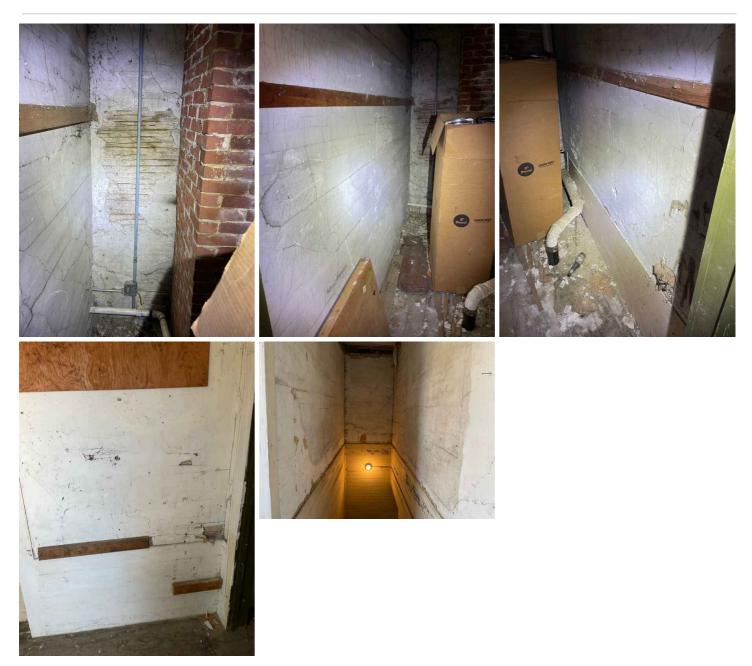
PLASTER - DAMAGED & DETERIORATED

Be advised - some old plaster contains asbestos-based materials and should be tested and professionally remediated if present.

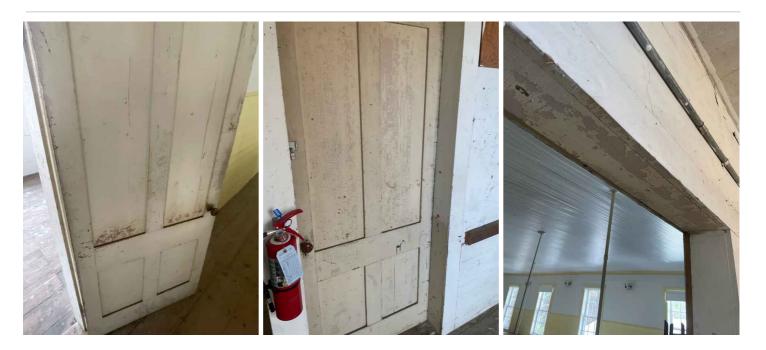
Paint observed on some of the doors and adjacent trim around the interior and exterior of the home has characteristics common with lead-based paints. It is recommended that suspect paint be tested and removed or encapsulated (if present or peeling) by certified/licensed professionals to prevent environmental and/or health impacts.
