## **Julian Scott Building Inspection Report**

8/13/26 Duncan Hastings with 8/20/26 updates

### **Notes from House inspection:**

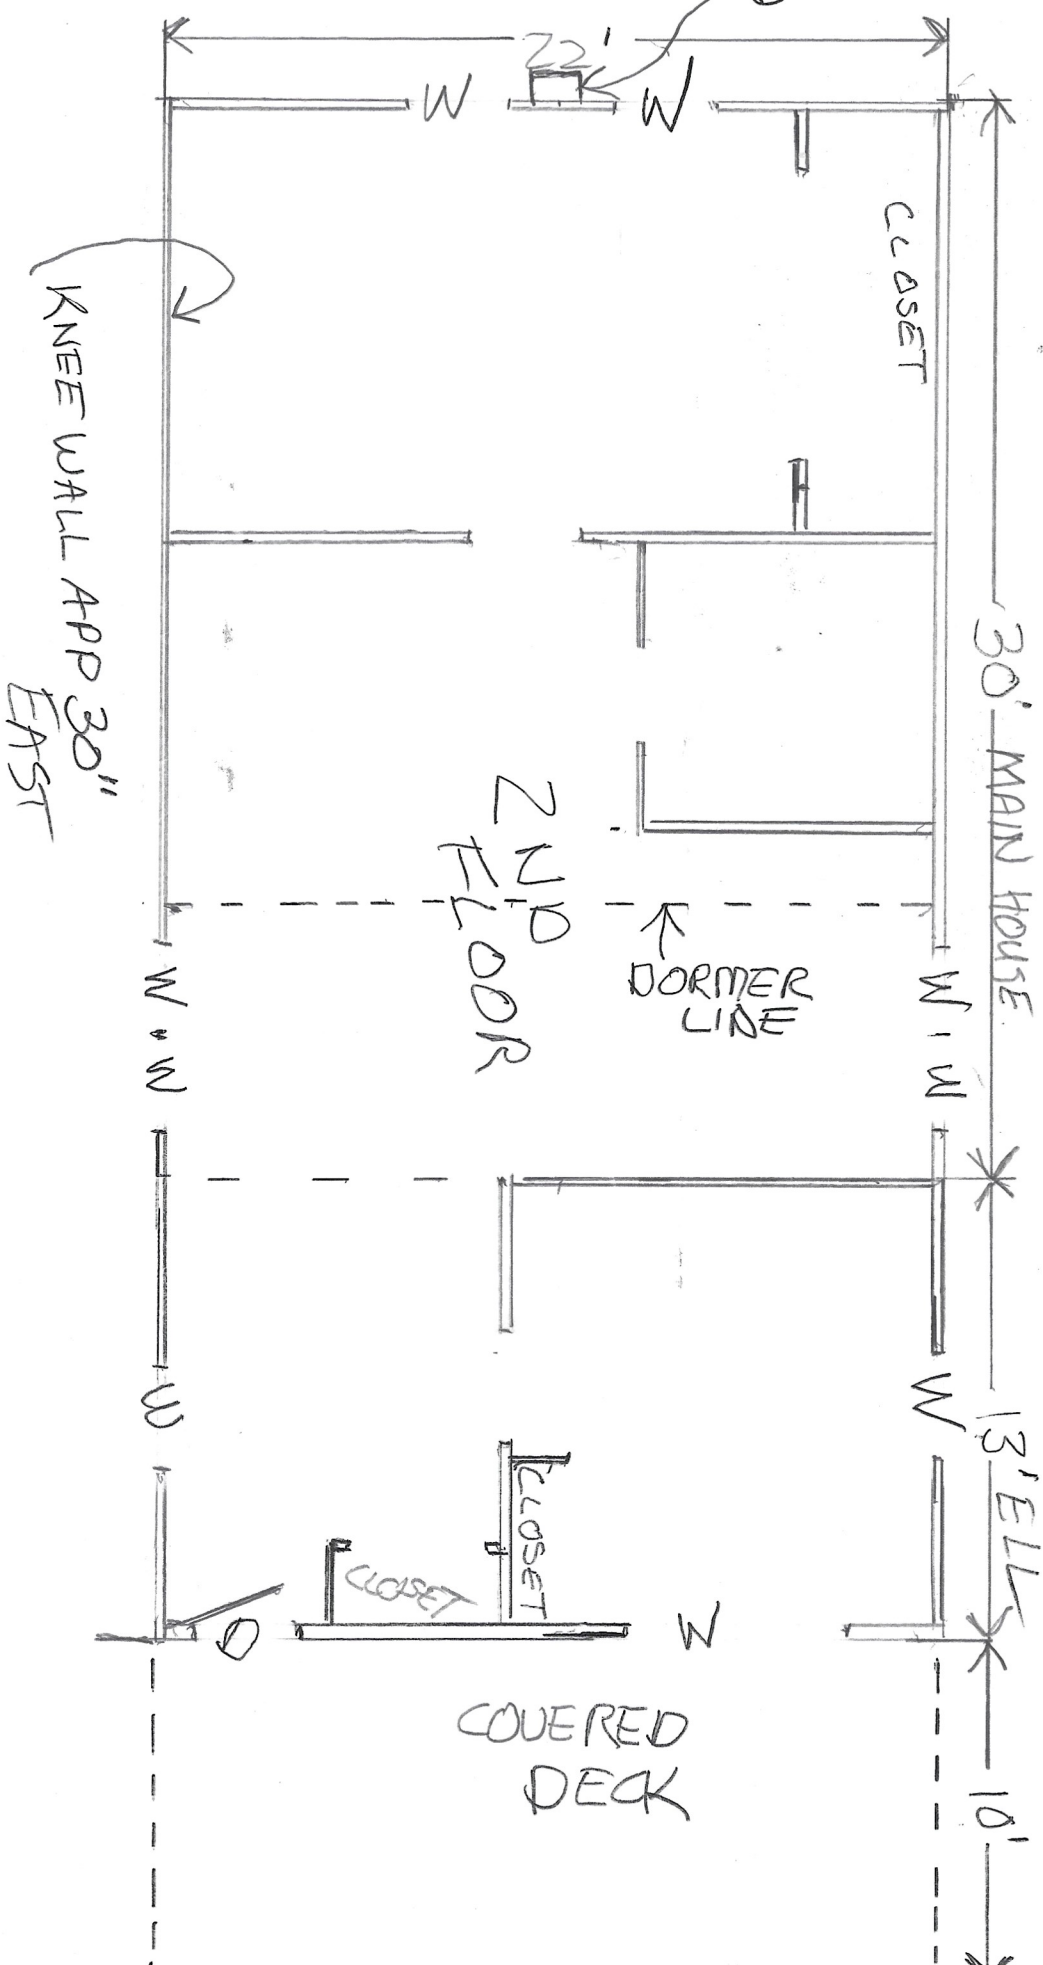
I transferred a flood high water (2023) line from the Municipal building to the Julian Scott House. I borrowed the Highway Dept laser level to transfer this line. The high water was just under the window ledges (3") on the East side of the house. That translates to app 16" to 18" of water on the first floor. If the building were to remain on site, one can assume elevating approximately 3 feet would be necessary to prevent water from inundating the first floor, *using the 2023 flood levels as a base line.*

MEASURED TO FLOOR LINE HERE. WRITE 18" ON FIRST FLOOR
