Town of East Troy Town Hall and Municipal Needs Analysis Report

Architecture, Fire Protection, Plumbing, HVAC, Electrical

March 8, 2019

zimmerman
ARCHITECTURAL STUDIOS, INC.

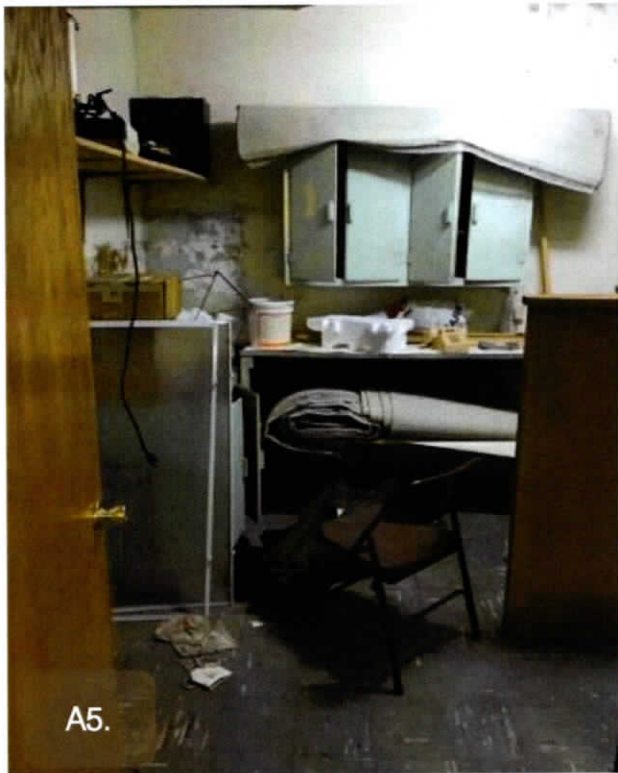
A5.

The basement, which is only under the original 1904 building, is used for file storage but has multiple issues. It has several water infiltration issues and the floor does flood occasionally. There is asbestos floor tile which is buckling. An unused toilet room is locked and situated near some mechanicals (See A4, A5, A6, A7 & A8).

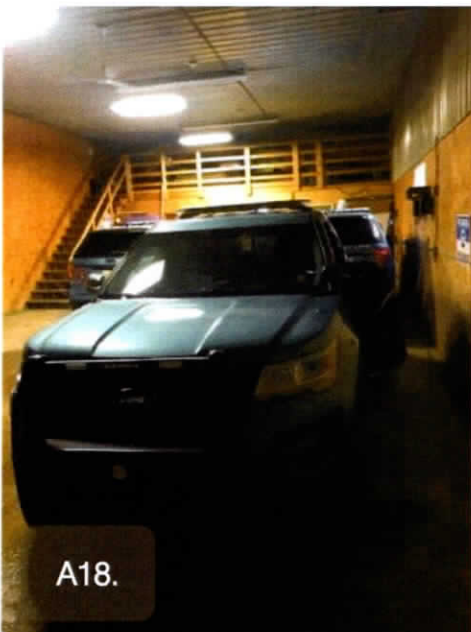
A18.

The current space the DPW has in the DPW building (See A16) is crowded with the storage of the town trucks (See A17). Part of the building is being used by the Police Department for evidence storage, gun cleaning and parking of the police vehicles (See A18). By moving this into a new area adjacent to the Police Department, the DPW can use it for their vehicle maintenance and storage. A cold storage takes up the remaining area. By building a new cold storage area by the salt storage shed (See A19), adding a break room, a new restroom and a storage area the DPW can fully utilize the building

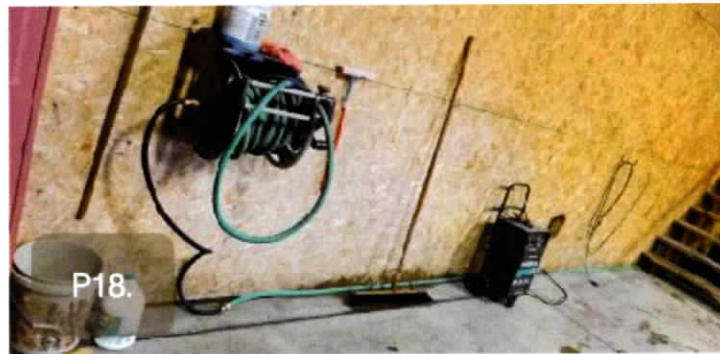
P18.

Hose reel used for vehicle cleaning and general wash down in vehicle storage area is connected to the laundry tray sink. The type of connection is not code compliant.

Laundry tubs are used as lavatories and general use sinks. Fixtures are not ADA compliant. Fixtures are in poor condition (See P32, P34). Laundry tub in police storage area has hose connection with hose reel to spout. (See P16, P17, P18, P32).

Properly connect hose reel with code compliant water connection (See P16, P17, P18).

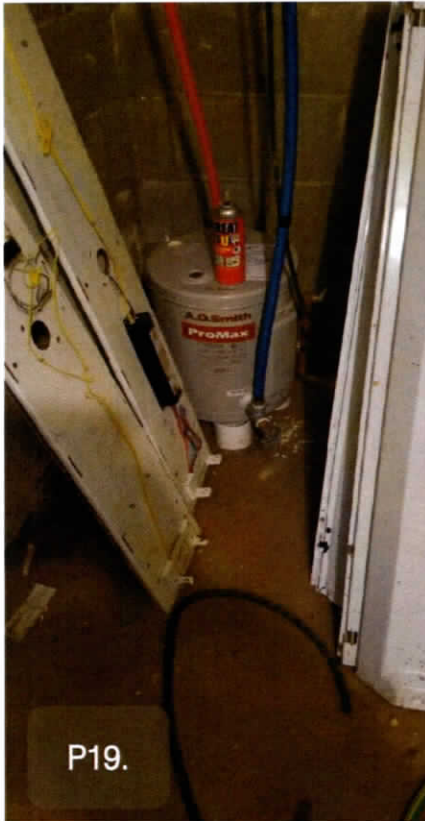
P19.

System is a mixture of galvanized and copper water piping (See P8, P15, P21, P22, P24, P25, P37, P38, P39). Galvanized piping is original to the building. Modifications and repairs have been made to the system to keep it functioning. Some piping has been abandon in walls (See P1, P12, P26). Hangers are missing and are not code compliant at various locations (See P13, P14, P19, P21, P22, P39). System hot water is supplied by an electric 6 gal water heater (See P19). Well casing located at lower level indicates water damage at floor level (See P37, P38).

Hot water heater and piping needs to be checked due to hot water supply volume issues.

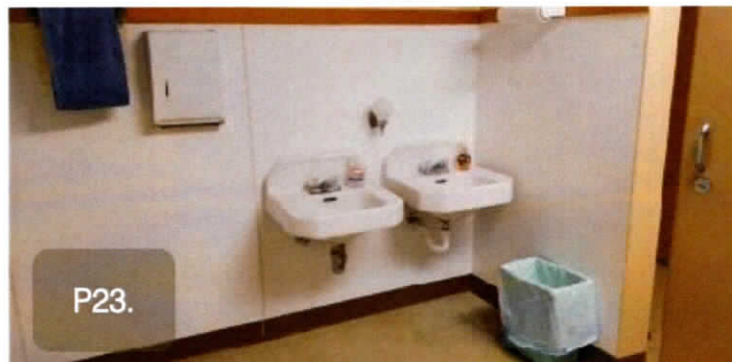
P23.

Lavatories are constructed of vitreous wall hung china and integral counter mounted top with manually operated faucets (See P23 & P40).

The existing plumbing fixtures are in average condition and functional. The majority of the plumbing fixtures in the building are not ADA compliant. The current faucets do not meet current code stands of 100% lead free materials or current water conservation standards.

Replace faucets with lead free water conserving type and ADA models.

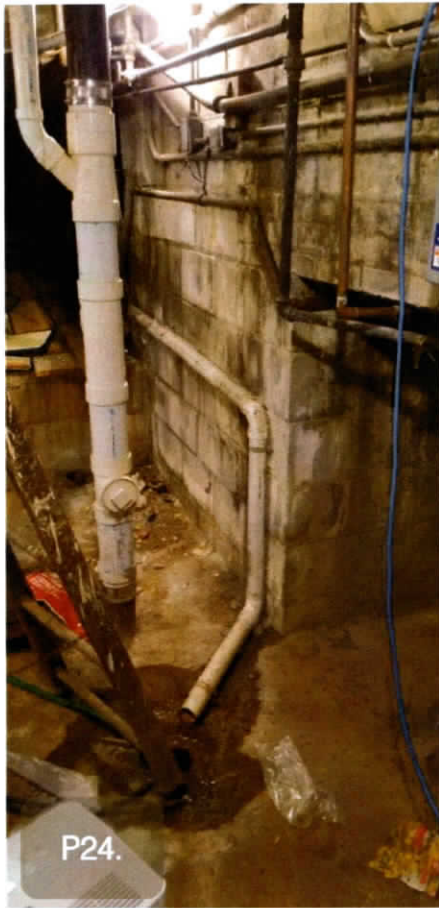
P24.

Piping is a mixture of cast iron, galvanized and PVC. Cast Iron and galvanized is original to the building (See P6, P8, P10, P11, P24, P25, P26, P29, P30). Piping has been replaced or repaired at various locations.

Local waste piping isn't installed code complaint (See P24, P30).

Properly install local waste receptor and local waste piping.

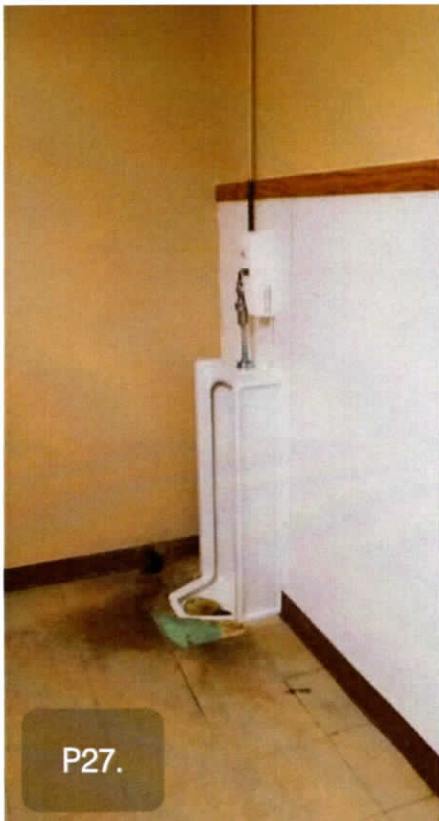
P27.

Urinal is constructed of vitreous china, floor set type with a manual flush valve converted from a tank type washdown flushing type (See P27& P15).

Replace water closets and urinals with water conserving and ADA models.

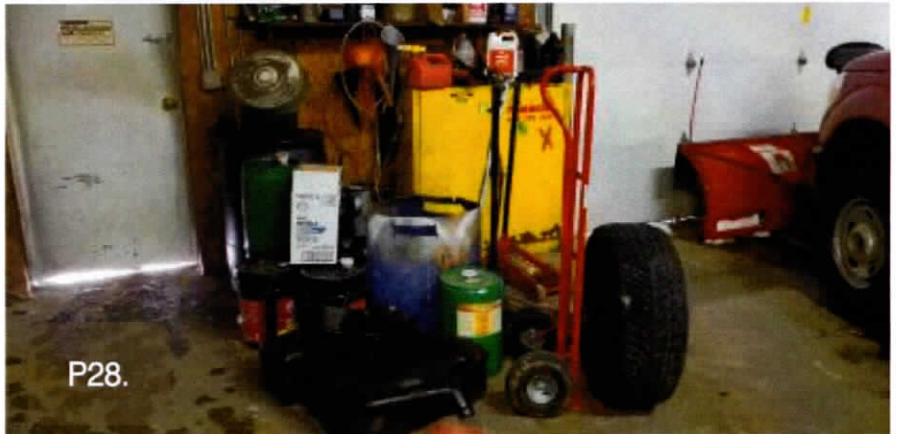
P28.

Better oil containment needs to be addressed to prevent oil from entering the drain system (See P28).

Code compliant oil containment needs to be determined for in ground private waste drain system connection.

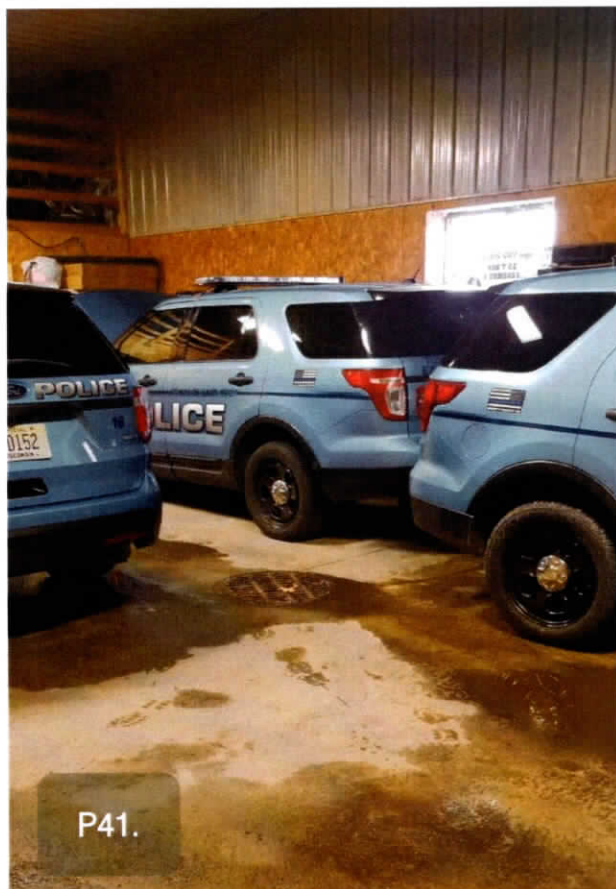
P41.

Floor area drainage may need to be addresses to prevent water on floor in vehicle storage areas (See P3, P4, P5, P41).

Install more drains or trench drains to collect water on floor areas (See P4, P5, P41).
