BUILDING CONDITIONS ASSESSMENT REPORT  
FOR THE

# OLD HAMMOND TOWN HALL & OPERA HOUSE

17 NORTH MAIN STREET  
HAMMOND, NEW YORK 13646  
TOWN OF HAMMOND / ST. LAWRENCE COUNTY

**JULY 15, 2026**

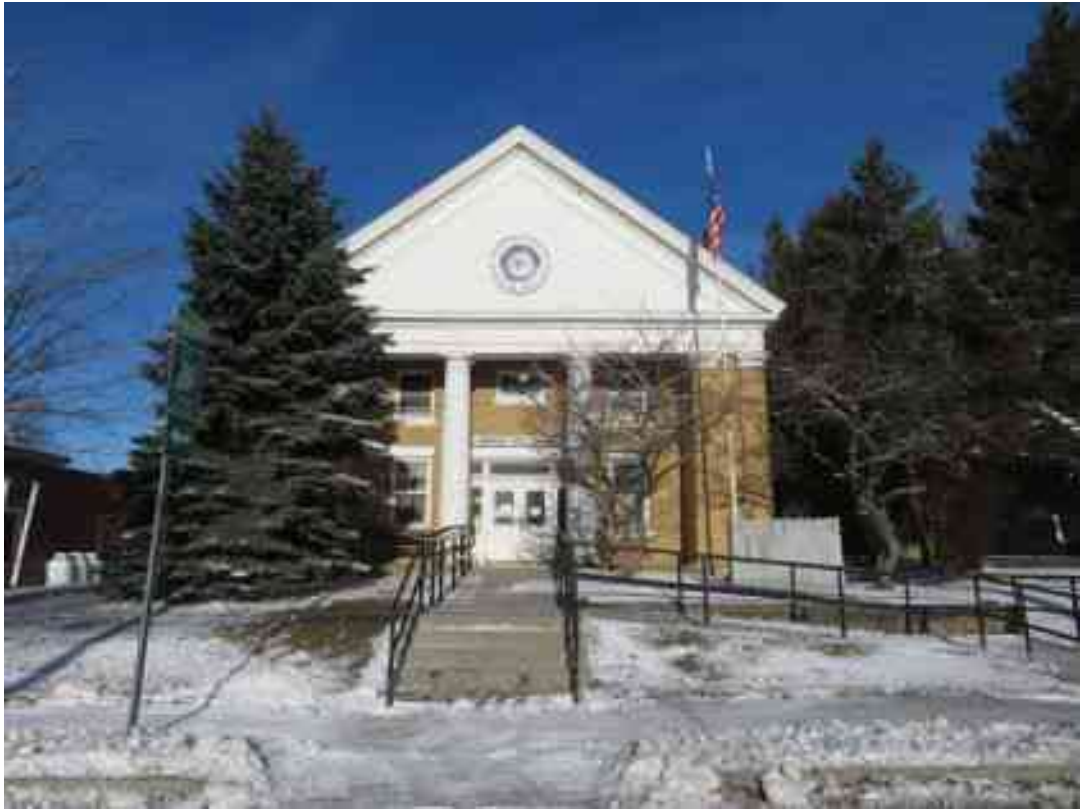
A concrete walk and ramp have been constructed to bring pedestrians from the street to the building entry. In general this is in acceptable condition and functional, but where the walk abuts the concrete deck at the entry recess it has settled several inches making the route inaccessible to wheelchairs and a tripping hazard to others.

Photo 03: Front (East) elevation. Note concrete walk with ramp for accessibility and veteran's memorial.

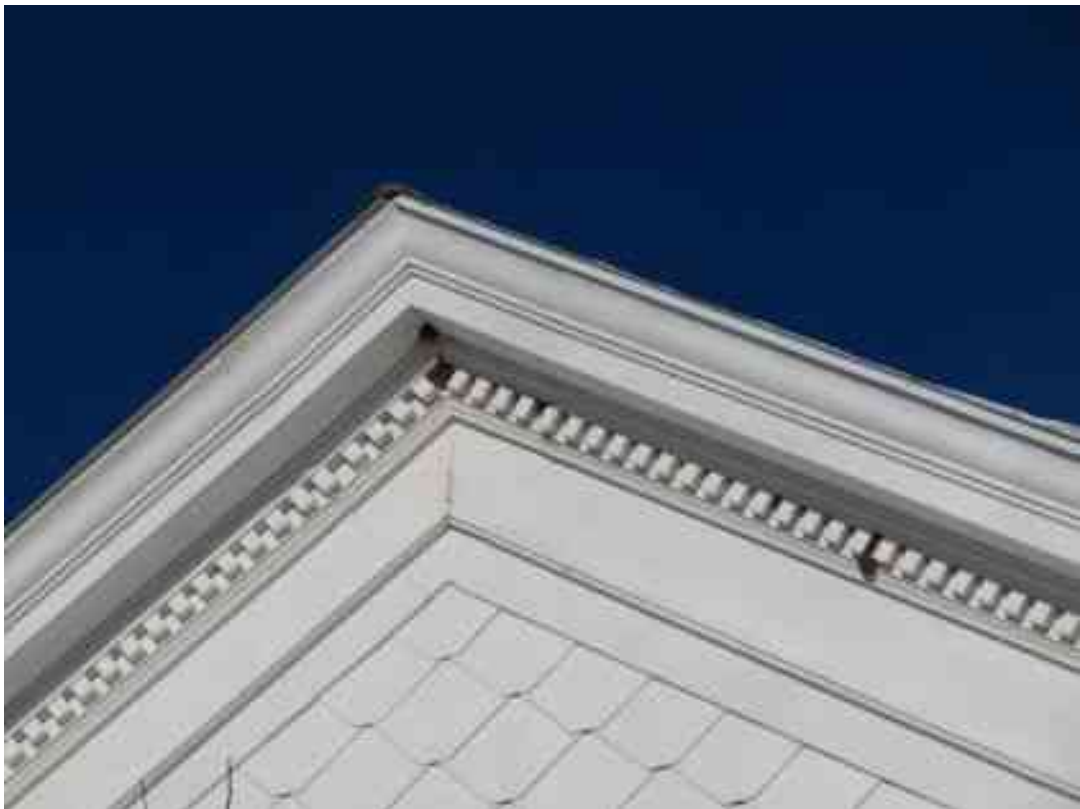
The tympanum, i.e. the triangular face of the front gable, is faced with diamond-shaped shingles which could be asbestos. The Town logo at the center of the tympanum is deteriorated.

Photo 04: Detail at peak of front gable. Note sheet metal trim with decorative diamond shingles.

- ***Assess the tympanum diamond shingles. Removal may not be required even if they are asbestos.***
- ***Secure, repair, and properly paint the metal cornice and trim.***

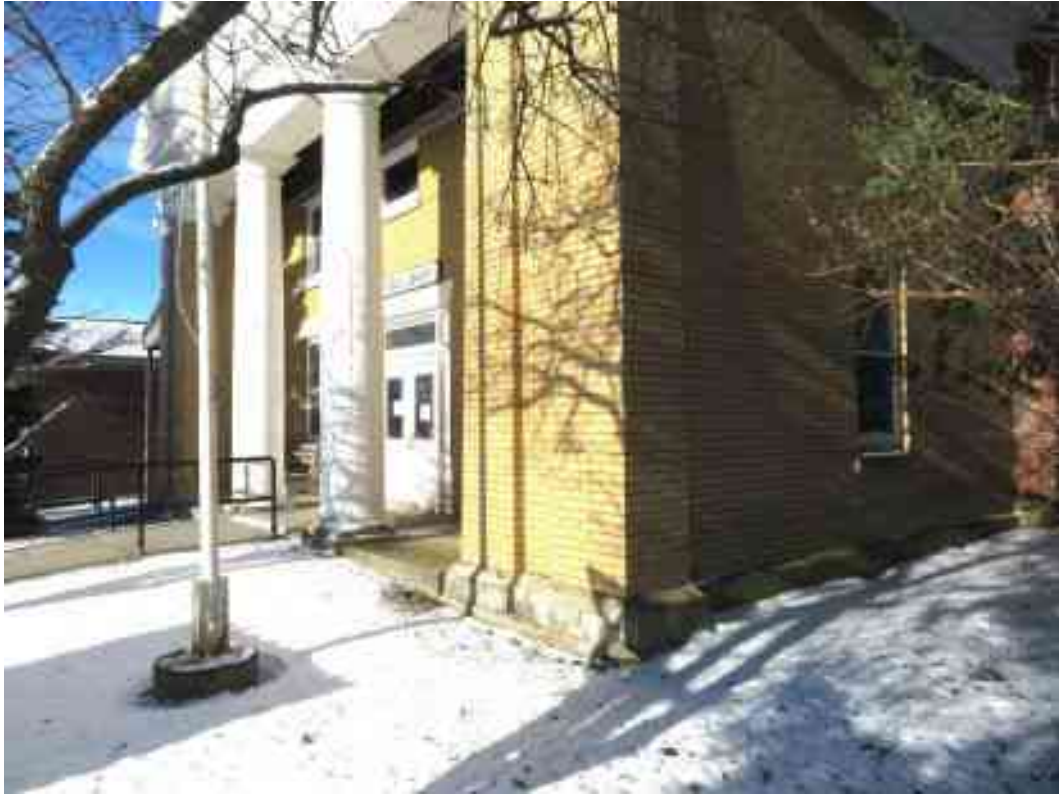
Photo 05: Looking southwesterly at front entry. Note that concrete walk has sunken to create shallow step at access to front doors.

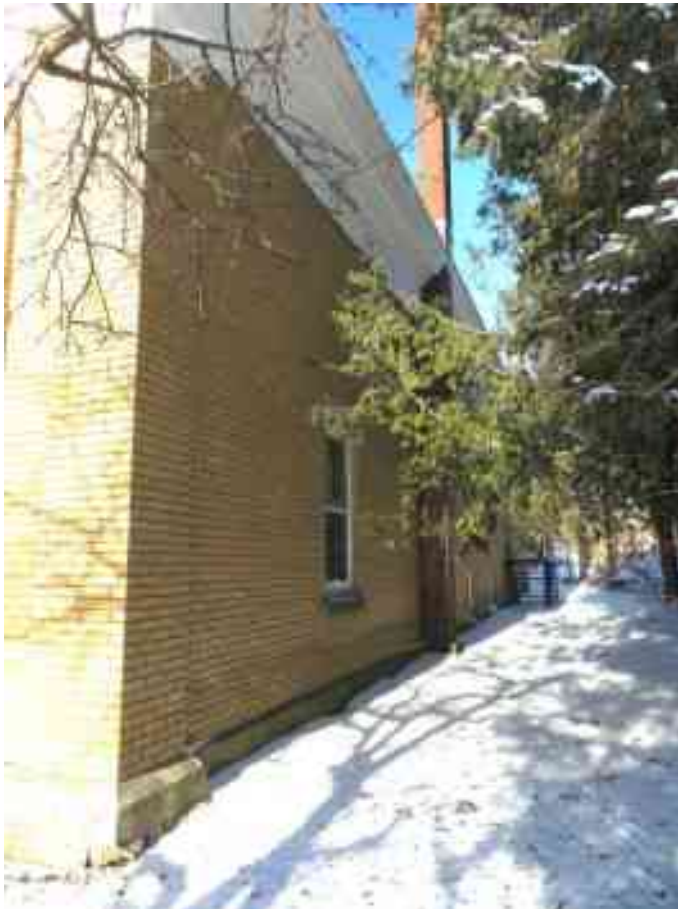
The top of the external chimney, apparently a later addition, on the north side of the building appears to be in questionable condition and warrants investigation.

Photo 06: Looking westerly along north side of building. Note external brick chimney.

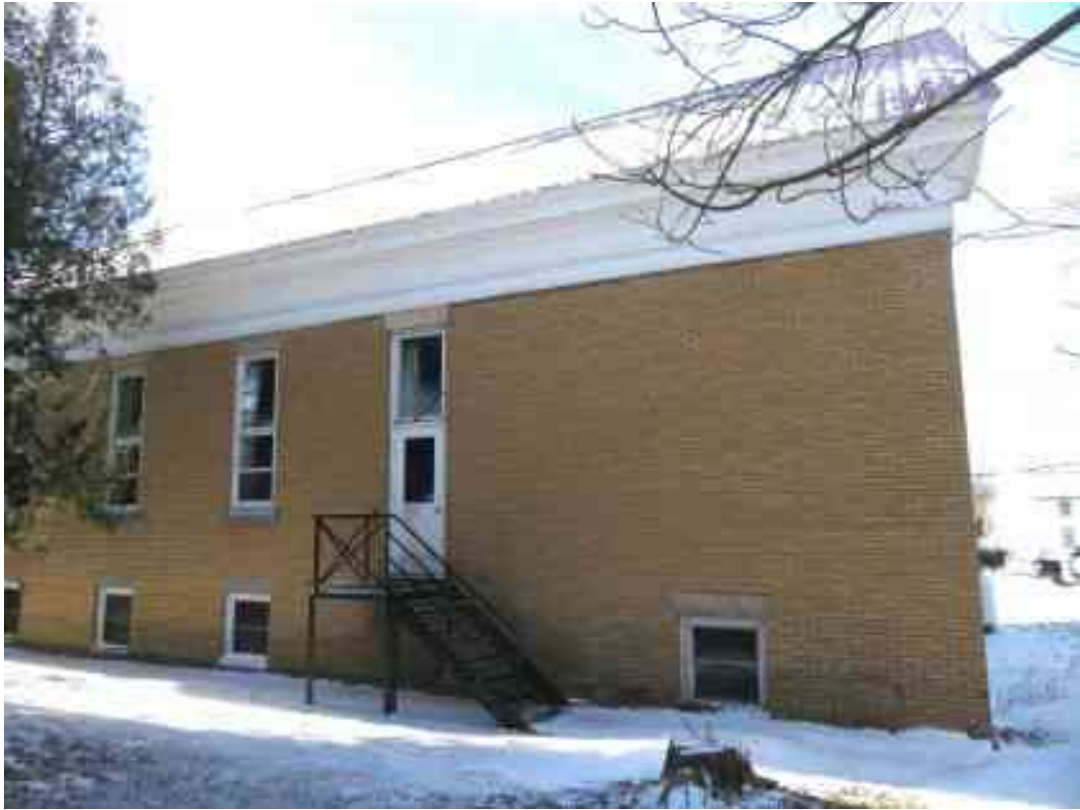
4. Site Features: External metal steps project from the north and south faces of the building to exit the theater space and warrant repairs. A somewhat flimsy porch roof with plain wood posts has been constructed at the south face to protect the Southeast Exit from the historic interior stairs.

Photo 07: Looking southeast to north face of building. Note metal steps and exit from stage left at theater floor level.

- ***Unless otherwise addressed as part of proposed additions to the south side of the building, reinforce or, preferably, replace the current porch roof with something sturdier and more visually appropriate.***
  - ***Repair the side steps to sound condition unless they're to be replaced.***
  - ***Raise the settled concrete walk to align with the recess deck and correct other walk safety issues.***
  - ***Remove the entire slab within the front entry recess and install one that meets accessibility standards, doesn't compromise the columns, pitches to drain, and withstands deicing salts in winter.***
  - ***Repair other concrete walks to sound, safe, accessible condition and coordinate with any new circulation around the building.***
5. Trees: At least three trees around the building obscure the front face or otherwise present a potential danger of causing damage if they fail.

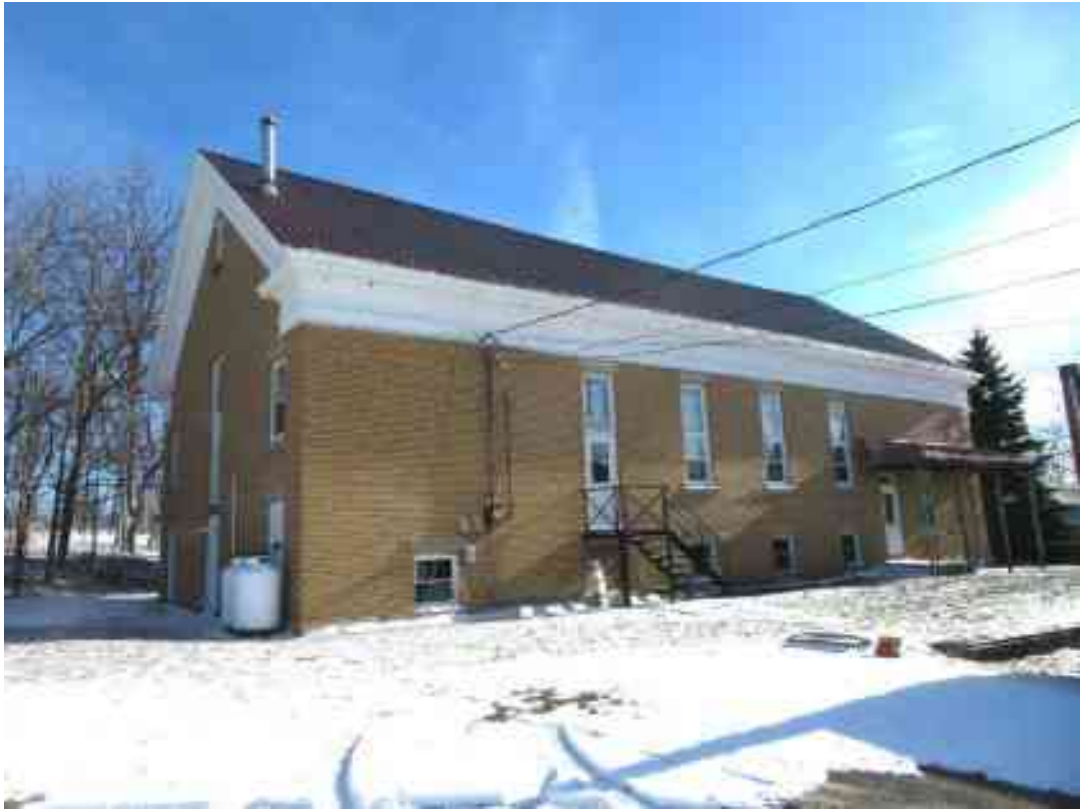
Photo 09: Looking northeasterly to south face of the building. Note exit and metal steps at stage right as well as southeast stair egress beyond.

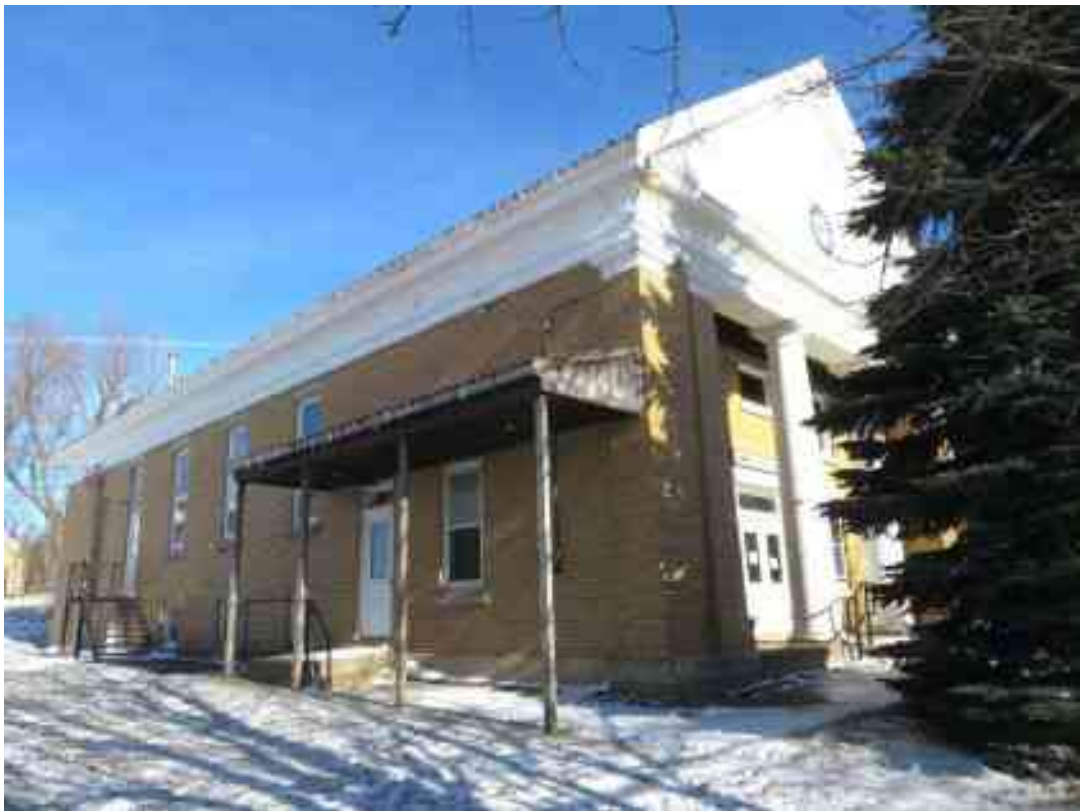
Photo 10: Looking northwesterly to south face of building. Note light framed protective canopy.

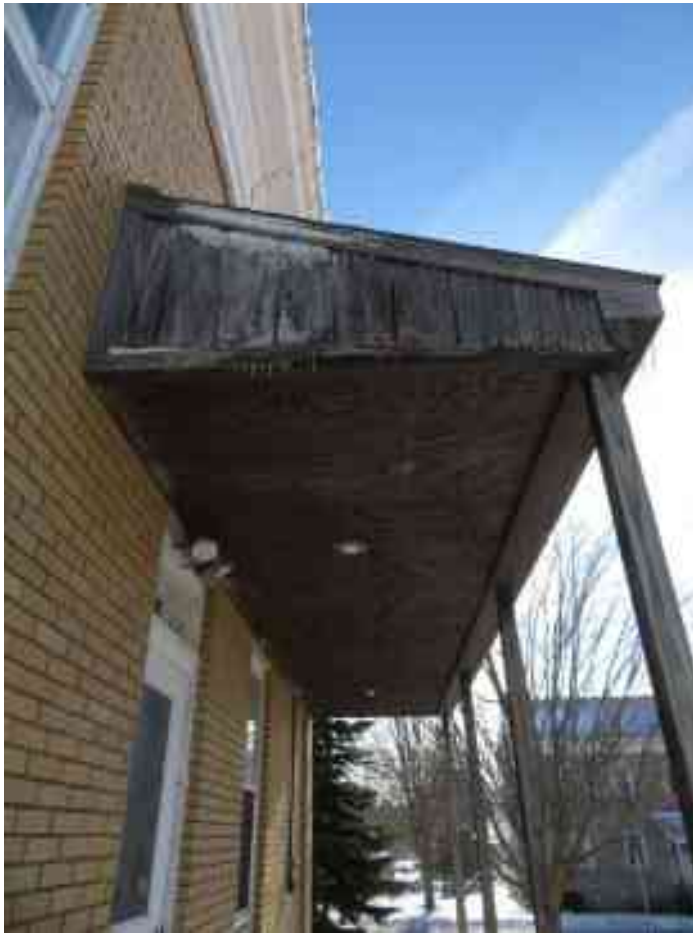
Photo 10.1: (left) Detail at west end of canopy over Southeast Exit.

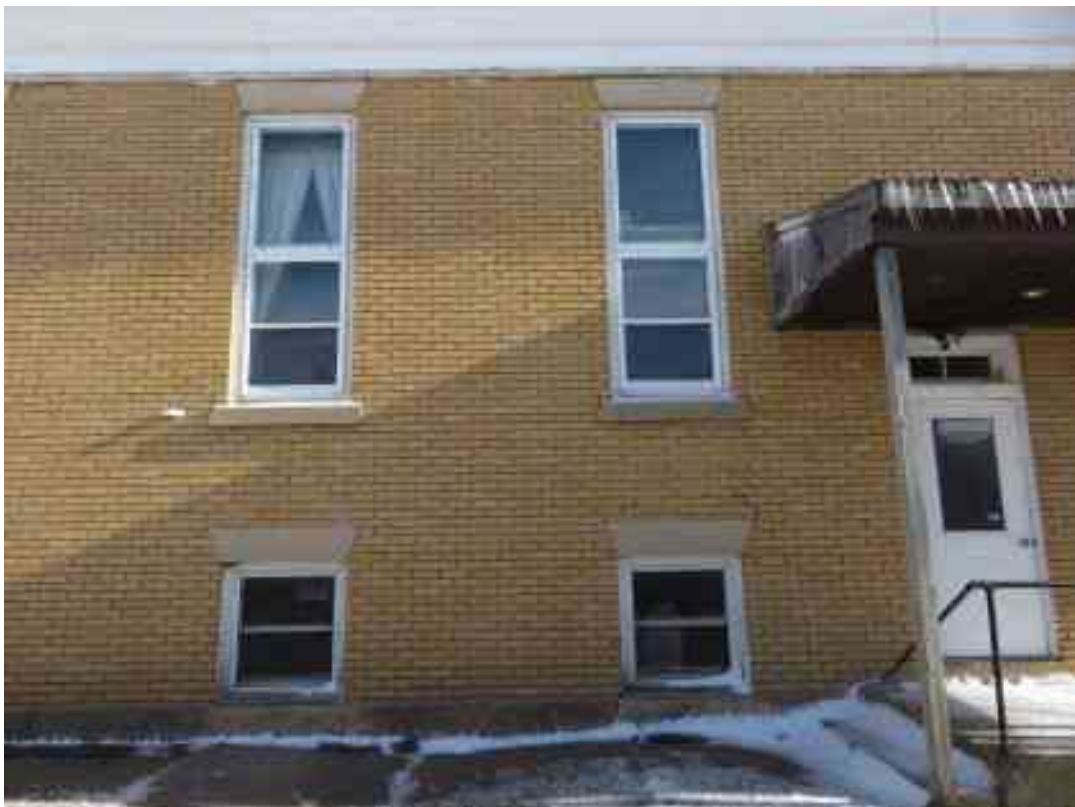
Several specific issues were noted with the masonry. First, there are numerous instances where the bricks above window and door openings have dropped slightly creating stepped cracks in an inverted "V" form. This might be related to sagging of the lintels, but couldn't be confirmed.

Photo 10.2: (below) Detail of exterior, south face. Note miscellaneous step cracks above the basement windows.

- ***Undertake a thorough assessment and scoping of the exterior masonry to identify areas needing attention then make repairs properly using an appropriate lime-based mortar to improve the wall's ability to pass moisture outward.***

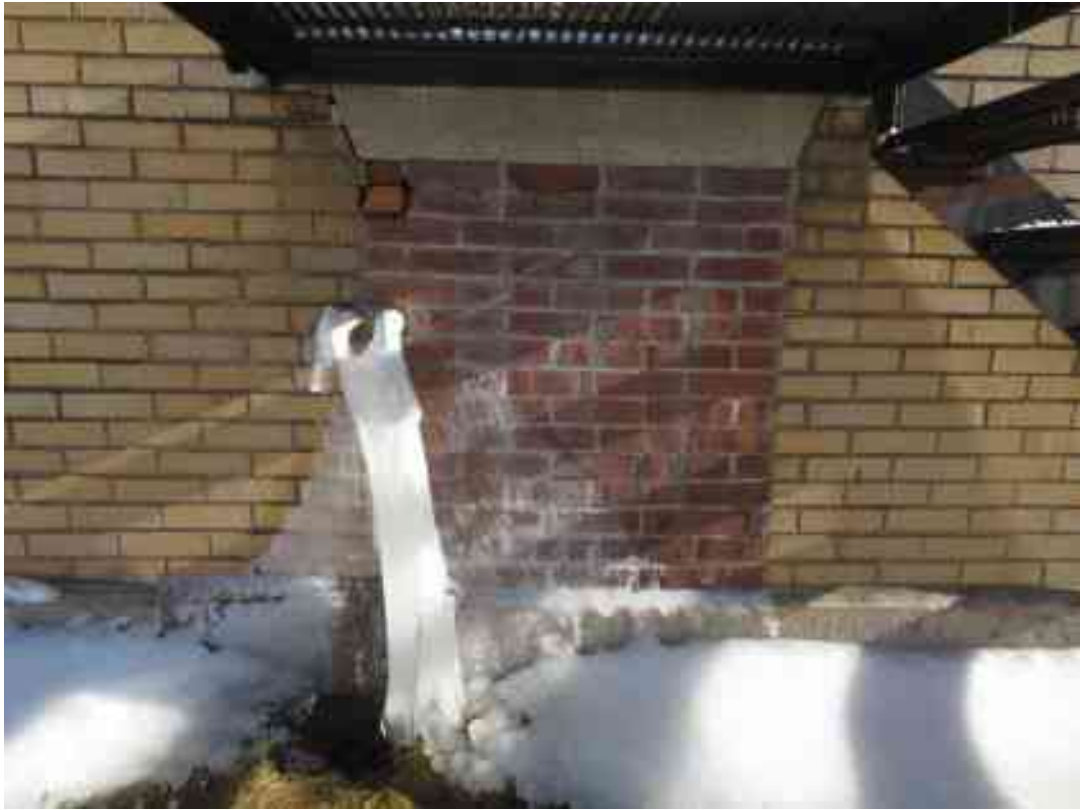
Photo 10.3: Detail of frozen basement sump pump discharge to exterior at Southwest Exit.

- ***Investigate the two sumps and pumps carefully to confirm effective operation. Consider installing a third sump and pump at the northeast corner of the large space and draining out through the north foundation wall to a secure drainage path.***

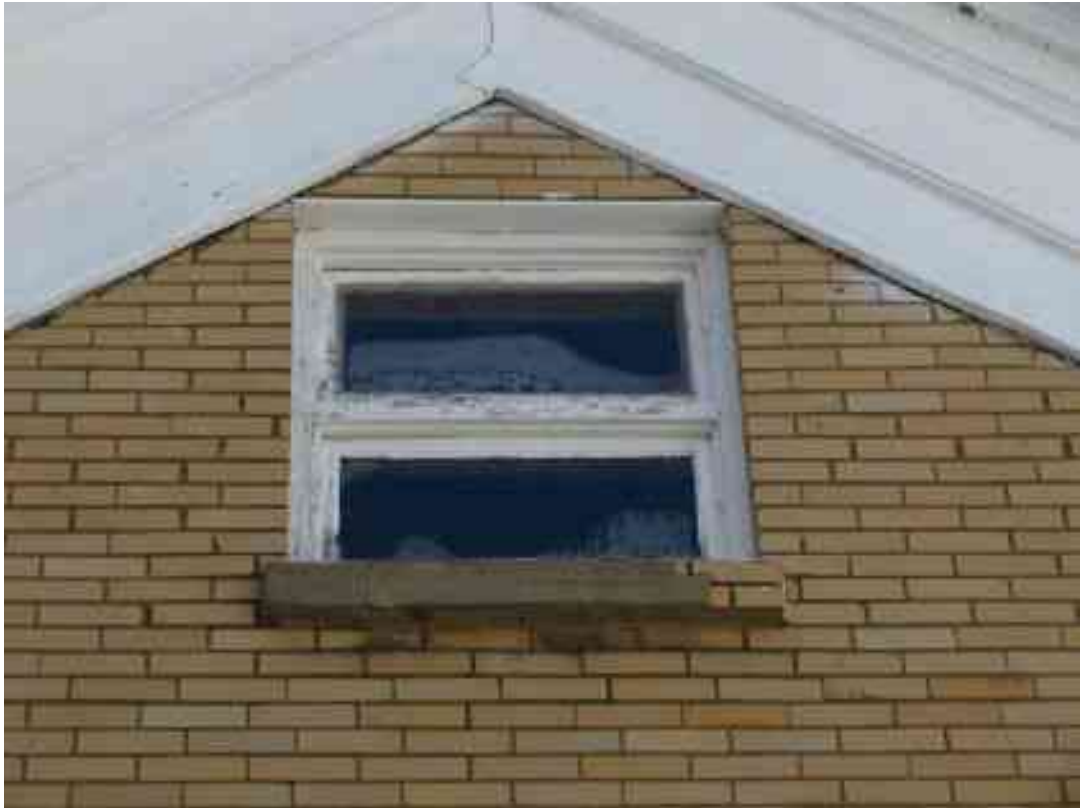
Third, in several cases bricks bearing on the concrete sills at the sides of window openings have failed as the result of water getting under them, freezing, and heaving.

Photo 10.4: Detail of gable window at west elevation. Note deteriorated and poorly patched brick sill.

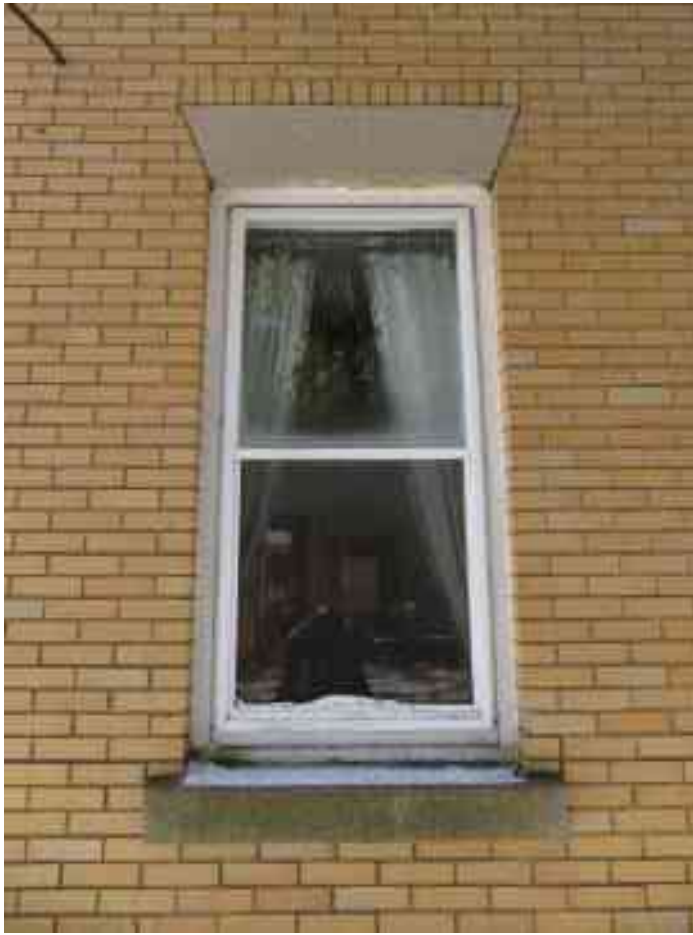
Photo 10.5: (left) Detail at exterior of typical window with an exterior aluminum storm window unit.

- ***Each window should be evaluated and documented carefully to assess conditions and needs. In general, restoration with new unobtrusive triple track aluminum storms & screens is recommended to preserve the historic features, but - subject to SHPO as applicable - costs (especially if the glazing putty has asbestos) and difficulty of operation (especially storms) may lean towards replacement with double glazed, aluminum clad, wood units that match the originals accurately.***

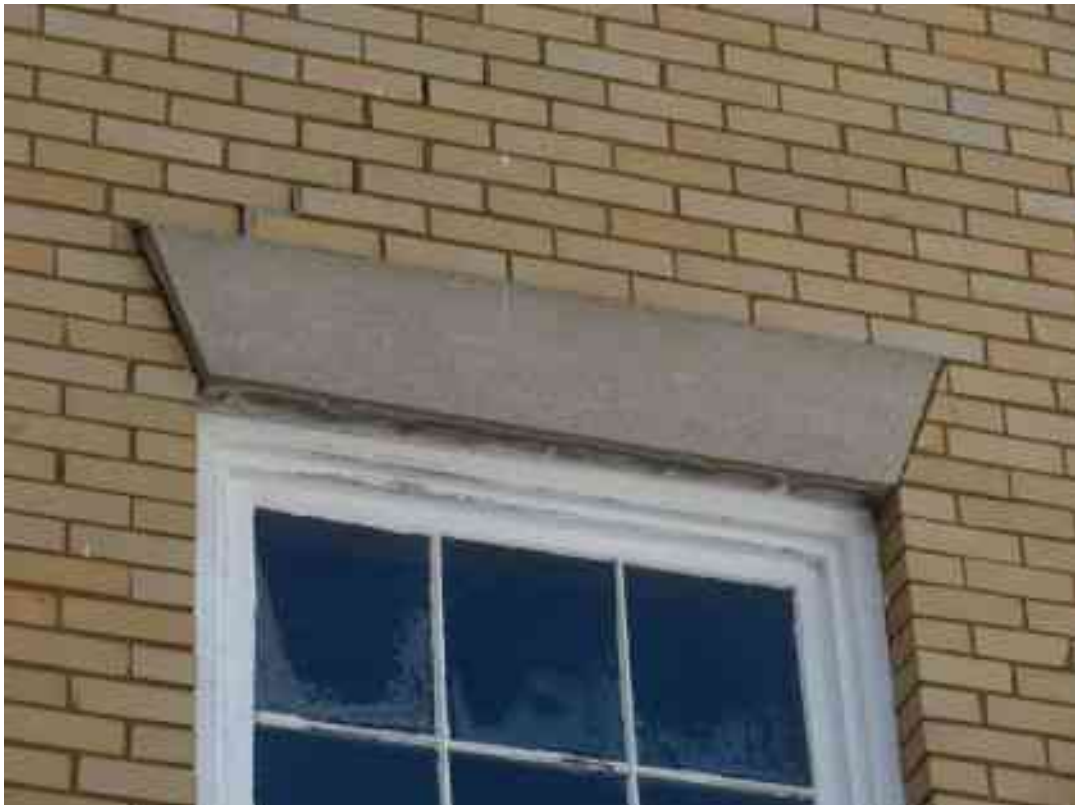
Photo 10.6: (below) Detail of displaced header and step cracking at typical window.

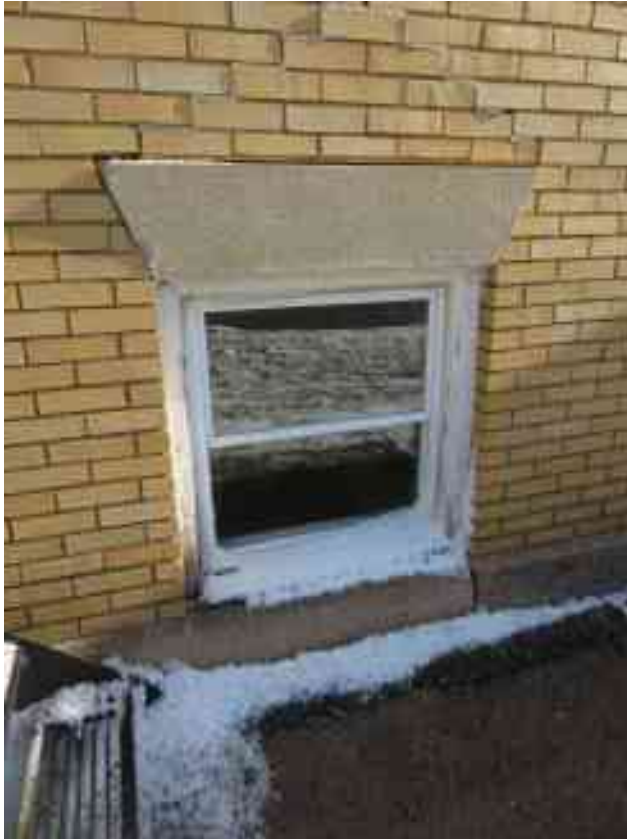
Photo 10.7: Detail of displaced lintel at basement window with triangular step-cracking above it.

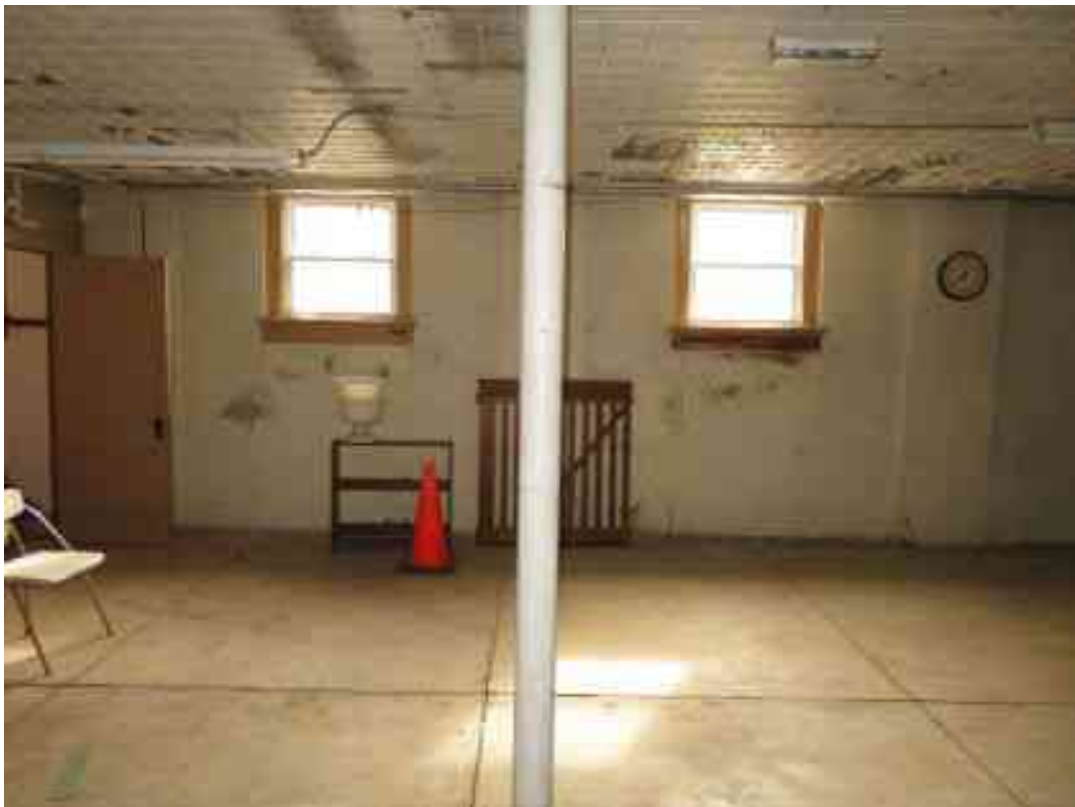
The floor of the basement is concrete, the walls are concrete below grade and clay tile above with a cracking and failing parge coating in most areas, and the ceilings are tin, i.e. pressed metal, with peeling paint. It's not clear where, or if, the concrete foundation wall itself might be cracking behind the parging.

There is evidence of general moisture infiltration plus more specific instances at the

Photo 34: (below) Looking south in Center Basement. Note tin ceiling and water damage below windows.

- ***As part of a comprehensive basement renovation plan remove all loose paint from the tin ceiling, secure a/o patch pieces as necessary, and repaint.***

- ***Correct conditions at water infiltration locations from the exterior. Do not try to waterproof the interior face of the foundation walls as it is unlikely to be effective.***

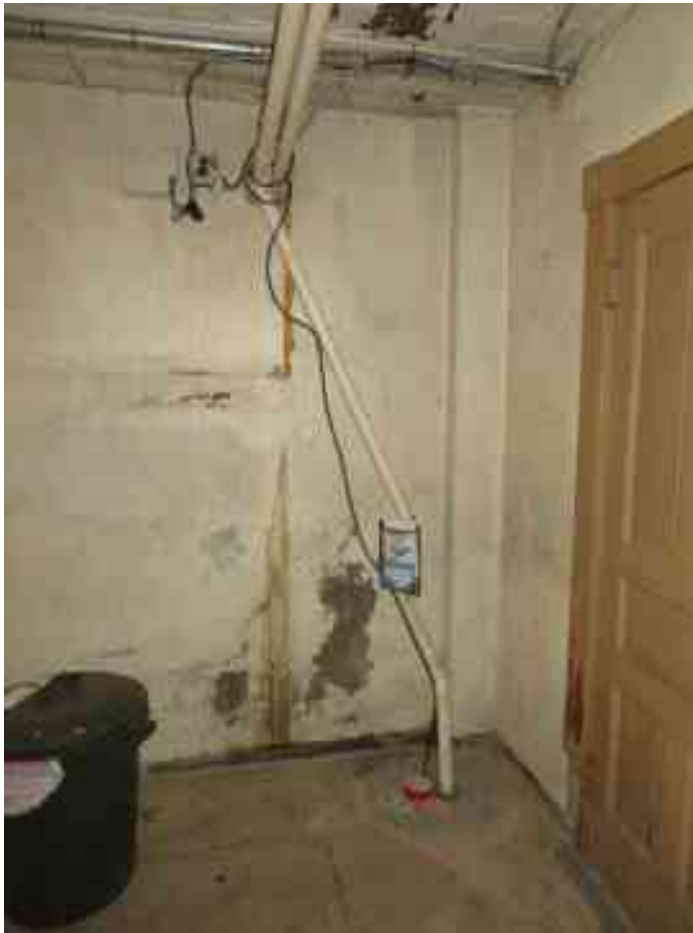
Photo 35: (left) Detail of sump, pump, and discharge piping at southwest corner of Center Basement.

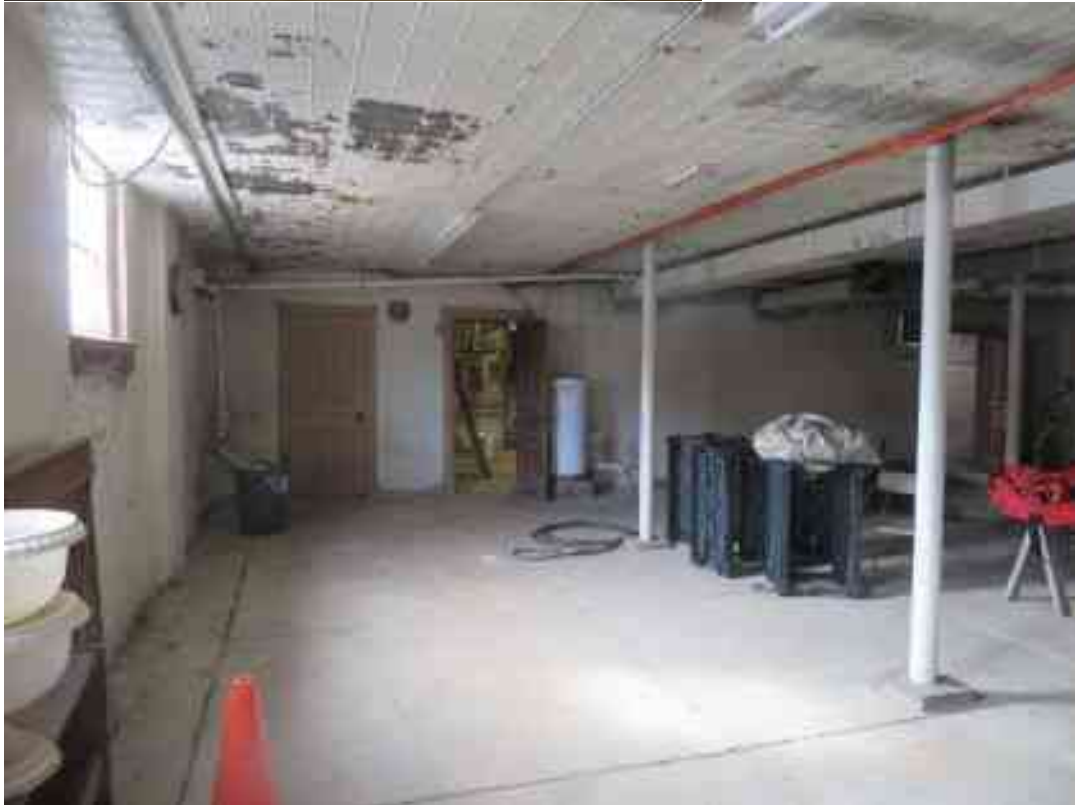
An electric 30 gal. Reliance 606 domestic water heater is located against the west wall of the Center Basement, presumably serving the toilet room. Fittings appear to be deteriorated and the top is badly rusted.

Photo 36: (below) Looking west in Center Basement. Note water heater and exposed mechanicals.

- ***Replace all plumbing as part of a comprehensive renovation of the building.***
