MIDDLETOWN SPRINGS FIREHOUSE STUDY

ARCHITECTURAL SERVICES - FEASIBILITY STUDY
BY:
CENTERLINE ARCHITECTS & PLANNERS, P.C.
RUSSELL CONSTRUCTION SERVICES, INC.
DECEMBER 2020

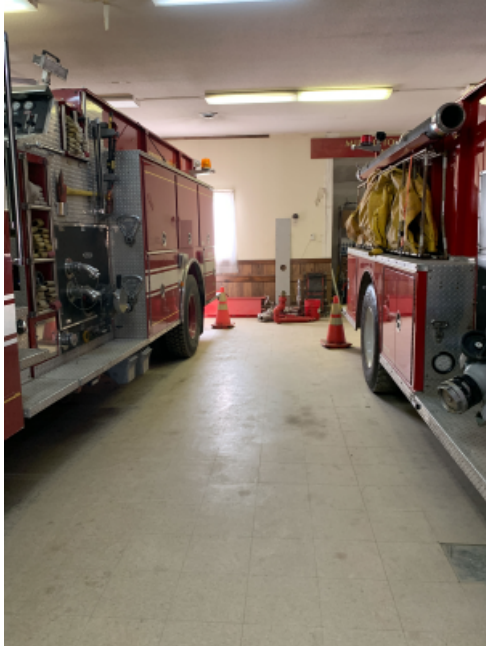
TRUCK SIZE VERSUS APPARATUS BAY SIZE: The fleet of fire trucks do not fit into the apparatus bay. The bay shown in this photo was designed as a bingo parlor and not as a garage. The trucks height barely fit the facility. The facility floor is vinyl tile and not a proper bay surface. No floor drain is present. Snow and water from trucks accumulates on the floor, creating a moisture and cleanliness issue.

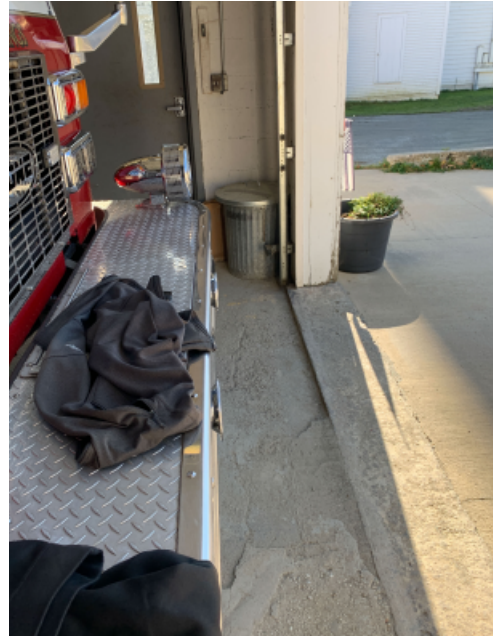
TRUCK SIZE VERSUS APPARATUS BAY SIZE: The fleet of fire trucks do not fit into the apparatus bay. The photo shown illustrates the 1950's bay that houses a single truck. There is no room to access the truck or it's equipment.

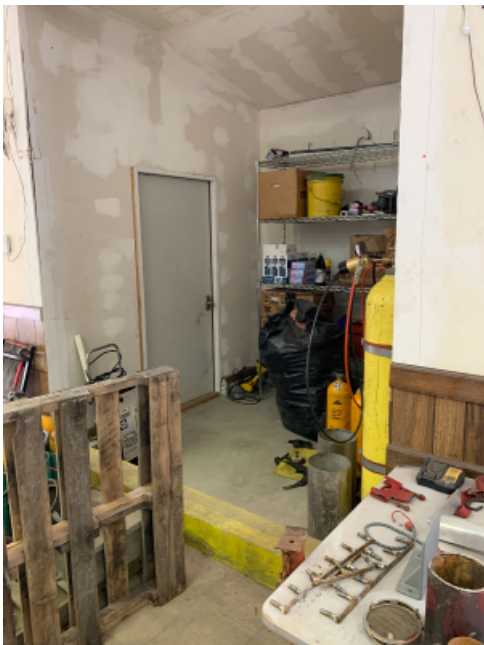
TRUCK SIZE VERSUS APPARATUS BAY SIZE: The fleet of fire trucks do not fit into the apparatus bay. The following bay expansion, attempted to alleviate the bay size constraint, but the layout was determined to be inadequate. There is not adequate storage for equipment, thus it is placed on the bay floor.

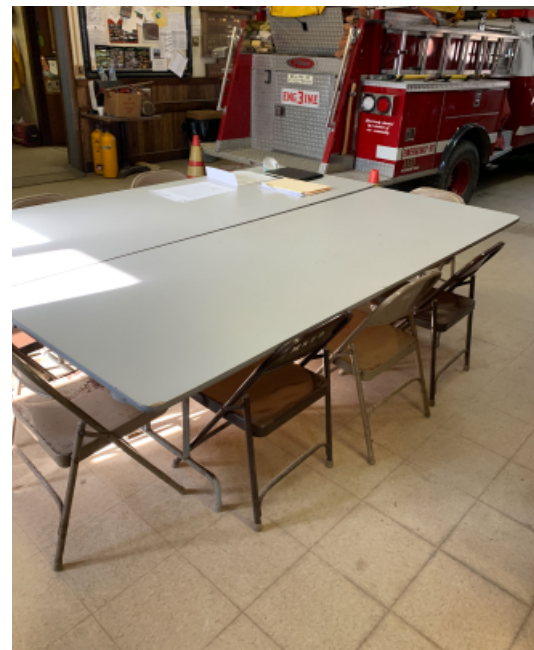
OFFICES: There are no space for offices in the building. The only office or meeting room occurs in the apparatus bay.

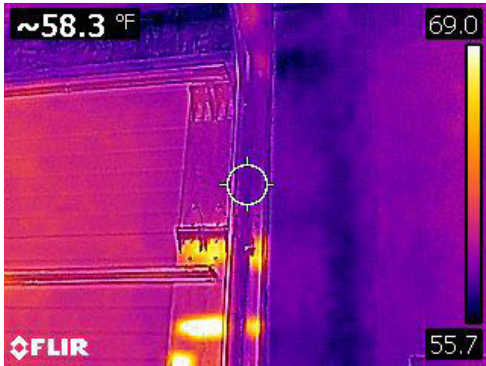
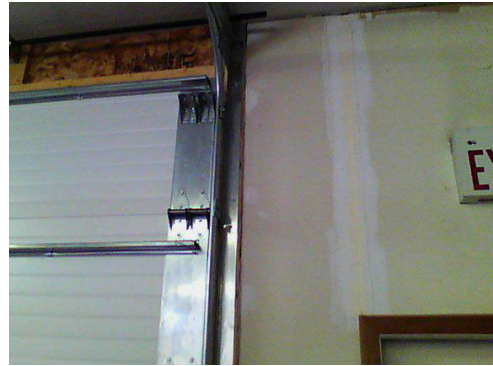
THERMAL SCAN AT APPARATUS BAY WALL: As is illustrated in this thermal scan, the darker portions of the photo illustrate the cold sections of the walls. In this photo there are portions of the wall that are completely uninsulated and therefore are subject to moisture due to condensation.

THERMAL SCAN- IDENTIFIED PHOTO - This photo is the normal photo of the thermal scan shown on the left hand margin.

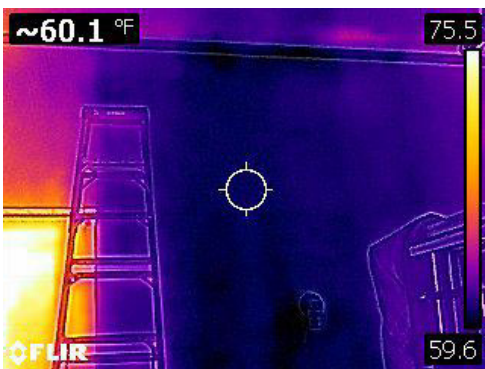
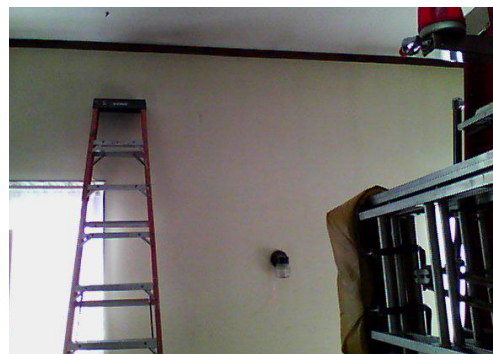
THERMAL SCAN AT APPARATUS BAY WALL #2: Here is another example of an exterior wall not insulated. The result is moisture and eventually mold within the wall cavity.

THERMAL SCAN- IDENTIFIED PHOTO #2- The following wall is not properly insulated. Therefore this section of wall is subject to thermal conductivity.

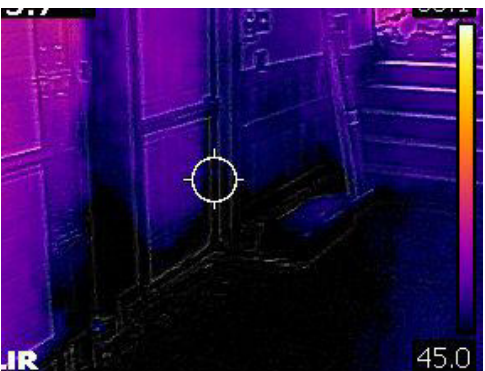
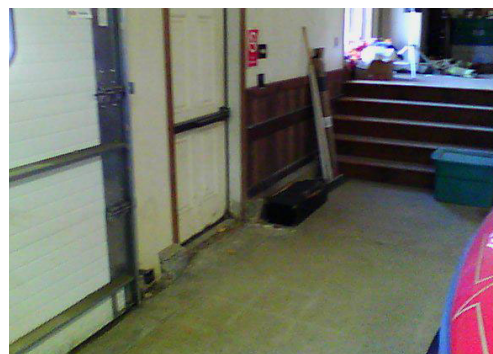
Per the images on Page 9, subsurface insulation barrier under the apparatus slab edge is not present. It was reported by the owner, that ice under the overhead doors will often accumulate and remain throughout the winter months. Ice is a failure of not only the bottom overhead door seal failing but also with a lack of sub-slab insulation.

THERMAL SCAN AT APPARATUS BAY WALL #3: The floor at the door again illustrates the lack of insulation. In addition, the concrete sub-floor is cold inside the building. In the winter, as has been noted, that ice forms at inside portions of the building especially at the overhead doors and entrances. Under the floor tile, the slab is wet and prone to mold.

THERMAL SCAN- IDENTIFIED PHOTO #3- The floor tile telegraphs the joints between tile, indicated possible moisture at the concrete sub-floor.

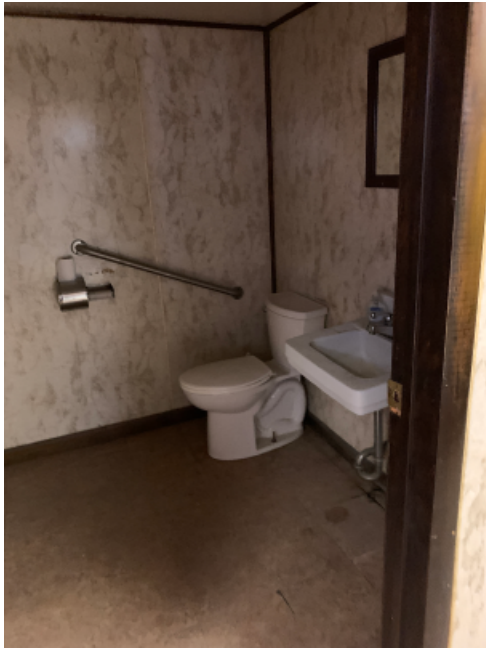
RESTROOM: The bathroom is not accessible. The plumbing fixtures are not accessible. The toilet grab bars are missing, and the one that is present is not to code. An additional bar is required. The existing bar is to be replaced and set at the correct height. The faucet levers are not to code, and need to be replaced with levers. The mirror is not to code, and needs to be replaced. Under counter piping insulation is required.

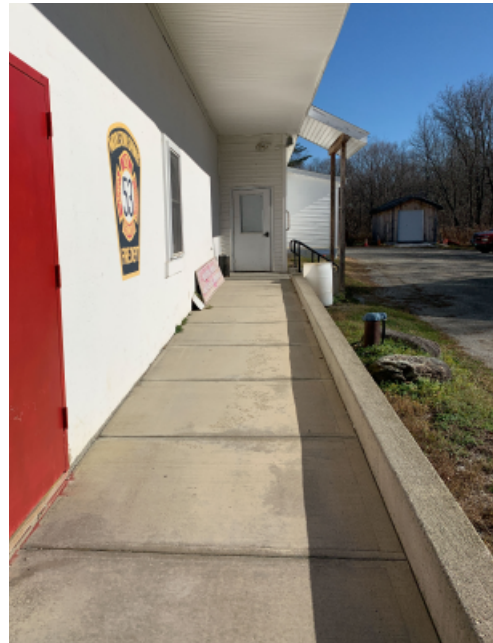
RAMP : The entrance ramp is not accessible. The ramp requires an accessible rail along the path of travel. The ramp itself is required to have rails at the side of the ramp. A intermediate landing is required at 12' of run. The rails at the stairs are not to code. The railing returns at the top and bottom run are not to code.

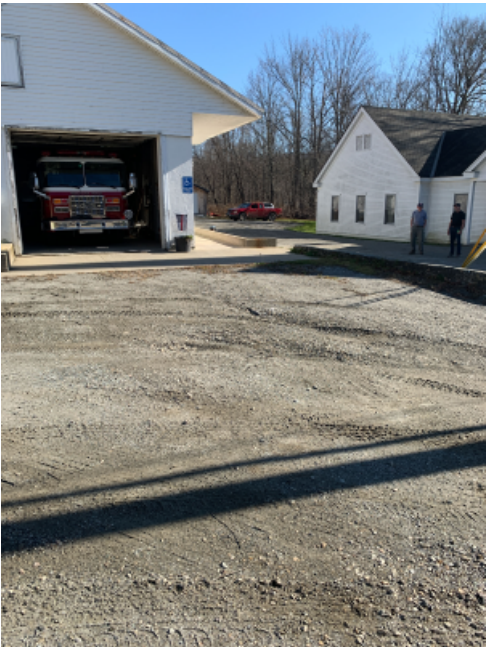
ACCESSIBLE BUILDING ACCESS: In order for a building to be accessible, designated accessible parking is required, near the building. An accessible pathway is then required to the main accessible entrance. Both elements are missing and are required.

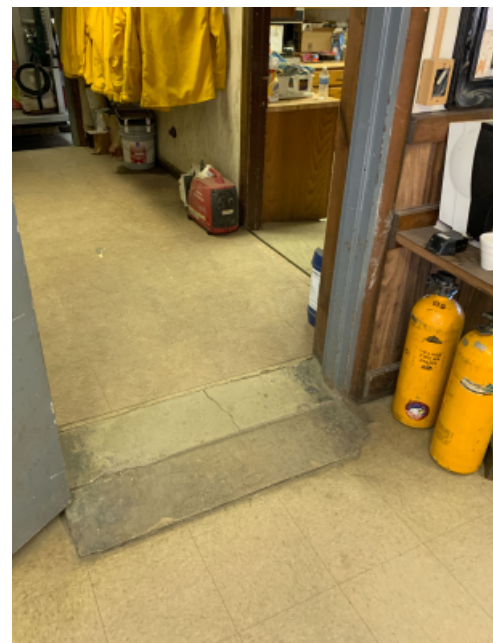
ROOM ENTRANCE : The middle portion of the 1950's section is raised from the apparatus bays. The raised floor is to allow for a crawlspace piping chase. The result however is that not all rooms are accessible, including storage rooms, kitchen, apparatus bays, and stage. This raised portion needs to be removed and all floors are to be on the same plane.

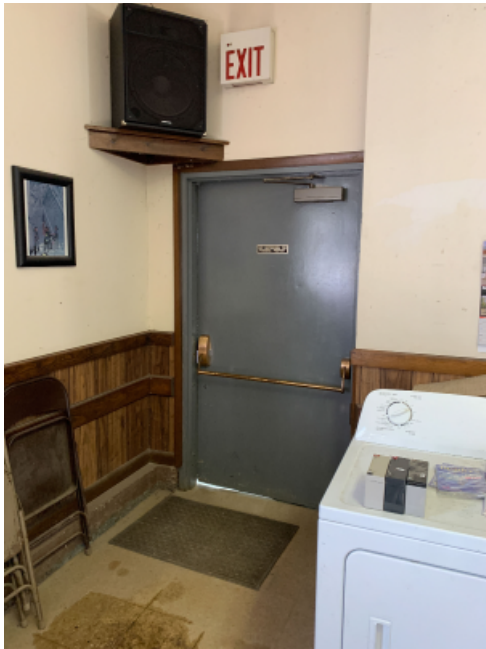
MEANS OF EGRESS: The following photo is the only code compliant means of egress in the building. The other exit doors are either missing exit hardware, have a step, are not clearly identified as means of egress, or the pathway to that egress door is not clearly defined.

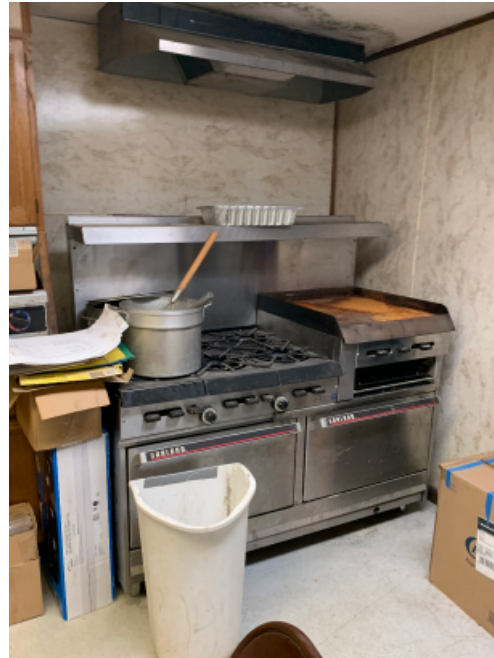
In the kitchen, the exhaust hood is not code compliant. The hood is a residential hood, and is without a proper hood or fire suppression system.

KITCHEN EXHAUST: The kitchen exhaust shown is a residential hood and is not allowed per the mechanical code. The propane stove is a commercial stove, which is allowed, however the exhaust hood is required to have an ansul system, fire alarm, make up air, as well as to be enlarged to over the stove's footprint.

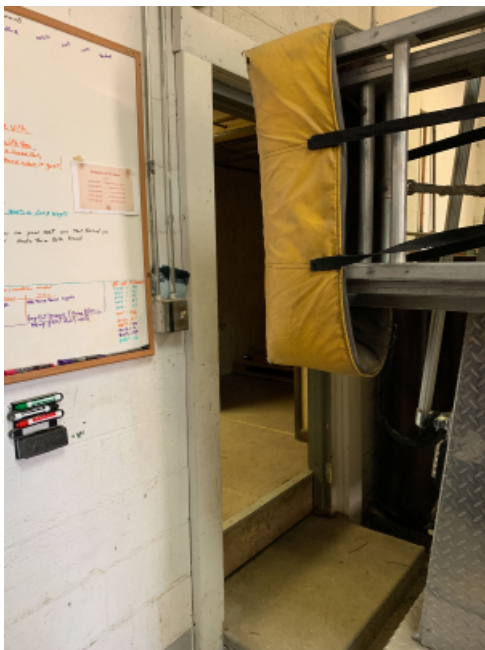
MEANS OF EGRESS: The following photo is an example of an obstructed means of egress from the building. The photo illustrates how the truck blocks the means of egress. The steps at the door are also not allowed per the NFPA 101, and present a clear and present danger for those exiting the building during a fire or smoke event.

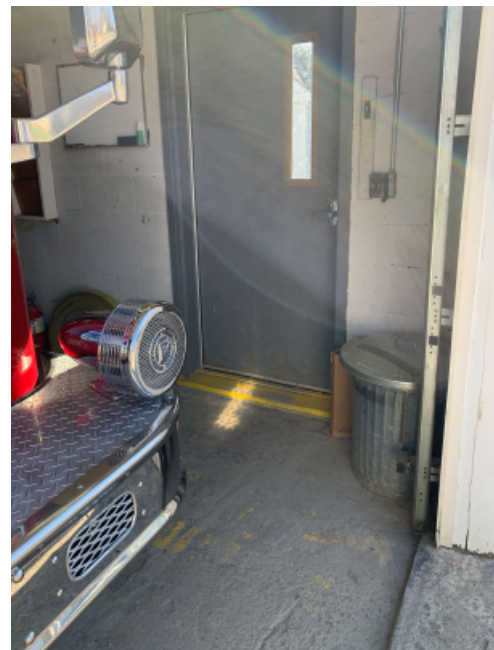
MEANS OF EGRESS: The following photo is an example of an obstructed means of egress from the building. The photo illustrates how a truck is blocking the means of escape from the building in case of a fire. The door illustrated here does not have proper egress hardware, and opens upon a portion of the ramp.

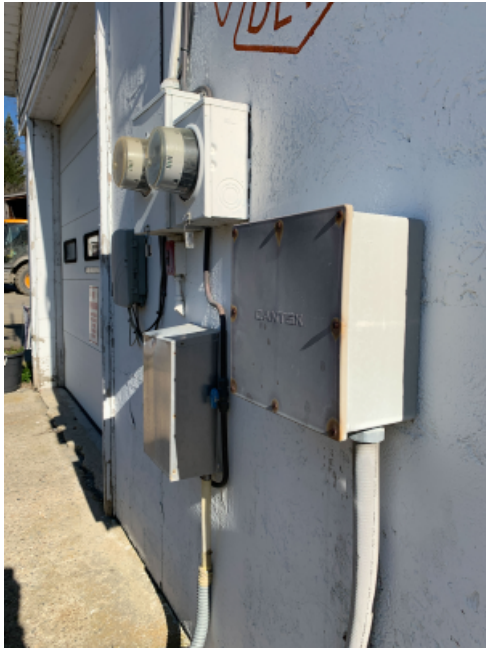
ELECTRICAL SERVICE: There is adequate power that runs from the road, however the distribution at the building is antiquated and should be redistributed. It was noted by the Owner that 3-Phase is available from the street. Three phase is used for the siren. No other items, appear to require 3 phase power.

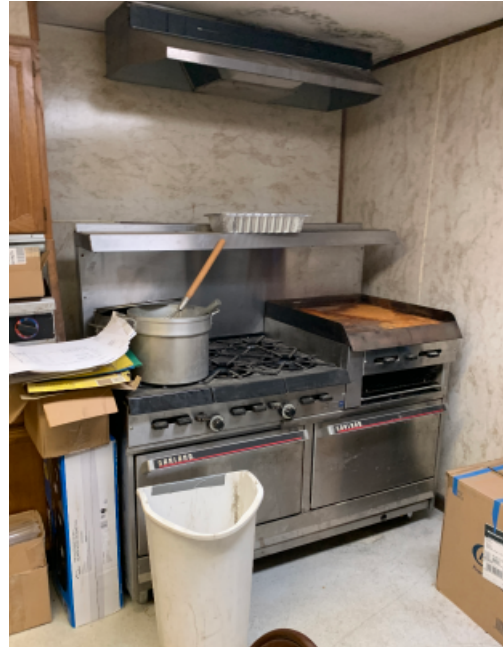
MECHANICAL VENTILATION: As noted previously, the kitchen ventilation is limited to this hood. The hood is required to be an commercial hood. Makeup air would need to be part of the system.

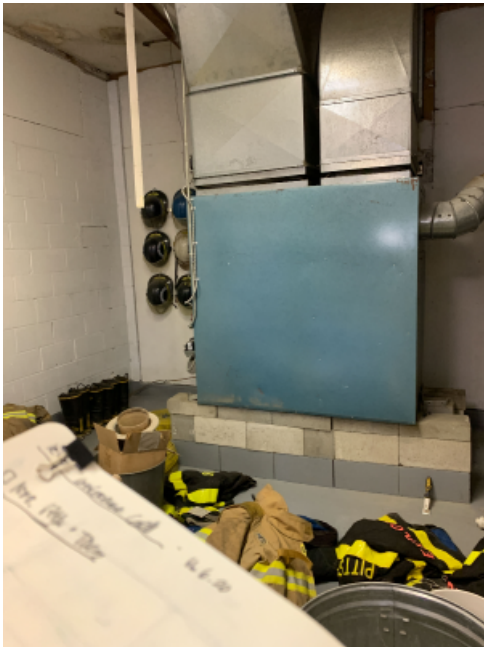
MECHANICAL SYSTEM: The current heating system is forced hot air. There is no active make up air, no energy recovery units. There is a furnace which supplies heated air to the building. The furnace is inefficient and outdated.

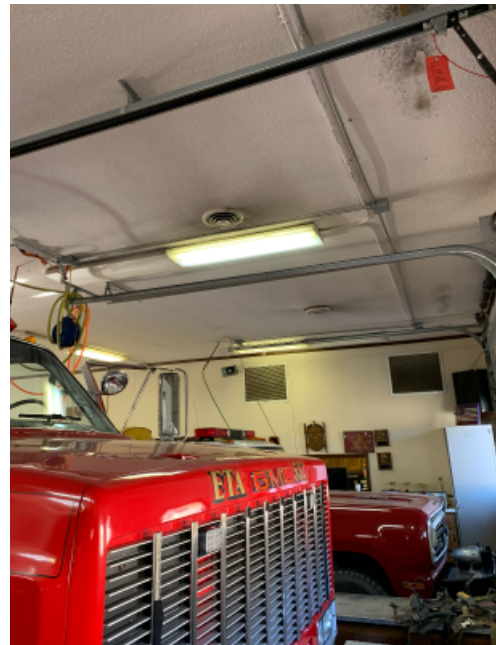
VENTILATION SYSTEM: The passive ventilation system shown by the two wall vents. The system is not appropriate for this building's use. Vehicles exhaust in a enclosed space is potentially dangerous to occupants. Walking through the space, one can smell the diesel fumes.

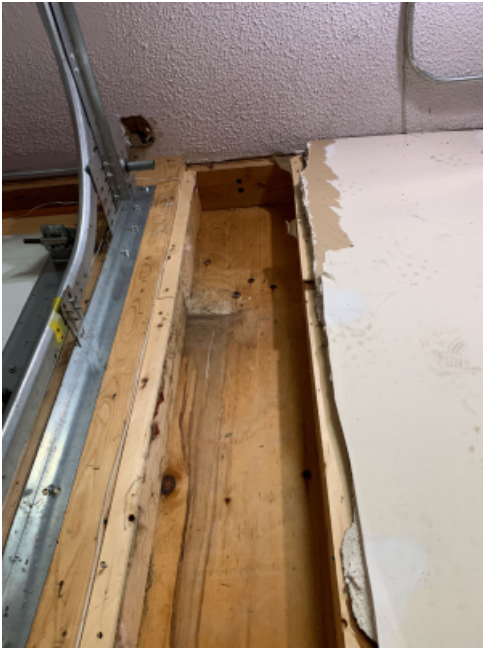
The exterior walls have been hit by firemen parking trucks. Two to three areas in the building remain unfixed, and are without insulation or areas of damaged insulation.

AREAS OF REPAIR: There are areas of the building that have been patched due to trucks hitting the building. These areas are places where there are thermal breaks. To reestablish the thermal barrier, insulation and drywall patching are to take place.

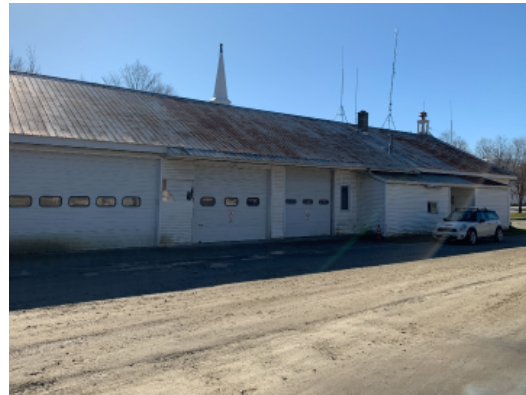
The roof is a simple metal panel sheathing. These panels are at the end of their normal lifespan and fail to keep water out of the building. The owner notes that there are distinct portions of the roof that are leaking.

ROOF SHEATHING: A new roof is suggested. The current roof metal panel system currently leaks. It appears that the service life of the building's roof is coming to an end.

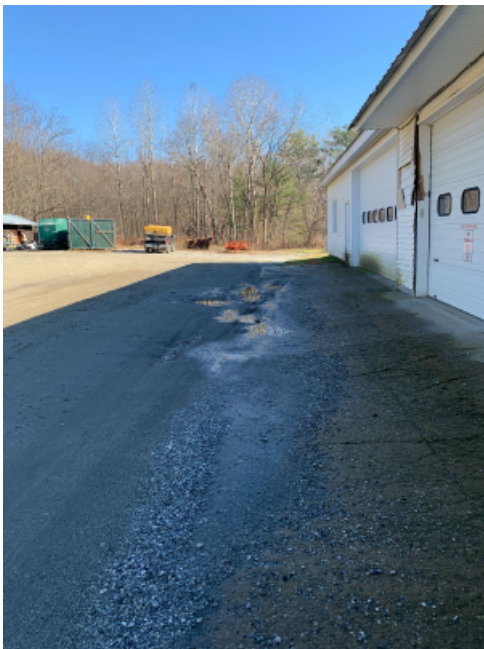
The apron to the building slopes towards the overhead doors. Therefore during rain events, water tends to flow into the building. In combination with the thermal issues at the slab, there is ice build up at the overhead door entrance.

BUILDING APRON: The apron to the building has been washed away by the neighboring sand pile, belonging to the town. The apron no longer pitches away from the building, and therefore during sizable rain events, the apparatus bay, especially in front of the overhead doors receives water.

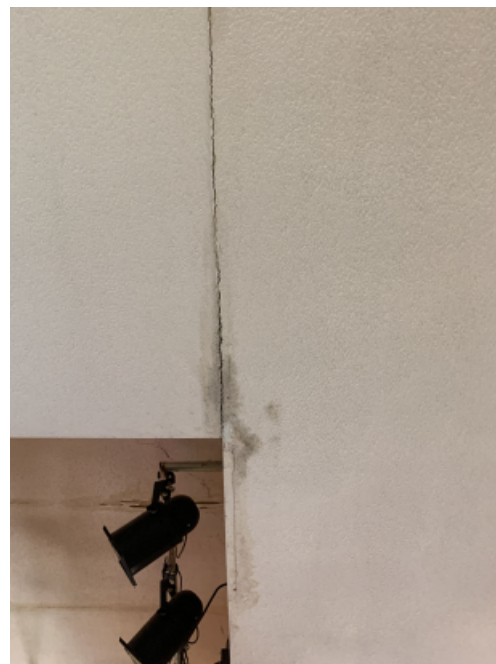
At the 1950's portion of the building, there is evidence of cracking at the cmu blocks that comprise the exterior walls. Considering the age of the building, one can assume that the foundation walls have settled.

STRUCTURAL MOVEMENT: The following cracking in the drywall is an indication of structural elements that have moved within the building. Proper expansion joints are required in order to account for movement between elements.
