# Arboricultural Consulting Report

Aaron Josi  
Chaps Development Group

413 East 47<sup>th</sup> Street  
Garden City, Idaho

April 14th, 2026

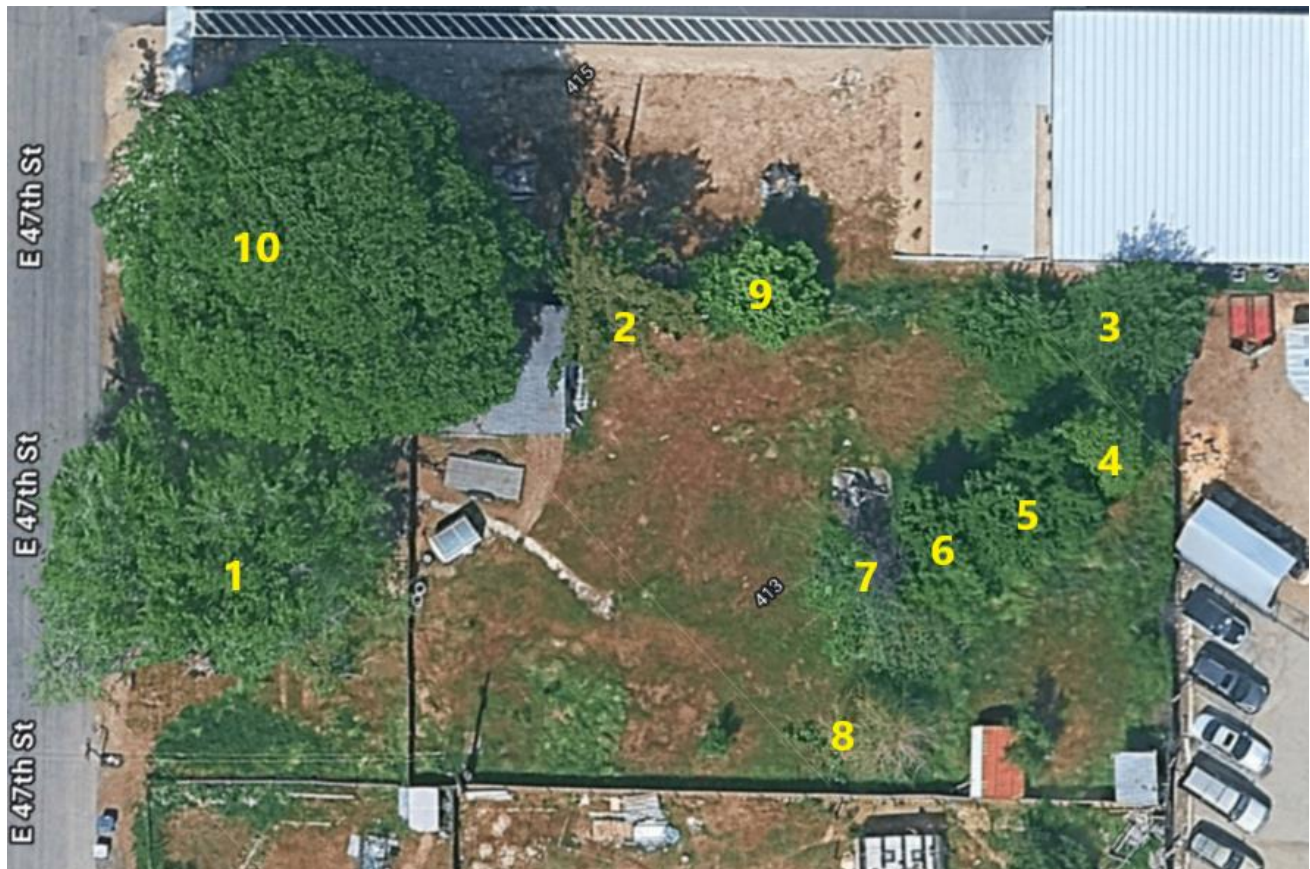
Figure 1. Subject property and trees with identifying tree numbers.

We collected data on 10 trees (Figure 1).
