**Environmental Services, Inc.**

January 28, 2014

**RE: VILLAGE OF MILLBROOK  
ANNUAL INFLOW AND INFILTRATION MANAGEMENT REPORT  
SPDES Permit No. NY-0025429**

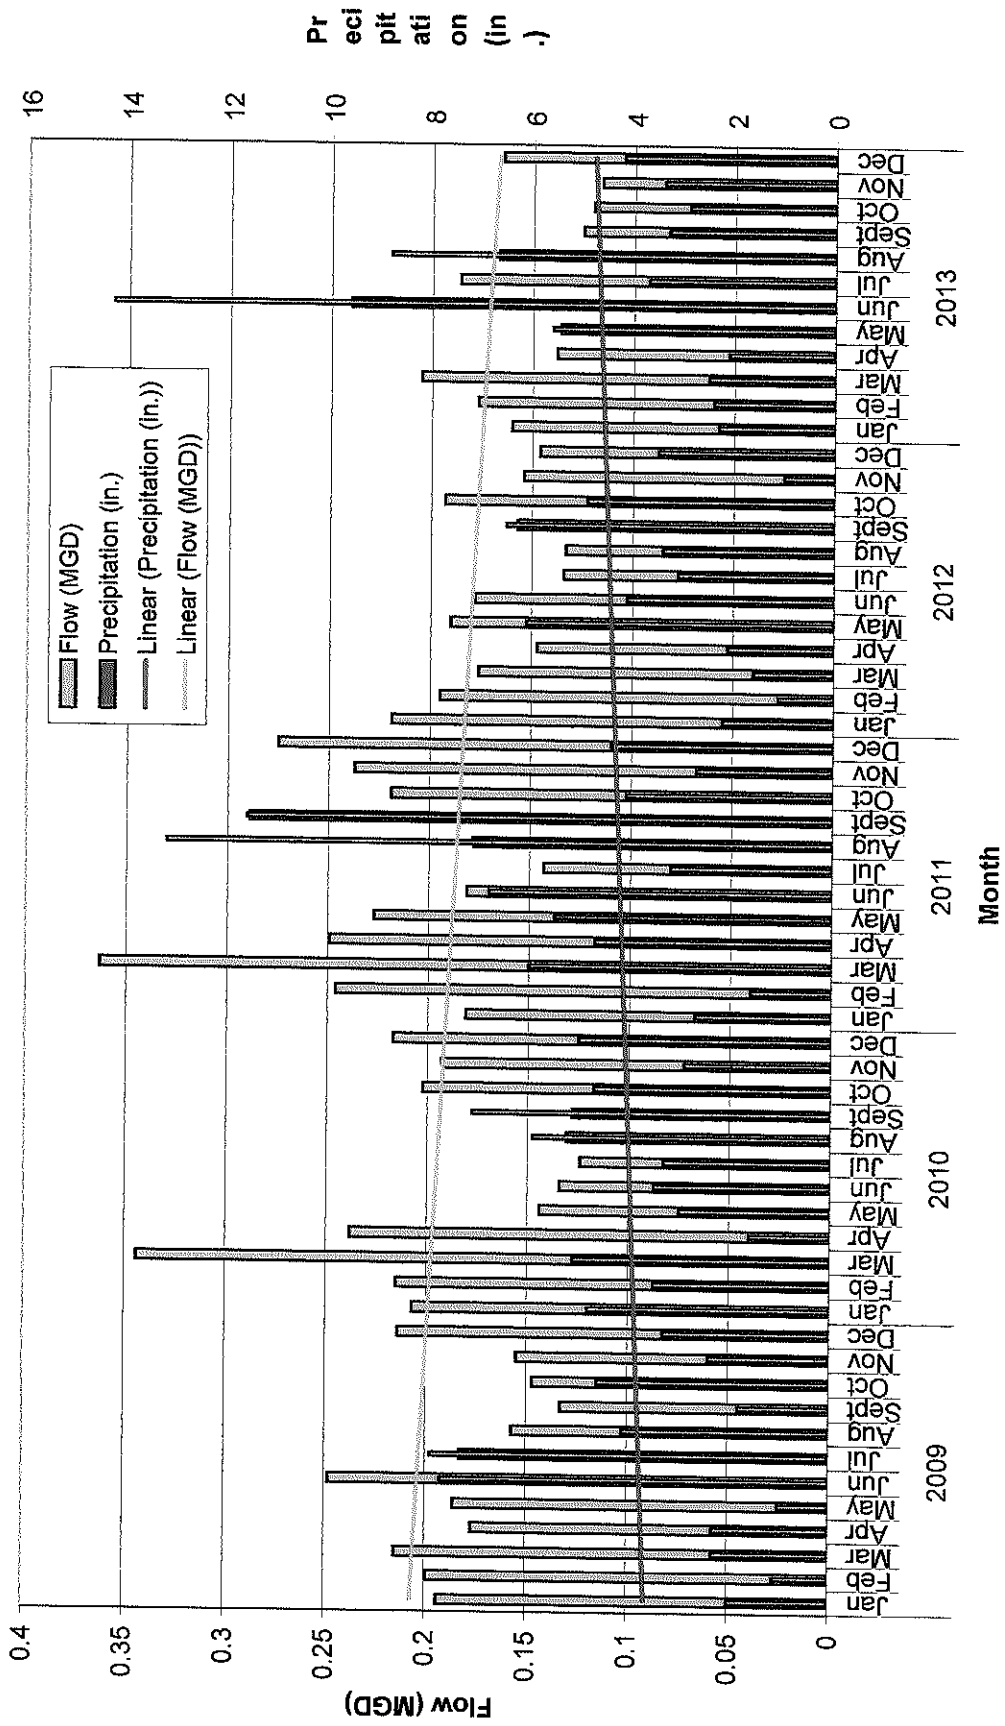
**Figure 1**  
**Monthly Average Flow and Precipitation VS. Time**

I have also included 2 graphs, the first showing the monthly average flows along with monthly precipitation from 2009 to the present. The second graph (Figure 1) shows the same data but also includes the trend over time for flow and precipitation. Over the past year the monthly average flow exceeded 200,000 GPD only twice. As you can see on the

second graph (Figure 1) the monthly flows have decreased significantly over the past several years indicating a reduction of I&I.
