**cheshire fire station
building condition assesment**

**cheshire
ma**

: 15 august 2022

existing building report

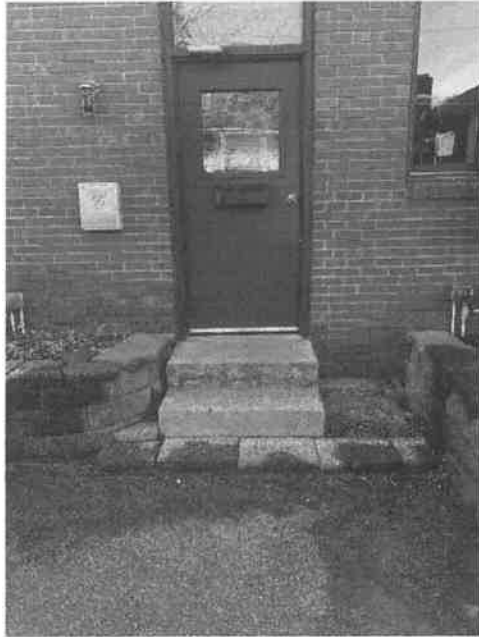
The main entrance to the building is not handicap accessible.

Main Entry

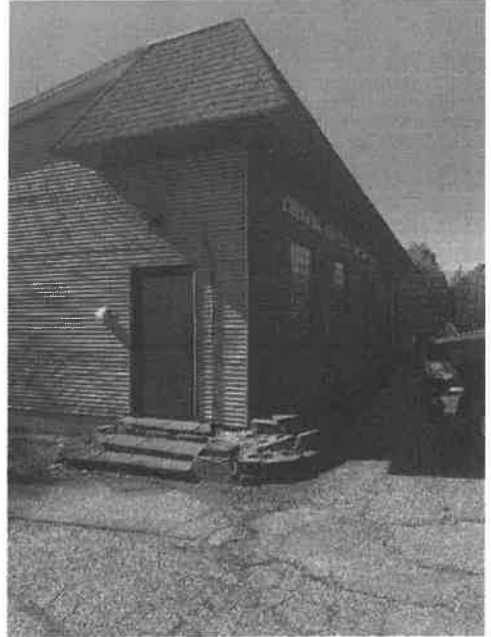
The landing and railing on exterior door on the north side west corner is not code compliant

Door at Northwest corner

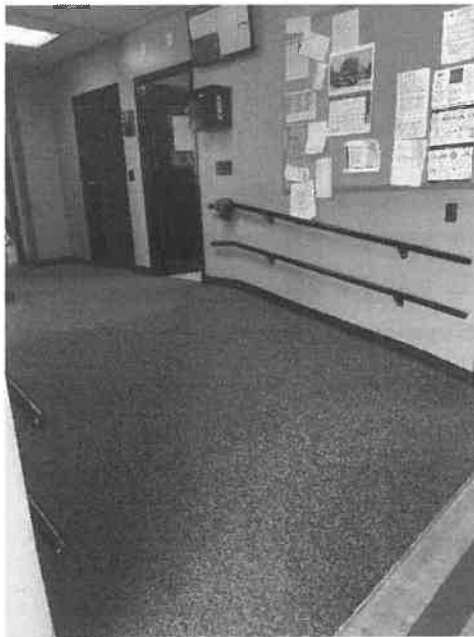
The ramp between the office area and the apparatus bay is not ADA compliant

Ramp to Offices

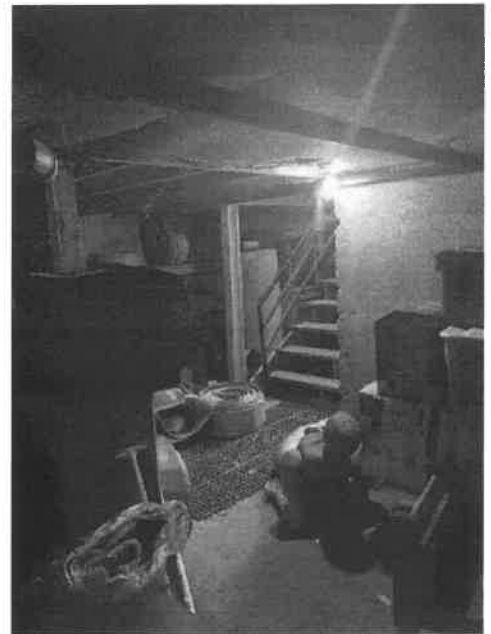
The basement furnace room ceiling room nor code compliant

If the Construction Classification is 5A the furnace room ceiling is required to be 1 hour rated

Basement Ceiling

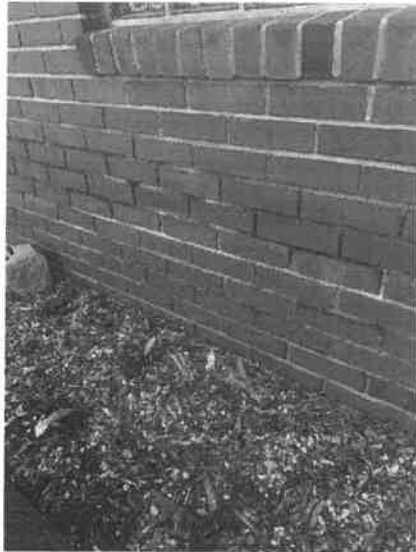
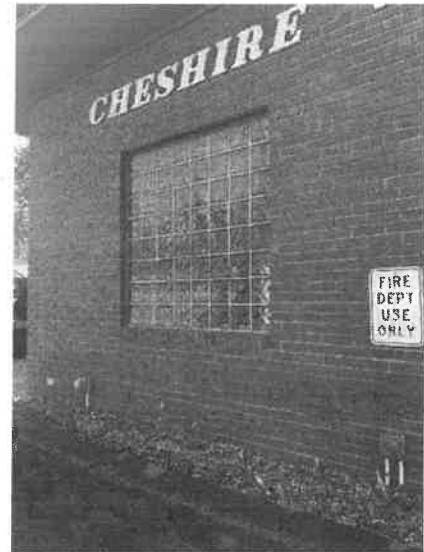
The brick veneer is showing signs of water infiltration and pulling away from the substrate (see structural report)

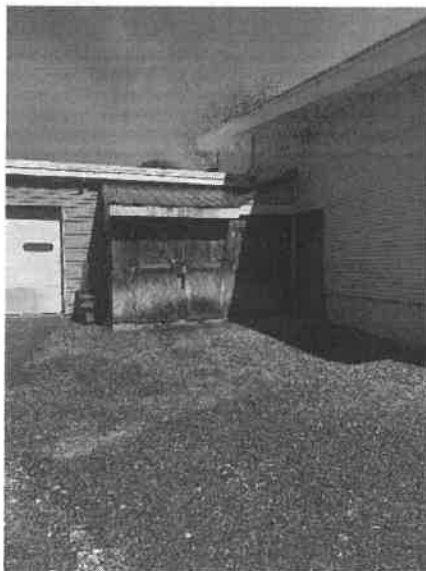
The storage shed in the southeast corner is in disrepair and should be demolished and replaced.

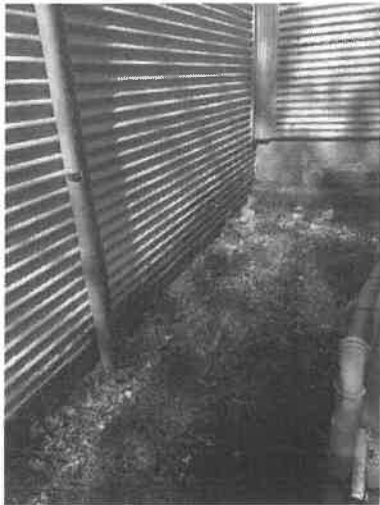
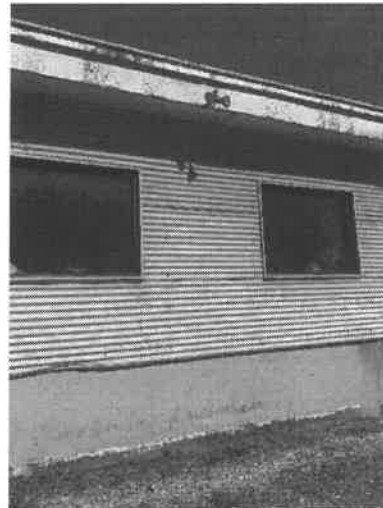
The metal siding is in moderate to poor condition and should be replaced within 5 years.

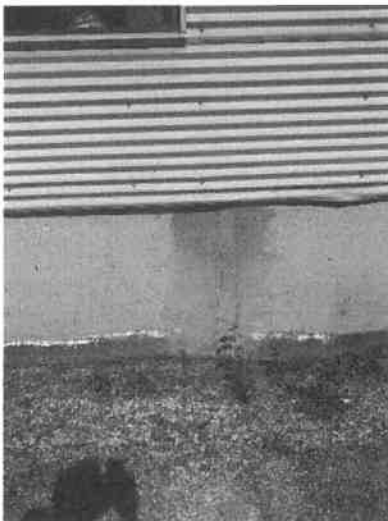
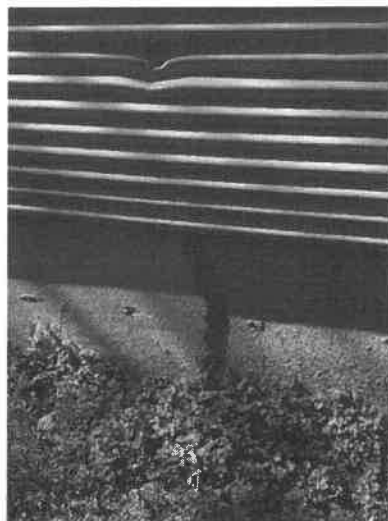
The foundation has settlement cracks in two locations and the Training room floor is sagging (see structural report)

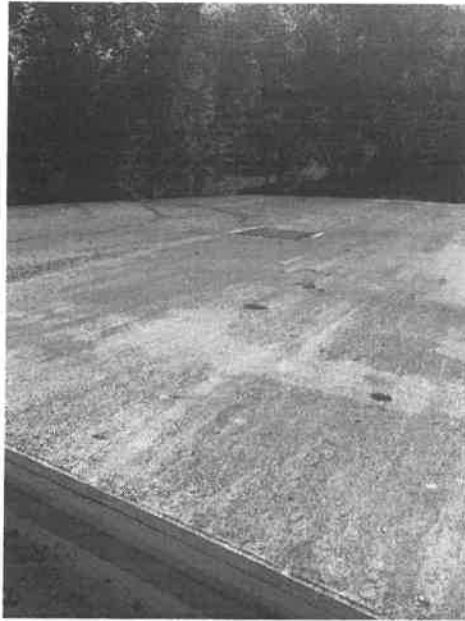
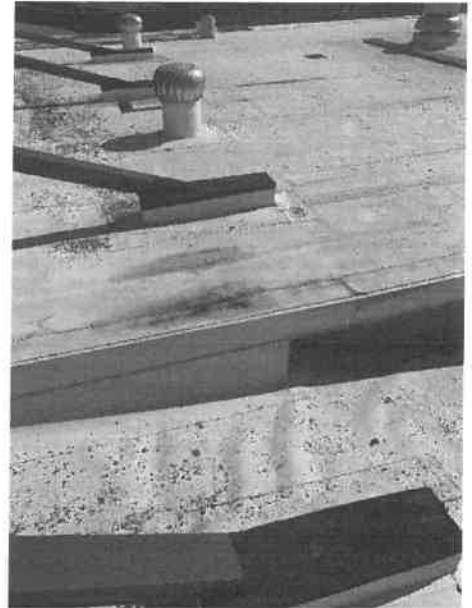
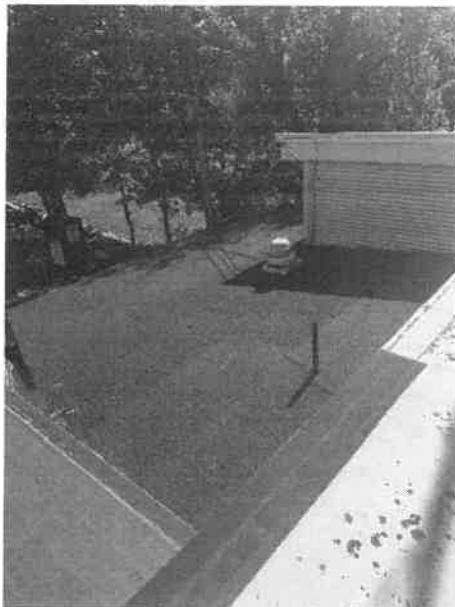
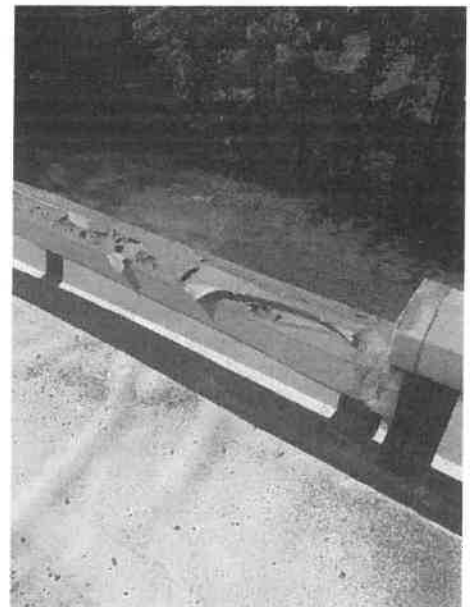
The white mebrance roof is in poor condition and requires replacement. The black membrane roof is in fair conditon and does not require immediate replacement. The roll roofing is intended for temporary roofs and should be replaced with membrane roofing. All metal fascias are in poor condition and require replacement.

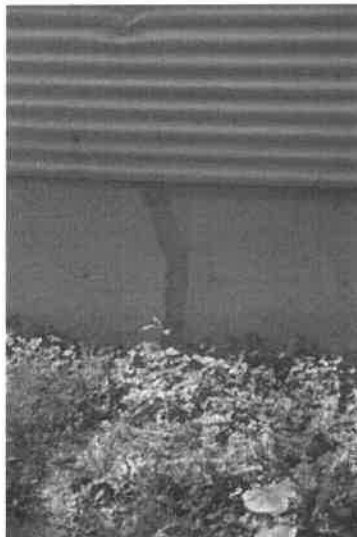
- Settlement was easily observed at the Northeast corner of the Training Room. A previous foundation crack had been repaired, although additional cracks were observed in this area. See the pictures below:

Previously Repaired Crack North Side Training Room Associated with Northeast Corner Settlement

- Training Room foundation settlement – Due to the severity and continued settlement of the foundation it is recommended that subsurface investigation be performed to determine the cause of the settlement. The repair requirements could vary from do nothing option, to a subsurface soil improvement and a new foundation system under the Training Room.
- Foundations cracks in areas other than the Training Room – These cracks were observed and were noted not to be severe enough to require any foundation repairs.

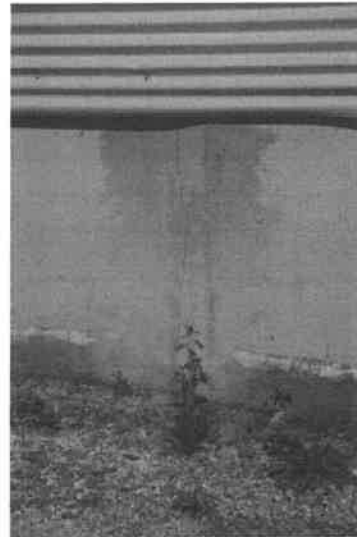
Previously Repaired Crack East Side Training Room Associated with Northeast Corner Settlement

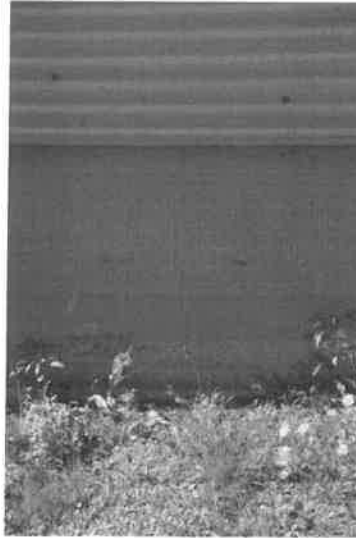
- On further observation it was noted the entire East side of the Training Room exhibited a previous settlement. Cracking of the foundation along this area was also observed. See the picture below:

Typical Crack Along Training Room

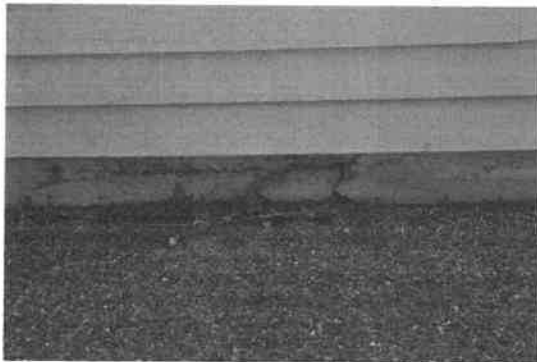
Foundation Crack South Side Apparatus Bays

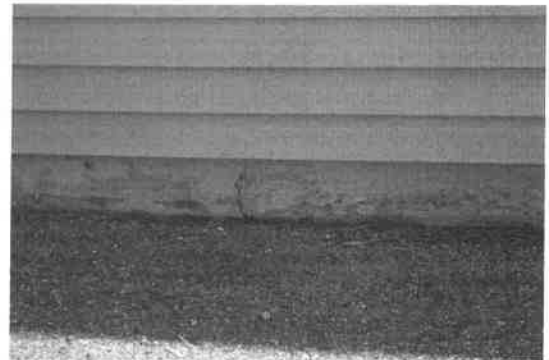
Foundation Crack South Side Apparatus Bays

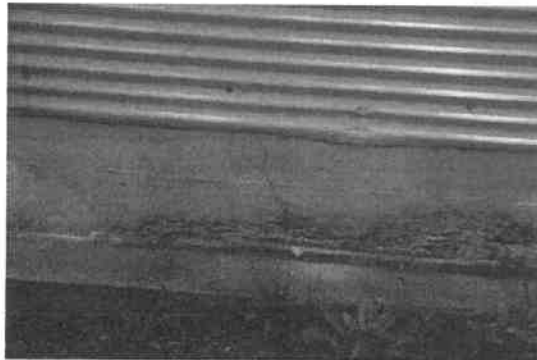
Foundation Crack North Side Day Room

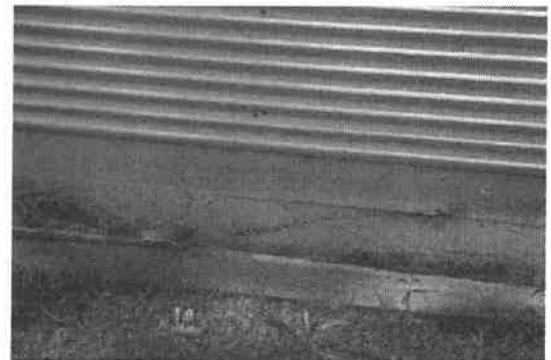
Foundation Crack and Cold Seam North Side Day Room

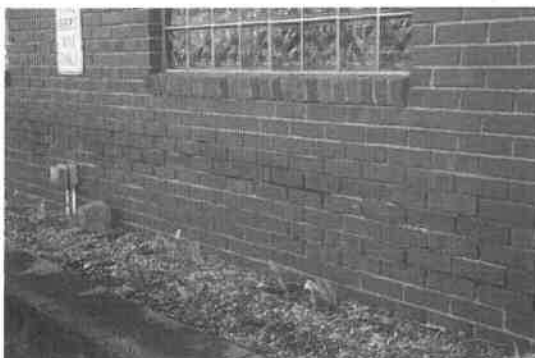
- Mortar joint erosion and top of foundation erosion was observed along the West side of the structure. See the pictures below:

Mortar Joint Erosion West Wall Day Room

- Mortar joint erosion – It is recommended that the eroded mortar joints be cleaned and repointed. After the repointing is complete the brick masonry should be coated with a waterproof agent to assist in delaying future repointing requirements.

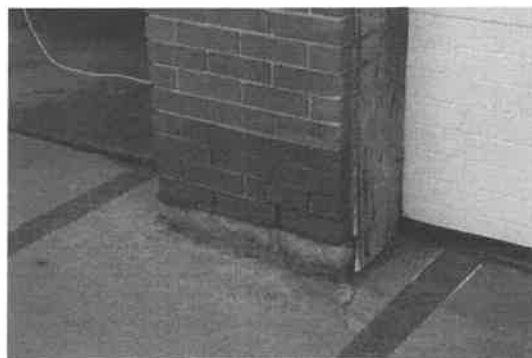
Mortar joint Erosion and Foundation Erosion West
Wall Apparatus Rave

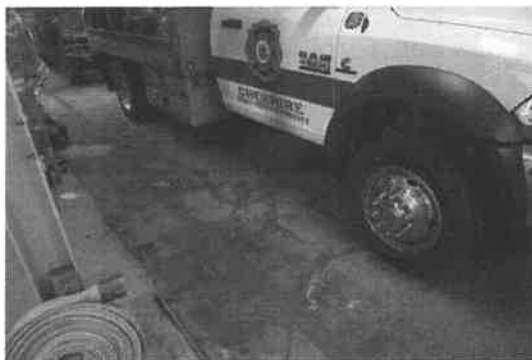
- The slab condition in the Apparatus Bays was noted to be inconsistent with areas where the slab is in good condition and areas where the slab is severely cracked and in poor condition. Additionally, it was noted the areas of the slab had settled forming an uneven surface. See the pictures below:

Newer Slab Area Adjacent to a Severely Cracked
Slab Area

- Apparatus Bay slab – The slab in the Apparatus Bay is a patchwork of damaged slab areas and previous patches, it is recommended this slab be removed and replaced with a new 6" thick reinforced concrete slab.

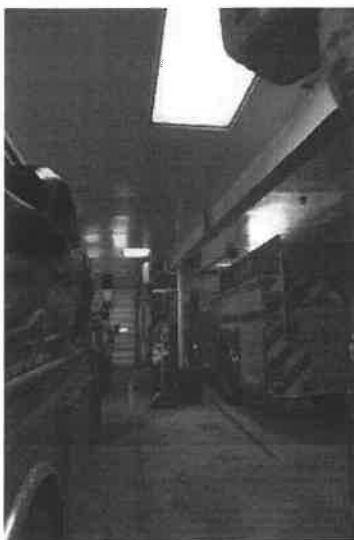
Cracked Slab

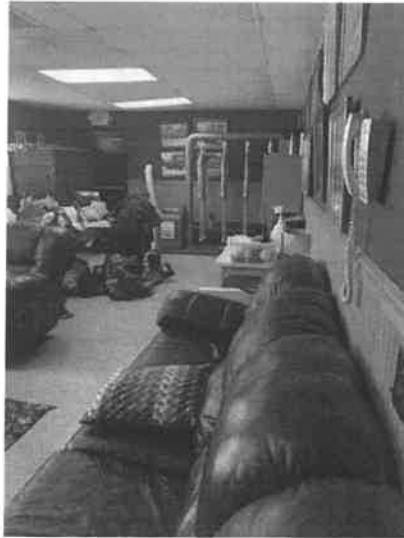
- The ceiling suspension system support in the Day Room was observed to be in failure. See the picture below:

Suspended Ceiling Suspension
Support Failure

- Suspended ceiling system support failure – The failure of the suspended ceiling system support in the Day Room should be investigated as to the cause of the failure, repairing damaged elements that contributed to the failure and re-supporting the suspended ceiling system.

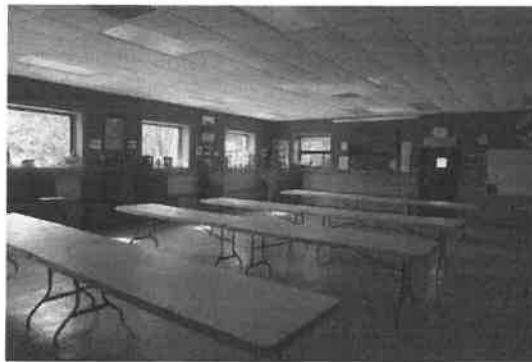
- The slab in the Training Room is cracked in the North South orientation. See the picture below:

Crack in Slab – Training Room

- Floor crack in the Training Room – The floor crack should be addressed as part of Training Room foundation repair. See Training Room foundation settlement above.

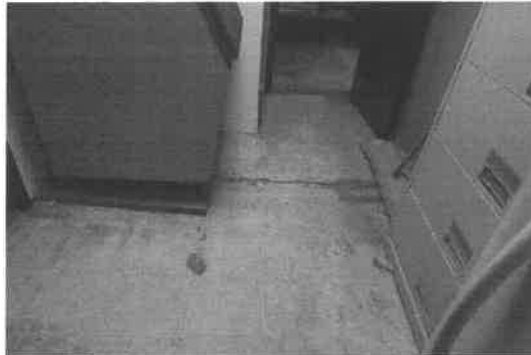
- A crack was observed in the floor finish between the Kitchen and Kitchen Storeroom. See the picture below:

Crack in Floor Finish

- Crack in the floor finish between the Kitchen and the Storeroom – The area of the crack is located at change of support for the floor from a concrete slab to a wood framed floor. The floor finish crack is most likely due a differential finished floor elevation and/or floor movement differential between the slab on grade and the wood floor. The wood floor framing shall be investigated to determine if it adequate for the loads applied to the floor and if not adequate reinforced to carry the existing floor loads. Particular attention should be given to settlement and movement during the present potential loads.

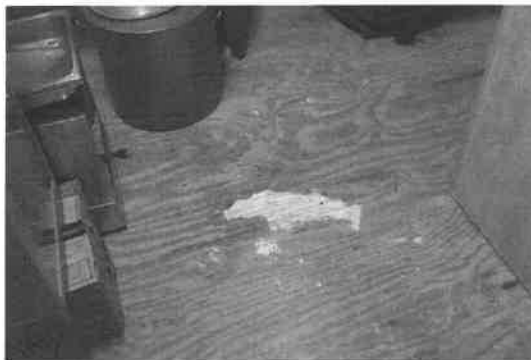
- Floor Sheathing in Kitchen Storeroom was observed to have been water damaged. See the picture below:

Water Damaged Floor Sheathing

- Water damaged floor sheathing – The water damaged sheathing in the Kitchen Storeroom shall be scheduled for replacement.

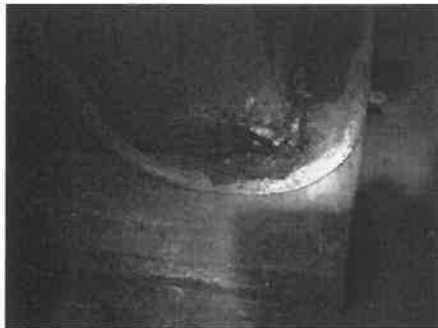
Observed rust at front boiler section

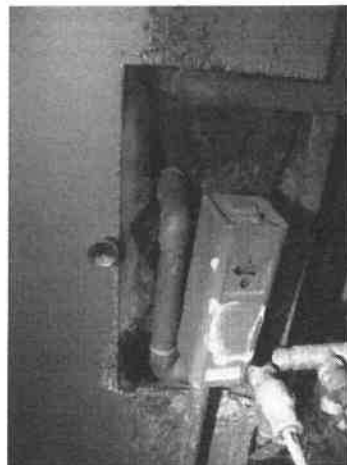
Observed rust at integral exchanger

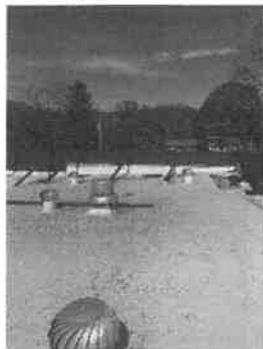
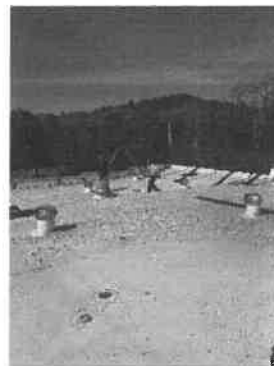
There are 8 wind turbine gravity roof vents and 4 mechanical exhaust fans on the roof. We were told that the rotating-top gravity ventilation units serve the attic areas. The mechanical exhaust fans appear designed to serve occupied areas, and we were told that of the four rooftop exhaust fans, only one is in operation. Apparatus Bay ceiling exhaust grilles exist, however, most of them are inoperative. These mechanical exhaust fans should be serviced and where impractical to repair, replaced in year 1.

Roof view of turbine & EF

Another roof view of turbines & EF

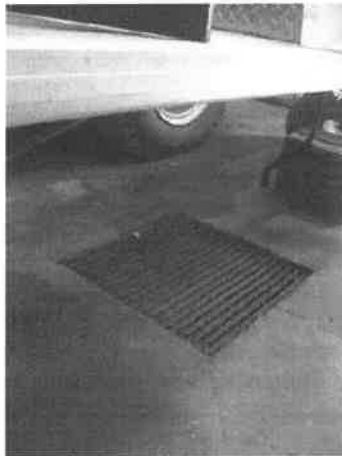
Four large capacity drainage pits with heavy grating set flush with the finished floor exists in the apparatus bays, along with a diamond plate floor grating of what was described as the filled-in hole from the original hydraulic lift piston; as the owner was not certain where these drains and floor access discharge, these drains need to be serviced, cleaned and investigated as to where they drain to. Given that the drains are in the apparatus bay with diesel and other vehicles, this report recommends a LSP Recommendation be obtained and pursued in year 1.

Apparatus Bay H.D. Grating

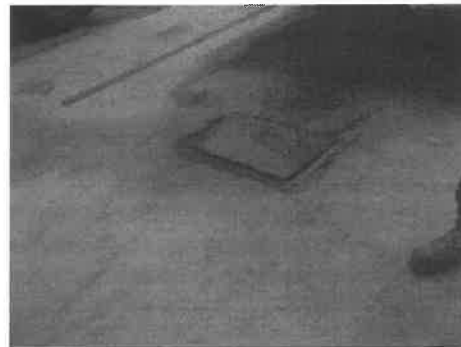
Apparatus Bay Diamond Plate Grating

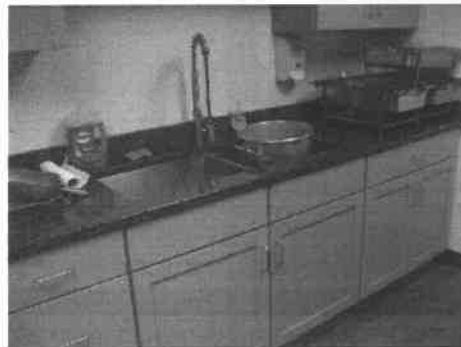
The kitchen with the two-bay undercounter pot sink should be run through a grease interceptor. As none was observed, there was a question about where the kitchen sink and other sanitary drains discharge to. The owner advised that they did not know. An allowance for a Big Dipper Automatic Grease Removal Unit if no interceptor exists, or remove the pot sinks in year 1.

Kitchen sink and faucet

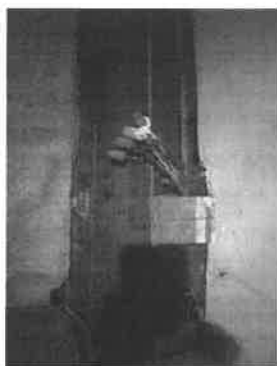
During the walk thru some wiring, issues were found. These include wires spliced outside of a junction box and junction boxes with no covers. Grounding may be insufficient as there was no jumper across the water meter

Figure 15 wiring code violation

An electrical contractor should inspect existing branch circuit wiring and correct any code violations, such as found above. All new receptacles, lighting, and mechanical equipment shall be served with new wiring.

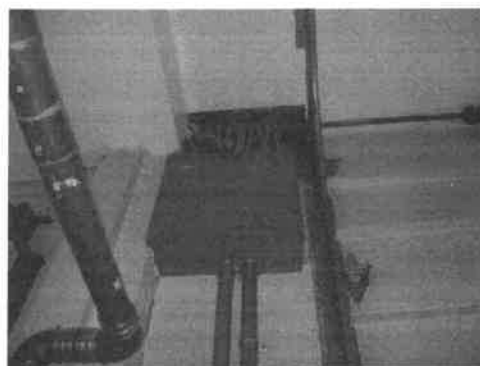
Figure 16 wiring code violation

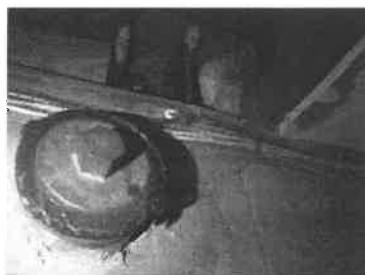
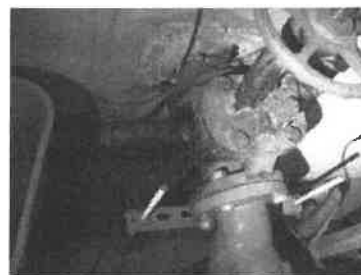
Figure 17 grounding electrode conductor

Figure 18 grounding electrode conductor

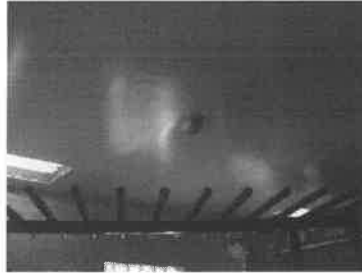
There does not appear to be a fire alarm system. There is two heat detectors. One is located in the center of each truck bay. They are connected to an abandoned control panel that is not connected to an alarm system

Figure 19 heat detector
