## **APPENDIX A    Photographs**

**ORLAND VILLAGE DAM  
ALTERNATIVES STUDY**

APPENDIX A     Photographs

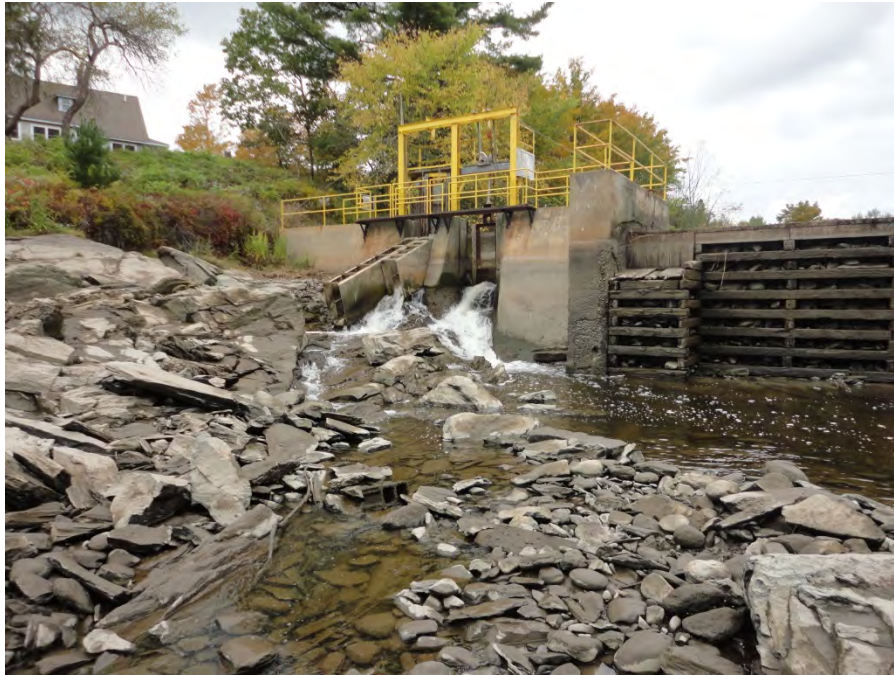
Control gates and fishway sections, low tide – fishway non-operational, non-functional.

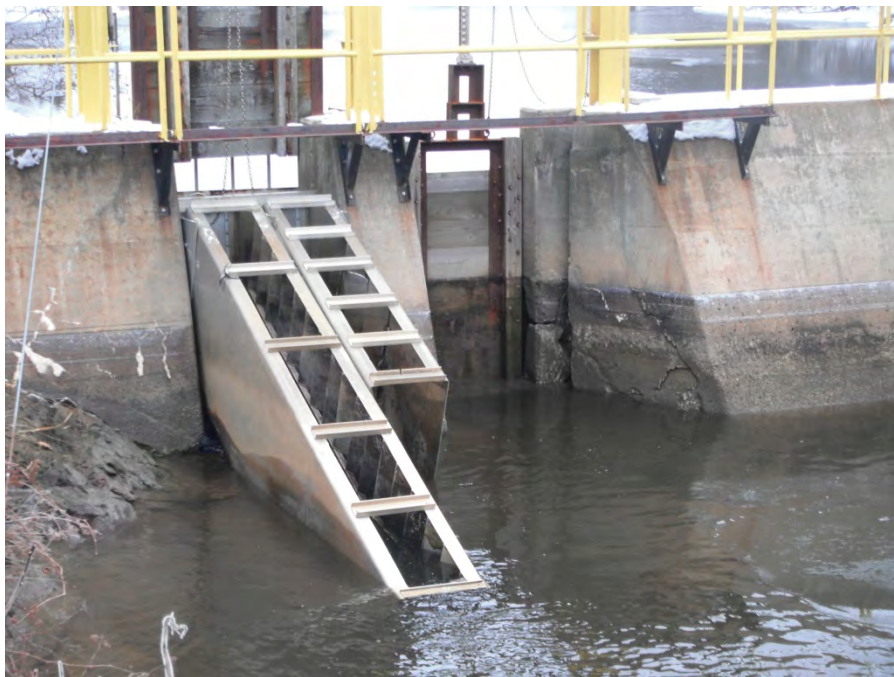
Control gates and fishway sections, middle of the tide – fishway non-operational, non-functional.

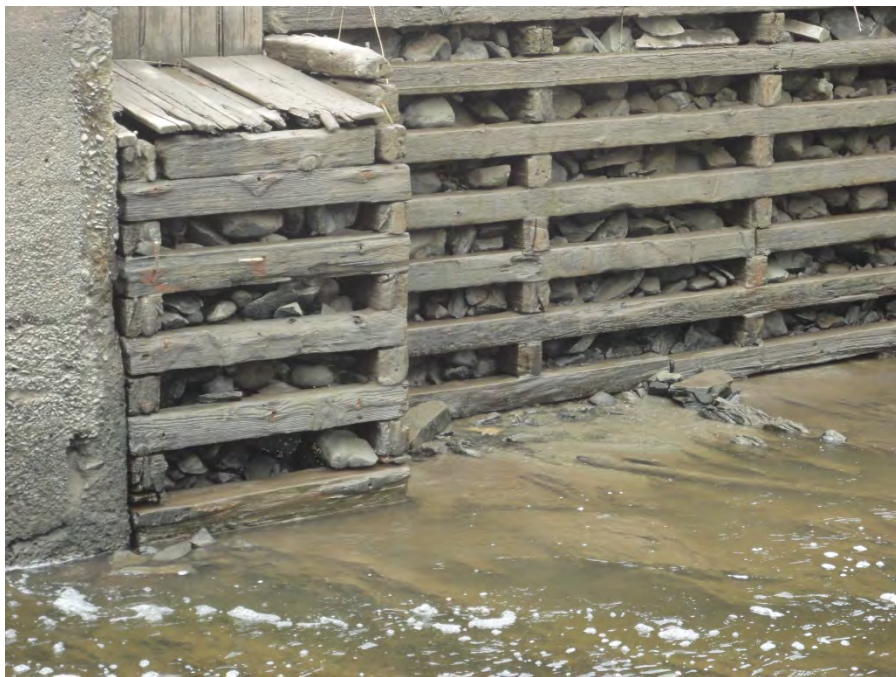
Seepage under/through dam.

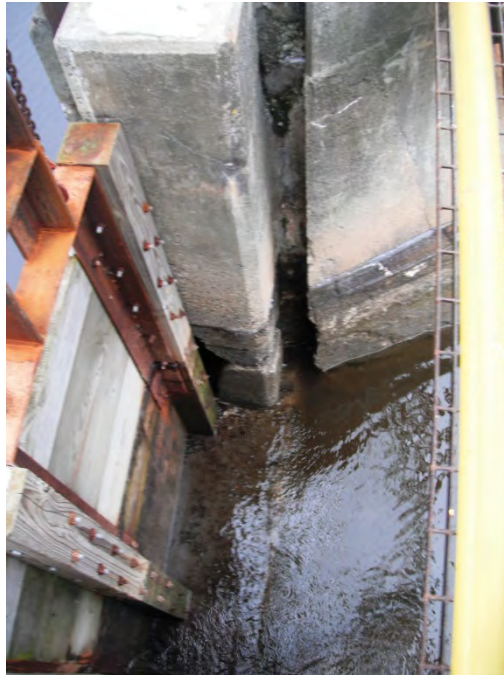
Degraded concrete near left control gate.

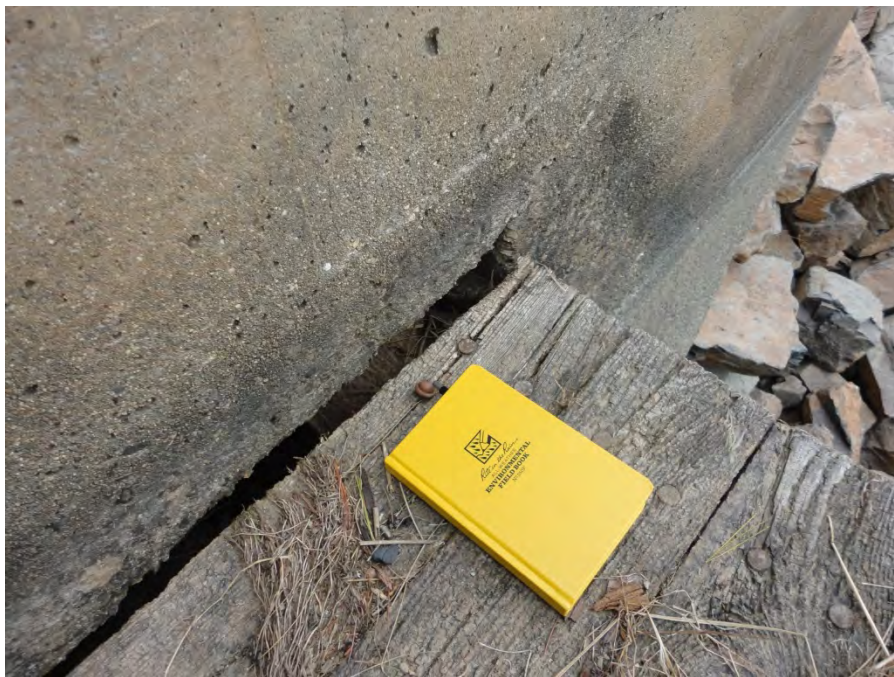
Spillway separation from left concrete abutment.

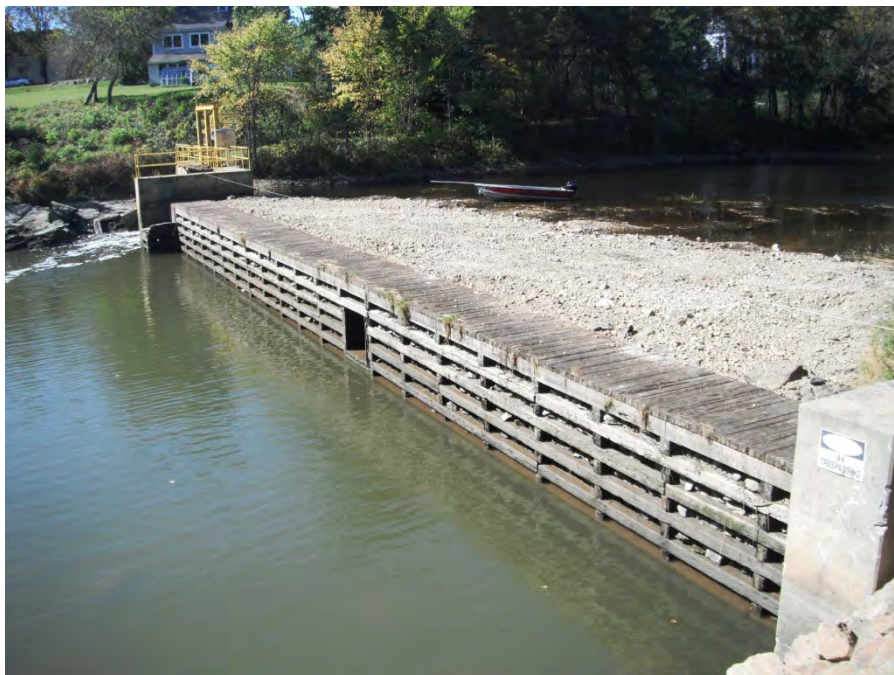
Dam following 2012 repair work performed by Town.

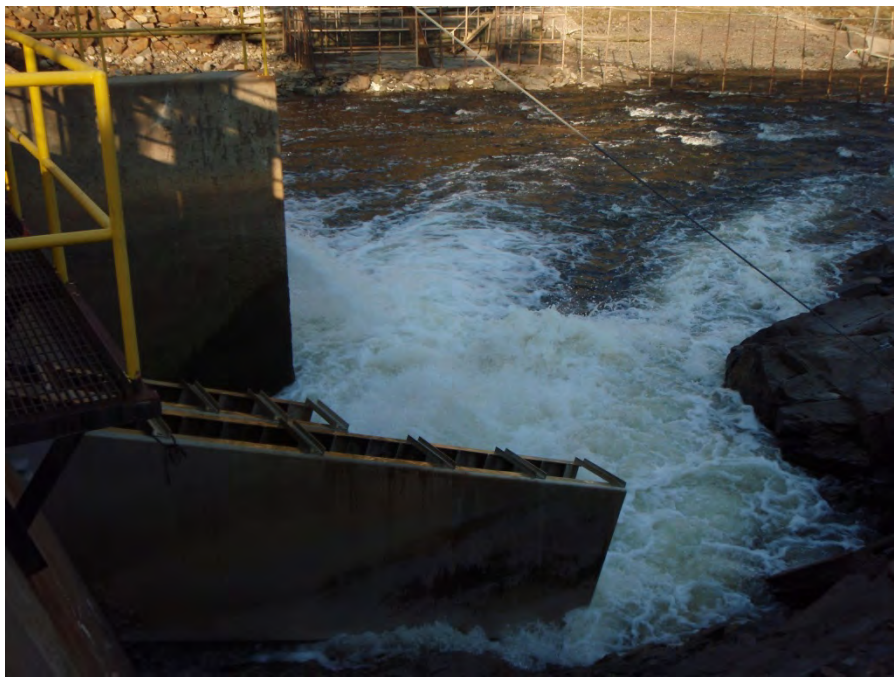
Fishway (operational, but non-functional) at low tide with flow over the dam. Note the alewife harvesting operations in background

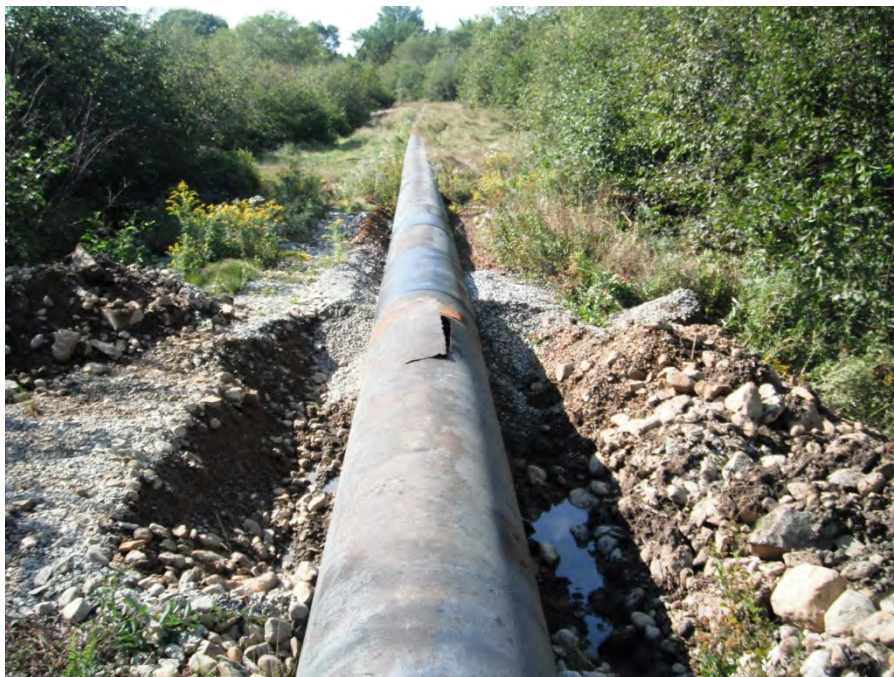
The Verso Corporation water diversion aqueduct. A “water hammer” ruptured pipe in 2012.

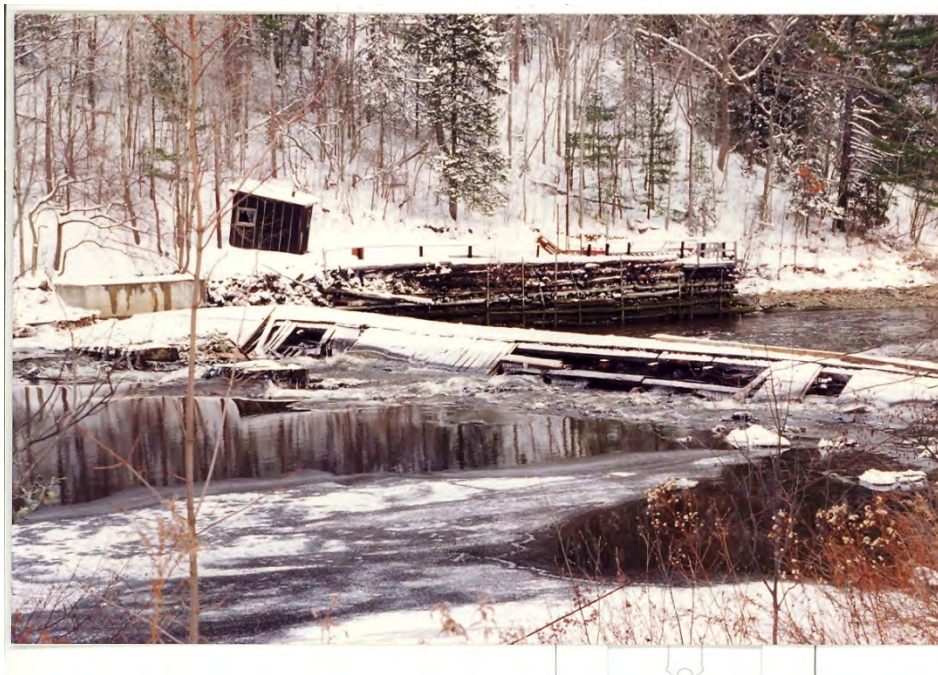
1994 storm surge damage – photo courtesy of Sharon Thompson (Orland Historical Society).

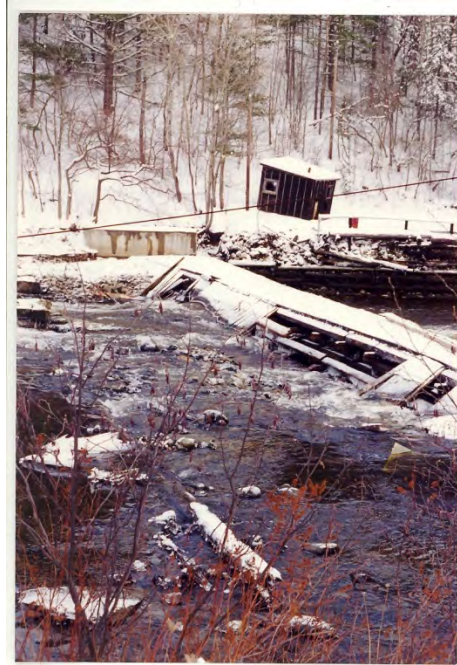
1994 storm surge damage – photo courtesy of Sharon Thompson (Orland Historical Society).
