To: Village of Cambridge
From: MSA Professional Services
Subject: Vineyards Pond Inspections and Maintenance Recommendations
Date: November 11th, 2024

INTRODUCTION

On September 17th, 2024, MSA Professional Services performed visual inspections of four stormwater ponds in the Village of Cambridge, Dane County, WI. The purpose of the inspections was to address Village and resident concerns regarding performance, visual observations, modifications made by the previous developer and sump backup issues. Inspections included visual checks of detention basins, infiltration basins, inlet and outfall structures, bank erosion, berms, erosion control such as rip rap and erosion fabrics, as well as checking pond footprints to construction plans. Observations and recommended maintenance are included in this memo to maintain pond function in the Vineyards Development.

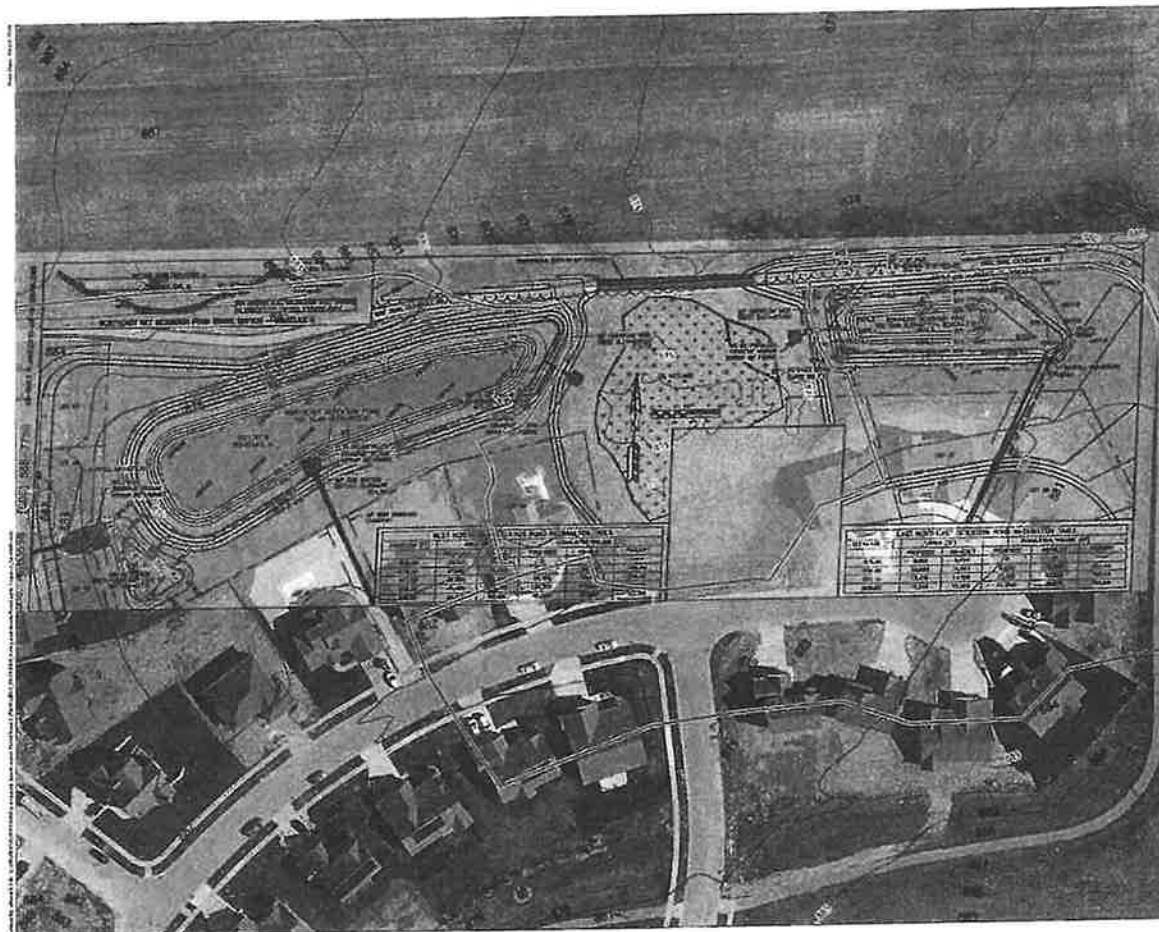
Figure 2: Aerial Footprint
Comparison for North Vineyards
Ponds

As shown in Figure 2, the North Vineyards Ponds consist of two wet detention basins and an infiltration basin located north of Kenseth Way. The following observations were identified as a result of MSA's inspection

1. The infiltration basin located adjacent to the west pond has been filled in and is no longer functioning as designed. Rip rap has been installed between the infiltration basin and the detention basin that is not included in the original design.
2. The infiltration basin is lacking bio-retention vegetation called out in design plan.
3. The erosion socks located in the filled-in infiltration basin are insufficient for a permanent solution of directing water to the pond.
4. Excessive vegetation is present throughout the western inlet structure and rip rap.
5. Trash was observed at the southern inlet rip rap.

6. Large cattails are present within the majority of the wet detention basin and extend into the designed permanent pool, which is indicative of insufficient depth of permanent pool.
7. The permanent pool appears to be smaller than in the design plans.
8. Woody overgrowth is present on the northern edge of the pond.
9. Outlet structures from the pond to the wetland are overgrown.

1. Clear the inlet and outlet structures of growth and debris for all ponds.
2. Remove vegetation and trees from the banks of all ponds.
3. Cut or remove cattails located in the South Vineyards Pond infiltration basin south of the berm.
4. Infiltration basin for the North Vineyards Ponds – West to be excavated back to design depth and plant appropriate bioretention vegetation.
5. Replenish rock supply to dividing berm in Vineyards South Pond.
6. After maintenance items 1-5 are completed, re-inspect ponds within one year to evaluate effects of maintenance on basins and potential functionality improvements. Additionally, re-inspect for evaluation of condition and expanse of permanent pools.

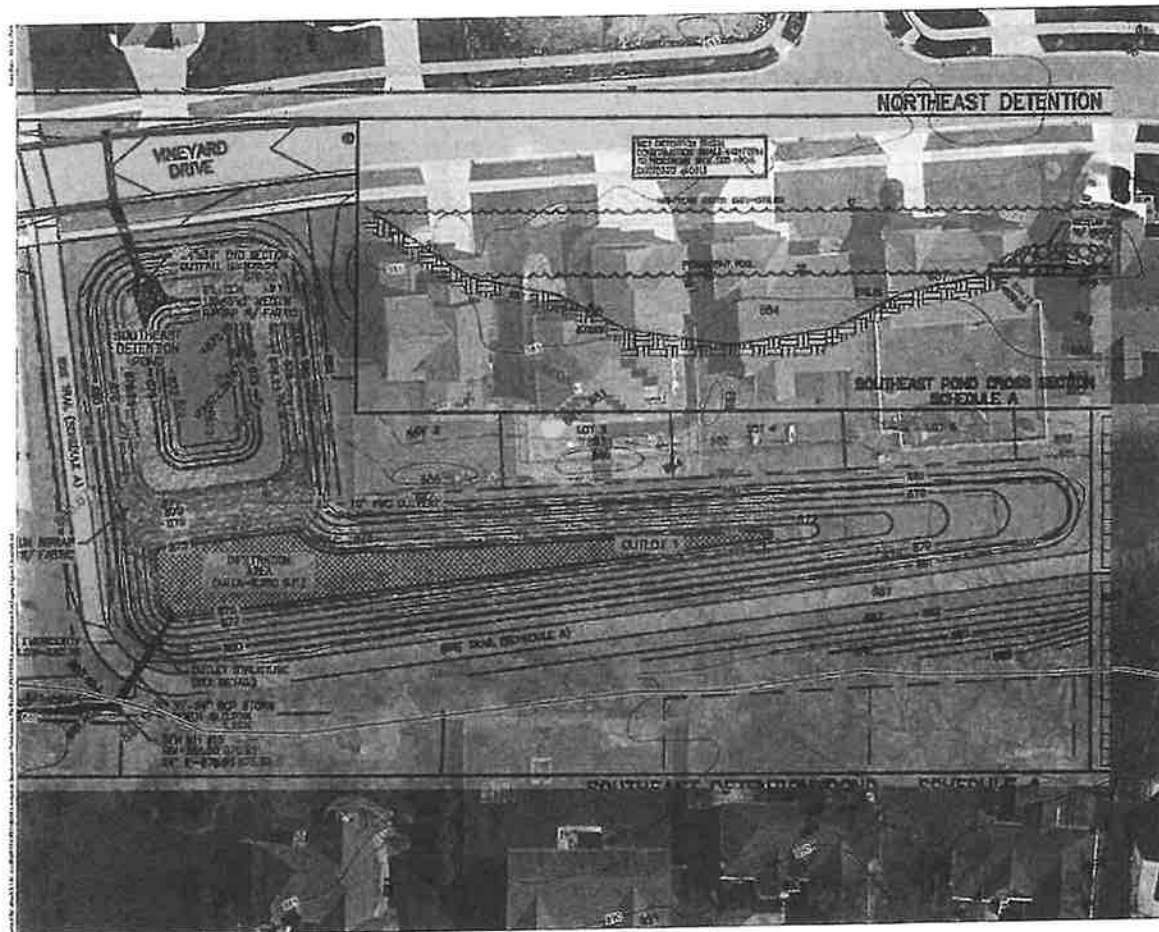
Figure 3: Aerial Footprint Comparison for South Vineyards Pond

As shown in Figure 3, the South Vineyards Pond consists of a wet detention basin and infiltration area located south of Vineyard Drive. The following observations were identified as a result of MSA's inspection.

1. There are large trees and vegetation on the pond banks and berm separating the infiltration and detention basins.
2. Erosion fabric has been exposed on the dividing berm.
3. The inlet structure is overgrown.
4. There is a small amount of standing water in the infiltration basin.
5. Both the infiltration and detention basins are full of cattails which indicates insufficient depth of the permanent pool; Infiltration basin design plans indicate no vegetation within basin.
6. The pipe to the outlet structure is overgrown.
7. The outlet structure is full of lawn clippings.

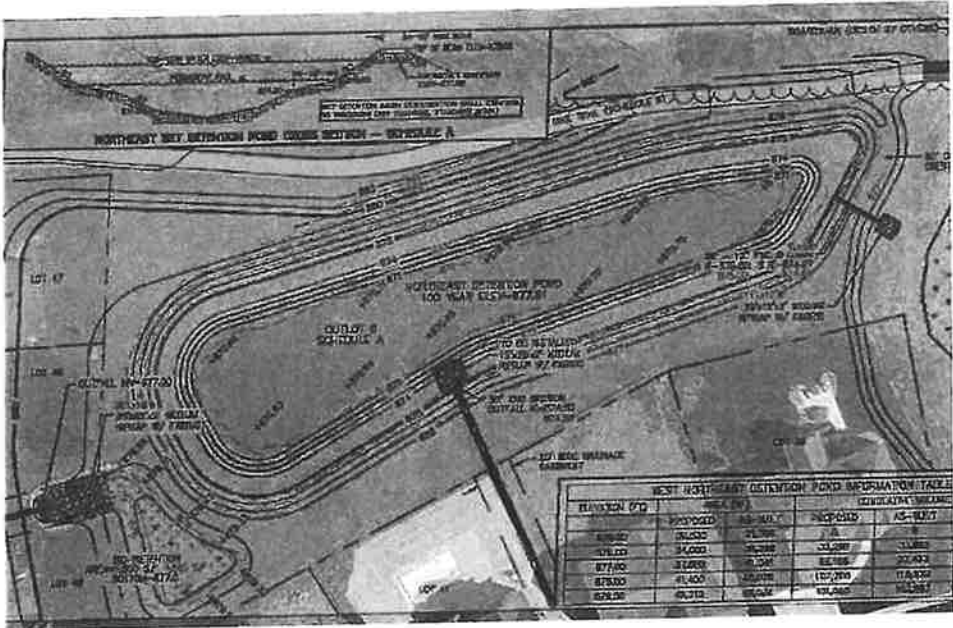
North Vineyards Ponds - West

1. The infiltration basin located adjacent to the west pond has been filled in and is no longer functioning as designed.
2. The infiltration basin is lacking bio-retention vegetation called out in design plan.
3. Rip rap has been installed between the infiltration basin and the detention basin that is not included in the original design.
4. The erosion socks located in the filled-in infiltration basin are insufficient for a permanent solution of directing water to the pond.

1. Excavate infiltration basin back to design depth and plant appropriate bio-retention vegetation.
2. Correct design of inlet structure to flow to infiltration basin, as per design.

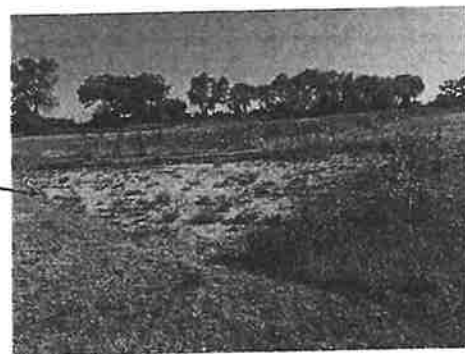
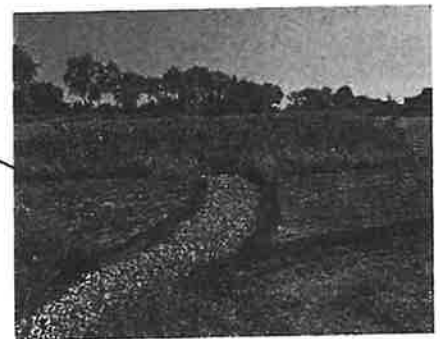
1. Excessive vegetation and woody vegetation present on inlet/outlet structures and pond banks.

Woody vegetation on north bank

1. Clear excess growth from banks and structures.

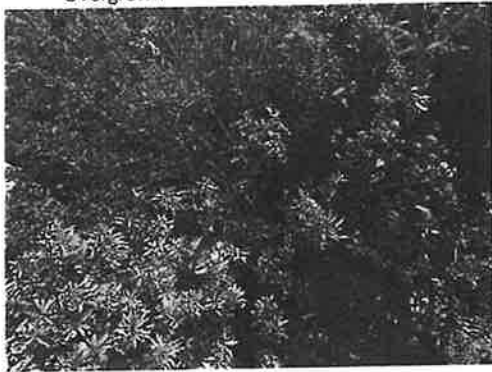
Overgrown outlet structure to wetland

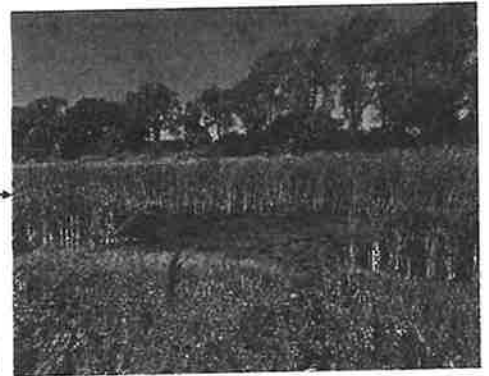
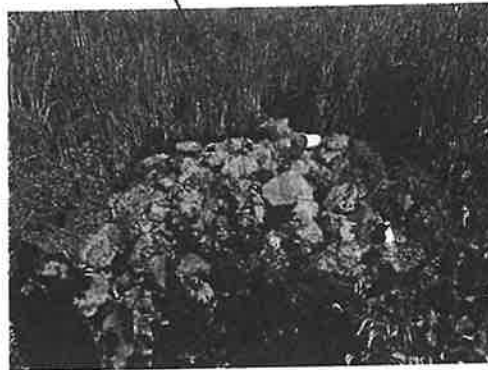
1. Large cattails are present within the majority of the wet detention basin and extend into the designed permanent pool, which is indicative of insufficient depth of permanent pool.
2. Trash was observed at the southern inlet rip rap.

1. Remove trash from rip rap.

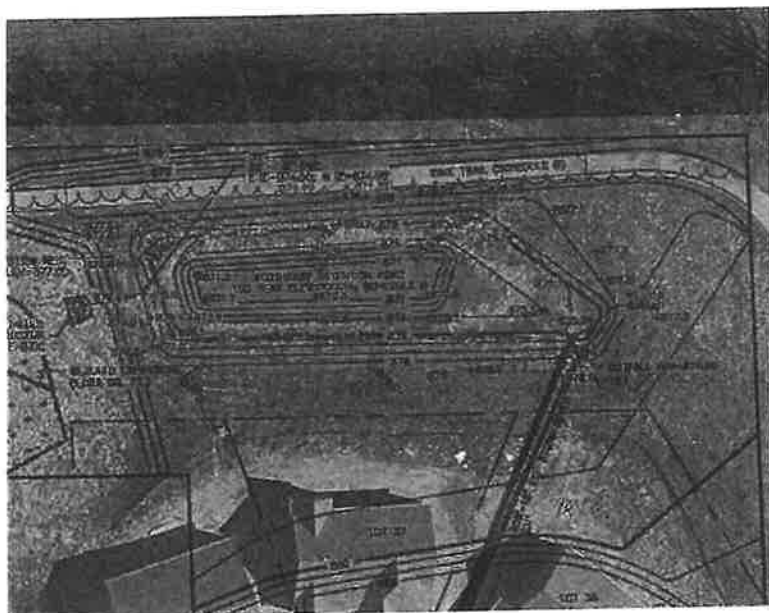
North Vineyards Ponds - East

1. The banks of the pond are fully overgrown.
2. Large cattails are present within the majority of the wet detention basin and extended into the designed permanent pool which is indicative of insufficient depth of permanent pool.
3. The SE inlet structures are overgrown with woody vegetation.

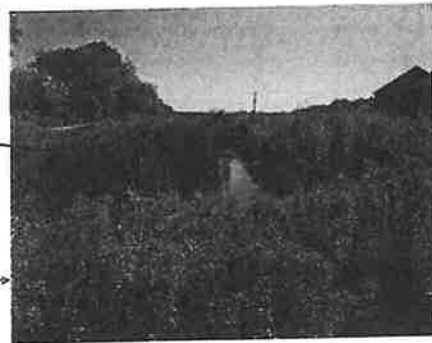
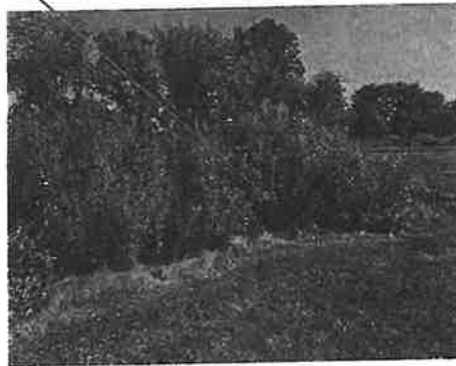
1. The banks of the pond are fully overgrown.
2. Large cattails are present within the majority of the wet detention basin and extended into the designed permanent pool which is indicative of insufficient depth of permanent pool.
3. The SE inlet structures are overgrown with woody vegetation.

1. Clear excess growth from banks and structures.

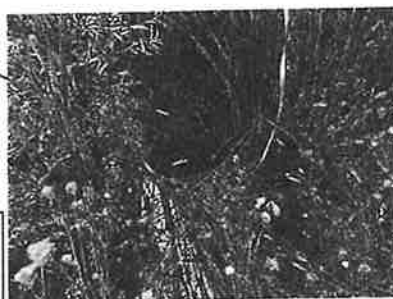
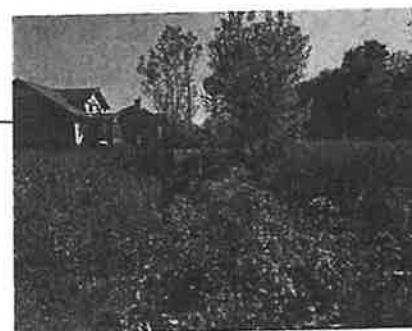
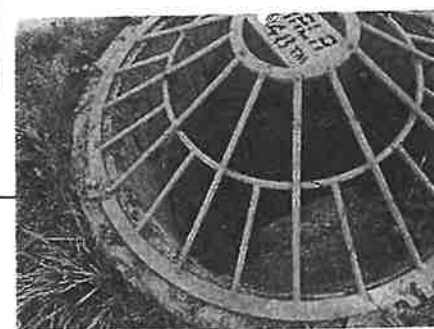
1. There are large trees and vegetation on the pond banks and berm separating the infiltration and detention basins.
2. Erosion fabric is exposed on the dividing berm.
3. The Pond Inlet structure is overgrown.
4. Both the infiltration and detention basins are full of cattails which indicates insufficient depth of the permanent pool
5. The pipe to the outlet structure is overgrown.
6. The outlet structure is full of lawn clippings.

1. Clear excess growth from banks, the berm, and structures.
2. Replenish rock supply to the berm to cover all fabric.
3. Cut or otherwise remove the cattails from the infiltration basin.
4. Clean the outlet structure.

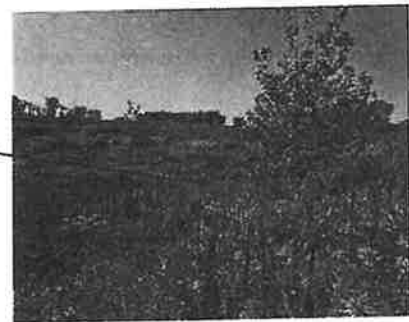
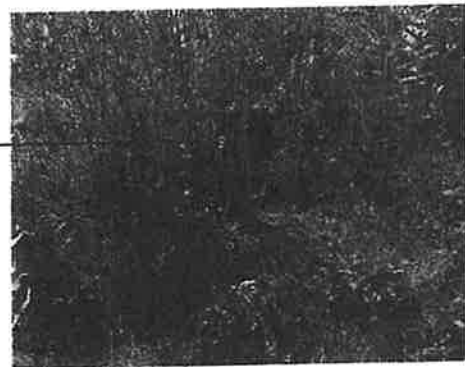
1. The banks of the pond are overgrown.
2. A small tree is present on the northern bank of the pond.
3. The outlet structure is overgrown.
4. Cattails are present at the northeast edge of the pond.

1. Clear excess growth from the banks and structures.

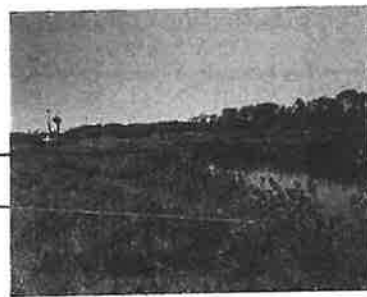
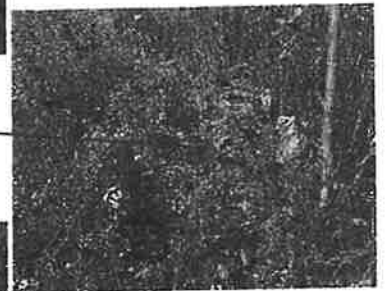
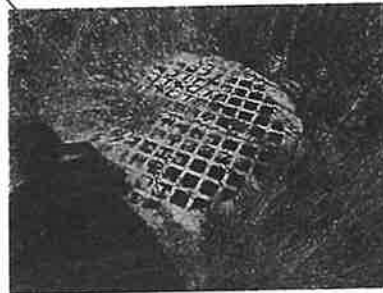
1. Cattails are filling much of permanent pool, indicating insufficient depth.
2. There is overgrowth and woody vegetation present on the pond's banks.
3. There is woody vegetation along the east edge of the pond obstructing the inlet structures.
4. Dense woody vegetation is obstructing the outlet pipe. The standpipe is overgrown with grass.

1. Clear excess growth from the banks and structures.
