DIXON

Maintenance Inspection

150,000 Gallon Spheroid

Ontonagon, Michigan

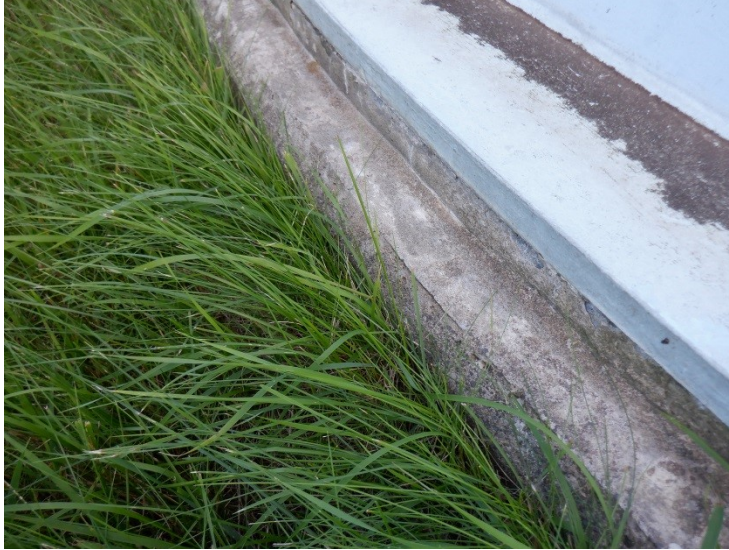
The exposed concrete foundation is in good condition with no deterioration. The foundation is not coated.

1) The concrete foundation is in good condition with no significant deterioration.

Coat the exposed concrete with an epoxy coating system to help prevent deterioration. The cost would be incidental to exterior painting.

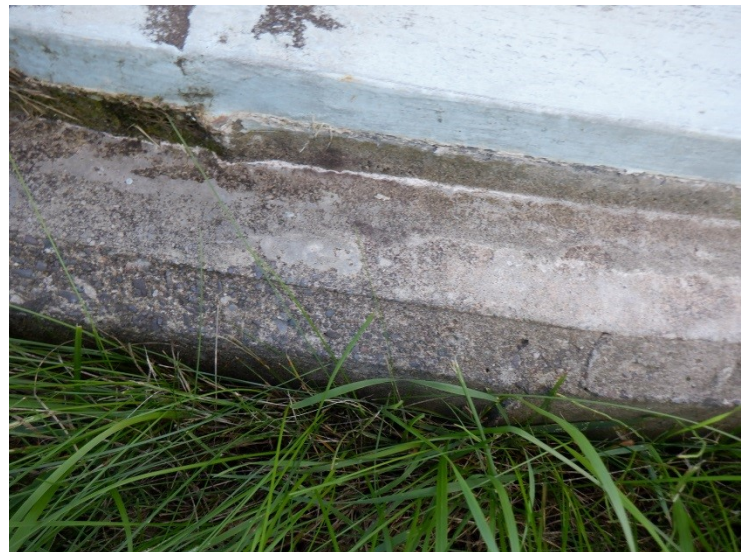
The grout between the steel baseplate and the concrete foundation is in good condition with none damaged or missing.

2) The grout between the steel baseplate and concrete foundation is intact.

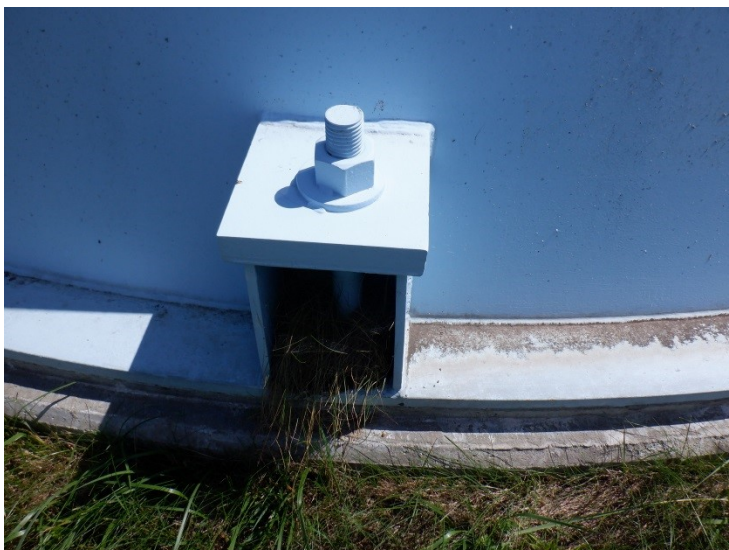
There are anchor bolts evenly spaced on the baseplate around the basebell. The anchor bolts are in good condition with no deterioration.

3) The anchor bolts are in good condition.

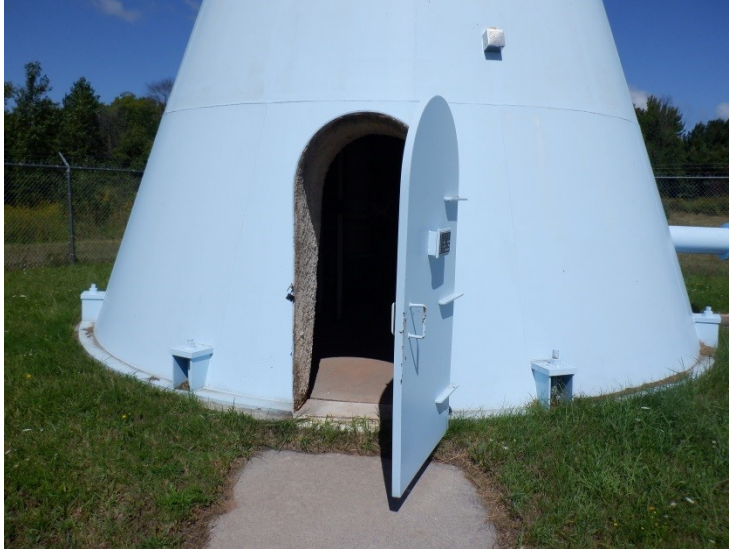
4) The service door in the basebell operated properly during the inspection.

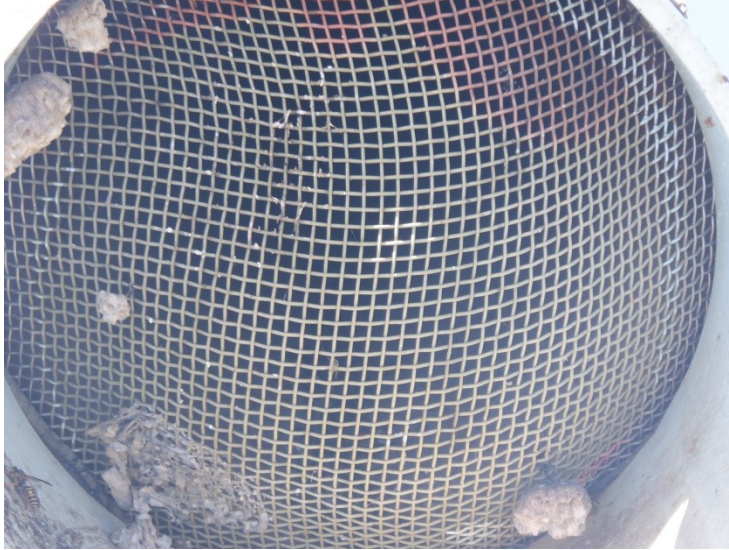
The overflow pipe extends along the access tube in the dry interior, down through the dry riser, and exits near the bottom of the basebell. The overflow pipe discharge is horizontal. The discharge end of the overflow pipe is screened. The screen is in good condition but is oversized. The end of the pipe is equipped with a solid flap gate that is in good condition. The pipe discharges to a concrete splash pad. The air gap does not meet the required 12 to 24 inches. The discharge area is in good condition.

7) The screen at the overflow pipe discharge is intact but oversized.

Replace the screen at the overflow pipe discharge to meet current EGGLE requirements. The cost would be incidental to the next painting project or could be performed by in-house personnel.

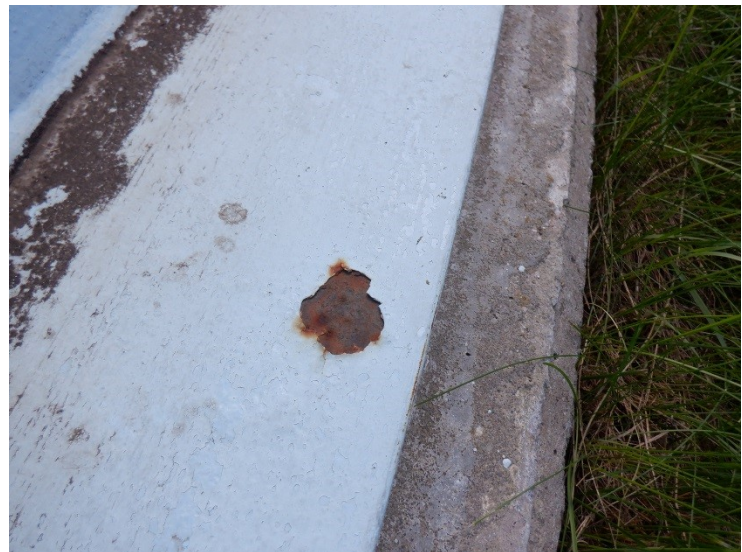
Basebell comments: **There are five coating failures that are ½ inch diameter on the baseplate and areas of erosion throughout**

8) There are a few coating failures on the baseplate.

Remove the existing coating on the basebell and riser by dry abrasive blast cleaning the steel to a commercial (SSPC-SP6) condition and apply a urethane system. All blast work would be performed inside a dust tight containment system using negative air pressure.

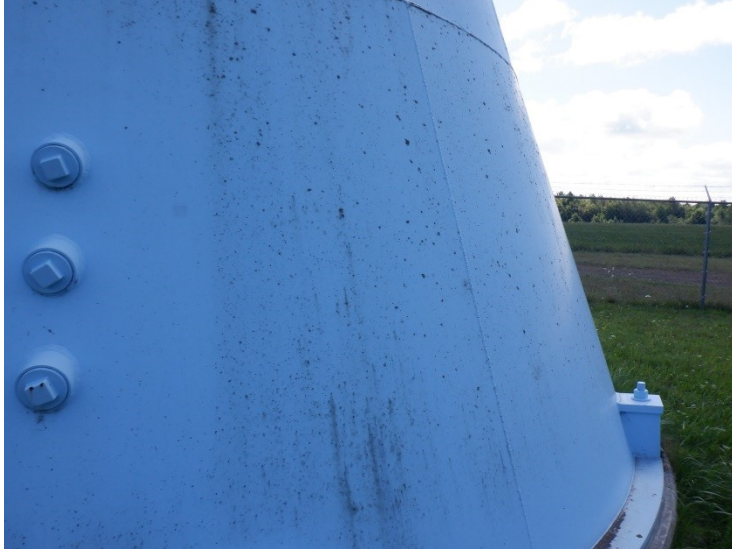
The basebell coating is in good condition with a few failures. Primary methods of deterioration are spot failures to the substrate with rust undercutting and erosion.

10) There are a few minor coating failures on the basebell.

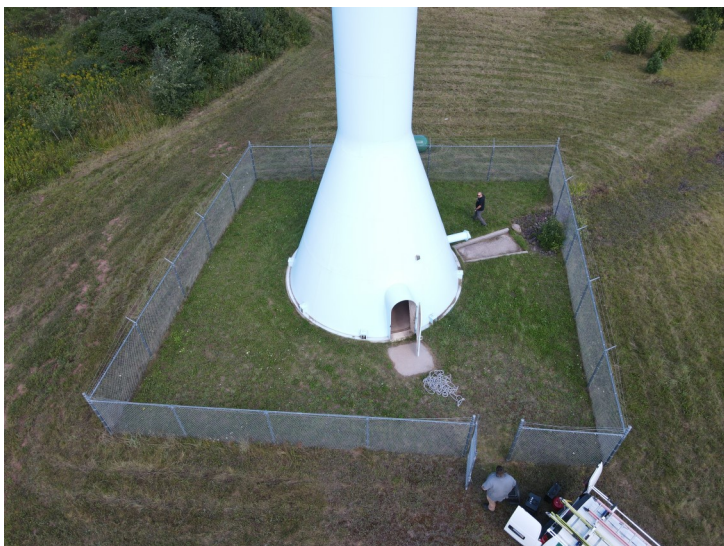
12) The basebell coating is in good condition overall.

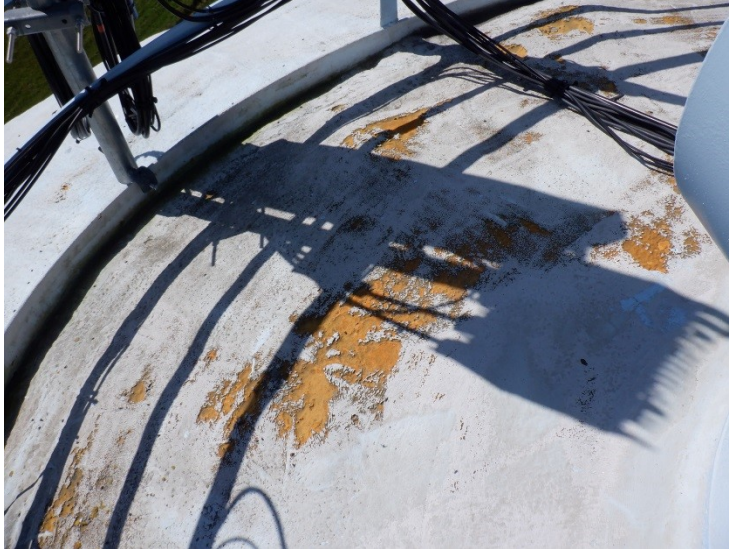
The bowl, sidewall, and roof is covered with spray foam insulation with an acrylic coating. The coating is in fair condition with areas of erosion. The insulation on the roof has deteriorated.

25) The insulation on the roof has deteriorated.

Budget for exterior coating removal and repainting on the basebell and riser in approximately one to two years or when aesthetics dictate. Fading will continue and more coating failures will occur decreasing the tank's aesthetic appearance. Repair any damaged insulation on the ball and apply an acrylic system.

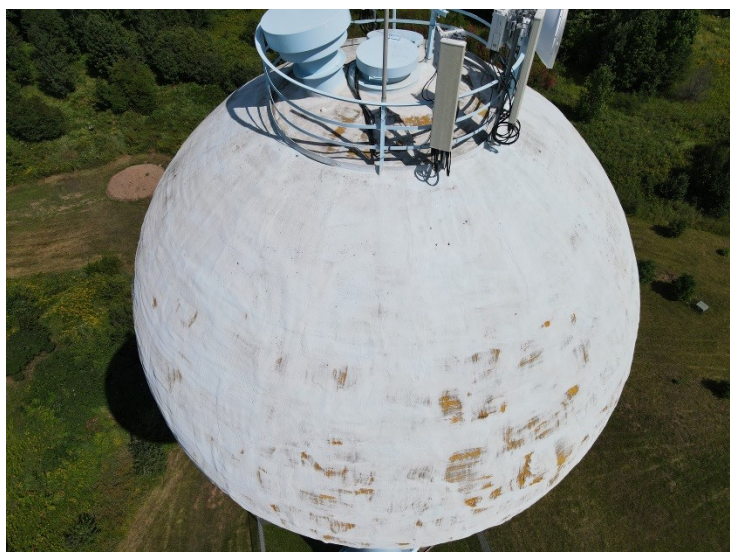
27) The coating on the roof insulation is in fair condition with areas of erosion.

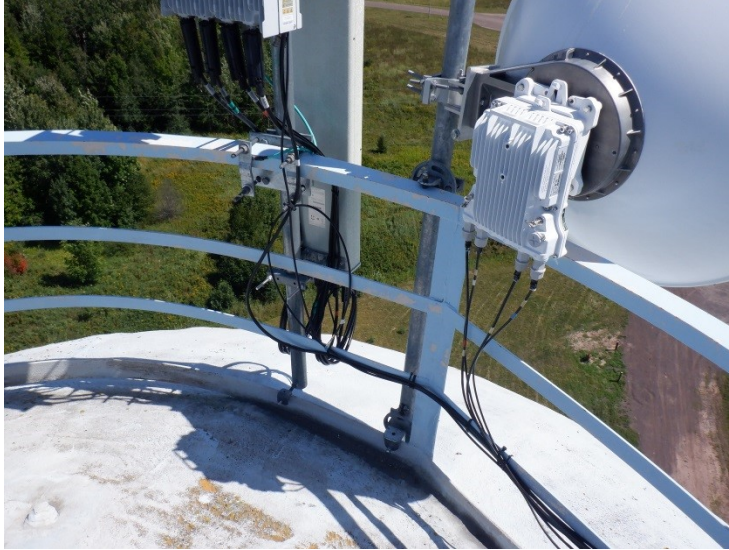
There is a handrail on the roof surrounding the roof hatches and the vent. The handrail is in good condition. The handrail is being used for antenna mounting. The handrail conforms to current OSHA requirements.

31) The roof handrail is in good condition.

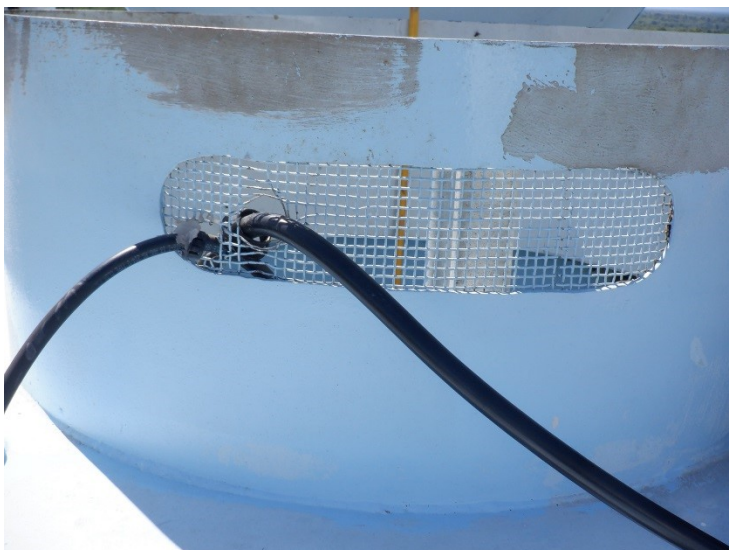
33) Antenna cables are routed through the screens on the access tube roof hatch neck. The screen are oversized.

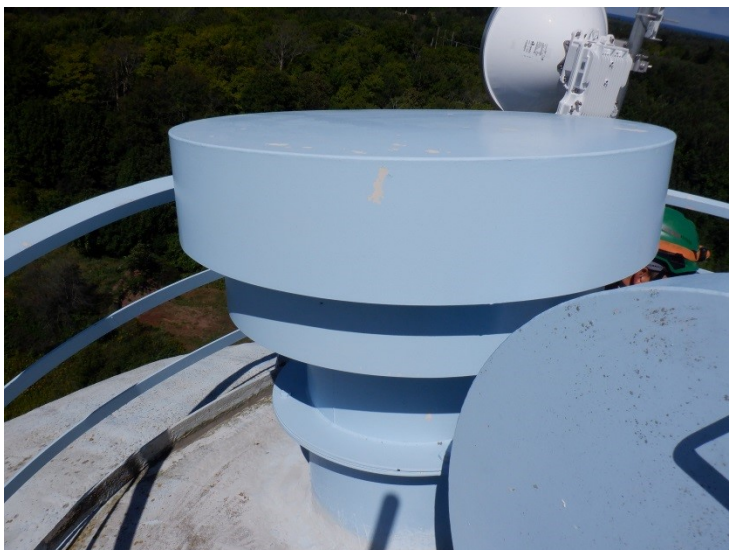
36) The pressure vacuum roof vent is in good condition.

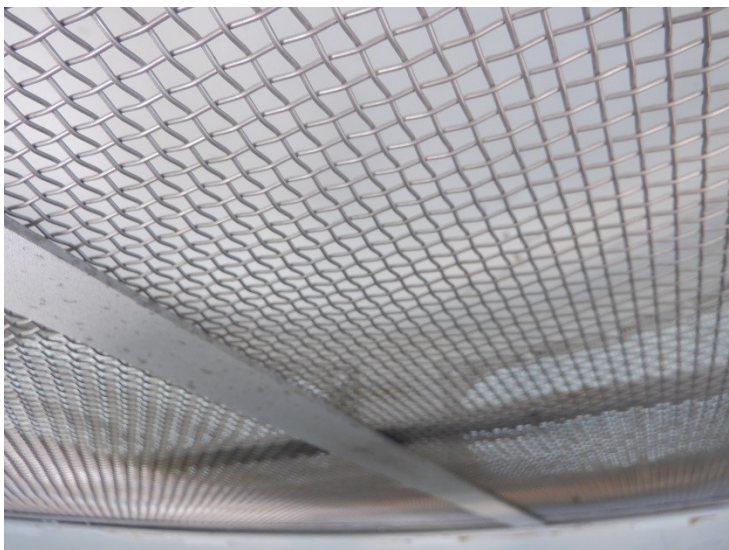
The roof vent is a pressure vacuum design that is in good condition. The screened pressure vacuum plate was found to be properly aligned. There is a large external screen intended to keep birds out and a smaller mesh screen on the interior intended to keep insects out. The screens are in good condition. The interior screen mesh size is larger than the recommended 24 mesh. This is a possible entry point for insects, though none were observed inside the tank. There is a rain shield over the outer screen.

39) The interior roof vent screen is in good condition but oversized.

Replace the roof vent screens with 24 mesh screens to meet current EGLE requirements. The cost would be incidental to the next painting project or work could be performed by in-house personnel.

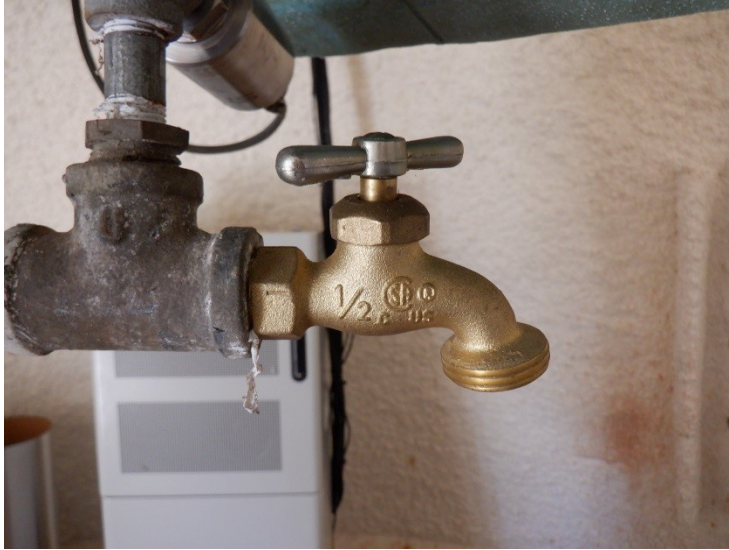
43) The sample tap on the fill/draw pipe in the basebell has a threaded end.

Replace the threaded sample tap on the fill/draw pipe with a smooth ended sample tap to meet current EGLE requirements. The work can be performed by in-house personnel.

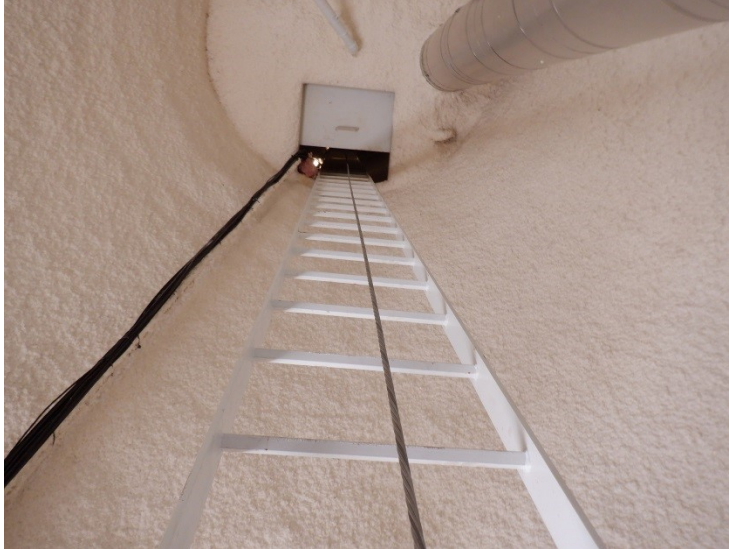
46) The basebell ladder is in good condition. The ladder is equipped with a fall prevention device.

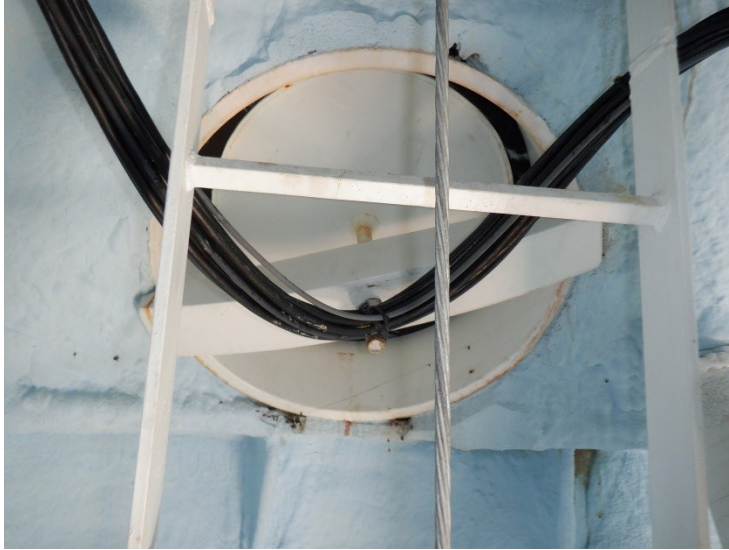
There is a 24 inch diameter manway in the transition cone to the wet interior that is in good condition. The manway gasket showed no signs of leakage and the bolt is in good condition.

61) The wet interior manway in the transition cone is in good condition.

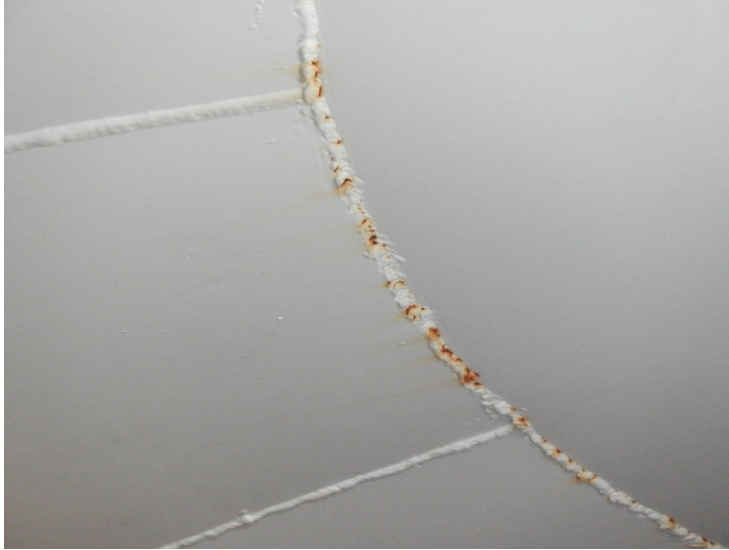
The roof coating is in good condition with a few failures. Primary methods of deterioration are spot failures to the substrate and rust bleedthrough. Most of the deterioration is along the welded lap seams.

67) There are a few coating failures at the welded lap seams on the wet interior roof.

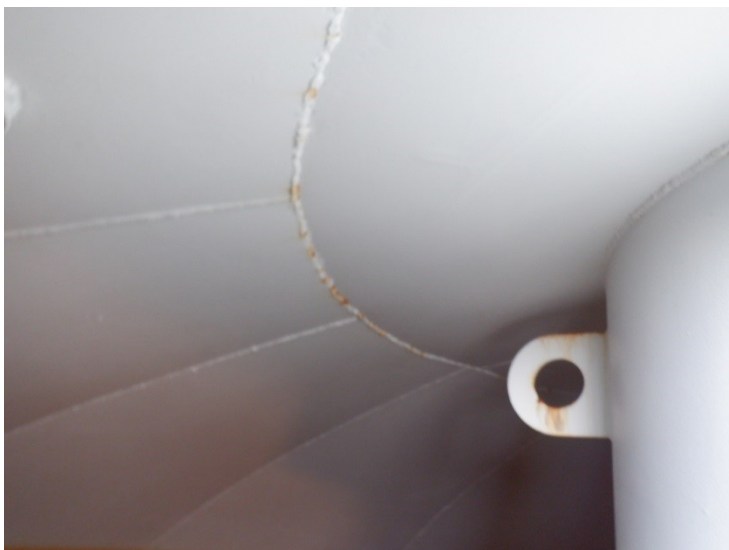
69) The wet interior roof coating is in good condition overall.

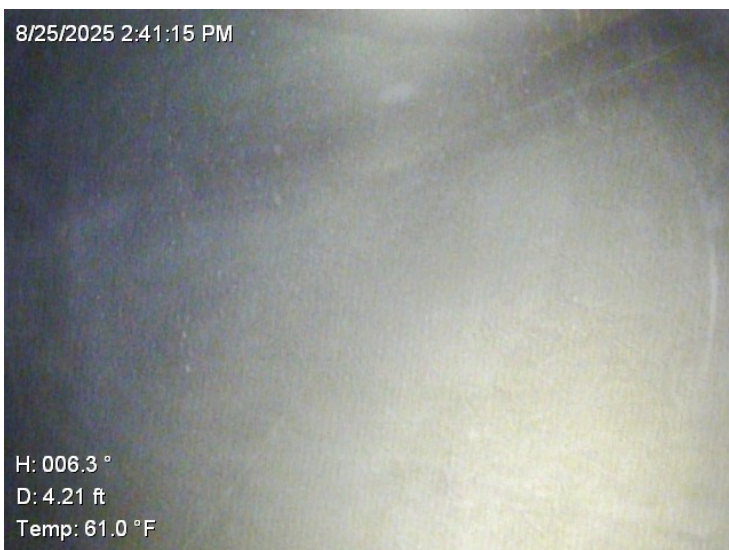
The sidewall and access tube coating is in good condition with a few failures. Primary methods of deterioration are spot failures to the substrate and rust bleedthrough. There is no significant coating damage at the high-water level which would be the area most affected by ice movement.

75) The wet interior sidewall coating is in good condition overall.

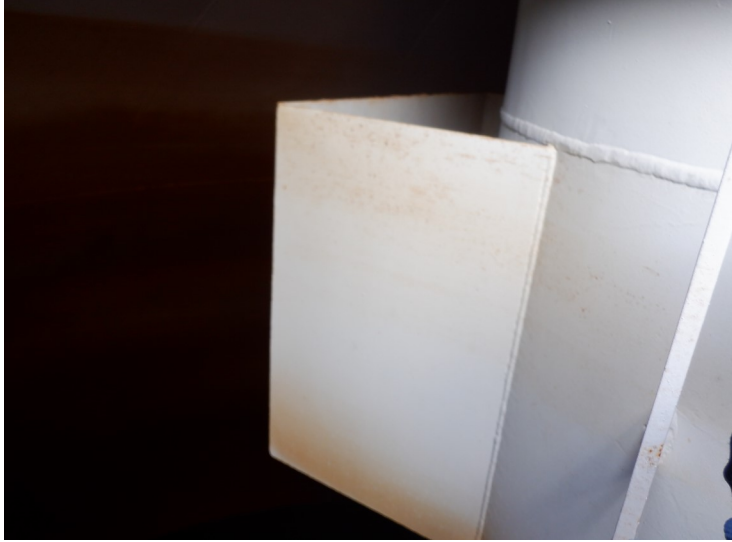
79) The overflow pipe weir box at the top of the access tube is in good condition.

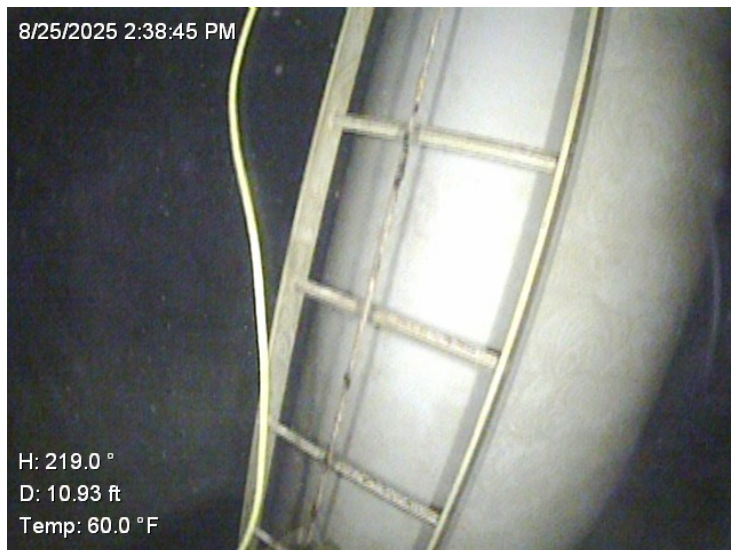
There is a wet interior ladder from the roof to the bowl that appears to be in good condition. The ladder meets current OSHA size requirements. The ladder is equipped with a cable-type fall prevention device that was not used during the ROV inspection.

82) The wet interior ladder appears to be in good condition. The ladder is equipped with a fall prevention device that was not used during the ROV inspection.
