Maintenance Inspection

250,000 Gallon Double Ellipse

Ontonagon, Michigan

Inspection Performed: September 25, 2025
Reviewed by: Joseph T. Hoban, P.E.: November 15, 2025

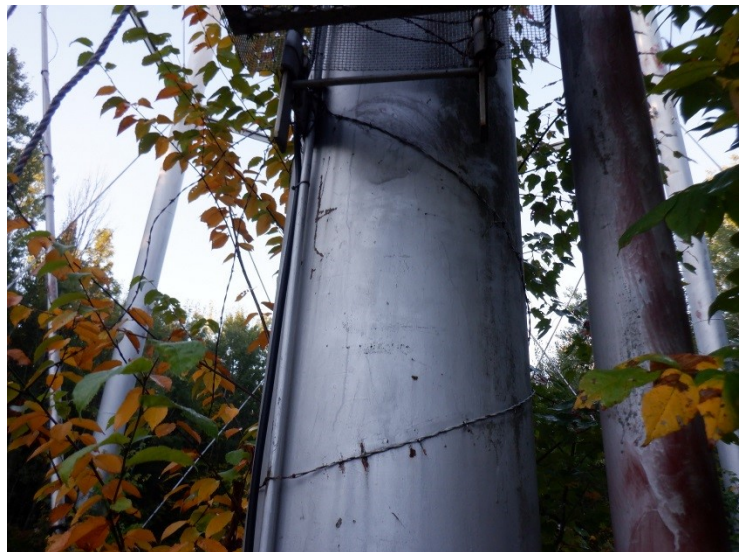
1) Tree branches and vegetation are rubbing and encroaching on the tank.

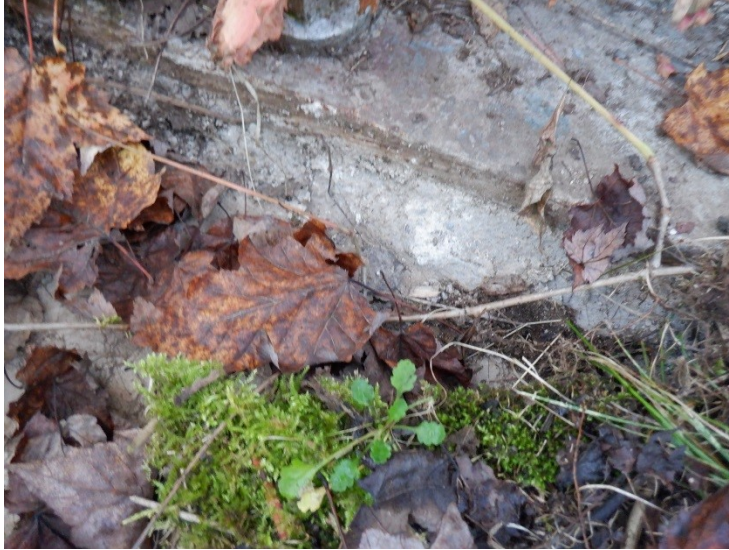
3) The concrete riser foundation is in good condition with no significant deterioration.

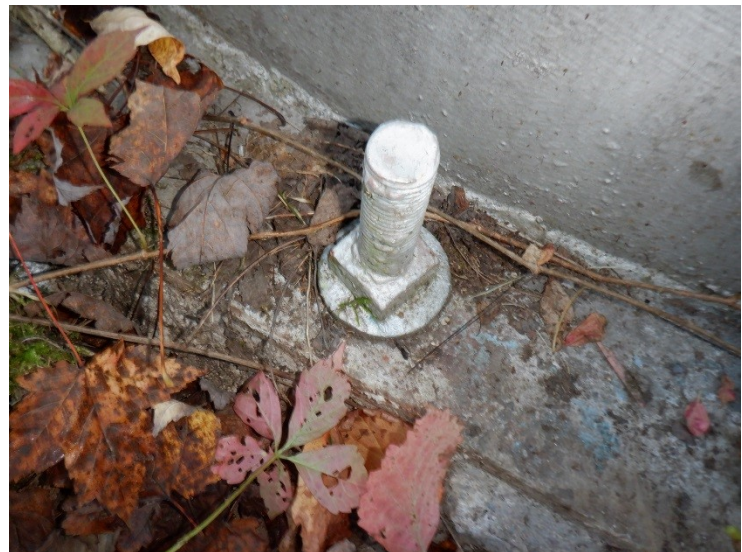
4) The grout between the steel riser baseplate and concrete foundation is intact.

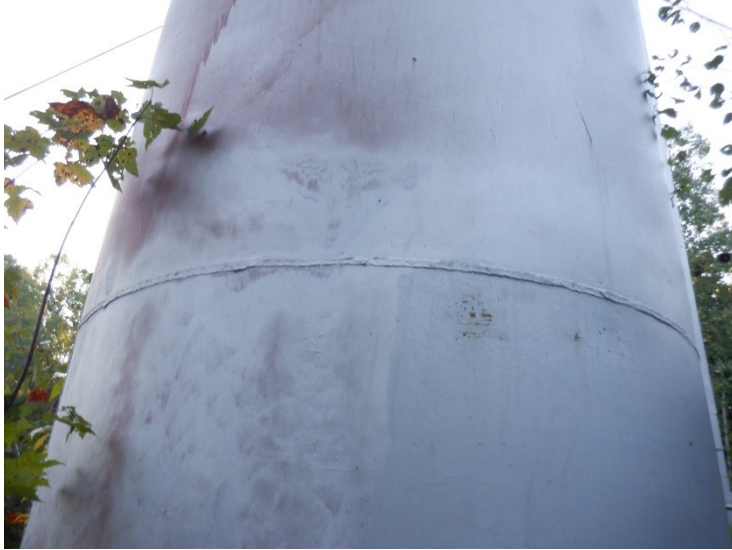
6) There are a few coating failures on the riser.

Budget for total exterior coating removal and repainting in approximately one to two years. Fading will continue and more coating failures will occur decreasing the tank's aesthetic appearance. Total removal is recommended because the coating failures are extensive and it is not practical to attempt to spot repair all failed areas.

Remove the existing coating by dry abrasive blast cleaning the steel to a commercial (SSPC-SP6) condition and apply a urethane system. All blast work would be performed inside a dust tight containment system using negative air pressure.

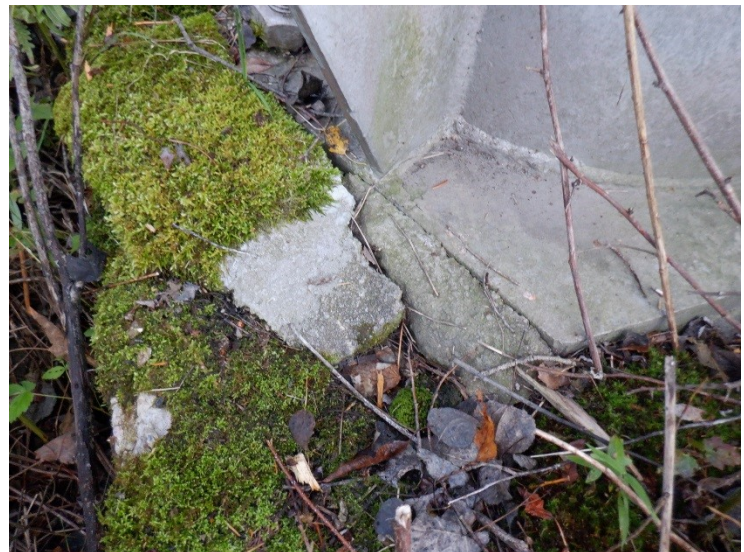
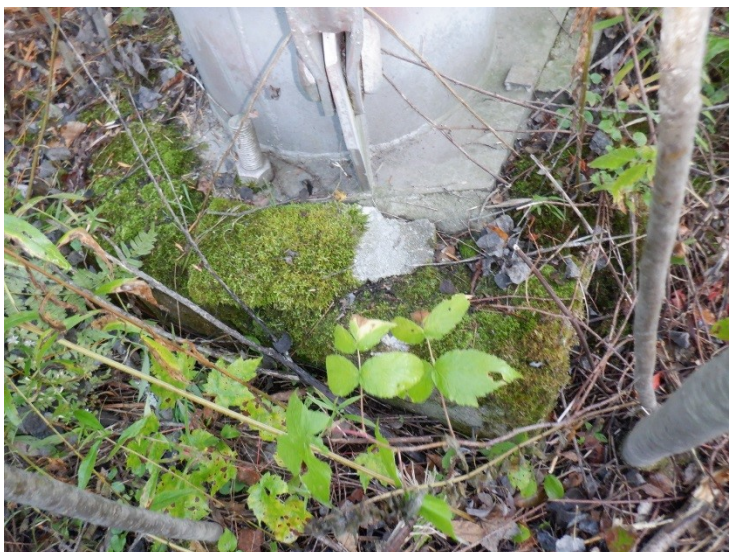
The exposed concrete foundations are in good to poor condition. There is extensive deterioration with some spalls on the leg foundations. The spalls are significant enough to create a structural problem. The foundations are not coated.

10) The concrete leg foundations are in fair to poor condition with moderate deterioration.

Coat the foundations to help prevent further deterioration. The cost would be incidental to exterior painting.

Repair spalls on the concrete foundation. Remove all loose and spalled concrete back to sound material by saw cutting then chipping. Replace the damaged concrete with a cementitious patching system. This work should be completed without loading from the tank proper. The estimated cost is \$3,000.

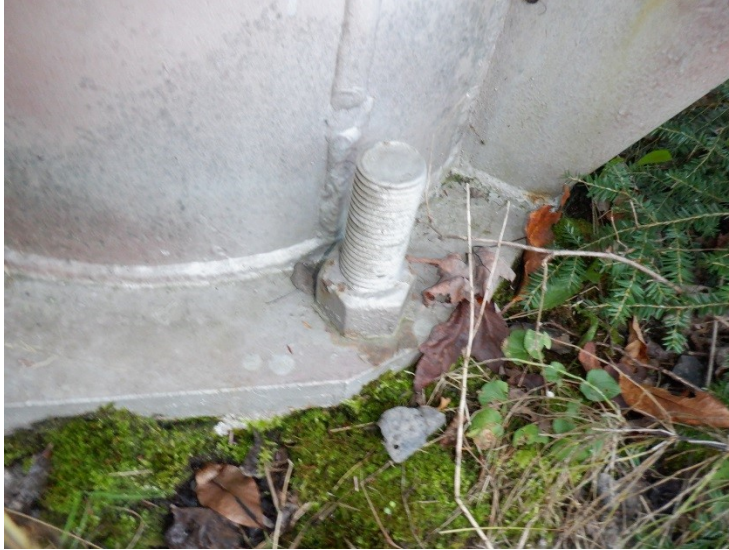
The grout between the steel baseplates and the concrete foundations is in good to fair condition with approximately 2 total lineal feet missing at the legs.

12) There is missing grout between the steel leg baseplates and concrete foundations.

The purpose of the grout is to evenly distribute the load onto the foundation and to prevent water from getting between the foundation and the tank. Repair areas of missing or damaged grout between the steel baseplate and the concrete foundation. The cost would be incidental to exterior painting.

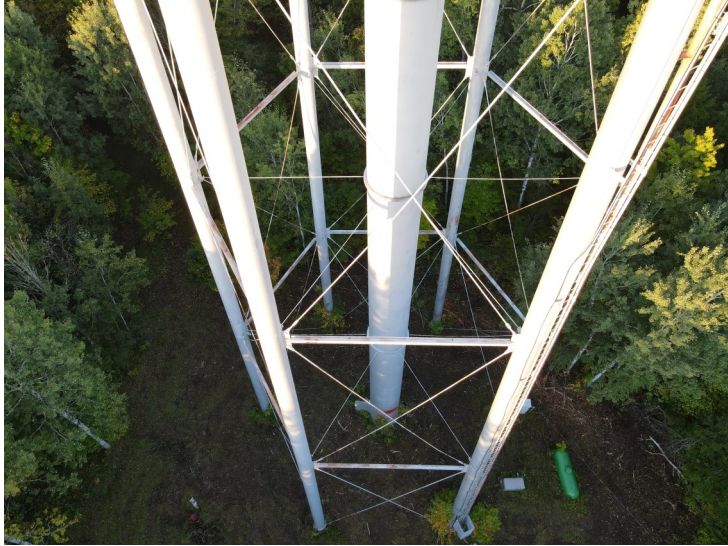
21) There are coating failures on the struts.

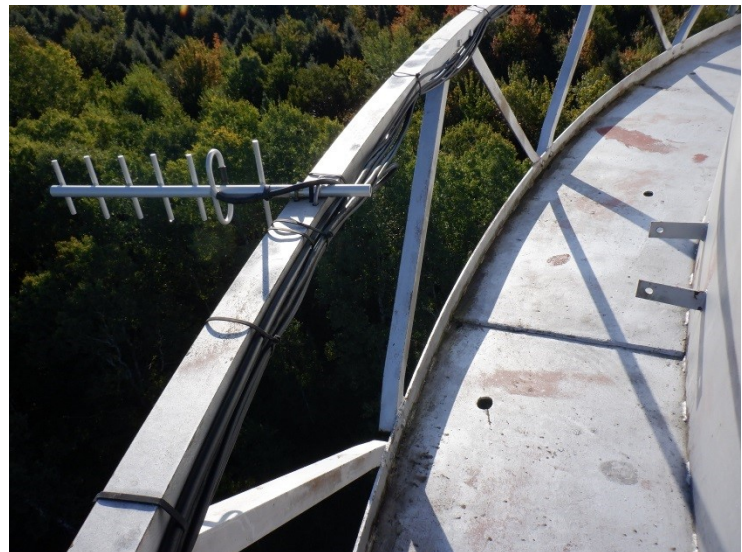
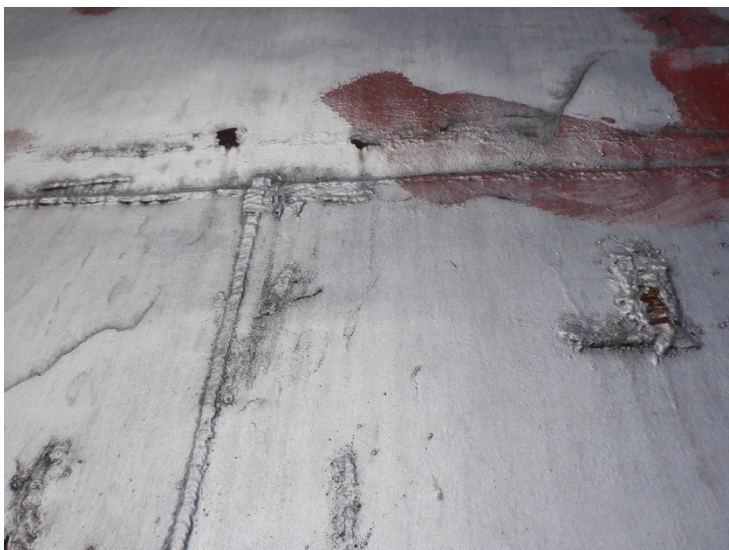
34) There is evidence of water ponding on the balcony.

35) There are numerous coating failures on the balcony.

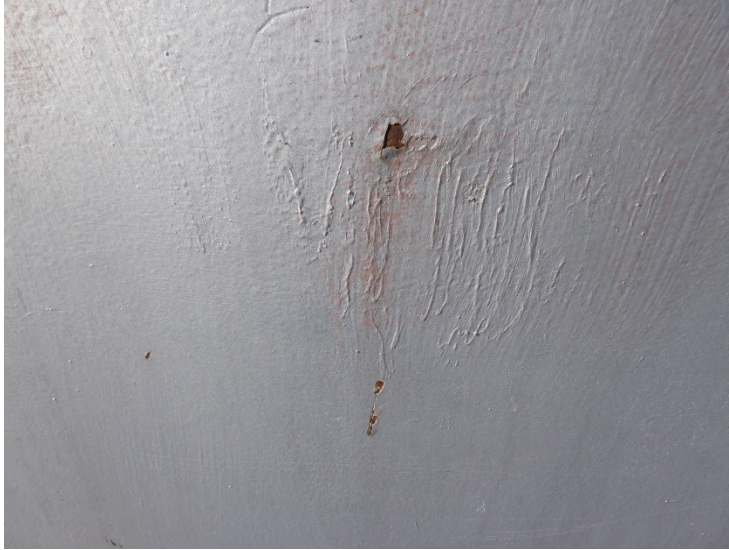
The coating on the balcony, sidewall, and roof is in poor condition with extensive failures. Primary methods of deterioration are spot failures to the substrate with rust undercutting, rust bleedthrough, delaminated topcoat, and erosion.

36) The sidewall coating is in poor condition with numerous failures.

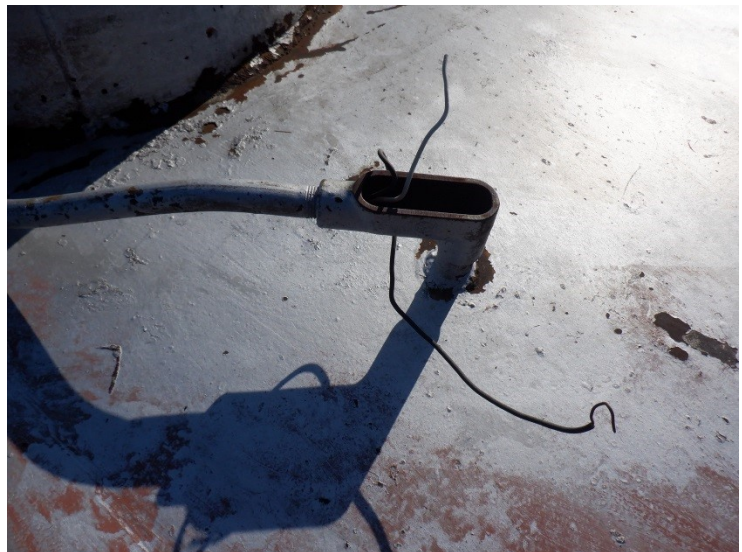
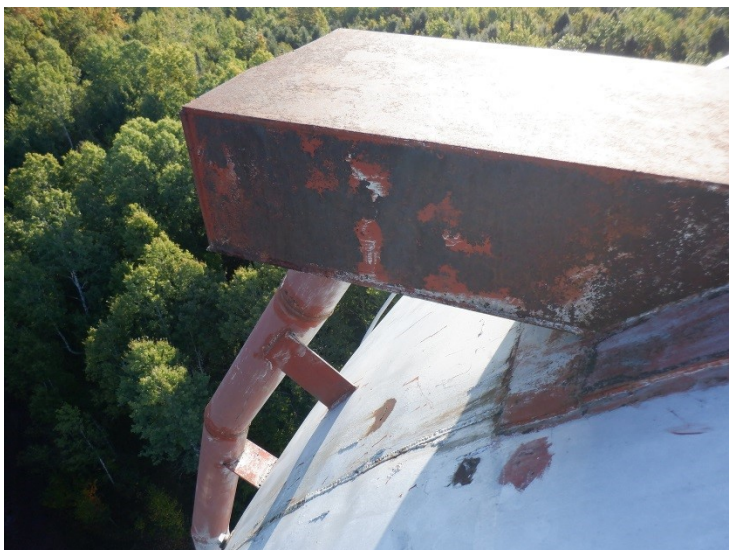
There is exposed electrical wiring at a damaged junction box on the roof.

47) There is exposed wiring at a damaged junction box on the roof.

Repair the damaged junction box on the roof so there are no exposed wires. The work can be performed by in-house personnel.

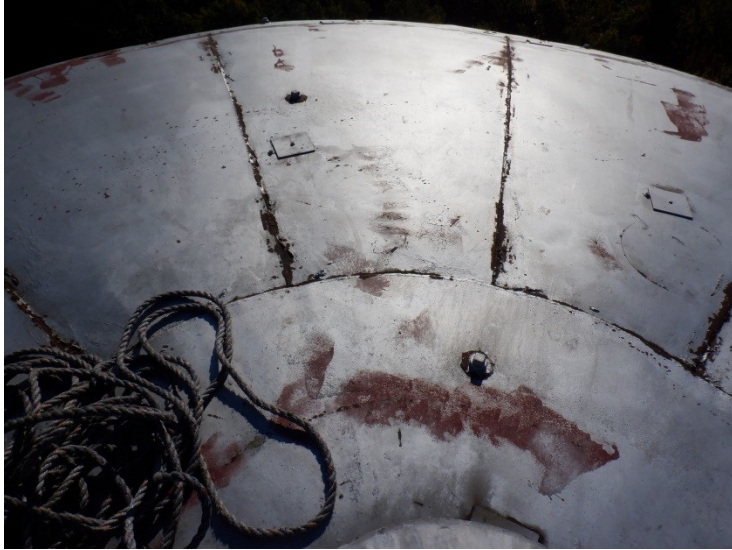
48) The roof coating is in poor condition with numerous failures.

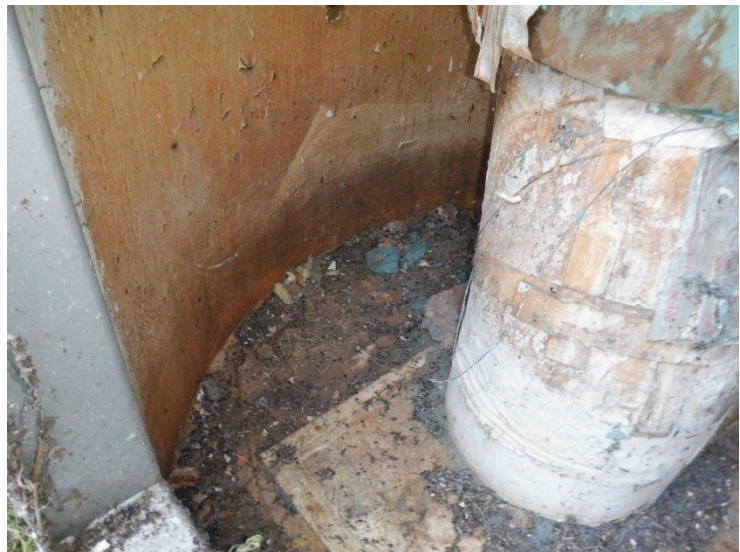
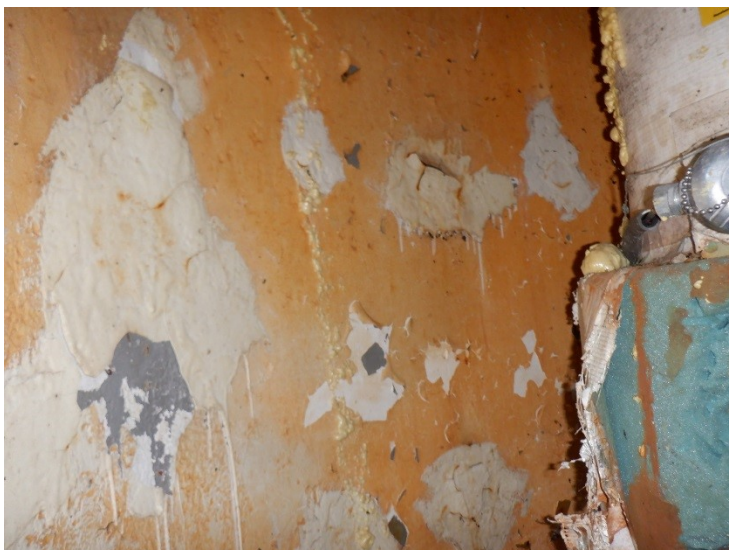
59) The expansion joint on the bottom of the fill/draw pipe in the riser is covered with insulation and not accessible for inspection.

A glandular style of expansion joint can seize if corrosion forming at the joint stops the joint from moving as designed. If the expansion joint seizes it cannot take up the longitudinal movement of the fill/draw pipe and the tank bottom will flex to compensate for this movement. With enough flexing, the weld at the tank bottom could crack and cause a leak. The type of joint should be verified. If it is determined to be a glandular expansion joint, then replace it with a bellows type joint. The estimated cost is \$15,000.

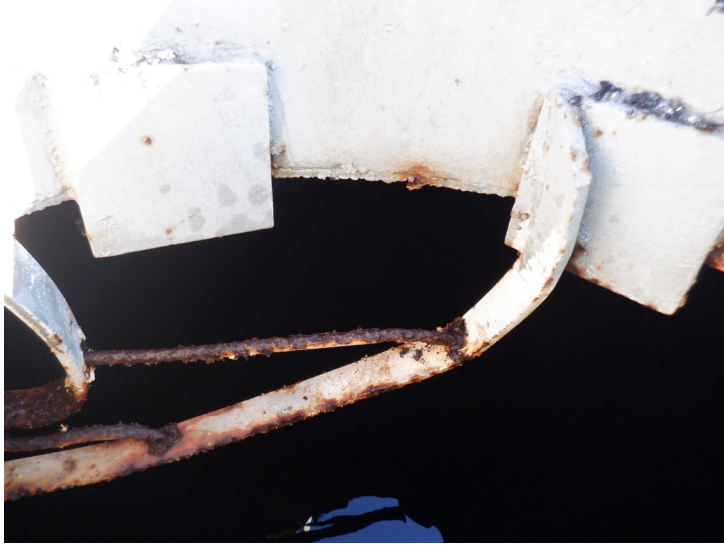
The coating is in poor condition overall. Primary methods of deterioration are spot failures to the substrate with rust undercutting and delaminated topcoat.

60) The dry riser coating is in poor condition with numerous failures.

Abrasive blast clean the entire dry interior to a commercial (SSPC-SP6) condition and apply an epoxy system. The existing coating is in poor condition and has deteriorated to the point where complete removal and repainting is necessary. The work should be performed with an exterior/wet interior painting project. The estimated cost is \$30,000.

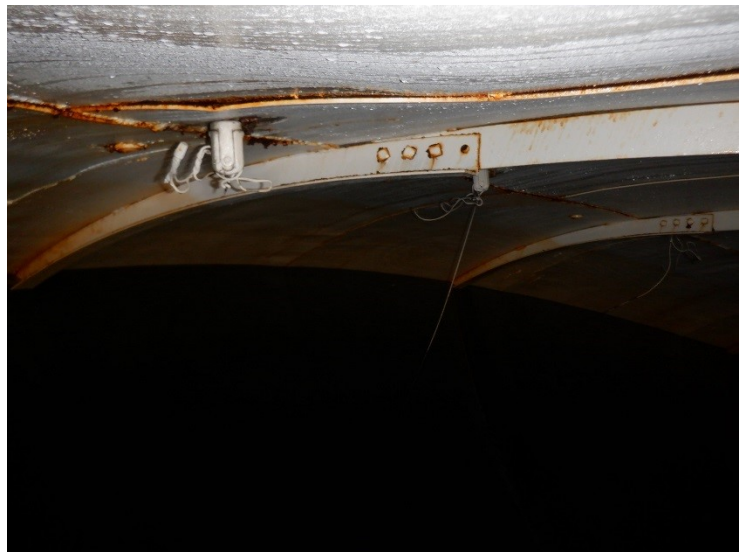
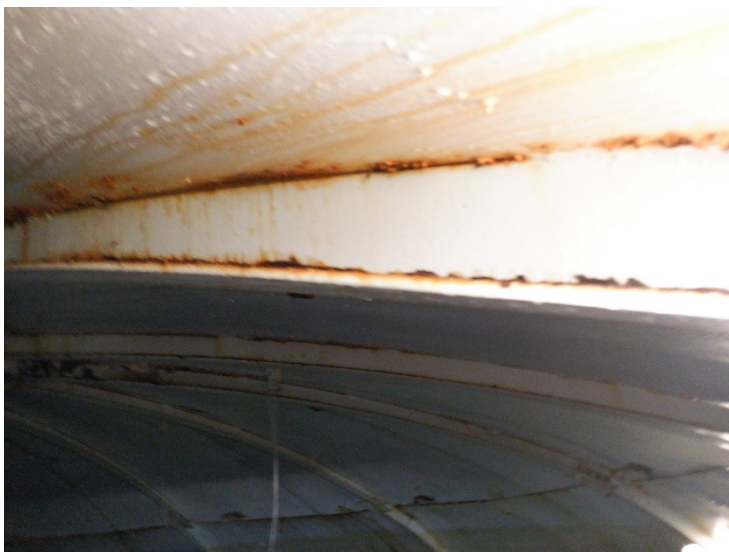
The roof coating is in poor condition with numerous failures. Primary methods of deterioration are spot failures to the substrate with rust undercutting and rust bleedthrough.

62) The wet interior roof coating is in poor condition with numerous failures.

Budget to repaint the wet interior in one to two years. Abrasive blast clean the entire wet interior to a near-white metal (SSPC-SP10) condition. Wet interior coating systems must be approved for potable water storage tanks contingent upon meeting requirements of NSF/ANSI 61.

Apply a three-coat epoxy system to the prepared surfaces. Epoxy coating systems are recommended in most applications because they have good adhesion and abrasion resistant qualities. The estimated cost is \$140,000.

Caulk the roof lap seams after the wet interior is repainted. The caulk will fill the open seams and help prevent corrosion. The estimated cost is \$3,000.

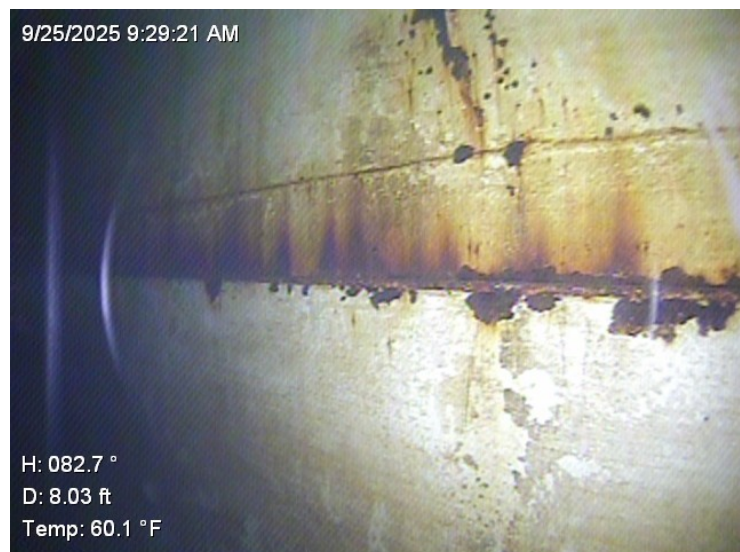
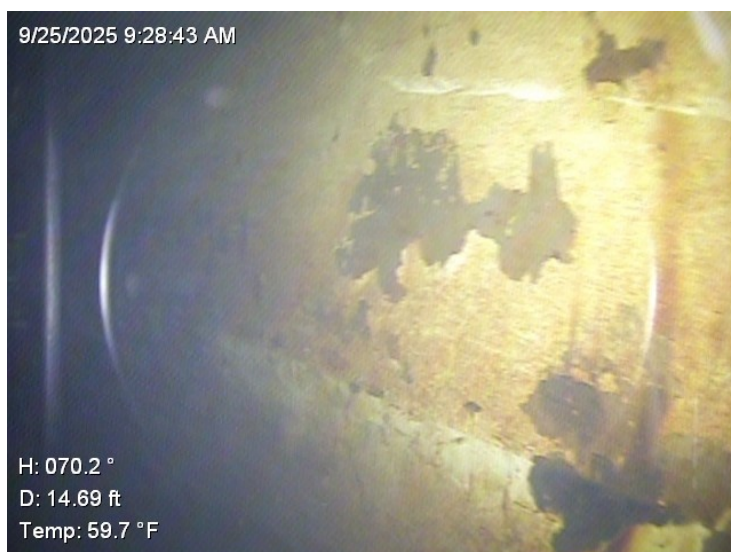
The sidewall coating is in poor condition with numerous failures. Primary methods of deterioration are spot failures to the substrate with rust undercutting, delaminated topcoat, rust bleedthrough, blisters, and abrasion.

67) The wet interior sidewall coating is in poor condition with extensive failures.

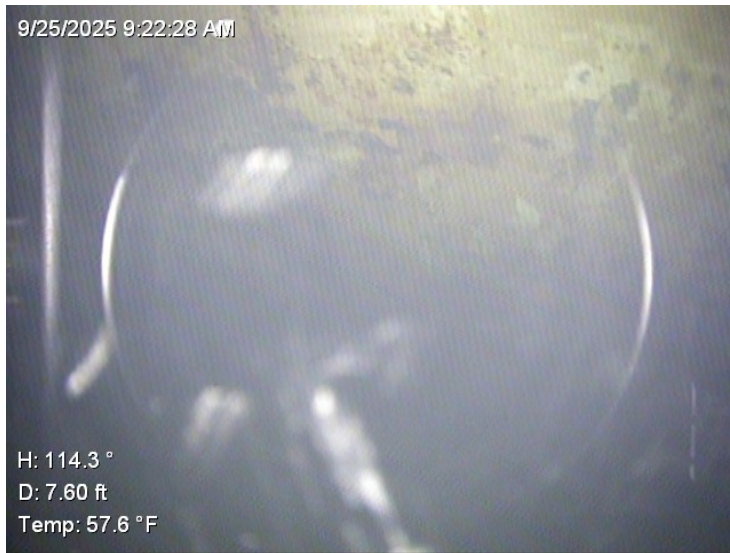
72) The bowl is covered with sediment that limited the amount of surface visible with the ROV.

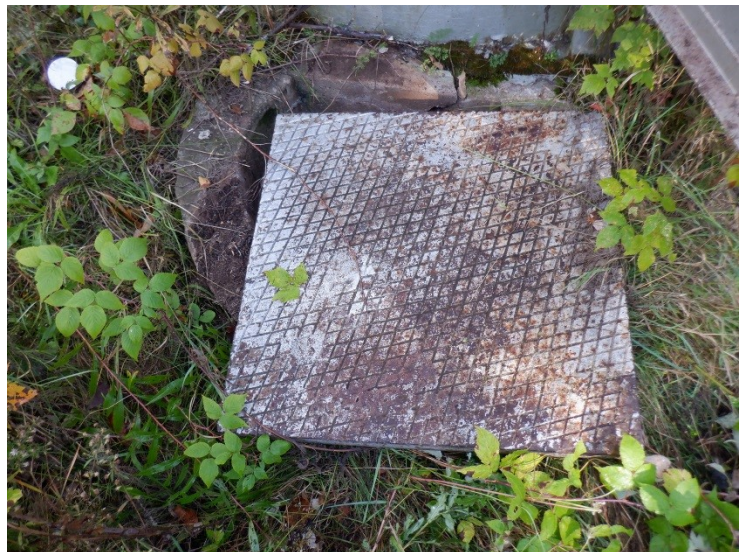
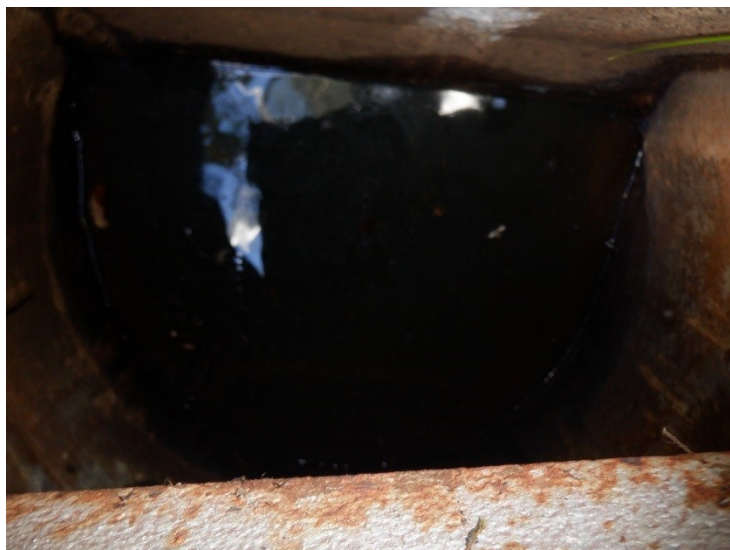
75) The pit was filled with water and the piping was not visible for inspection.
