Introduction

We have compiled the following images to demonstrate examples of non-conforming and non-fit for purpose powder coated tubular steel fencing.

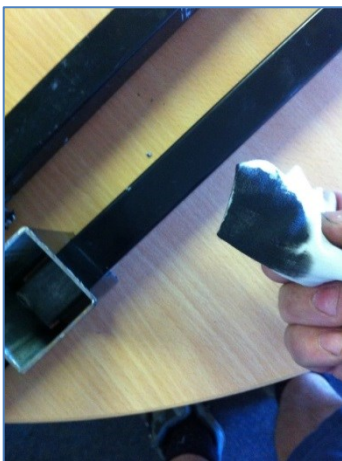
The failure of the coating to pass the basic MEK solvent rub test under AS4506. This indicates poor quality powder, poor metal pretreatment and under cure of the powder. Image of 'new' fence.

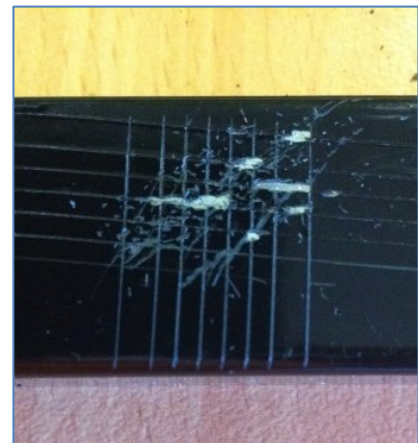
The coating failing the basic cross hatch test under AS4506. A blade creates a cross hatch on the powder surface. The powder sections should adhere when flicked with the edge of the blade. Image of 'new' fence.

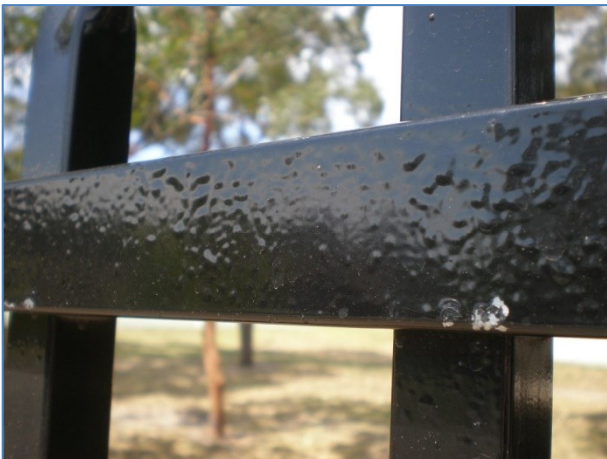
This finish show excess powder has been applied and will have poor adhesion as a result.

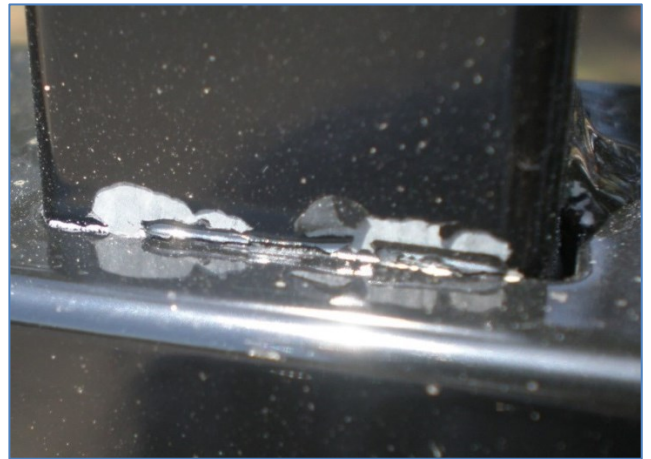
The delamination of the powder film is a result of poor metal pretreatment. Image taken less than 1 month after installation.

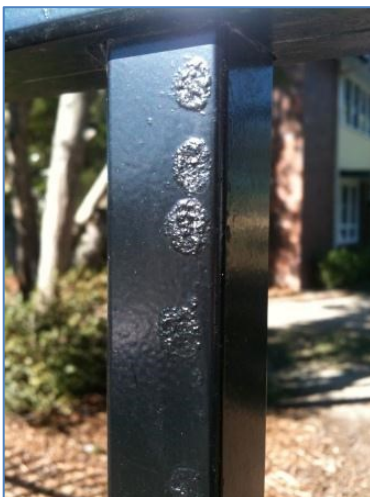
Blistering of the powder coating is a result of poor quality metal surface preparation on an imported panel. Fence installed 18 months.

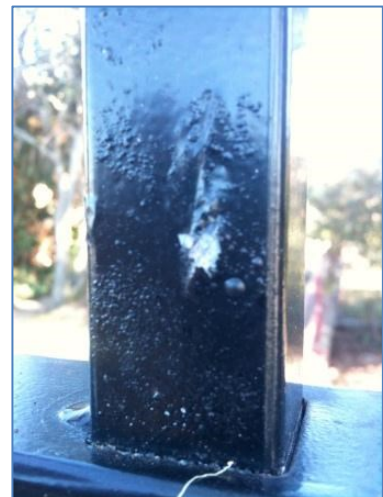
The delamination of the powder film is a result of oxidisation (white rust). Fence installed less than 18 months.

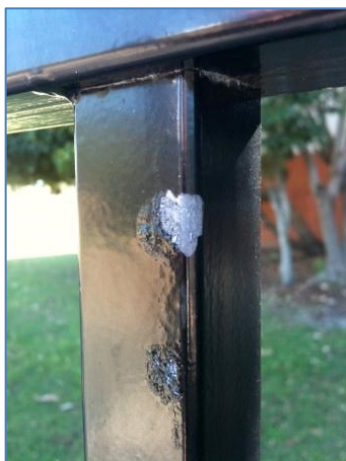
Delamination of the powder film. Proper chemical pretreatment and quality powders cost more.

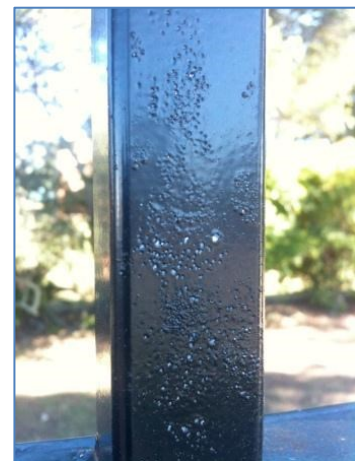
The 'orange peel' is a result of low quality powders and poor pretreatment and cleaning of the product and/ or inferior tube.

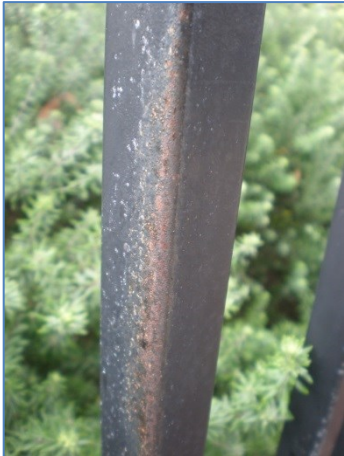
Red rust starting to appear through the powder coating at 3 years.

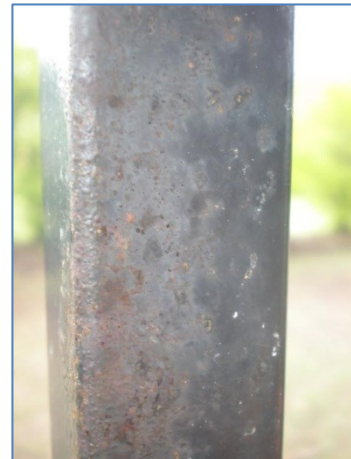
Red rust starting to appear through the powder coating at 3 years.

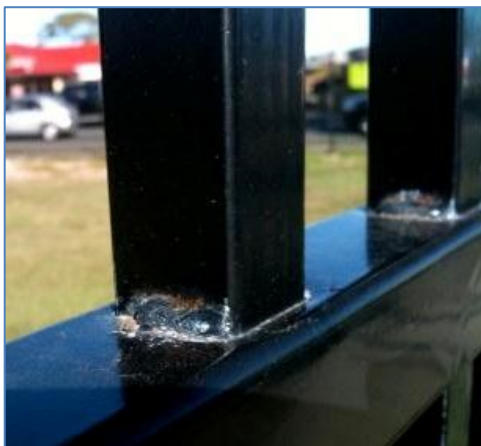
A mild steel or 'black' weld has been used instead of Silicon Bronze which is normally the case with imported panels. The mild steel is hotter than the bronze resulting in damage to the galvanised coating on the tube. In addition the mild steel weld is more prone to corrosion and is a lesser substrate for powder adhesion. This panel had been installed about 12 months.

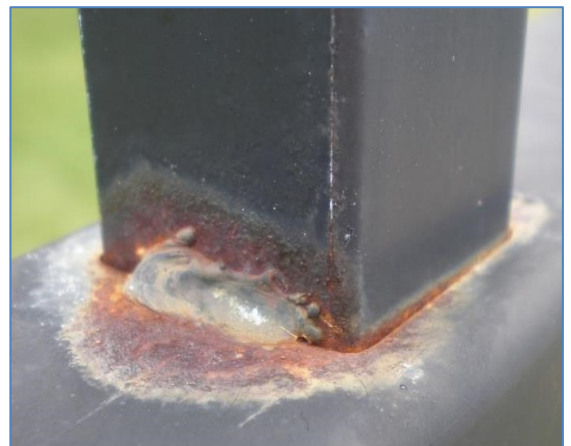
This is an image of the same section of fencing as image at left some 3 years later. Note the severe fading and the aggressive corrosion of the mild steel weld.

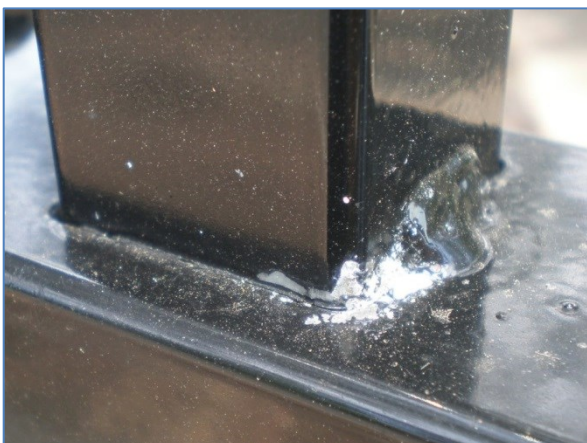
Another image of a mild steel or 'black' weld. This panel had been installed about 1 month.

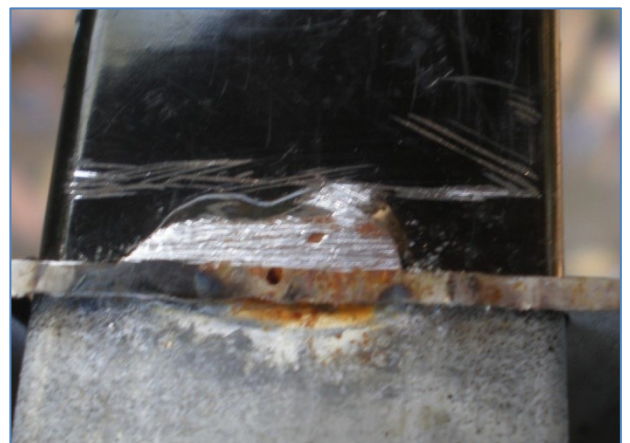
A cut away of a mild steel weld. The effect of weld heat on the gal coating is clearly evident. A silicon bronze weld is cooler so results in less damage to the zinc coating.

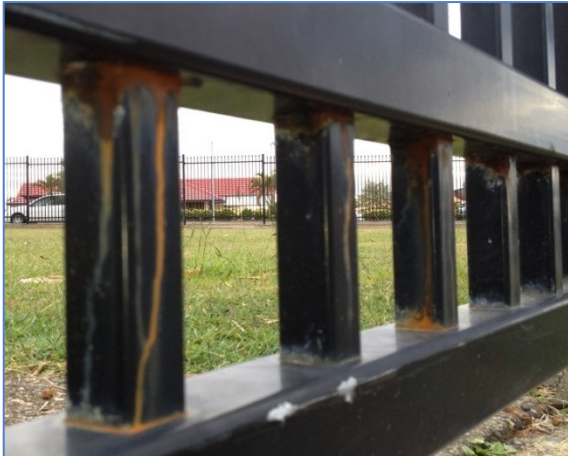
This corrosion suggests the tube may not be galvanised internally

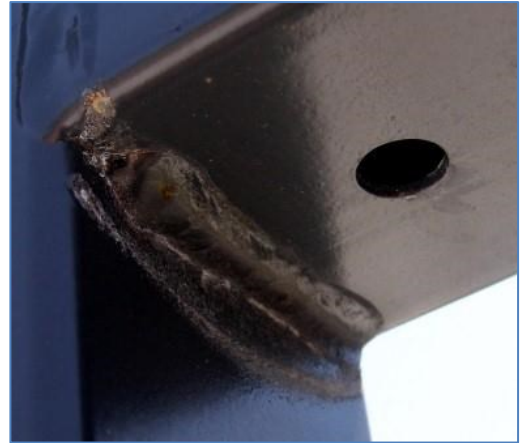
A mild steel weld similarly used on the gate frame. The effect of weld heat on the gal coating is clearly evident. The 'black' weld and damaged gal has begun to rust on this gate installed for less than 12 months.

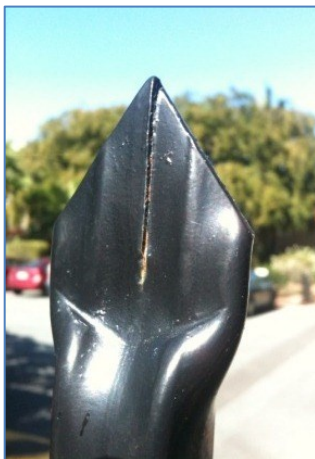
This is an imported panel installed about 15 months. The poor quality tube is brittle resulting in splitting during manufacture and consequent corrosion.

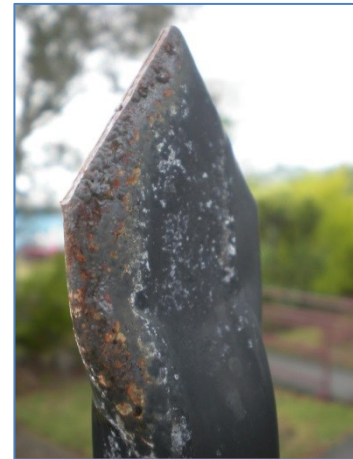
This is an image of a spear in the same section of fencing as the spear (left) some 3 years after installation.

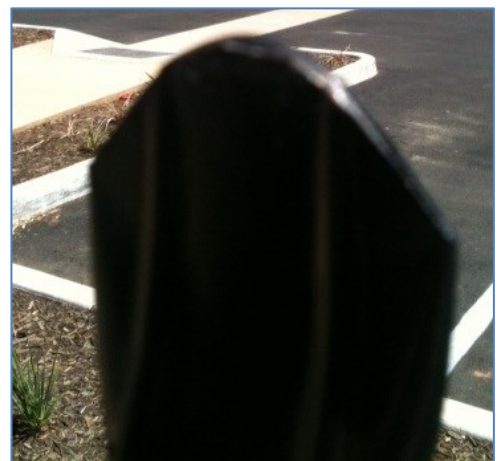
This was a sharp spear picket (on an imported panel) that has been rounded with a grinder to meet the specification. It is already showing signs of corrosion.

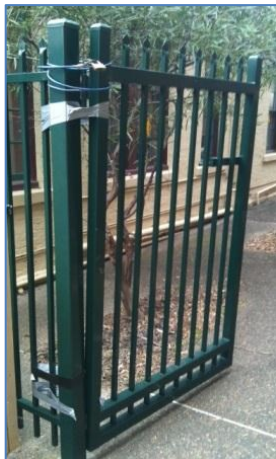
This gate has failed due to the top and bottom hinges seizing and failing.

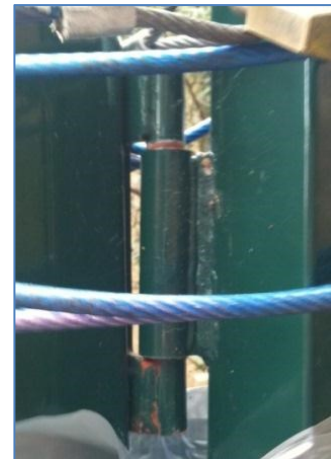
This is a dry top hinge. The pin has corroded, seized and failed.

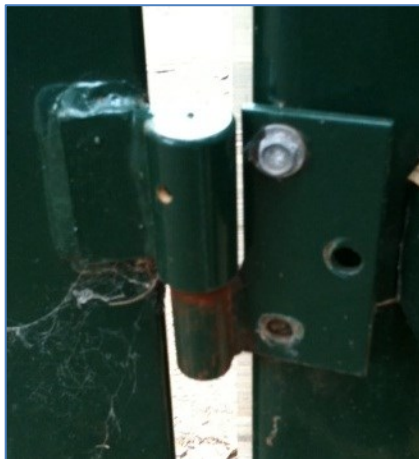
This is light weight Goliath ball bearing hinge that has seized and failed. These hinges are not sealed and cannot be greased. Tek screws have been used installed of a bolt through the post. Two of the three teks have failed.

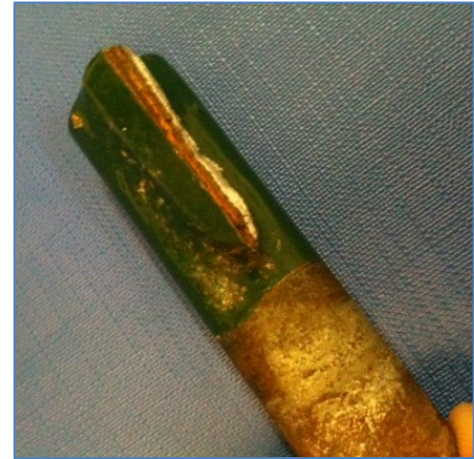
A Goliath hinge that has seized and failed snapping where it affixes to the gate resulting in the gate falling over.

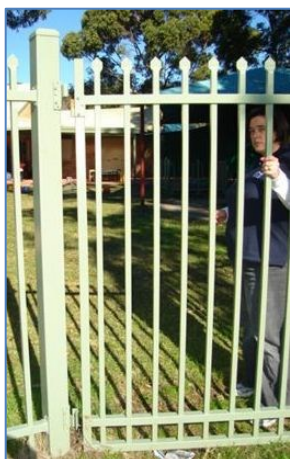
A school teacher holds a gate that had fallen off due to not fit for purpose hinge being used and installed (incorrectly).

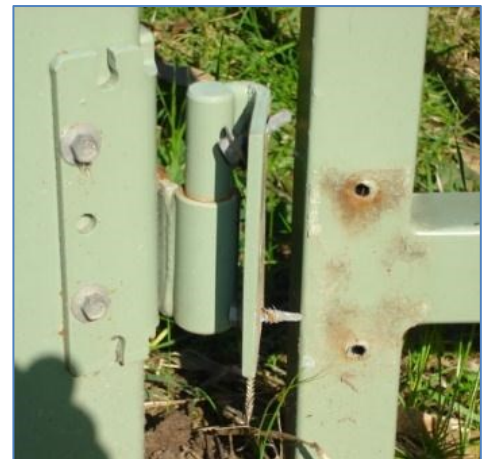
A goliath hinge tek screwed to the gate post and gate stile. The hinge has been installed upside down, it has seized resulting in the teks pulling out of the wall of the gate stile.

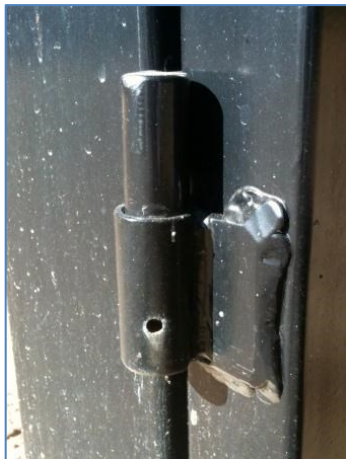
This is light weight Goliath ball bearing hinge that has been welded on upside down such that the 'female' housing collects water. The white corrosion can be seen on the oiling hole on the lower part. This results in the hinge eventually seizing and then failing resulting in the hinge coming loose.

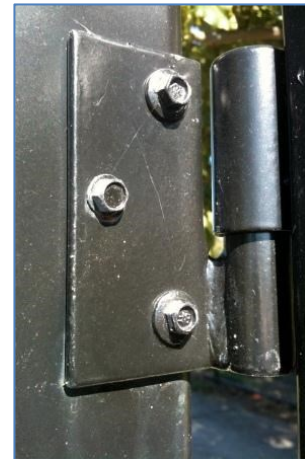
A Goliath hinge tek screwed to the gate post.

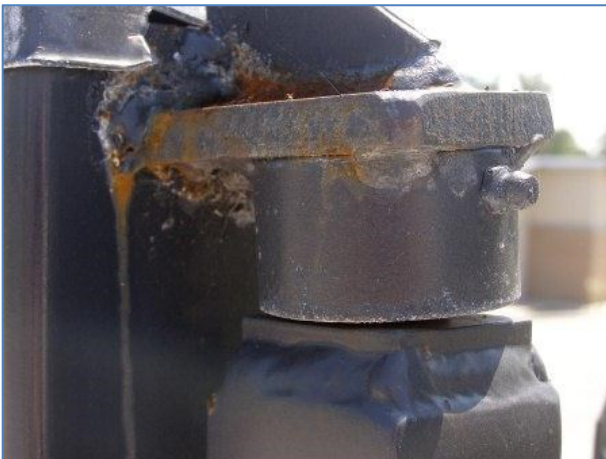
This is tapered roller bearing that has been installed upside down and incorrectly as a top hinge. It is a load bearing hinge that is only meant to be used as a bottom hinge. It also has not been greased after install. The hinge bracket has been welded on crooked.

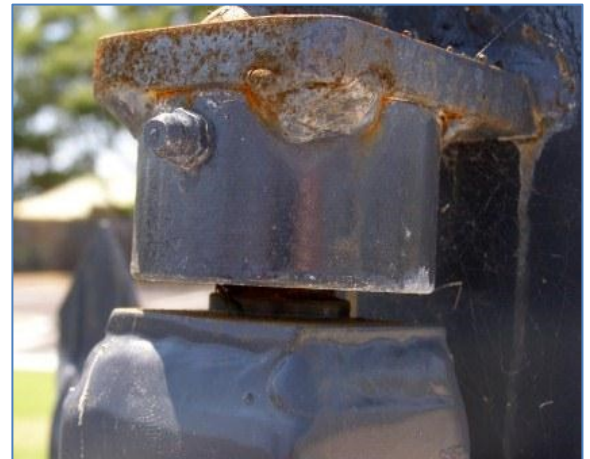
A 'black' steel bracket has been used welded to the bearing housing and post on site and 'touched up' with paint. It has begun corroding almost immediately.

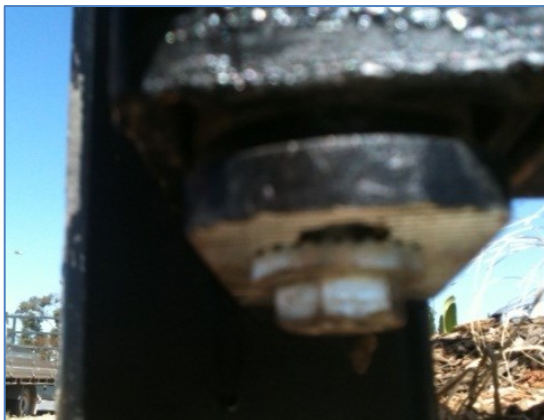
This is an adjustable sealed bearing. It is not a load bearing hinge yet it has been installed as the bottom hinge. The hinge has been welded on site to the gate stile resulting in damage to

the powder coating.

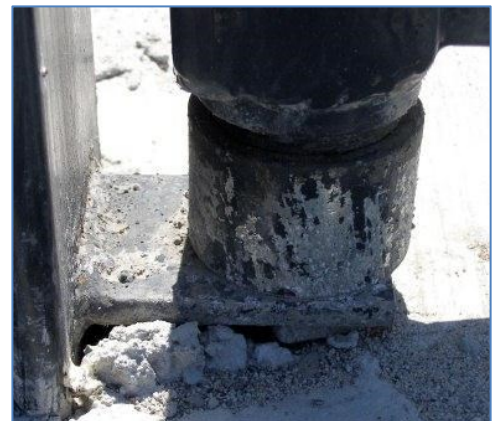
Similarly this is a sealed ball bearing installed incorrectly at the bottom. This type of bearing is not load bearing. In this position it will collect water and

grit resulting in eventual seizure.

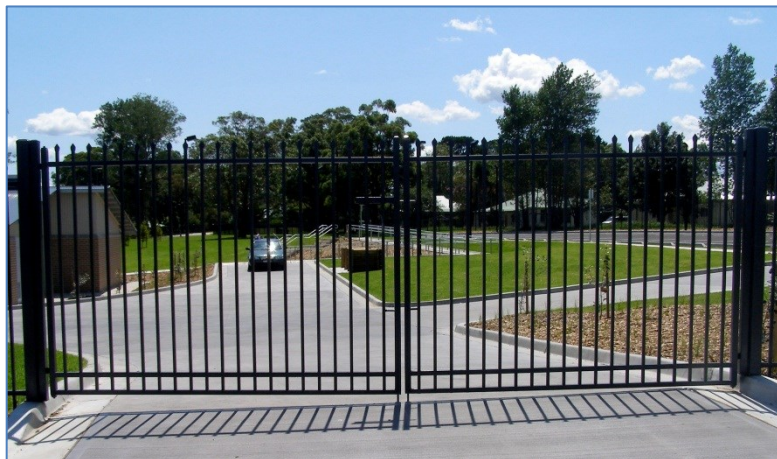
6m double gate frame with light 40x40x1.6mm stiles and rails swung from Goliath Hinges

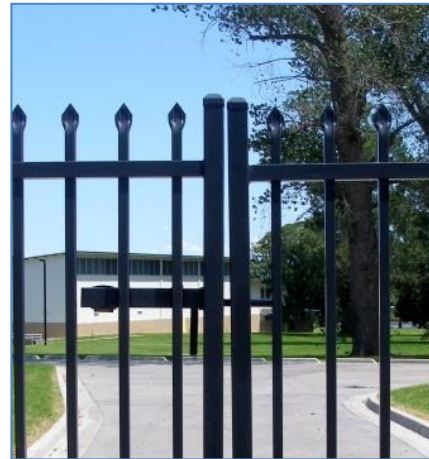
Large double gates swung from Goliath hinges sagging. The gates will soon become inoperable.

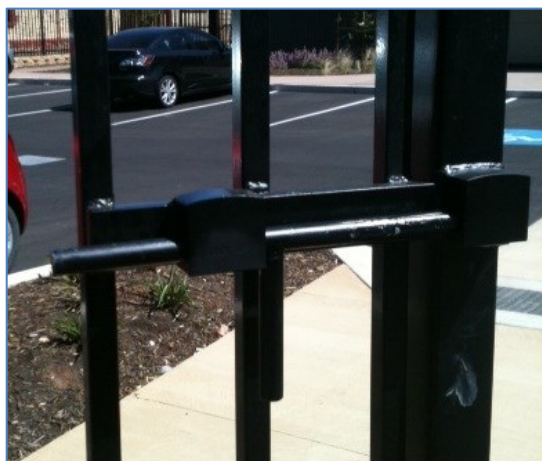
A slide bolt installed without perforated mesh to prevent it being used as a climb point over the gate.

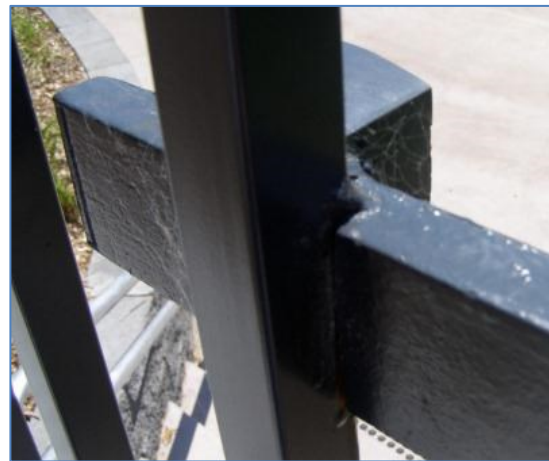
The slide bolt backing plate has been cut onsite to suit the incorrect stile and rail size that has been used.
