# FACILITY CONDITION ASSESSMENT

## **DLR Group**

Lakeview Elementary  
11500 Joslin Street  
Santa Fe Springs, California 90670

October 19, 2022

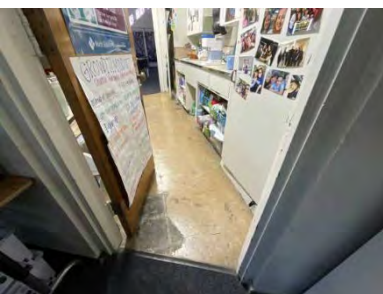
**Flooring in Failed condition.**

Vinyl Tile (VCT), w/ Asbestos Abatement  
 Building 600 Lakeview Elementary Throughout building

Tiles are coming off the floor and exposing the asbestos material underneath. - AssetCALC ID: 4270291

Uniformat Code: C2030  
 Recommendation: **Replace in 2022**

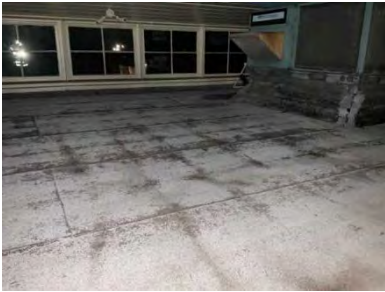
**Roofing in Poor condition.**

Built-Up  
Building 600 Lakeview Elementary Roof

The roof is worn and needs replacement soon. - AssetCALC ID: 4270294

Uniformat Code: B3010  
Recommendation: **Replace in 2024**

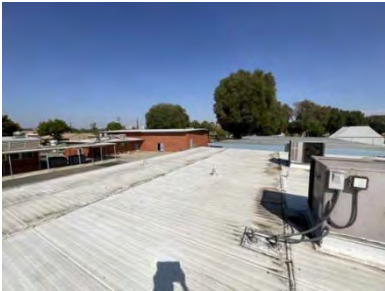
**Roofing in Poor condition.**

Single-Ply Membrane, TPO/PVC  
Building 104-105 Lakeview Elementary Roof

Evidence of roof leaking. Water is pooling on top of roof. - AssetCALC ID: 4275408

Uniformat Code: B3010  
Recommendation: **Replace in 2024**

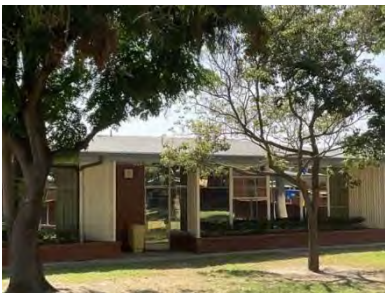
**Roofing in Poor condition.**

Built-Up  
Building 400 Lakeview Elementary Roof

Roof is wearing and needs to be replaced soon. - AssetCALC ID: 4276027

Uniformat Code: B3010  
Recommendation: **Replace in 2024**

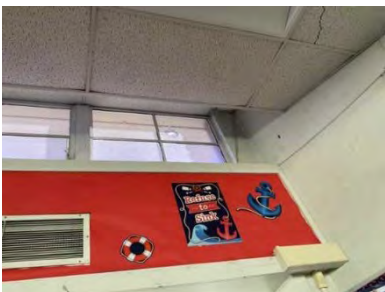
**Window in Failed condition.**

Steel, up to 15 SF  
Building 600 Lakeview Elementary Building  
Exterior

Broken glass. Needs replacement. - AssetCALC ID: 4270297

Uniformat Code: B2020  
Recommendation: **Replace in 2022**

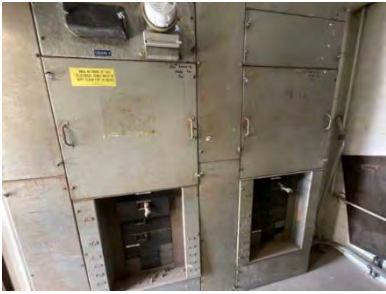
**Switchboard in Poor condition.**

120/208 V  
Building 400 Lakeview Elementary Electrical room

Item is passed its useful life and needs to be replaced. - AssetCALC ID: 4276040

Uniformat Code: D5020  
Recommendation: **Replace in 2024**

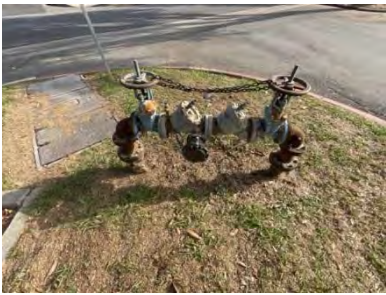
**Backflow Preventer in Poor condition.**

Domestic Water  
Office Administration Lakeview Elementary Site

Rusted and nearing the end of its life. - AssetCALC ID: 4268692

Uniformat Code: D2010  
Recommendation: **Replace in 2024**

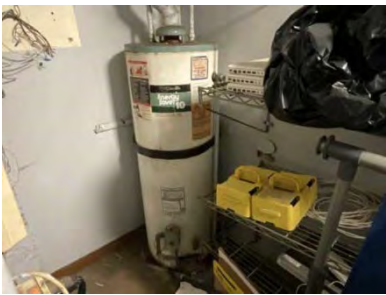
**Water Heater in Poor condition.**

Gas, Residential  
Building 700 Lakeview Elementary Utility closet

Water heater is passed it's useful life and needs to be replaced soon. - AssetCALC ID: 4275782

Uniformat Code: D2010  
Recommendation: **Replace in 2024**

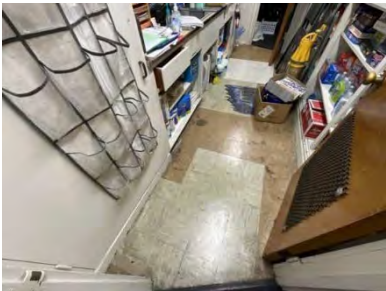
**Flooring in Failed condition.**

Vinyl Tile (VCT), w/ Asbestos Abatement  
Building 500 Lakeview Elementary Throughout building

Floor tiles are coming up off the floor and exposing asbestos material underneath. Needs to be addressed immediately. - AssetCALC ID: 4277163

Uniformat Code: C2030  
Recommendation: **Replace in 2022**

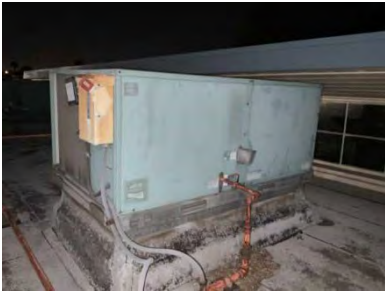
**Packaged Unit in Poor condition.**

Unit is passed its useful life and will need to be replaced soon. - AssetCALC ID: 4277147

Uniformat Code: D3050  
Recommendation: **Replace in 2023**
