# FACILITY CONDITION ASSESSMENT

Jersey Elementary  
9400 Jersey Avenue  
Santa Fe Springs, California 90670

*159753.22R000-002.017*

*October 27, 2022*

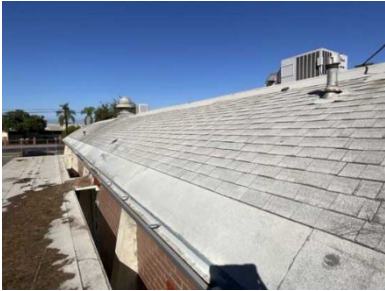
#### Roofing in Poor condition.

Asphalt Shingle, 20-Year Standard  
IMC Building Jersey Elementary Roof

Shingles are at end of life - AssetCALC ID: 4351076

Uniformat Code: B3010  
Recommendation: **Replace in 2022**

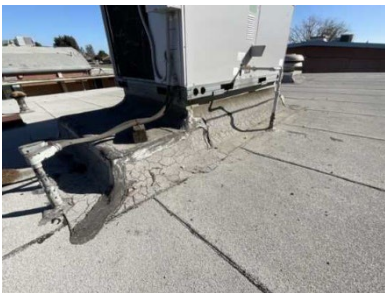
#### Roofing in Poor condition.

Built-Up  
Building 200 Jersey Elementary Roof

Roof leaks and should be replaced - AssetCALC ID: 4302025

Uniformat Code: B3010  
Recommendation: **Replace in 2022**

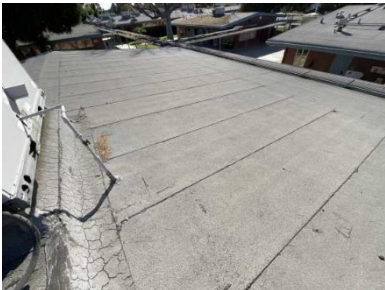
#### Roofing in Poor condition.

Built-Up  
Building 300 Jersey Elementary Roof

Roof leaks and should be replaced - AssetCALC ID: 4301885

Uniformat Code: B3010  
Recommendation: **Replace in 2022**

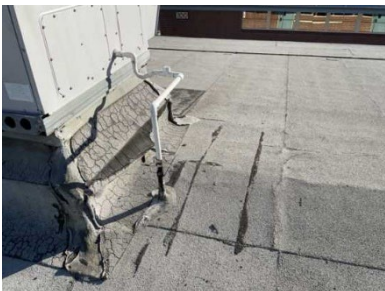
#### Roofing in Poor condition.

Built-Up  
Building 600 Jersey Elementary Roof

Roof is cracked and leaking. Replacement is recommended - AssetCALC ID: 4350637

Uniformat Code: B3010  
Recommendation: **Replace in 2023**

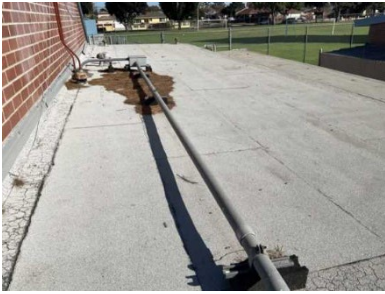
**Roofing in Poor condition.**

Built-Up  
IMC Building Jersey Elementary Roof

Roof should be replaced due to cracking and leaking. - AssetCALC ID: 4344452

Uniformat Code: B3010  
Recommendation: **Replace in 2023**

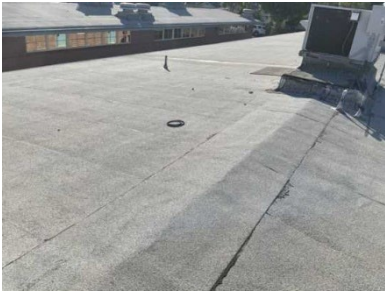
**Roofing in Poor condition.**

Built-Up  
Building 500 Jersey Elementary Roof

Roof has signs of leaking and needs to be replaced soon. - AssetCALC ID: 4350442

Uniformat Code: B3010  
Recommendation: **Replace in 2024**

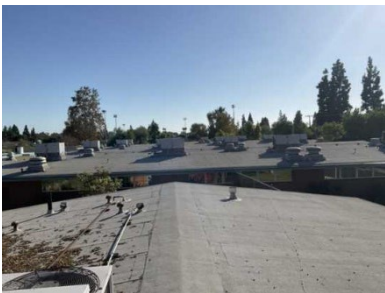
**Roofing in Poor condition.**

Built-Up  
Office Jersey Elementary Roof

Roof is cracked and wearing. Evidence of leaks present. Roof needs replacement soon. - AssetCALC ID: 4351211

Uniformat Code: B3010  
Recommendation: **Replace in 2024**

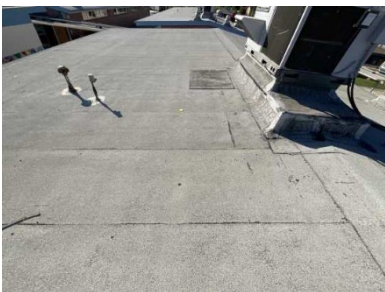
**Roofing in Poor condition.**

Built-Up  
Building 900 Jersey Elementary Roof

Roof is wearing and cracking. Will need to be replaced soon. - AssetCALC ID: 4350874

Uniformat Code: B3010  
Recommendation: **Replace in 2024**

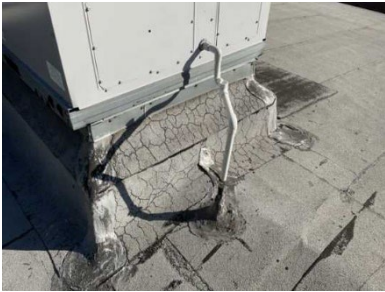
**Roofing in Poor condition.**

Built-Up  
Building 800 Jersey Elementary Roof

Roof is deteriorating and cracking. Recommend replacement soon. - AssetCALC ID: 4344286

Uniformat Code: B3010  
Recommendation: **Replace in 2024**

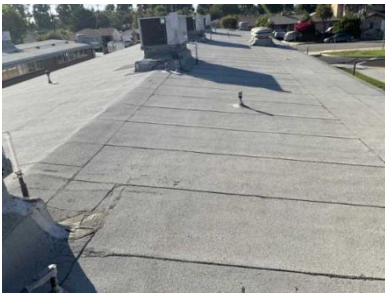
**Roofing in Poor condition.**

Built-Up  
Building 400 Jersey Elementary Roof

Roof has evidence of leaking. Material is cracked and falling apart. - AssetCALC ID: 4320989

Uniformat Code: B3010  
Recommendation: **Replace in 2024**

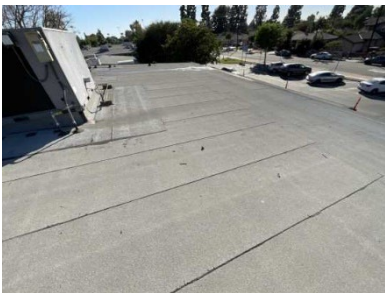
**Roofing in Poor condition.**

Built-Up  
Multi-Purpose Room Jersey Elementary Roof

Roofing is cracking and falling apart. Evidence of roof leaks found. - AssetCALC ID: 4351166

Uniformat Code: B3010  
Recommendation: **Replace in 2024**

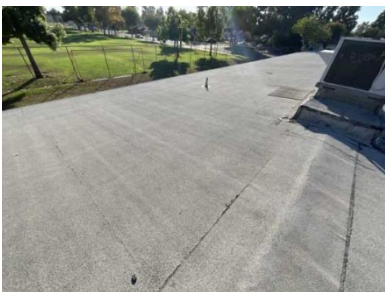
**Roofing in Poor condition.**

Built-Up  
Building 700 Jersey Elementary Roof

Roofing is nearing the end of its life and will need to be replaced soon. - AssetCALC ID: 4350829

Uniformat Code: B3010  
Recommendation: **Replace in 2024**

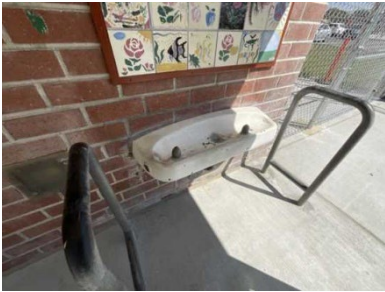
### Drinking Fountain in Failed condition.

Wall-Mounted, Single-Level  
IMC Building Jersey Elementary Building exterior

Drinking fountain does not function - AssetCALC ID: 4351097

Uniformat Code: D2010  
Recommendation: **Replace in 2022**

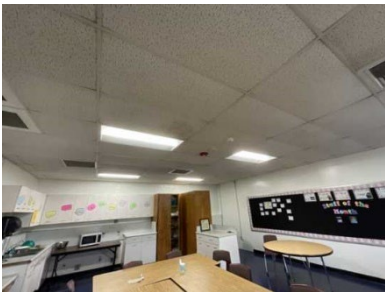
### Suspended Ceilings in Poor condition.

Acoustical Tile (ACT)  
Building 300 Jersey Elementary Throughout Building

ACT tiles are discolored and should be replaced - AssetCALC ID: 4301889

Uniformat Code: C1070  
Recommendation: **Replace in 2022**

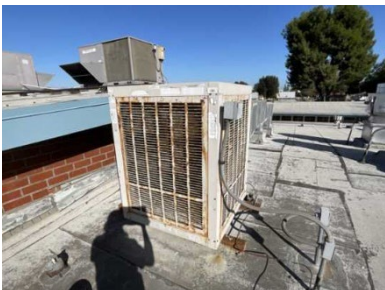
### Evaporative Cooler in Poor condition.

0.33 to 0.50 HP  
Multi-Purpose Room Jersey Elementary Roof

Item is badly rusted and well past its expected age. - AssetCALC ID: 4344726

Uniformat Code: D3030  
Recommendation: **Replace in 2022**

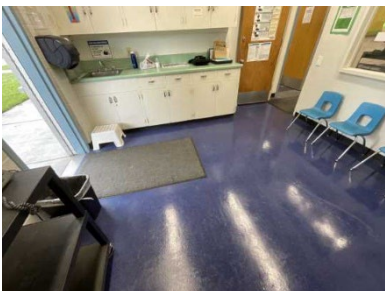
### Flooring in Poor condition.

Vinyl Sheetting  
Office Jersey Elementary Throughout building

Damage to floor is present and needs to be addressed. - AssetCALC ID: 4320953

Uniformat Code: C2030  
Recommendation: **Repair in 2022**

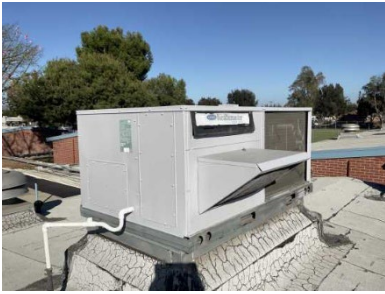
**Packaged Unit in Poor condition.**

RTU, Pad or Roof-Mounted  
Building 400 Jersey Elementary Roof

Item is passed its useful life and needs to be replaced soon. - AssetCALC ID: 4350414

Uniformat Code: D3050  
Recommendation: **Replace in 2023**

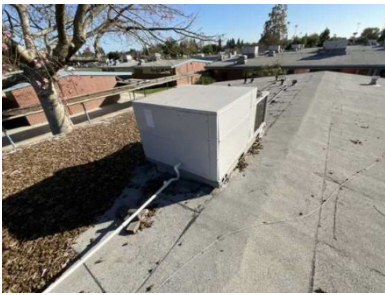
**Packaged Unit in Poor condition.**

RTU, Pad or Roof-Mounted  
Office Jersey Elementary Roof

Item is past its expected useful life and will need to be replaced soon. - AssetCALC ID: 4351214

Uniformat Code: D3050  
Recommendation: **Replace in 2024**
