FACILITY CONDITION ASSESSMENT

Cresson Elementary School
11650 Cresson Street
Norwalk, California 90650

159753.22R000-001.017

October 27, 2022

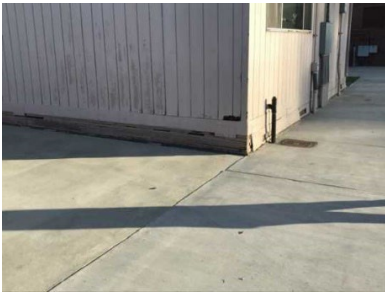
Exterior Walls in Poor condition.

Wood Siding
Site Cresson Elementary School Ancillary buildings

Deteriorated wood siding, repair is required. - AssetCALC ID: 4271276

Uniformat Code: B2010
Recommendation: **Replace in 2023**

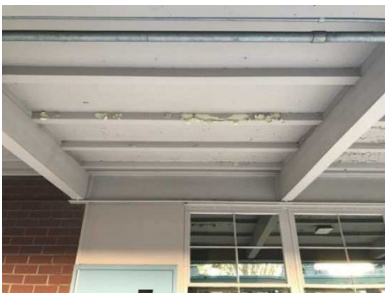
Exterior Walls in Poor condition.

any painted surface
Building-200 Cresson Elementary School
Building Exterior

New fresh paint is recommended. - AssetCALC ID: 4271119

Uniformat Code: B2010
Recommendation: **Prep & Paint in 2023**

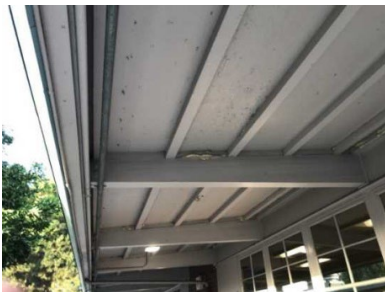
Exterior Walls in Poor condition.

any painted surface
Building-300 Cresson Elementary School
Building Exterior

New fresh paint is recommended. - AssetCALC ID: 4271159

Uniformat Code: B2010
Recommendation: **Prep & Paint in 2024**

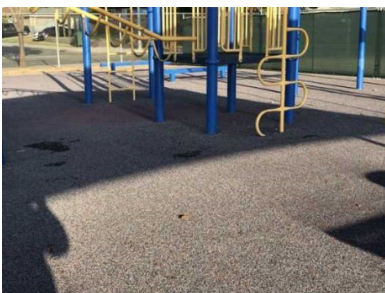
Playfield Surfaces in Poor condition.

Rubber, Small Areas
Site Cresson Elementary School Playground

Isolated area of deteriorated surface, repair is recommended. - AssetCALC ID: 4271278

Uniformat Code: G2050
Recommendation: **Replace in 2023**

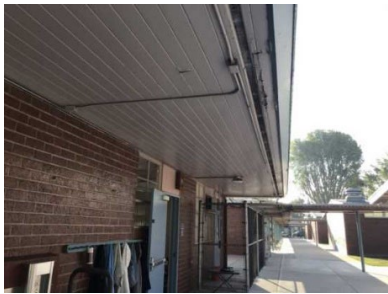
Soffit/Fascia in Poor condition.

Wood
Administration Building Cresson Elementary
School Building Exterior

Deteriorated wood façade, repair is required. - AssetCALC ID: 4271080

Uniformat Code: B3080
Recommendation: **Replace in 2022**

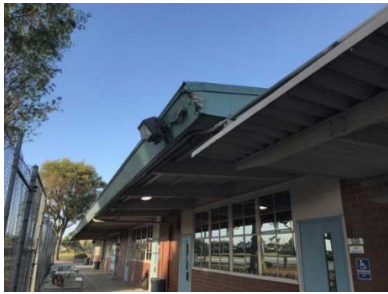
Soffit/Fascia in Poor condition.

Wood
Building-500 Cresson Elementary School
Building Exterior

Deteriorated façade, repair is required. - AssetCALC ID: 4271213

Uniformat Code: B3080
Recommendation: **Replace in 2023**

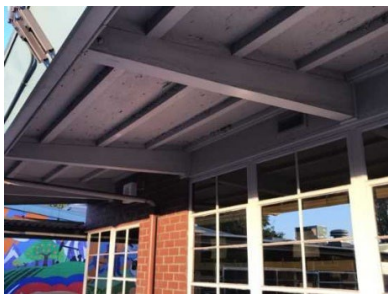
Soffit/Fascia in Poor condition.

Wood
Building-100 Cresson Elementary School
Building Exterior

Deteriorated wood façade, repair is required. - AssetCALC ID: 4271106

Uniformat Code: B3080
Recommendation: **Replace in 2023**

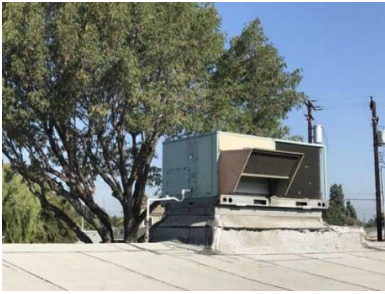
Packaged Unit in Poor condition.

Priority Score: **81.8**

The units have passed their life cycle and are not fully operational, replacement is recommended -
AssetCALC ID: 4271087

Uniformat Code: D3050
Recommendation: **Replace in 2023**

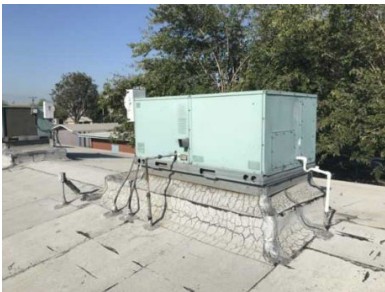
Packaged Unit in Poor condition.

Priority Score: **81.8**

The units have passed their life cycle and are not fully operational, replacement is recommended -
AssetCALC ID: 4271114

Uniformat Code: D3050
Recommendation: **Replace in 2023**

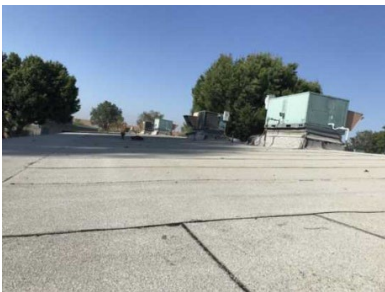
Packaged Unit in Poor condition.

Priority Score: **81.7**

The units have passed their life cycle and are not fully operational, replacement is recommended -
AssetCALC ID: 4271173

Uniformat Code: D3050
Recommendation: **Replace in 2024**

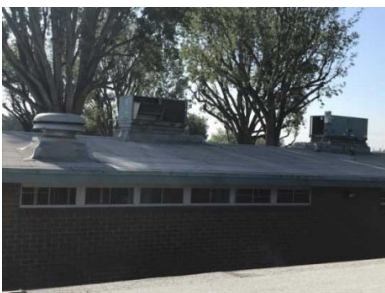
Packaged Unit in Poor condition.

Priority Score: **81.7**

The units have passed their life cycle and are not fully operational, replacement is recommended -
AssetCALC ID: 4271207

Uniformat Code: D3050
Recommendation: **Replace in 2024**

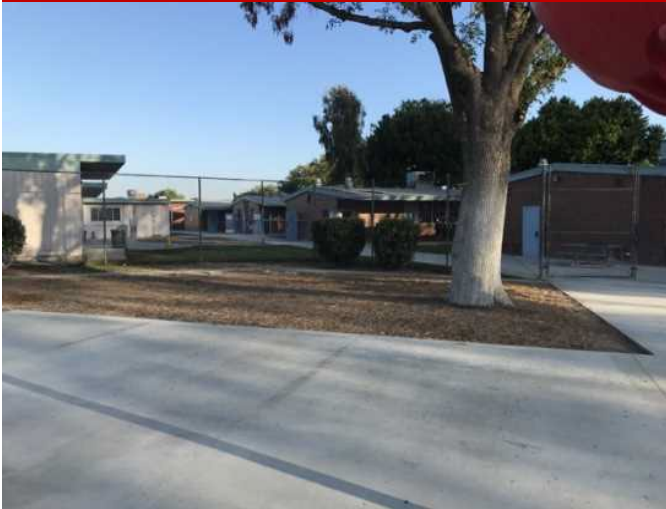
6 - DETERIORATED EXTERIOR FAÇADE
