FACILITY CONDITION ASSESSMENT

Lake Center Middle
10503 Pioneer Boulevard
Santa Fe Springs, California 90670

159753.22R000-003.017

October 13, 2022

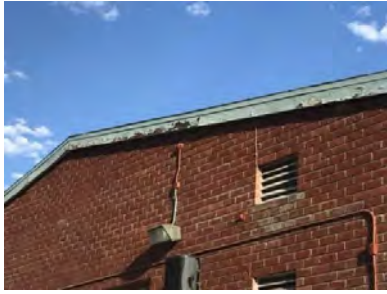
Roof Structure in Poor condition.

Pitched, Wood Heavy Timber
MPR Lake Center Middle Roof

Deteriorated façade, repair is required. - AssetCALC ID: 4270621

Uniformat Code: B1020
Recommendation: **Replace in 2023**

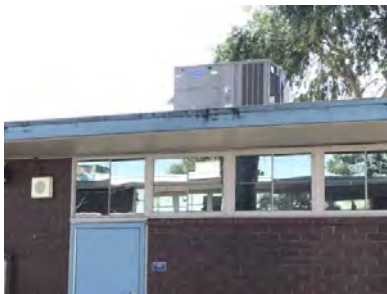
Exterior Walls in Poor condition.

Wood Siding
Building-400 Lake Center Middle Building
Exterior

Deteriorated façade, repair is required. - AssetCALC ID: 4270865

Uniformat Code: B2010
Recommendation: **Replace in 2023**

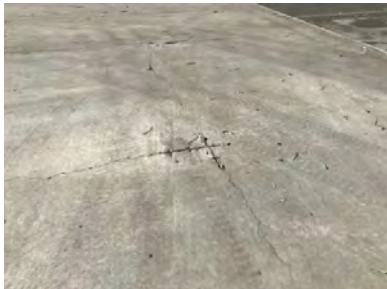
Sidewalk in Poor condition.

any pavement type, Sectional Repairs (per
Man-Day)
Site Lake Center Middle Basketball court

Cracked concrete surface throughout, repair is required. - AssetCALC ID: 4270680

Uniformat Code: G2030
Recommendation: **Repair in 2022**

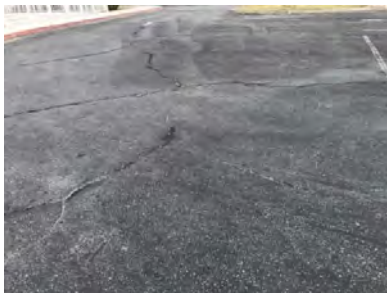
Parking Lots in Poor condition.

Pavement, Asphalt
Site Lake Center Middle Parking lot

Isolated areas of alligator asphalt surface, repair is required. - AssetCALC ID: 4270607

Uniformat Code: G2020
Recommendation: **Repair in 2022**

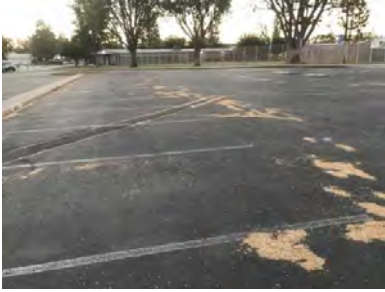
Parking Lots in Poor condition.

Pavement, Asphalt
Site Lake Center Middle Parking lot

New fresh seal and strip is required due to faded lines. - AssetCALC ID: 4270639

Uniformat Code: G2020
Recommendation: **Seal and Stripe in 2023**

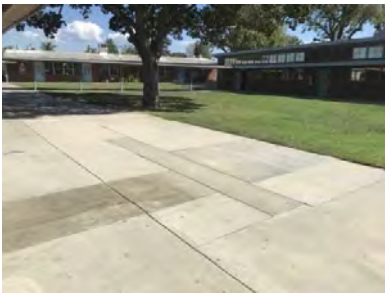
The site drainage system has been problematic. During heavy rain, an excessive water build-up was reported throughout various areas of the campus. A professional engineer must be retained to analyze the existing condition, provide recommendations and, if necessary, estimate the scope and cost of any required repairs. The cost of this study is included in the cost tables. Due to the ambiguity of the required repair scope at the time of this assessment, the cost for any possible subsequent repairs is not included.

**Recommended Follow-up Study:
Civil, Landscaping**

Civil, Landscaping
Site Lake Center Middle Site

Drainage issue was reported throughout the site. A professional consultant must be retained to analyze the existing condition, provide recommendations, - AssetCALC ID: 4270638

Uniformat Code: P2030
Recommendation: **Evaluate/Report in 2022**

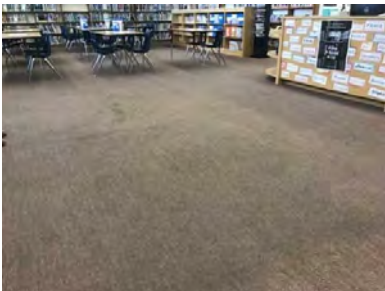
Flooring in Poor condition.

Carpet, Commercial Standard
Library Lake Center Middle Throughout building

Isolated areas of stain and deteriorated carpet, replacement is recommended - AssetCALC ID: 4271068

Uniformat Code: C2030
Recommendation: **Replace in 2023**

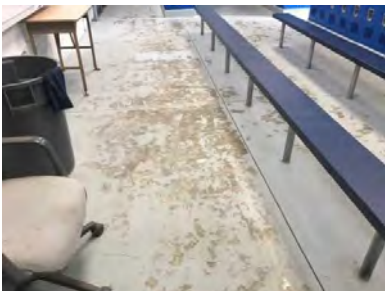
Flooring in Poor condition.

any surface, with Paint or Sealant
PE Buildings Lake Center Middle Throughout

Uniformat Code: C2030
Recommendation: **Prep and Paint in 2023**

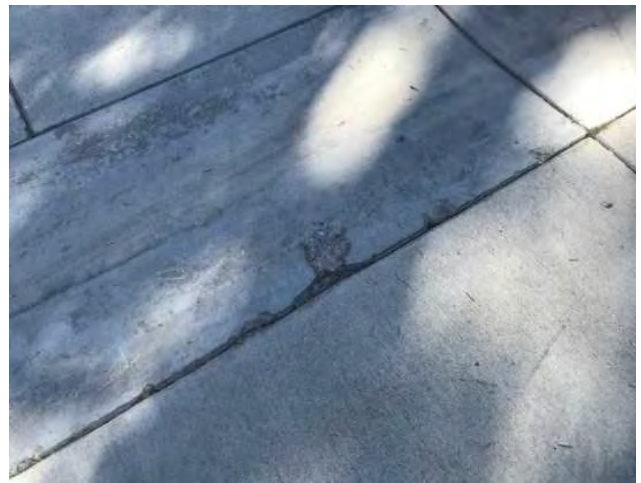
36 - DAMAGED SIDEWALK
