# FACILITY CONDITION ASSESSMENT

Lakeland Elementary  
11224 Bombardier Avenue  
Norwalk, California 90650

*159753.22R000-004.017*

*November 2, 2022*

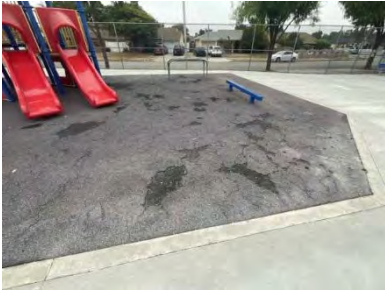
#### Playfield Surfaces in Failed condition.

Chips Rubber, 3" Depth  
Site Lakeland Elementary Site

All playground surfaces are in the same condition. Chunks of material are missing throughout playground. - AssetCALC ID: 4301411

Uniformat Code: G2050  
Recommendation: **Replace in 2022**

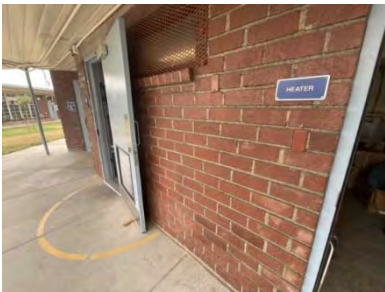
#### Exterior Walls in Poor condition.

Brick  
Building 13-14 Lakeland Elementary  
Building Exterior

Areas of mortar joints are failing at all buildings. - AssetCALC ID: 4306912

Uniformat Code: B2010  
Recommendation: **Repair in 2022**

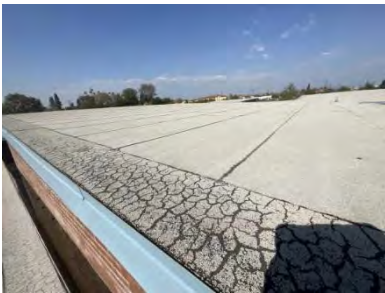
#### Roofing in Poor condition.

Built-Up  
Building 9-10 Lakeland Elementary Roof

Roof is cracking badly. Evidence of leaking roof. Needs to be replaced - AssetCALC ID: 4301544

Uniformat Code: B3010  
Recommendation: **Replace in 2023**

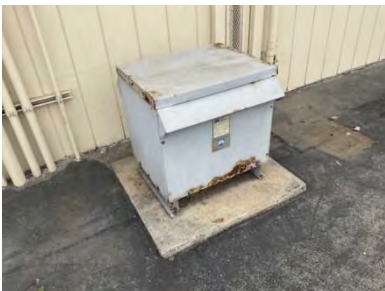
#### Secondary Transformer in Poor condition.

Dry, Stepdown  
Site Lakeland Elementary Site

Item is rusted and passed its useful life. Needs replacement soon. - AssetCALC ID: 4301412

Uniformat Code: D5020  
Recommendation: **Replace in 2023**

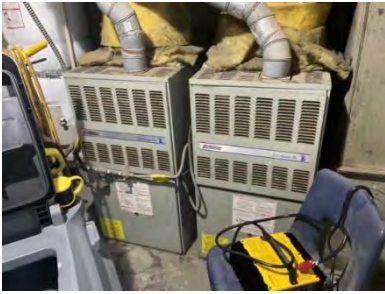
**Furnace in Poor condition.**

Gas  
Main Office Lakeland Elementary Heater room

Units are passed their useful life and will need to be replaced soon. - AssetCALC ID: 4301362

Uniformat Code: D3020  
Recommendation: **Replace in 2024**

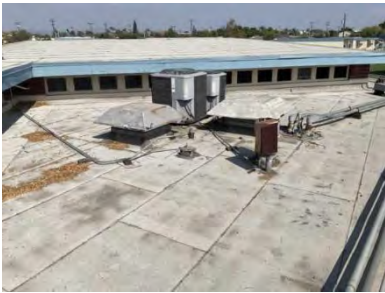
**Exhaust Fan in Poor condition.**

Centrifugal, 16" Damper  
Building 13-14 Lakeland Elementary Roof

Fans are badly rusted and beginning to deteriorate. - AssetCALC ID: 4301604

Uniformat Code: D3060  
Recommendation: **Replace in 2023**

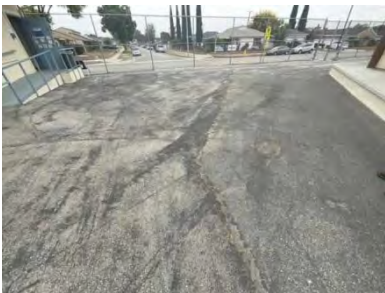
**Parking Lots in Failed condition.**

Pavement, Asphalt  
Site Lakeland Elementary Site

Pavement is torn up in most places, paint is almost completely gone. - AssetCALC ID: 4306681

Uniformat Code: G2020  
Recommendation: **Seal and Stripe in 2022**

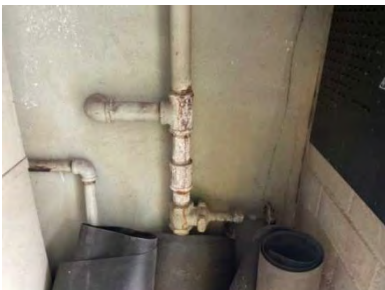
**Plumbing System in Poor condition.**

Supply and Sanitary, Low Density (excludes fixtures)  
Building 13-14 Lakeland Elementary  
Throughout building

Piping is original to the building and has begun to rust. - AssetCALC ID: 4301601

Uniformat Code: D2010  
Recommendation: **Replace in 2024**

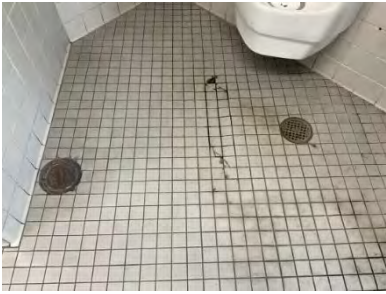
**Flooring in Failed condition.**

Ceramic Tile  
Building 9-10 Lakeland Elementary  
Restrooms

Tile has cracked and broken. Possibly exposing harmful material. - AssetCALC ID: 4301522

Uniformat Code: C2030  
Recommendation: **Replace in 2022**

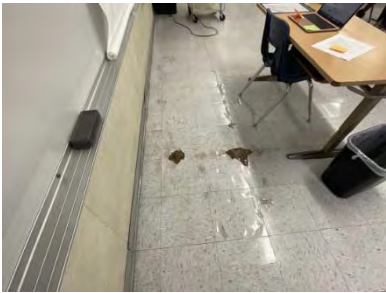
**Flooring in Failed condition.**

Vinyl Tile (VCT)  
Modular Lakeland Elementary Throughout  
building

Tile has come off the floor. Appears to have water damage. Needs immediate replacement. - AssetCALC ID: 4301640

Uniformat Code: C2030  
Recommendation: **Replace in 2022**

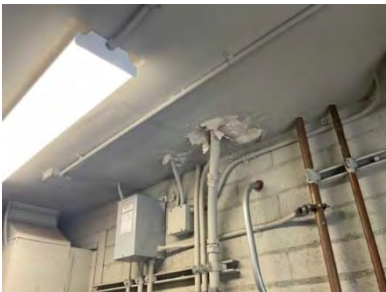
**Ceiling Finishes in Failed condition.**

Any flat surface  
Building 3-4 Lakeland Elementary  
Throughout building

Interior ceiling needs paint in the heater room. - AssetCALC ID: 4301428

Uniformat Code: C2050  
Recommendation: **Prep and Paint in 2022**

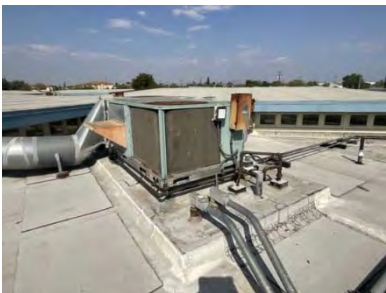
**Packaged Unit in Poor condition.**

RTU, Pad or Roof-Mounted  
Building 5-6 Lakeland Elementary Roof

The units are past their estimated useful life and are rusting. They will need to be replaced soon. - AssetCALC ID: 4301459

Uniformat Code: D3050  
Recommendation: **Replace in 2023**

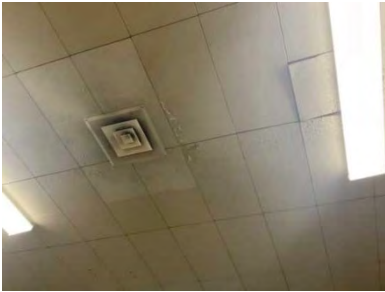
**Suspended Ceilings in Poor condition.**

Hard Tile, Replacement w/ ACT  
Main Office Lakeland Elementary  
Throughout building

Panels are deteriorating and falling apart. Replacement is necessary. - AssetCALC ID: 4301367

Uniformat Code: C1070  
Recommendation: **Replace in 2023**
