FACILITY CONDITION ASSESSMENT

Lakeside Middle School
11000 Kenney Street
Norwalk, California 90650

159753.22R000-005.017

October 14, 2022

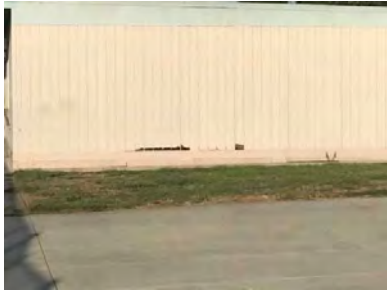
Exterior Walls in Poor condition.

Wood Siding
Site Lakeside Middle Site-Ancillary Building

Isolated areas of deteriorated wood siding, repair is required. - AssetCALC ID: 4268596

Uniformat Code: B2010
Recommendation: **Replace in 2023**

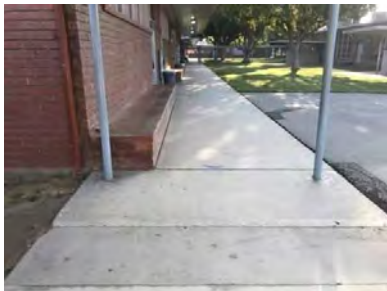
Sidewalk in Poor condition.

Any pavement type, Sectional Repairs
(per Man-Day)
Site Lakeside Middle Sidewalk

Isolated areas of concrete sidewalk cracks, repair is required. - AssetCALC ID: 4268590

Uniformat Code: G2030
Recommendation: **Repair in 2022**

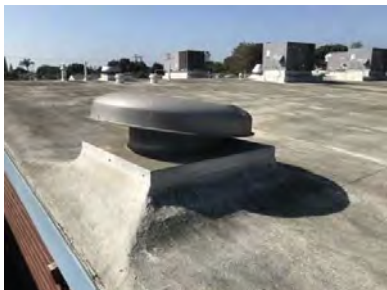
Exhaust Fan in Poor condition.

Roof or Wall-Mounted, 16" Damper, 1001
to 2000 CFM
Building-500 Lakeside Middle Roof

The units are not fully operational and damaged, replacement is recommended. - AssetCALC ID: 4268471

Uniformat Code: D3060
Recommendation: **Replace in 2023**

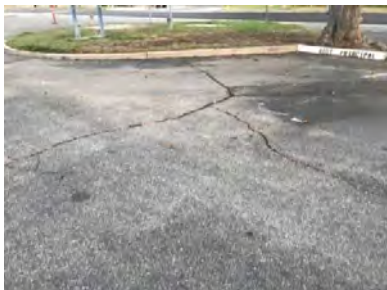
Parking Lots in Poor condition.

Pavement, Asphalt
Site Lakeside Middle Parking lot

Isolated areas of alligator asphalt surface, repair is required. - AssetCALC ID: 4268591

Uniformat Code: G2020
Recommendation: **Repair in 2022**

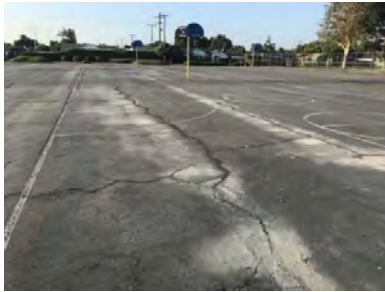
Athletic Surfaces and Courts in Poor condition.

Basketball/General, Asphalt Pavement
Site Lakeside Middle Basketball court

New fresh strip and seal is recommended. - AssetCALC ID: 4268598

Recommendation: **Seal and Stripe in 2023**

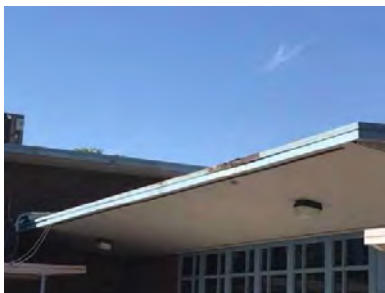
Soffit/Fascia in Poor condition.

Wood
MPR Lakeside Middle Building exterior

The exterior wood fascia is deteriorated, repair is required. - AssetCALC ID: 4268311

Recommendation: **Replace in 2023**

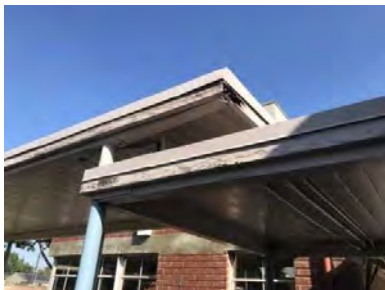
Soffit/Fascia in Poor condition.

Wood
Site Lakeside Middle Walkway

Isolated areas of deteriorated wood fascia, repair is required. - AssetCALC ID: 4268597

Recommendation: **Replace in 2023**

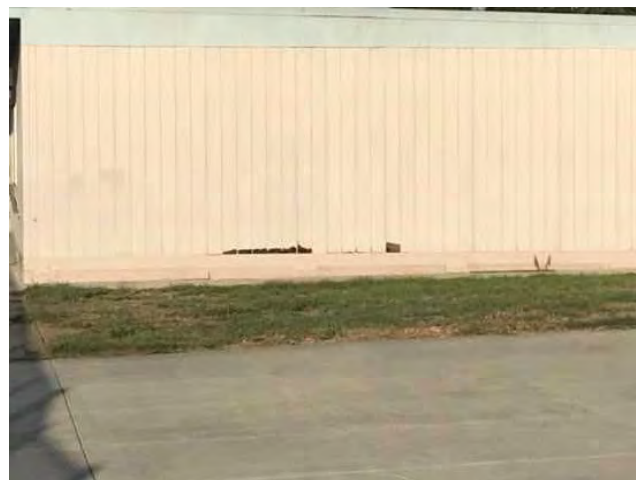
6 - DETERIORATED ANCILLARY EXTERIOR WALL
