FACILITY CONDITION ASSESSMENT

DLR GROUP

October 26, 2022

Paddison Elementary School
12100 Crewe Street
Norwalk, California 90650

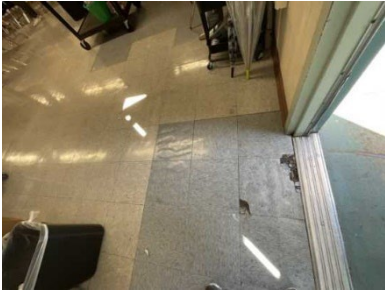
Flooring in Poor condition.

Vinyl Tile (VCT)
 Building 801 Paddison Elementary P801
 Throughout Building

Damaged - AssetCALC ID: 4271314

Uniformat Code: C2030
 Recommendation: **Replace in 2024**

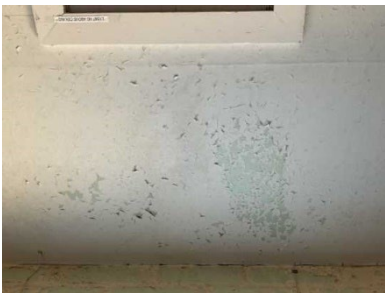
Ceiling Finishes in Poor condition.

any flat surface
 Building 600 Paddison Elementary Building 600
 Restroom

Uniformat Code: C2050
 Recommendation: **Prep & Paint in 2024**
