FACILITY CONDITION ASSESSMENT

Studebaker Elementary School
11800 Halcourt Avenue
Norwalk, California 90650

159753.22R000-008.017

October 27, 2022

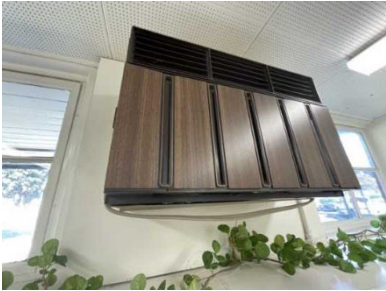
Air Conditioner in Failed condition.

Window/Thru-Wall
Office Studebaker Elementary Office
Throughout

Not functional - AssetCALC ID: 4278496

Uniformat Code: D3030
Recommendation: **Replace in 2022**

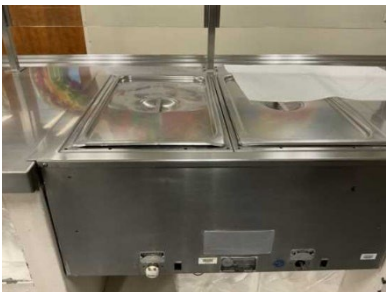
Foodservice Equipment in Poor condition.

Food Warmer, Proofing Cabinet on Wheels
MPR (Multipurpose Room) Studebaker
Elementary Kitchen

1 isn't functional - AssetCALC ID: 4278689

Uniformat Code: E1030
Recommendation: **Replace in 2023**

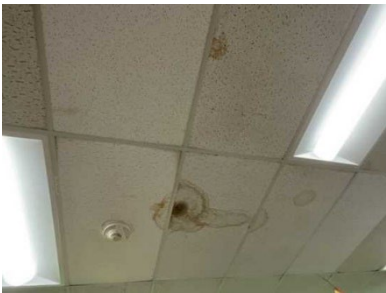
Suspended Ceilings in Poor condition.

Acoustical Tile (ACT)
Building 500 Studebaker Elementary 500
Throughout

water damaged - AssetCALC ID: 4278740

Uniformat Code: C1070
Recommendation: **Replace in 2024**
