FACILITY CONDITION ASSESSMENT

DLR Group

Administration
10515 South Pioneer Boulevard
Santa Fe Springs, California 90670

October 7, 2022

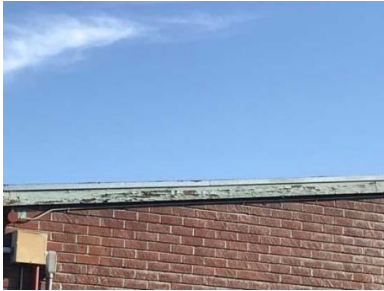
Structural Flooring/Decking in Poor condition.

Wood
Administration Building Administration Building
Exterior

Isolated areas of deteriorated wood façade, repair is required. - AssetCALC ID: 4257825

Recommendation: **Repair in 2022**

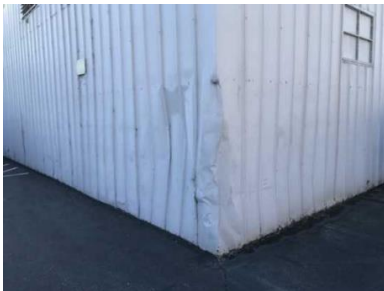
Exterior Walls in Poor condition.

Insulated Finishing System (EIFS)
Maintenance Warehouse Administration
Building exterior

Isolated areas of exterior wall metal dents, repair is required. - AssetCALC ID: 4257840

Recommendation: **Repair in 2022**

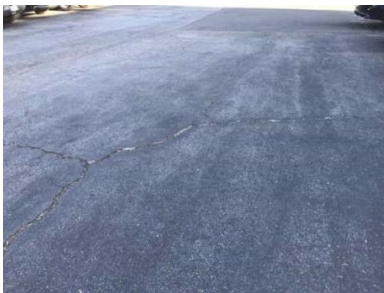
Parking Lots in Poor condition.

Pavement, Asphalt
Site Administration Parking lot

Isolated areas of alligator asphalt surface, repair is required. - AssetCALC ID: 4257856

Recommendation: **Repair in 2022**

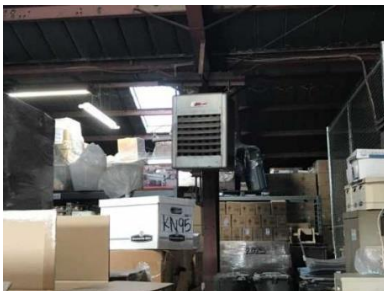
Unit Heater in Failed condition.

Natural Gas
Maintenance Warehouse Administration
Warehouse

Unit is not operational, replacement is required. - AssetCALC ID: 4257810

Recommendation: **Replace in 2022**

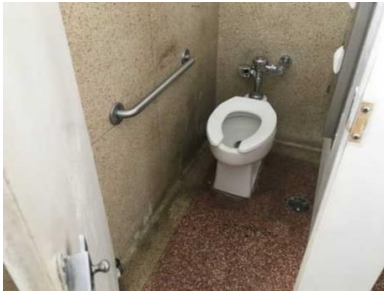
ADA Miscellaneous

Level III Study, Includes Measurements
Administration Building Administration
Restrooms

Restrooms are not ADA accessible. Bureau Veritas recommends a study be performed to take measurements, provide additional itemized details, research local requirements, and, if necessary, estimate the scope and cost of any required improvements. - AssetCALC ID: 4257836

Unifomat Code: Y1090
Recommendation: **Evaluate/Report in 2022**

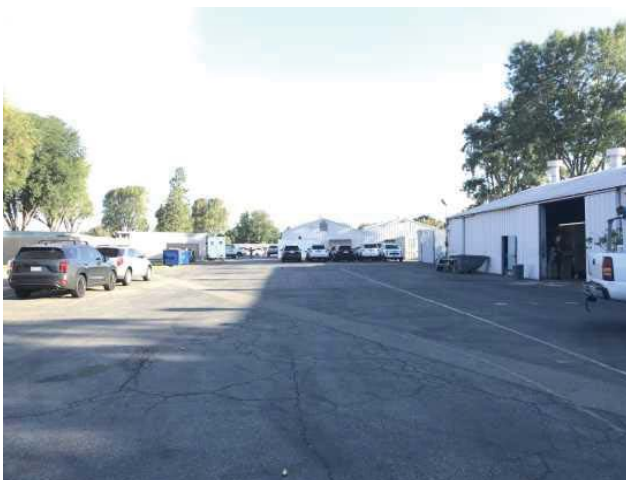
17 - PARKING LOTS

<i>System</i>	<i>Description</i>	<i>Condition</i>
Pavement/Flatwork	Asphalt lots with limited areas of concrete aprons and pavement and adjacent concrete sidewalks, and curbs	Poor
Site Development	No signage; chain link fencing	Fair
Landscaping and Topography	Limited landscaping features including lawns, trees, and bushes Irrigation present No retaining walls Low to moderate site slopes throughout	Fair
Utilities	Municipal water and sewer Local utility-provided electric and natural gas	Good
Site Lighting	Pole-mounted: None Building-mounted: Incandescent	Fair
Ancillary Structures	None	--
Accessibility	Presently it does not appear an accessibility study is needed for the exterior site areas. See Appendix D.	
Key Issues and Findings	Severe alligator cracking and potholes
