**WALL TOWNSHIP GABION WALL PROTECTION  
MONMOUTH COUNTY, NEW JERSEY, U.S.A.**

Reinforced Soil Walls and Slope Reinforcement

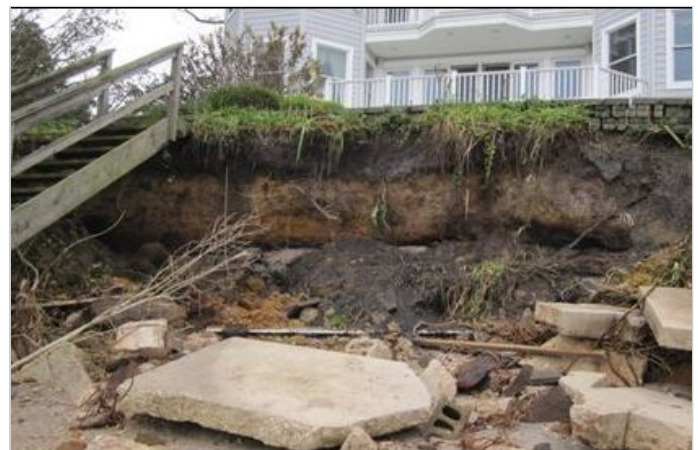
Damage and destruction done by Sandy to the existing concrete retaining wall along the rear of the homeowners property. With the failure of that retaining wall a portion of the backyard was lost and exposed to further erosion with any future storm events.

Damage caused by Sandy in October 2012

Gabions were installed from the beach elevation up to the yard elevation. The wall is 13' high with 3' buried at the bottom to act as a scour protection so that the wall can't be undermined by tides, future storm events etc.... so the wall has an exposed height of 10'. So the solution solved the problem of protecting the homeowners property as well as reestablishing the yard and giving the homeowner a flat backyard area again. The first step in the project was to clear the debris consisting of broken concrete from the patio area which collapsed due to the slope failure as well as drift wood and other debris brought in by the storm surge. The removal of this material from the slope failure was performed using an excavator. With the in-situ material mainly consisted of sand, the compaction of each level was necessary to maintain the strength of the back fill and enable each layer to have a strong base in which to build. Once cleared, the base of the gabion wall was installed with an 8oz. non-woven geotextile attached to the back of the wire basket. The new structure was installed approximately 40' from the back of the home. The only other stabilization measures done in the past were plantings placed along the slope to try and stabilize the soil/sand material. This failed due to undermining of the slope due to the surge and wave action at the base of the slope.

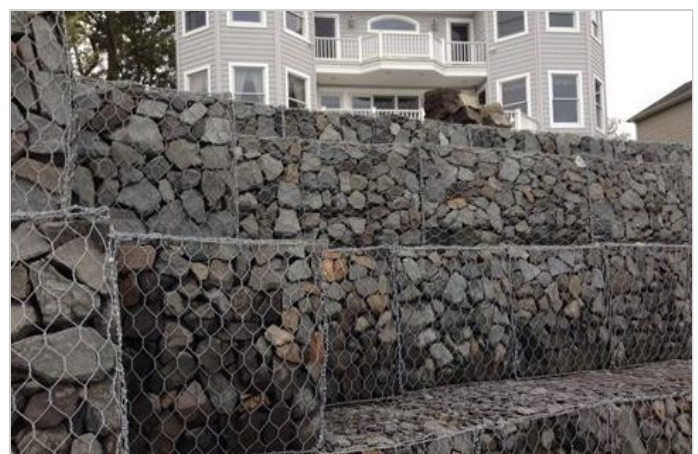
View of return wall

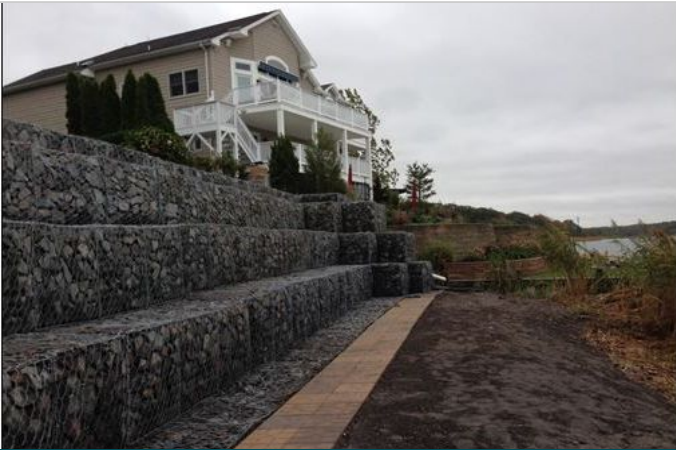
Post installation- completed wall

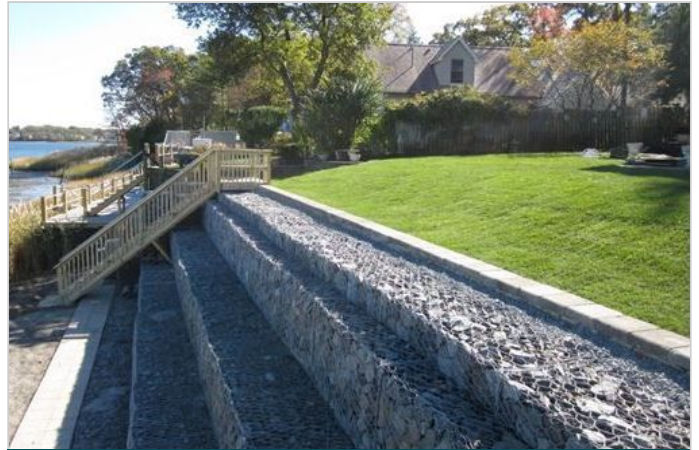
View of completed project approximately 1 year after installation.
