FACILITY CONDITION ASSESSMENT

Manhattan Beach USD
325 South Peck Avenue
Manhattan Beach, California 90266

Meadows Elementary School
1200 North Meadows Avenue
Manhattan Beach, CA 90266

June 13, 2024

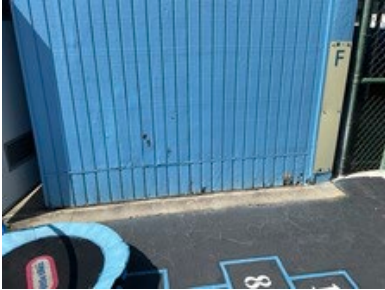
Exterior Walls in Poor condition.

Plywood/OSB
Classroom 1-2 Meadows Elementary School
Building Exterior

Rotting noted at lower siding. - AssetCALC ID: 7505978

Unifomat Code: B2010
Recommendation: **Replace in 2026**

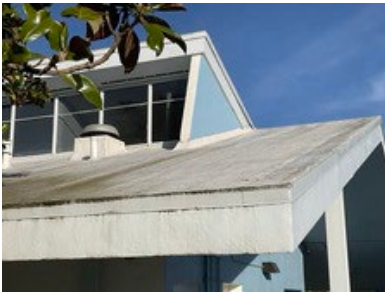
Roofing in Poor condition.

Modified Bitumen
Building B Meadows Elementary School Roof

Pasts its EUL - AssetCALC ID: 7505839

Unifomat Code: B3010
Recommendation: **Replace in 2026**

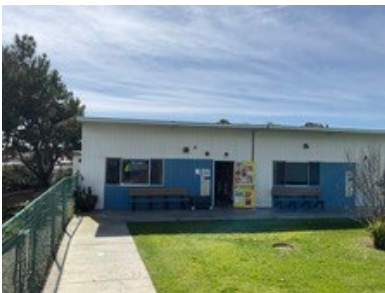
Roofing in Poor condition.

Modified Bitumen
Building J Meadows Elementary School Roof

Leaking noted during heavy rain. - AssetCALC ID: 7505965

Unifomat Code: B3010
Recommendation: **Replace in 2026**

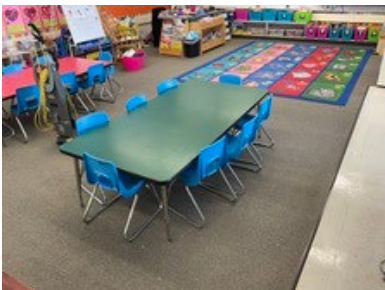
Flooring in Poor condition.

Carpet, Commercial Standard
Classroom 1-2 Meadows Elementary School
Classrooms

Warped and loose - AssetCALC ID: 7505984

Unifomat Code: C2030
Recommendation: **Replace in 2026**

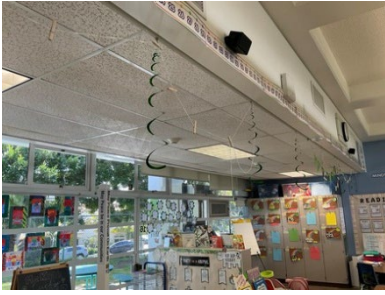
Suspended Ceilings in Poor condition.

Fiberglass Paneling
Classroom 16-21 Meadows Elementary School
Classrooms

Tiles are falling from the ceiling. - AssetCALC ID: 7505938

Unifomat Code: C1070
Recommendation: **Replace in 2026**

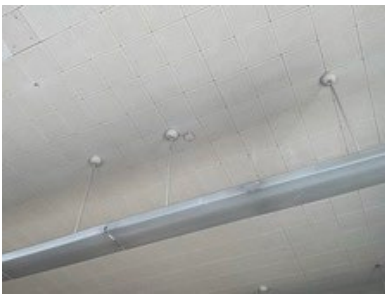
Suspended Ceilings in Poor condition.

Fiberglass Paneling
Building A (Cafeteria) Meadows Elementary
School Throughout building

Unifomat Code: C1070
Recommendation: **Replace in 2026**

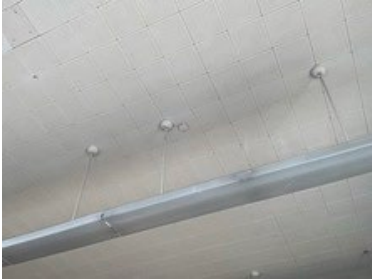
Suspended Ceilings in Poor condition.

Fiberglass Paneling
Cafeteria
Throughout building

Unifomat Code: C1070
Recommendation: **Replace in 2026**

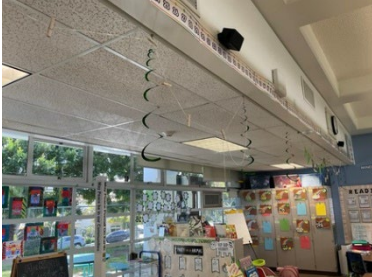
Suspended Ceilings in Poor condition.

Fiberglass Paneling
Classroom 16-21
Classrooms

Unifomat Code: C1070
Recommendation: **Replace in 2029**

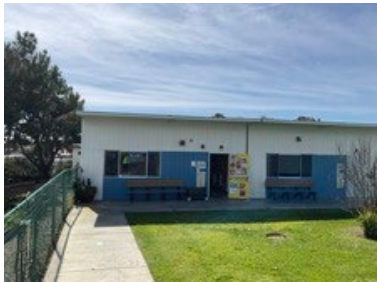
<p>Roofing in Poor condition.</p> <p>Modified Bitumen Classroom 22-24 Roof</p> <p>Uniformat Code: B3010 Recommendation: Replace in 2026</p>	<p>Plan Type: Performance/Integrity</p> <p>Cost Estimate: \$56,400</p>
<p>Leaking noted during heavy rain. - AssetCALC ID: 7505965</p>
