FACILITY CONDITION ASSESSMENT

Manhattan Beach USD
325 South Peck Avenue
Manhattan Beach, CA 90266

Grand View Elementary School
455 24th Street
Manhattan Beach, CA 90266

June 14, 2024

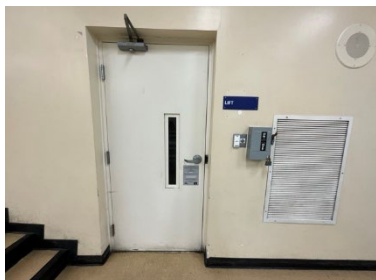
ADA Elevators

Wheelchair Lift, Up to One Floor
Building C
Throughout Building

Uniformat Code: Y1040
Recommendation: **Install in 2024**

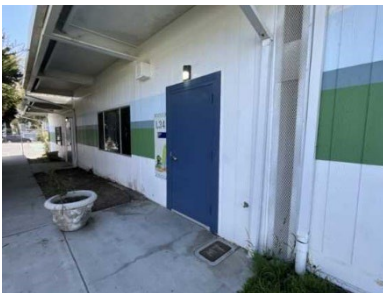
Exterior Walls in Poor condition.

Chipped and peeling - AssetCALC ID: 7471279

Unifomat Code: B2010
Recommendation: **Prep & Paint in 2025**

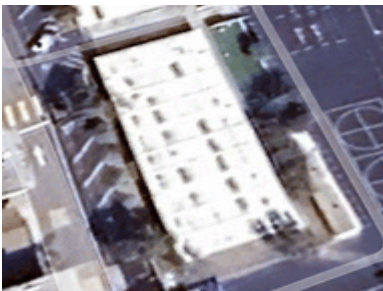
Roofing in Poor condition.

Past its EUL - AssetCALC ID: 7471284

Unifomat Code: B3010
Recommendation: **Replace in 2026**

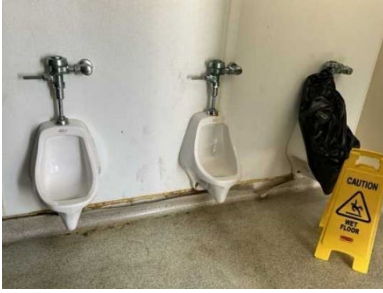
Urinal in Failed condition.

The urinal is out of service. - AssetCALC ID: 7471278

Uniformat Code: D2010
Recommendation: **Replace in 2024**

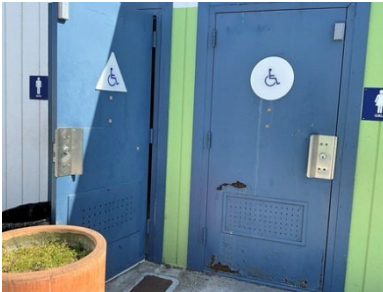
Exterior Door in Poor condition.

The restroom doors are rusted and in need of replacement. - AssetCALC ID: 7473120

Uniformat Code: B2050
Recommendation: **Replace in 2025**

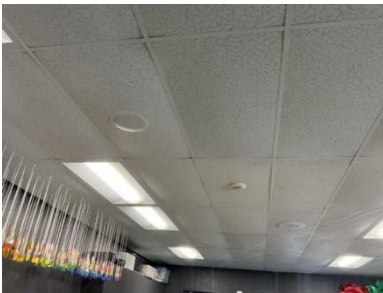
Suspended Ceilings in Poor condition.

Sagging throughout - AssetCALC ID: 7471262

Uniformat Code: C1070
Recommendation: **Replace in 2025**

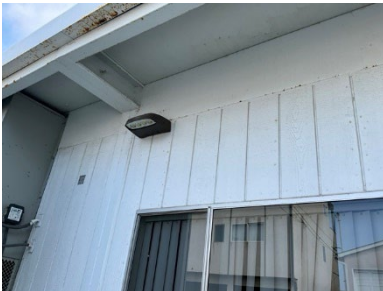
Roof Appurtenances in Poor condition.

The gutters and downspouts have deteriorated due to rust and breakage, thus necessitating their replacement. - AssetCALC ID: 7473113

Uniformat Code: B3020
Recommendation: **Replace in 2026**

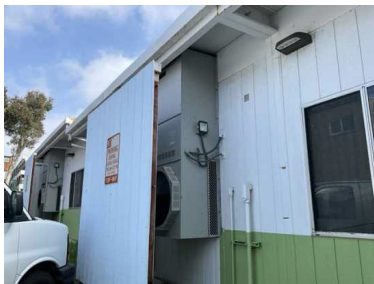
Roof Appurtenances in Poor condition.

The gutters and downspouts have deteriorated due to rust and breakage, thus necessitating their replacement. - AssetCALC ID: 7473093

Uniformat Code: B3020
Recommendation: **Replace in 2024**

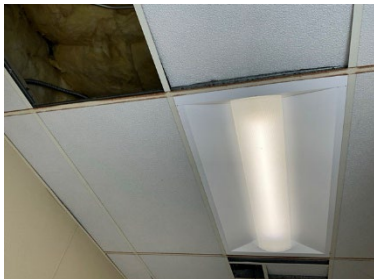
Suspended Ceilings in Poor condition.

The acoustic ceiling tiles are damaged or missing, and replacement is recommended. - AssetCALC ID: 7473089

Uniformat Code: C1070
Recommendation: **Replace in 2024**

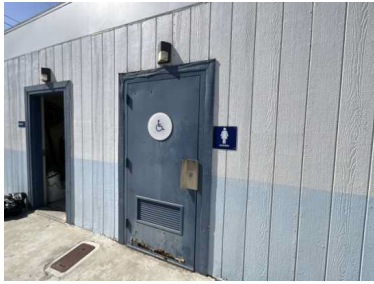
Exterior Door in Poor condition.

The restroom doors are rusted and in need of replacement. - AssetCALC ID: 7471239

Unifomat Code: B2050
Recommendation: **Replace in 2024**

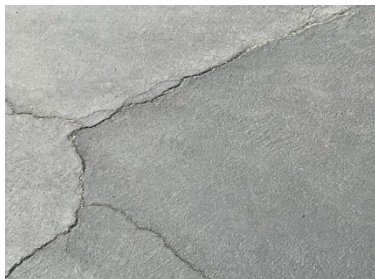
Athletic Surfaces & Courts in Poor condition.

Sport Field / General, Asphalt Pavement
Site
Sport Field Between building A,B and C

Some areas on the asphalt pavement between buildings C, B, and A pose a potential hazard due to significant signs of deterioration, including alligator cracking, transverse cracking, extensive raveling, and localized

Unifomat Code: G2050
Recommendation: **Mill & Overlay in 2024**

depressions. To address these issues effectively, it is strongly recommended to conduct a comprehensive milling and overlay of the entire lot. - AssetCALC ID: 7472451

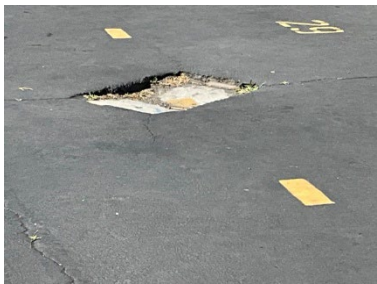
Athletic Surfaces & Courts in Poor condition.

Some areas on the asphalt pavement between buildings C, B, and A pose a potential hazard due to significant signs of deterioration, including alligator cracking, transverse cracking, extensive raveling, and localized depressions. - AssetCALC ID: 7472497

Uniformat Code: G2050
Recommendation: **Seal & Stripe in 2024**

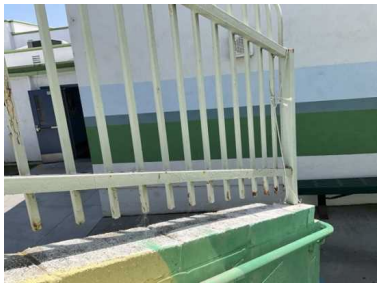
Fences & Gates in Poor condition.

The fences are corroded and at the end of their lifespan. - AssetCALC ID: 7471374

Uniformat Code: G2060
Recommendation: **Replace in 2024**
