Electromagnet Performance

Models Affected: All Magnet Equipped Battery Extractors

Tech Tip
TT-910

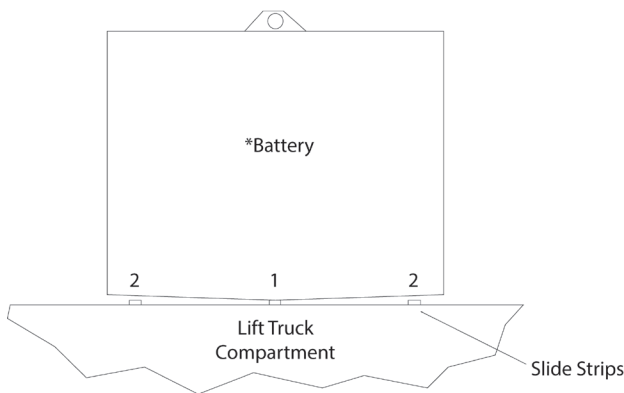
- a. **Slide Strips:** The most common impact on magnet performance when using slide strips is the number of slides in the compartment. All lift truck batteries have a natural “crown” to the bottom of the battery cases. When trucks are equipped with (3) slide strips, the majority of the battery weight rests on the center slide strip. This concentration of weight along

with a battery bouncing around for an entire work shift, causes the slide strip to cold-flow or conform to the irregularities of the bottom of the battery case. When this occurs, an excessive amount of force is necessary to start battery movement to overcome the increased friction between the battery case and the slide strip.

1. High loading in center slide strip
2. Minimal loading on outer slide strips

Corrective Action: In some instances, the center slide strip can be removed to allow for even distribution of the battery weight on the two remaining slide strips. Check with the lift truck manufacturer prior to performing any modifications to the lift truck.
