Battery Extractor Magnet Shaft Tensioners

Models Affected: Operator Aboard Battery Extractors with Shaft Mounted Magnets

Tech Tip
TT-949

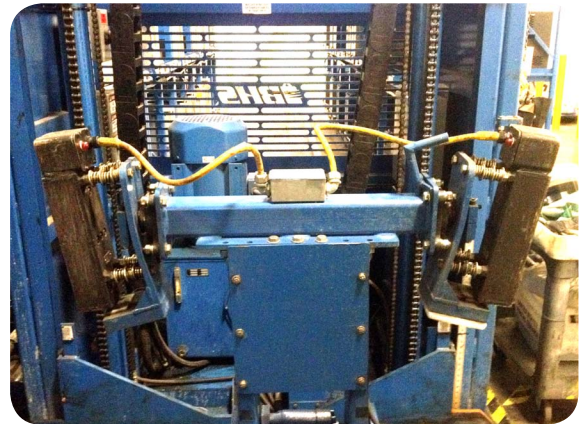
BE units built prior to 2012 utilized a swivel head type set screw and locking nut as the shaft tensioning screws. Since 2012, standard 3/8" x 2" set screws with locking nuts have been used instead. Regardless of the hardware used, the shaft tensioning screws must be kept tight to avoid damage to the magnet mount and components. If the shaft tensioning screws become loose, the magnet assemblies will lean forward. With the magnet assemblies not contacting the batteries squarely, the mounting hardware can be damaged or the mounting bolts can grind against the mounting holes causing deformation / elongation. Damage such as broken proximity switch covers could also occur to the magnet assembly itself.

Loose shaft tensioners allow magnet mounts to hang forward

Ensuring the shaft tensioning screws are properly tightened should be part of a daily or pre shift inspection. Loose tensioners should be tightened immediately to maintain proper magnet orientation, and broken or missing tensioners should be replaced.

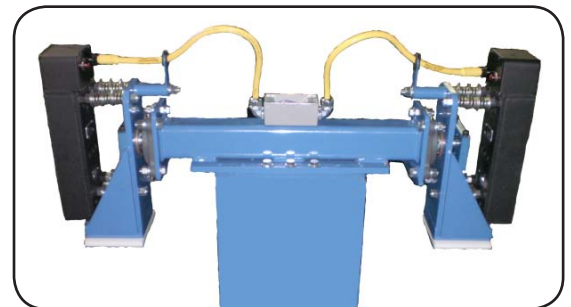
Properly tightened shaft tensioners hold magnet mounts upright
