Wittner Inspection Services

PROPERTY INSPECTION REPORT FORM

John Doe <i>Name of Client</i>	09/17/2024 <i>Date of Inspection</i>
12345 Anywhere Ct, Anytown, TX 77777 <i>Address of Inspected Property</i>	
Dauson Wittner <i>Name of Inspector</i>	TREC# 24364 <i>TREC License #</i>
<i>Name of Sponsor (if applicable)</i>	<i>TREC License #</i>

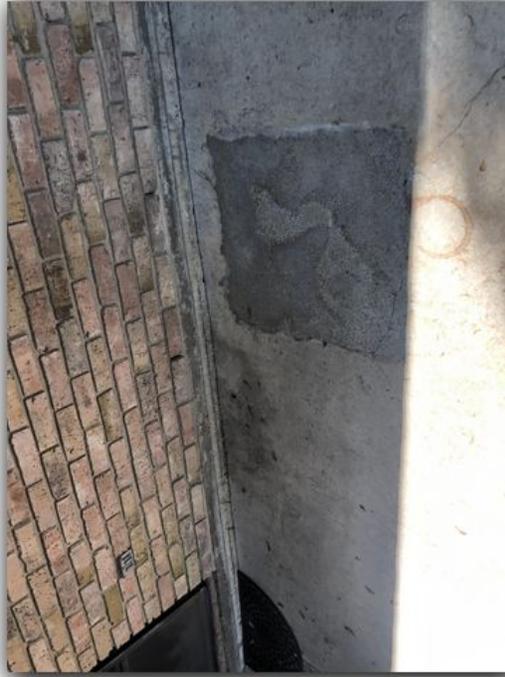
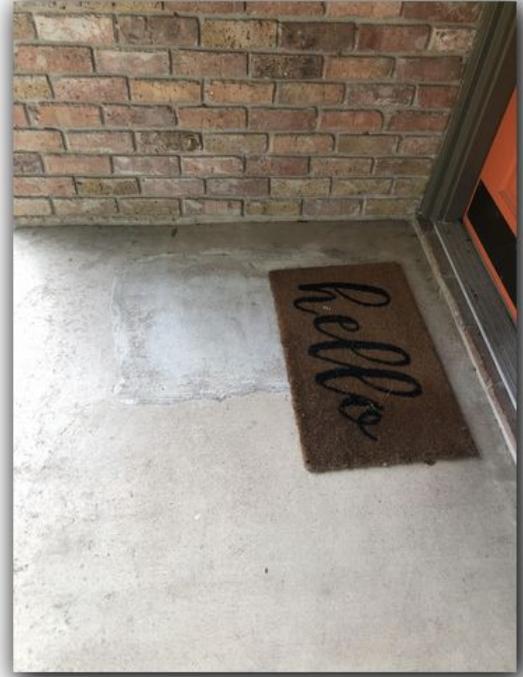
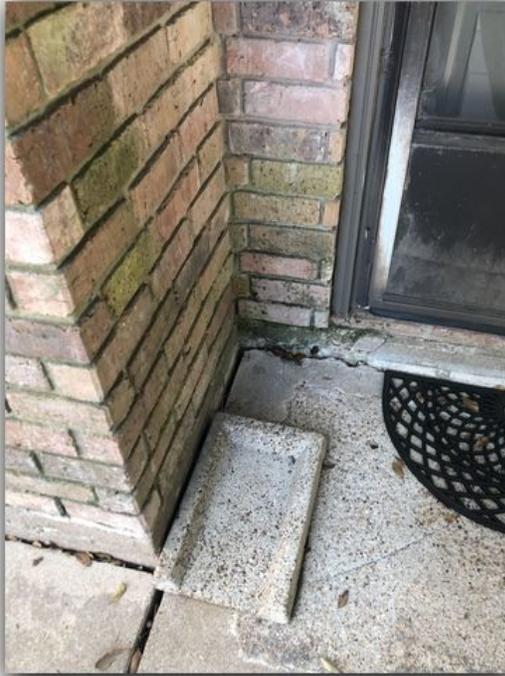
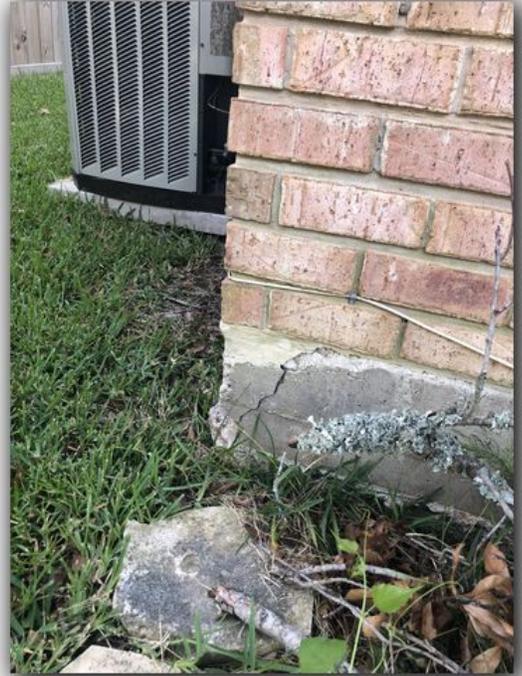
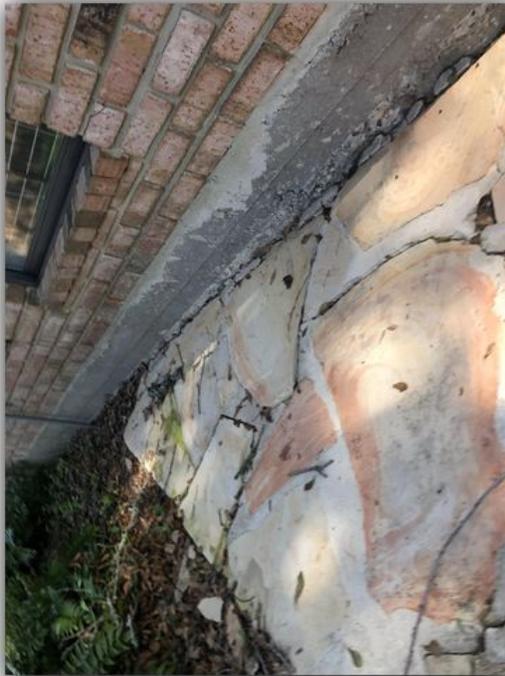
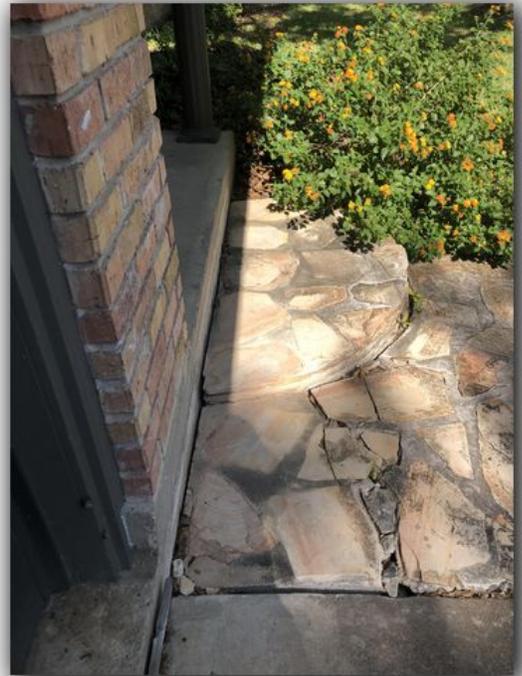
A. Foundations

Comments: Signs of previous foundation repair. Corner pops and cracks around the foundation. High step from grading to slab foundation onto front entryway. Recommend having the foundation evaluated by a qualified engineer.

Would recommend having the foundation evaluated by an engineer because of the observed cracking on the exterior and interior walls around the windows and doors. Foundation shows signs of previous repairs. The cracks could be from before the repair was made and was not properly repaired or the foundation continued to move and caused the cracks that was observed.

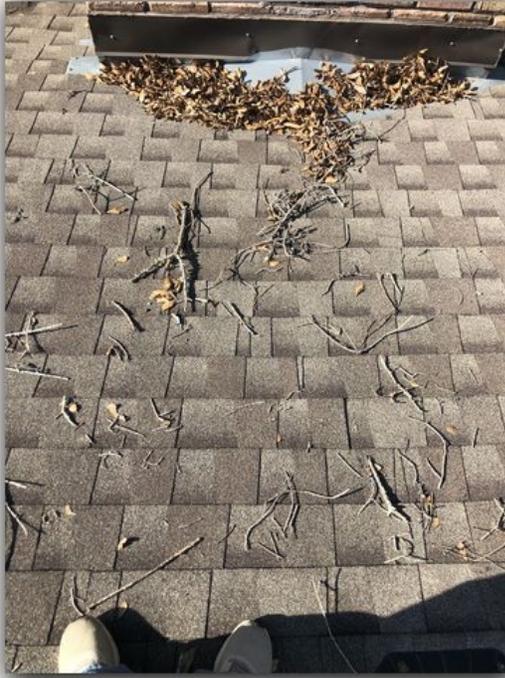
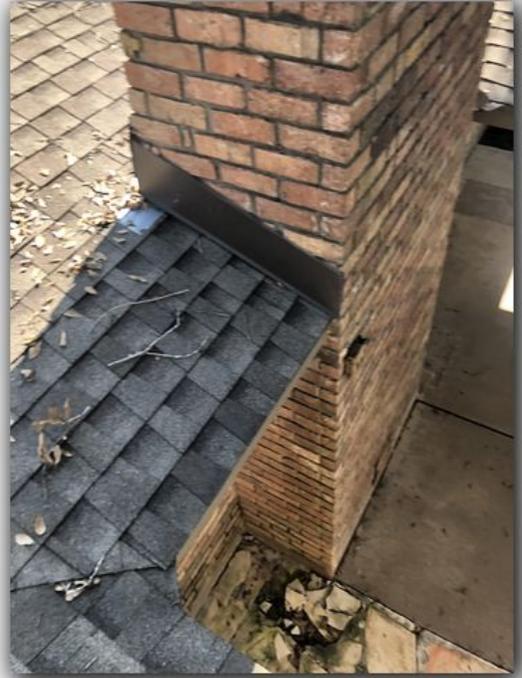
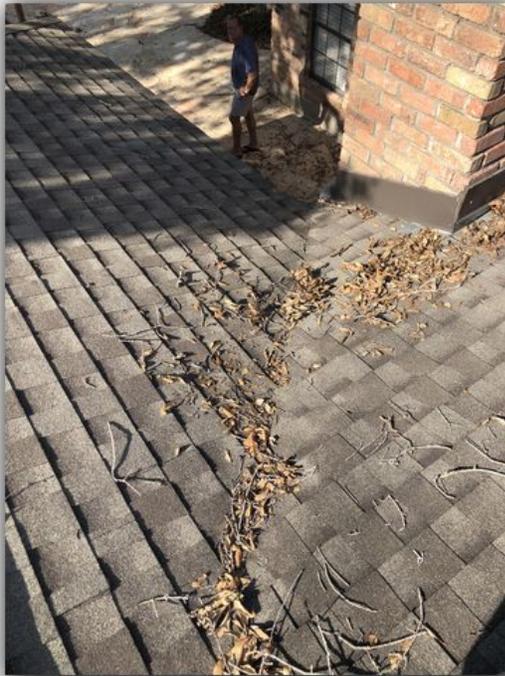
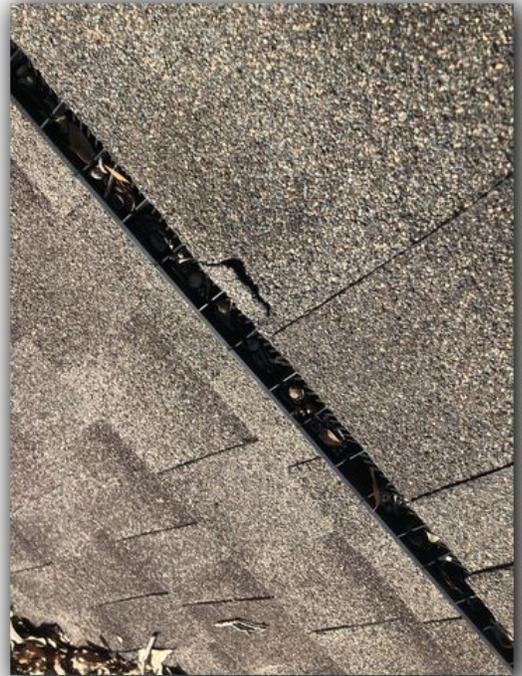
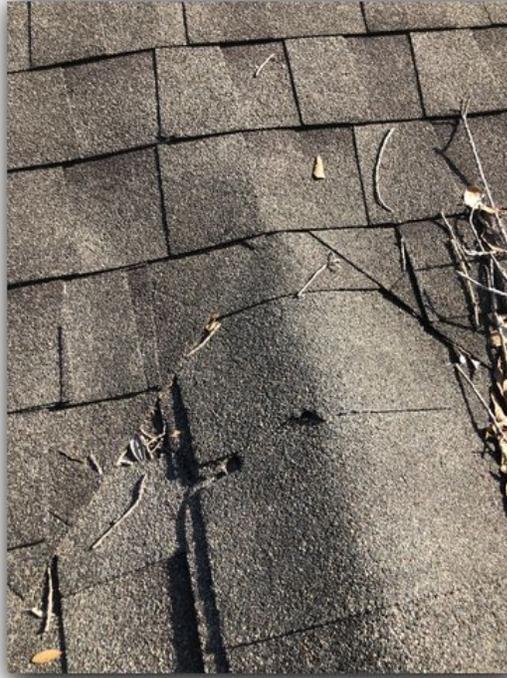
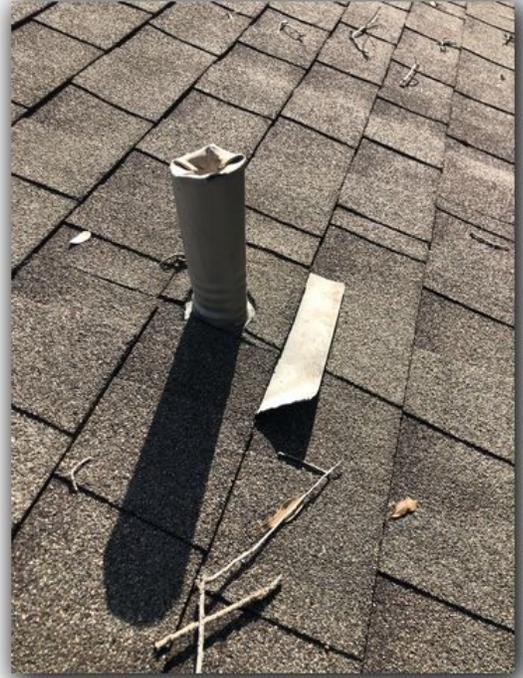
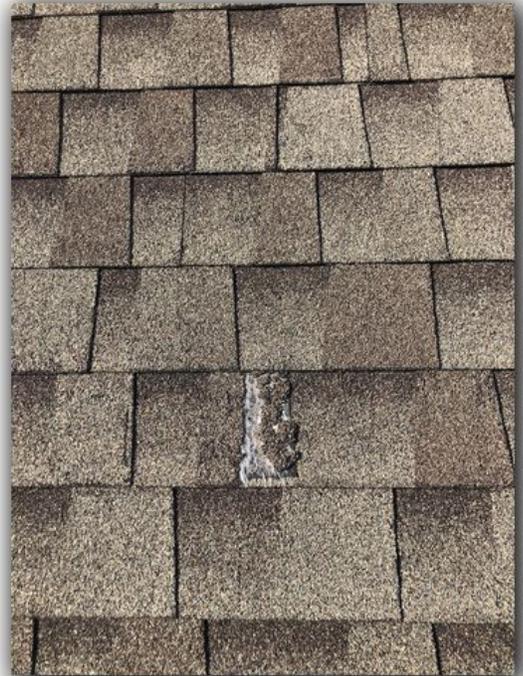
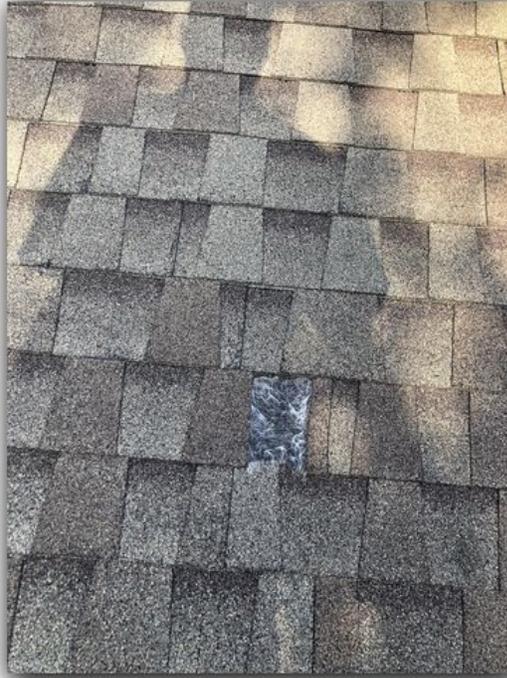
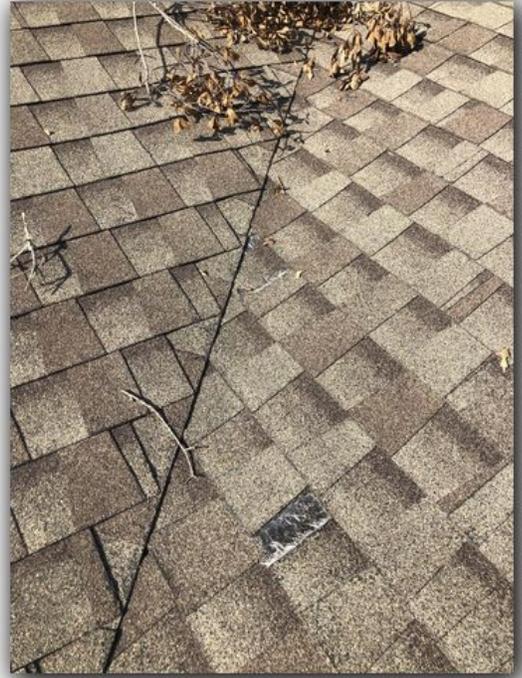
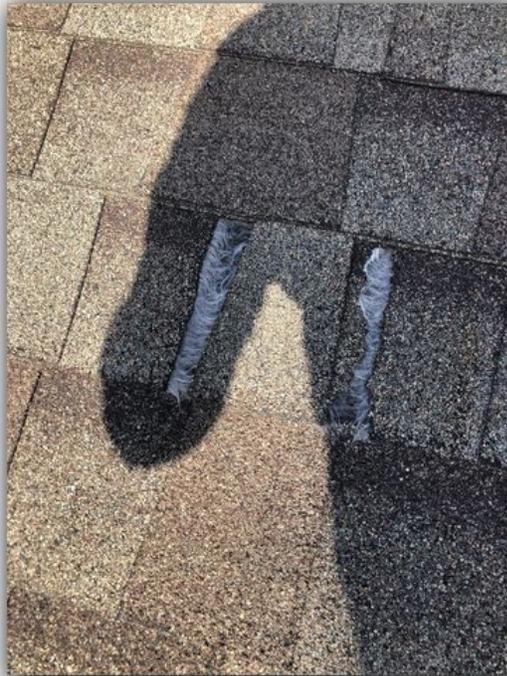
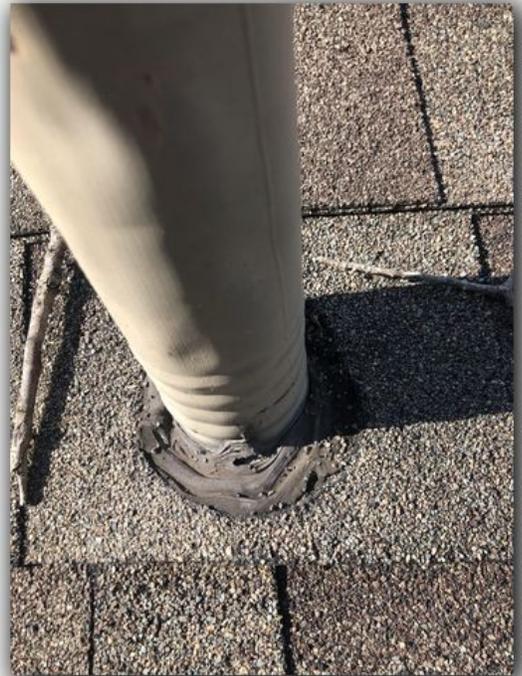
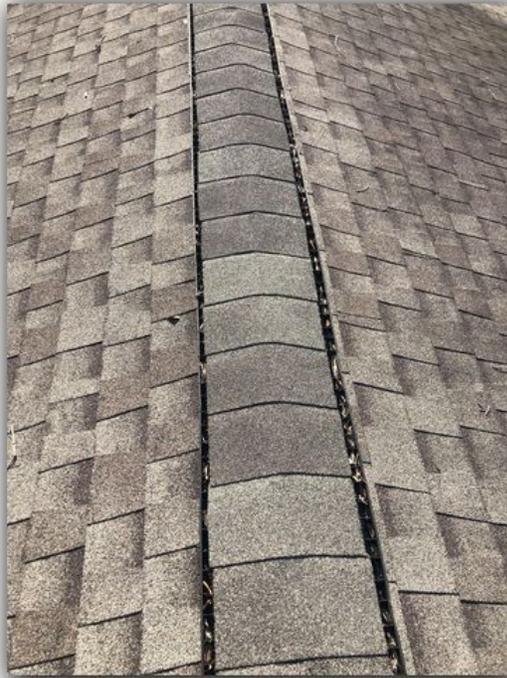
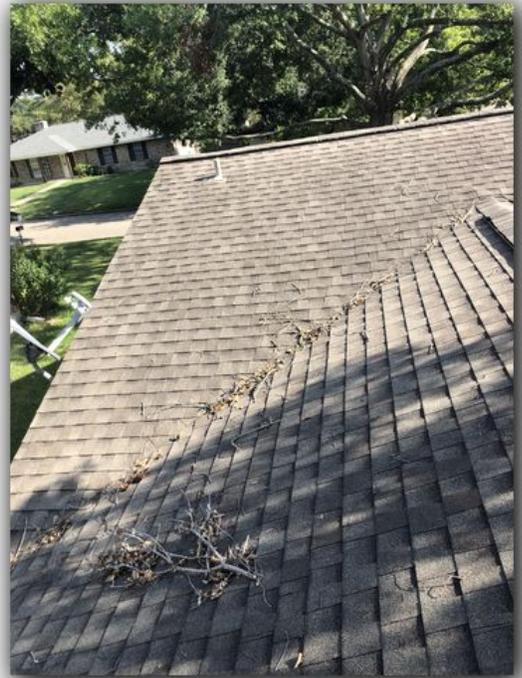
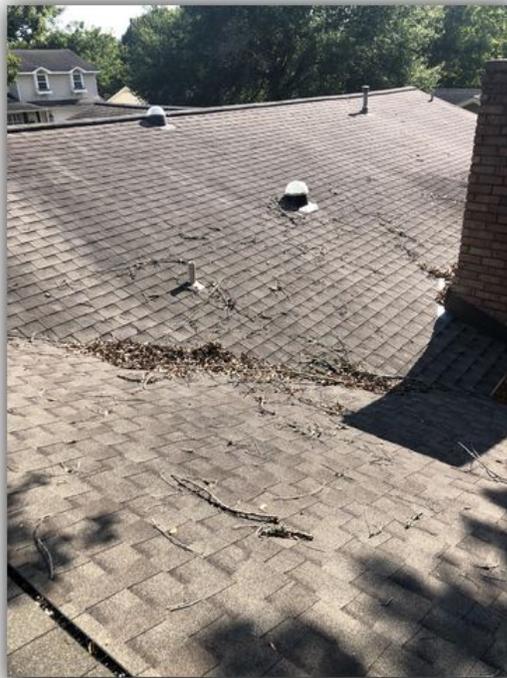
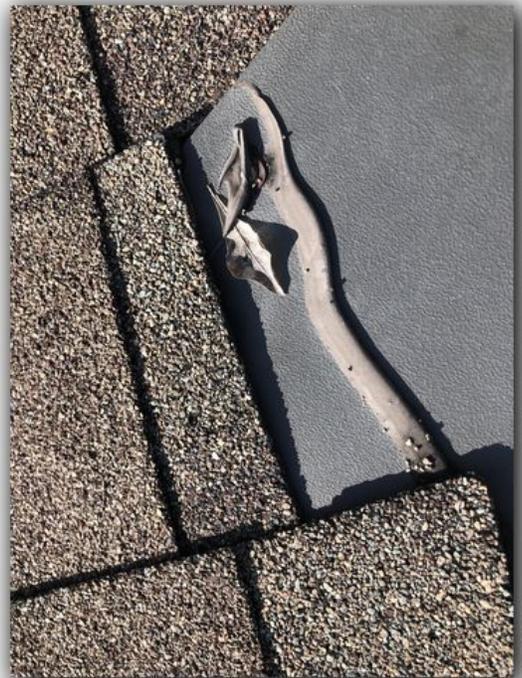
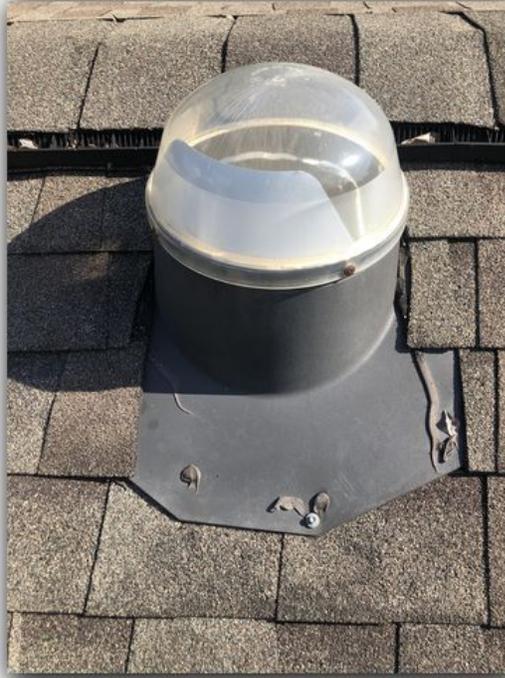
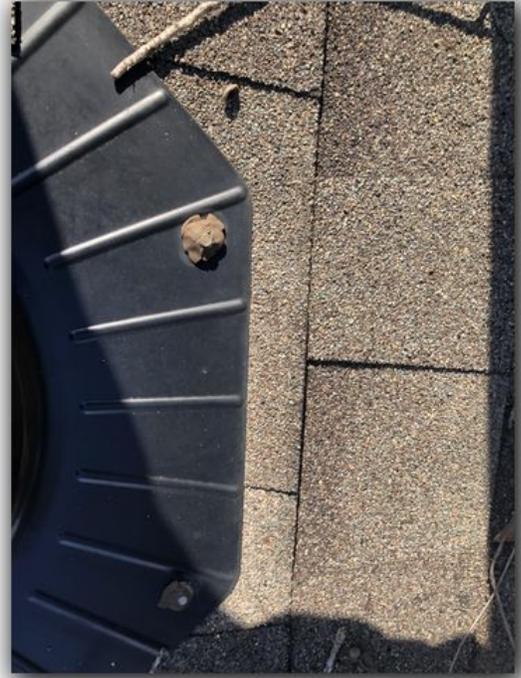
C. Roof Covering Materials

Comments: Deteriorated shingles have exposed fibers. Loose shingles around valley next to the chimney. Missing kickout flashing on chimney. Recommend cleaning debris off of roof. Multiple exposed nail heads should be resealed. Nail pushing shingle up around attic vent. Kitchen plumbing vent flashing bent up. Bath plumbing vent has caulking starting to fail.

Replace the missing roof shingles and seal exposed nail/screw heads to prevent water penetration. This can prevent further staining of the living room ceiling if this issue was not already addressed. Recommend a qualified roofer for repairs.

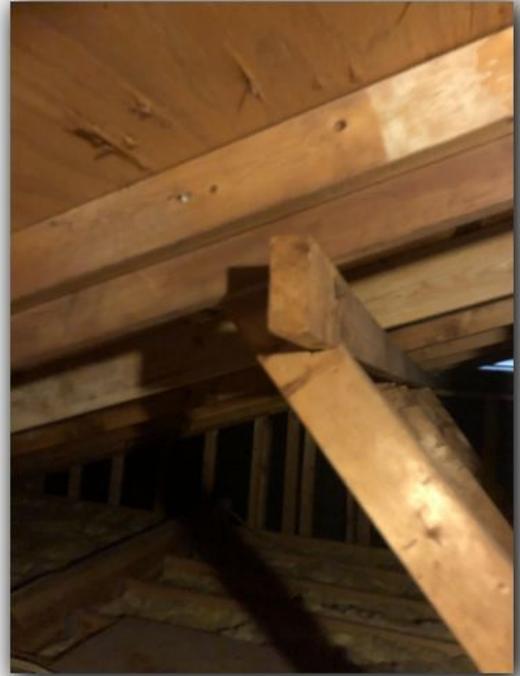
D. Roof Structures and Attics

Comments: No access to evaporator unit. Hallway attic access hatch was inaccessible. Truss appears to be notched and not attached properly. Smaller board placed in between rafter and ridge. Decking appeared to be soft in between the chimney and attic.

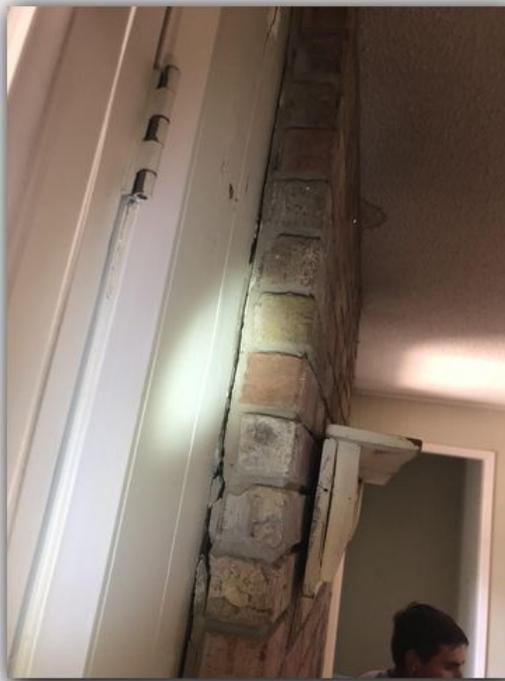
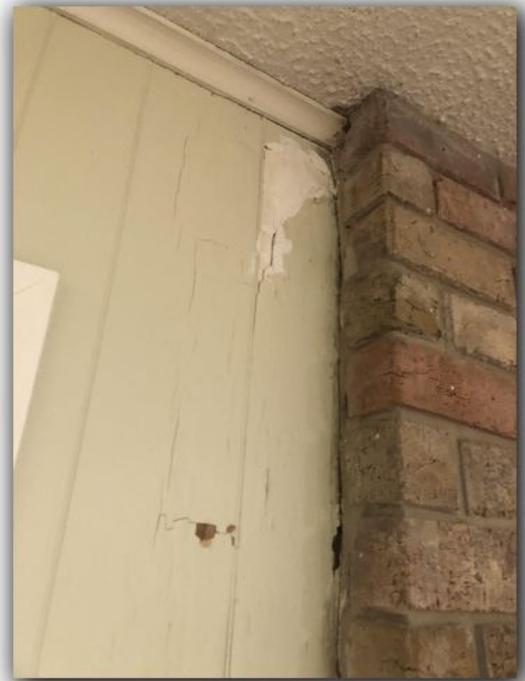
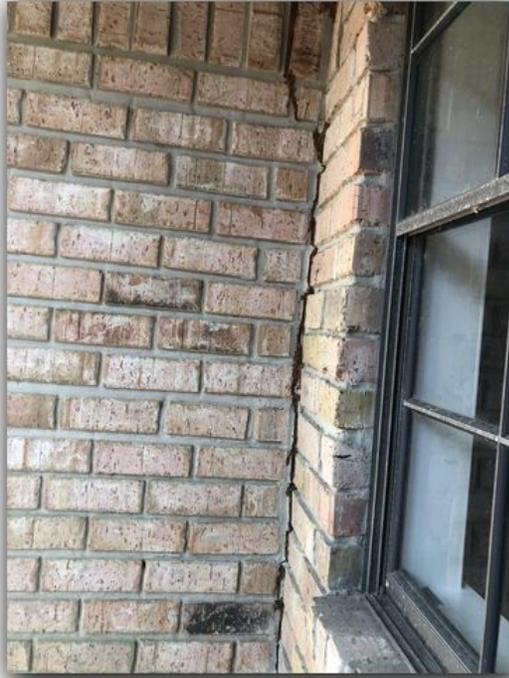
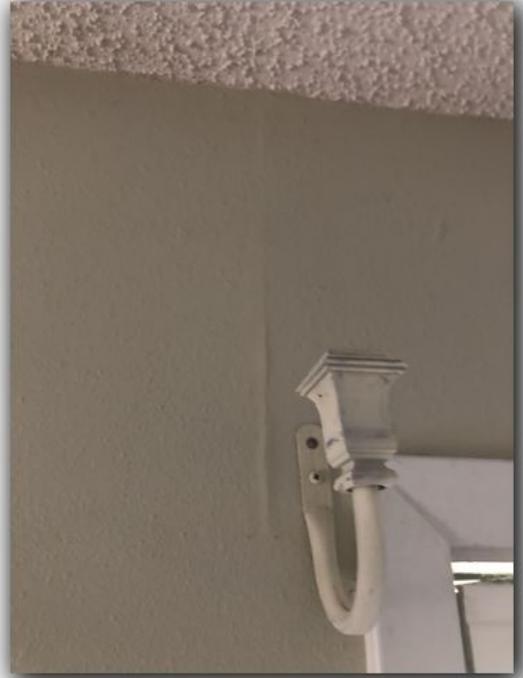
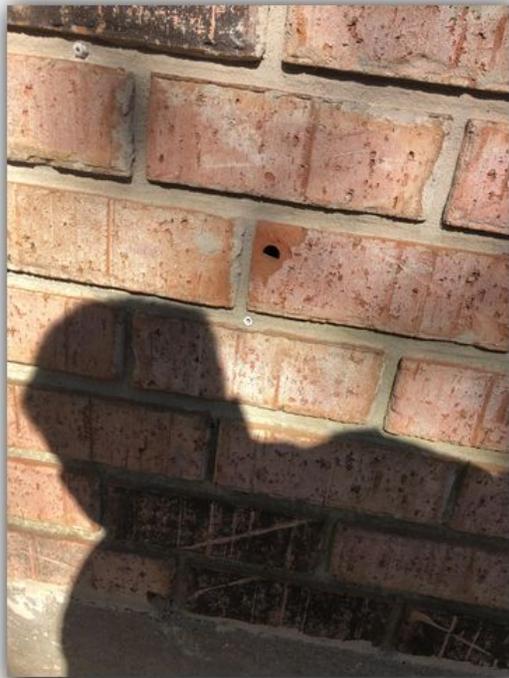
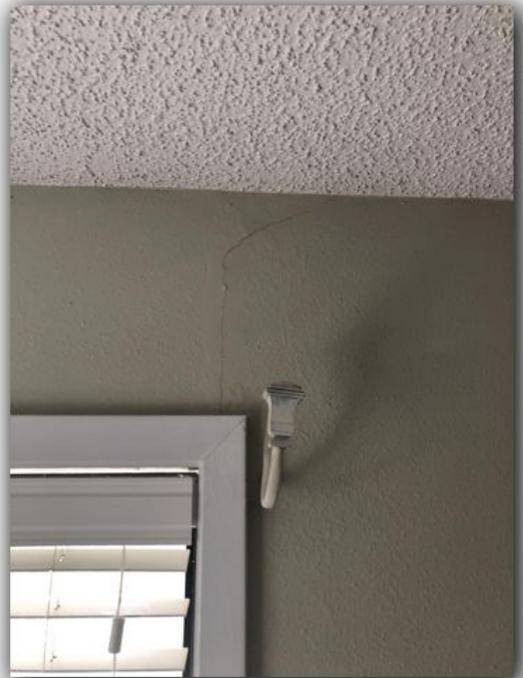
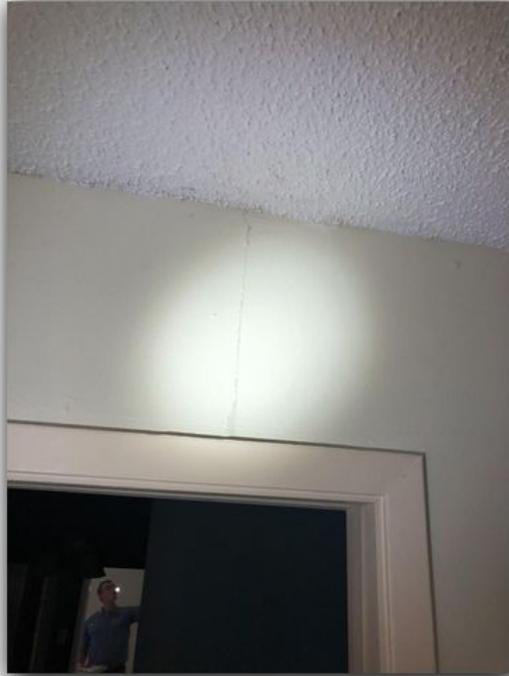
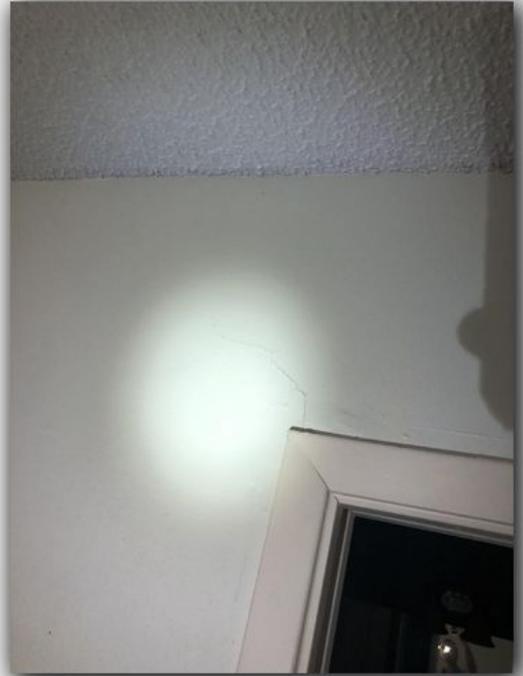
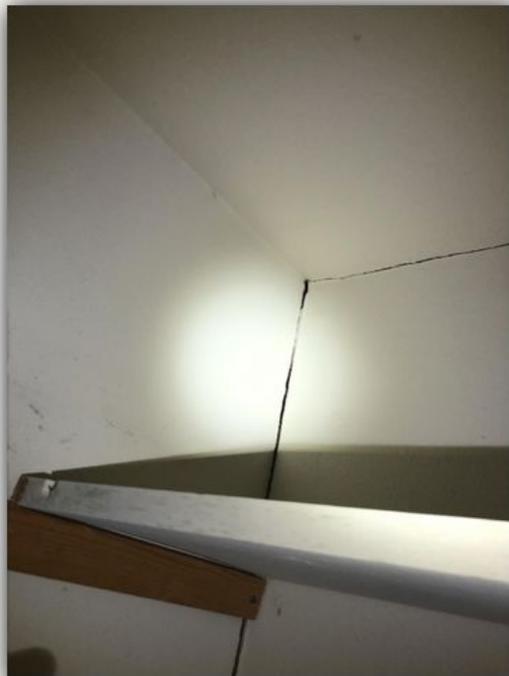
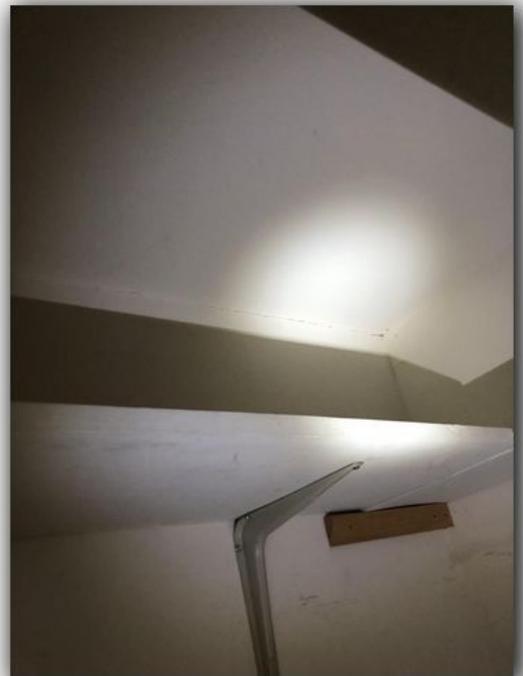
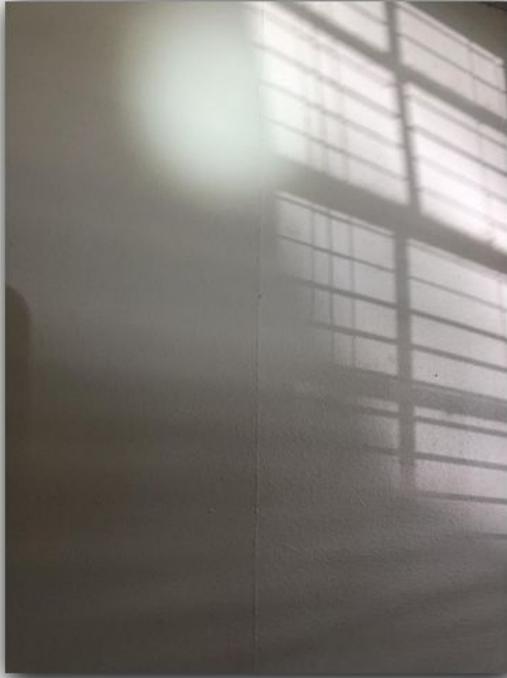
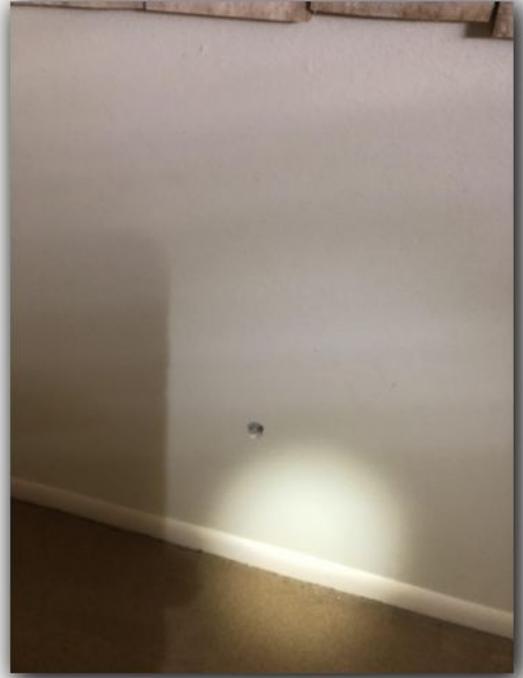
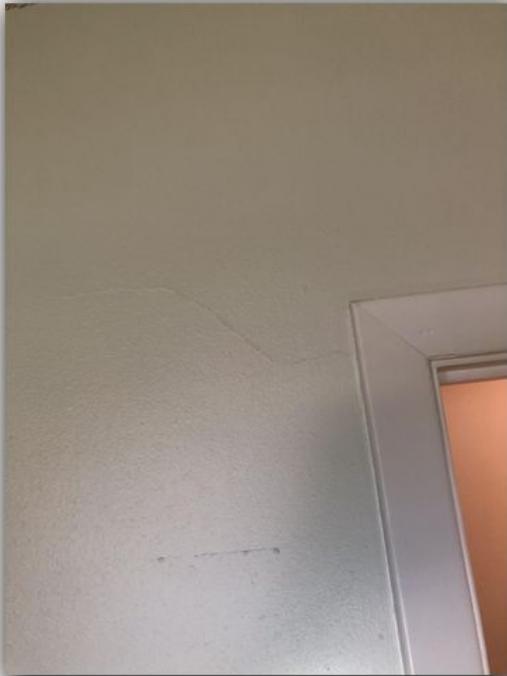
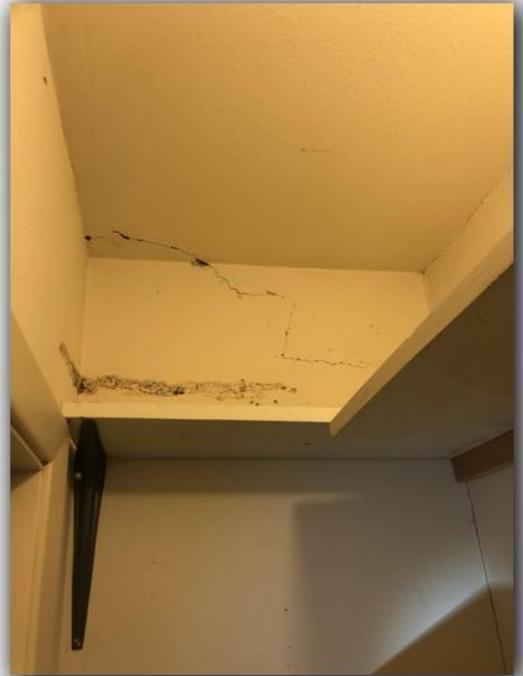
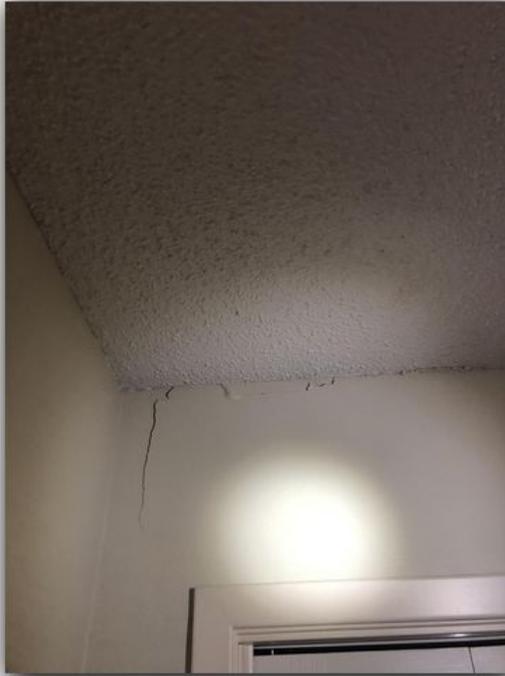
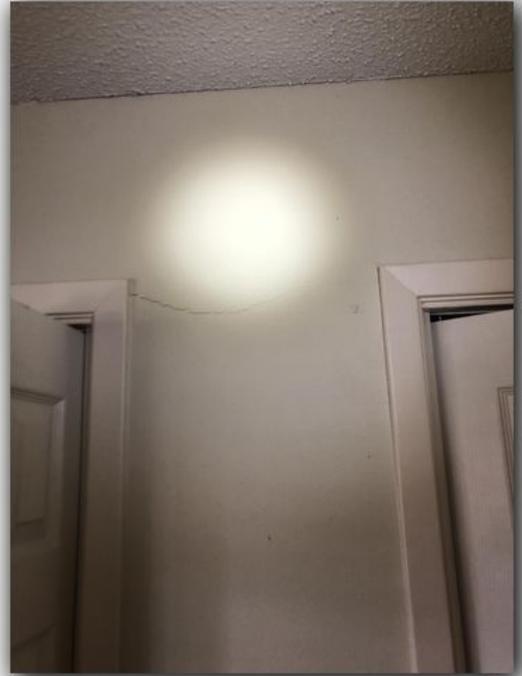
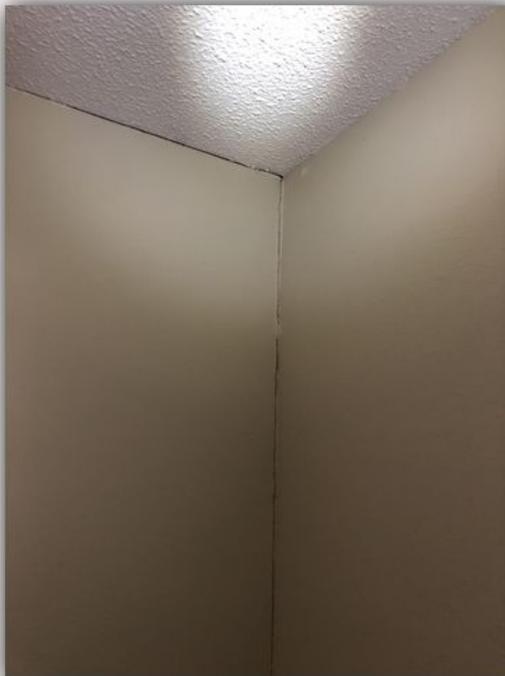
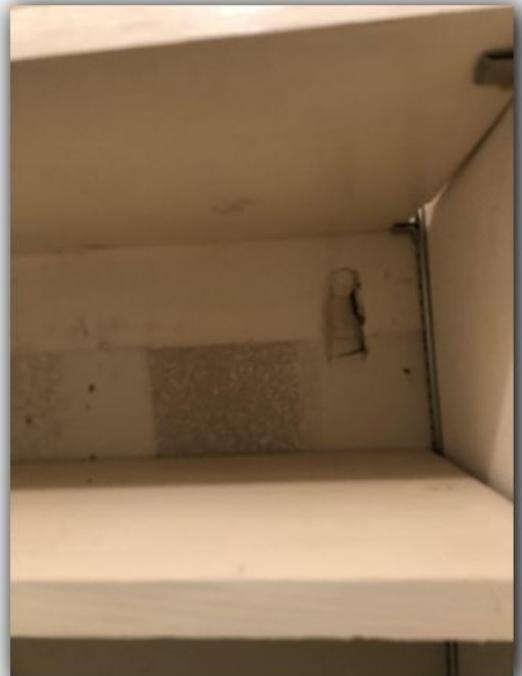
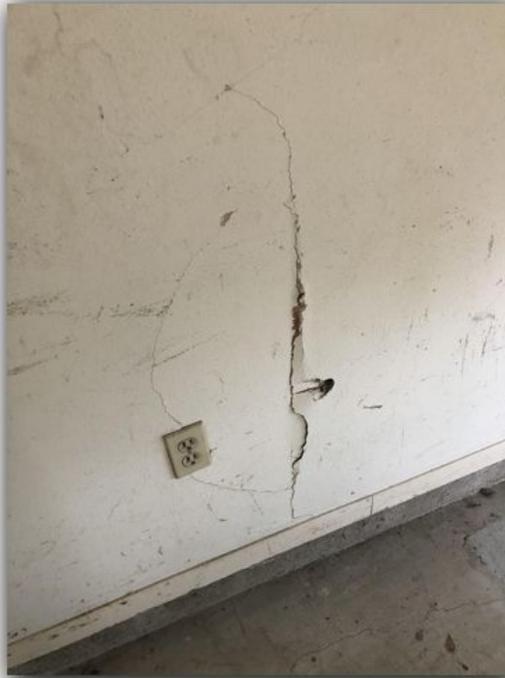
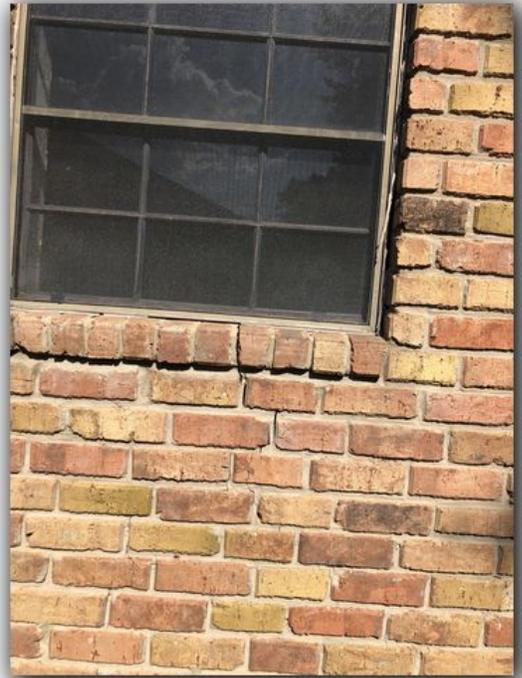
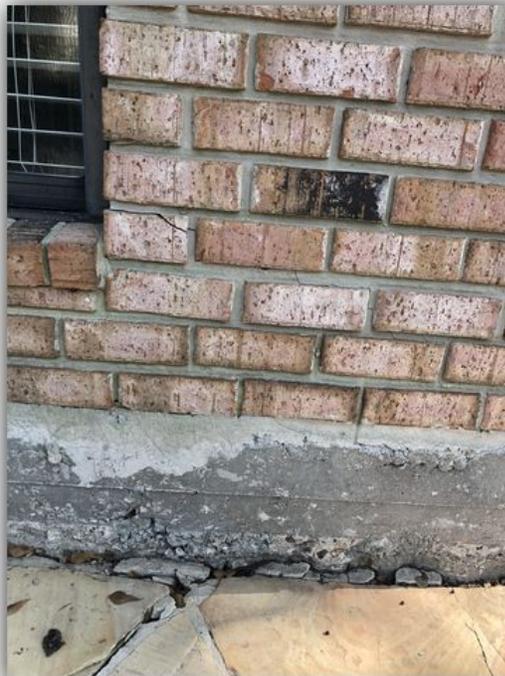
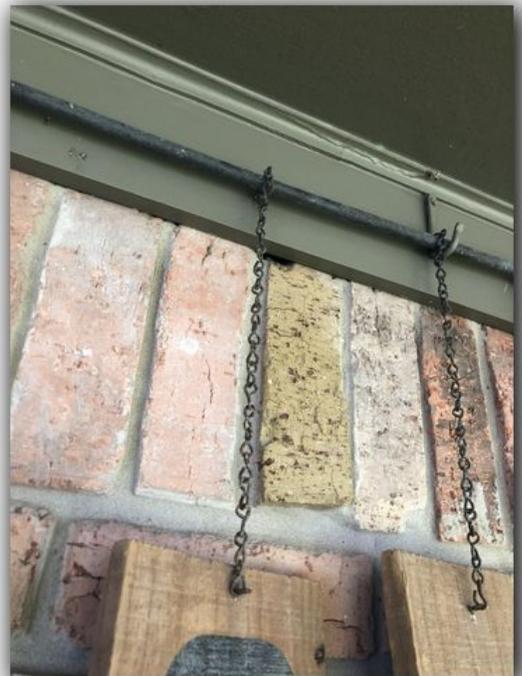
E. Walls (Interior and Exterior)

Comments: Interior wall on the left and right side of fireplace is separated and shows signs of deterioration. Cracks above doors and windows in the bedrooms appears to be from foundation movement. Flaking paint behind master bedroom wall appears to be cosmetic but could be related to the deteriorating caulking along the adjacent wall of the exterior. Exterior wall of master bedroom facing the patio has a hole with a wooden rod in it should be properly sealed. Multiple ceiling to wall separations in the front bedroom closets. Multiple cracks and repaired cracks in all bedrooms. Garage interior wall damages. Garage exterior wall has a crack below window that appears to be from foundation movement. Wood siding above garage sealant is failing and should be repaired. Kitchen and dining room walls cracking from corner of windows. Entryway missing piece or mortar in brick. Recommend further evaluation by a qualified contractor.

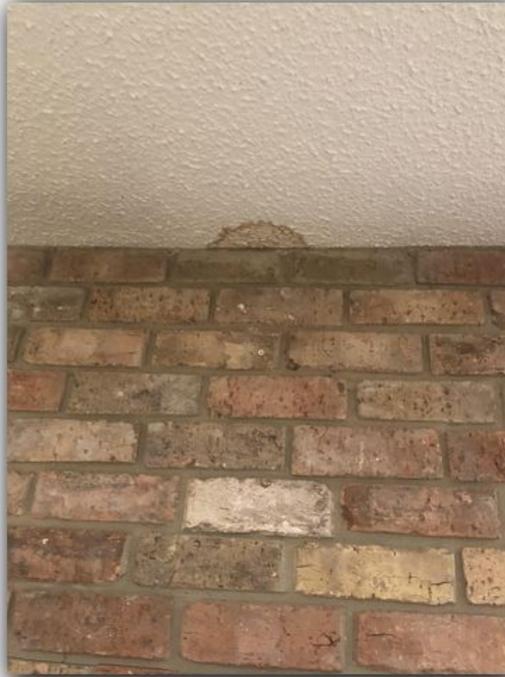
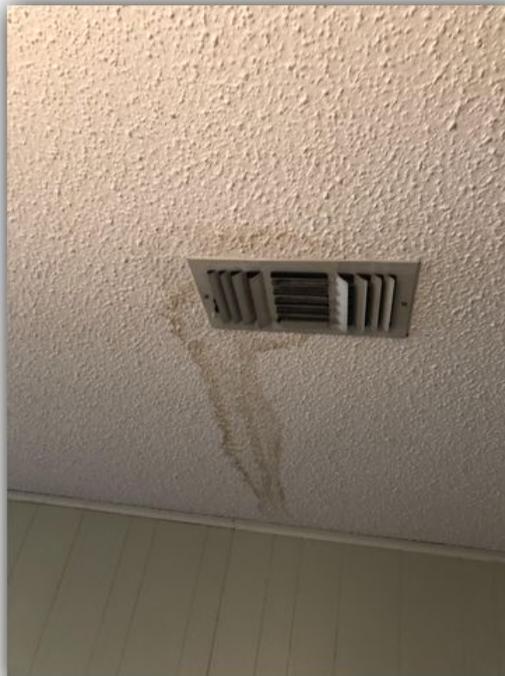
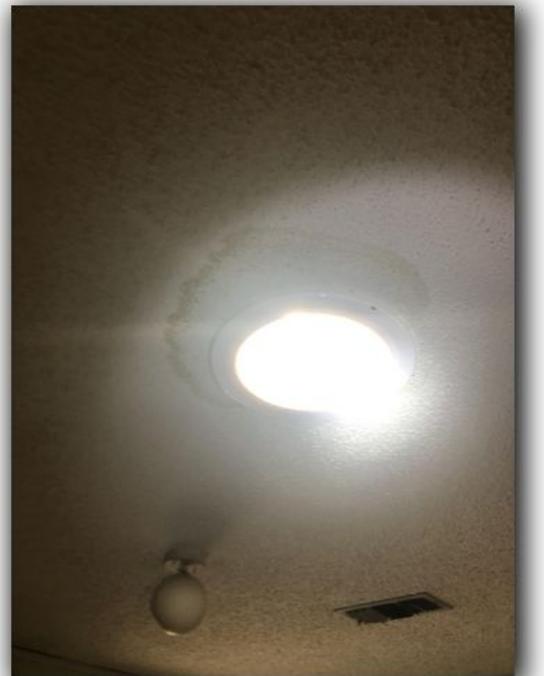
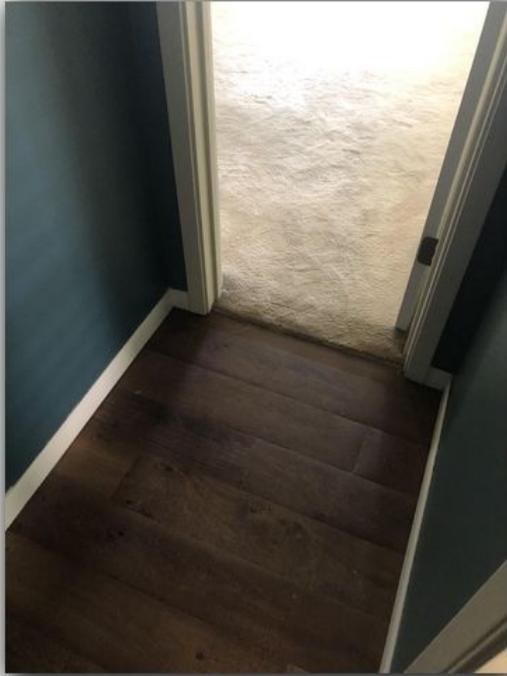
F. Ceilings and Floors

Comments: Water stain above fireplace, vent, and skylight in the living room. Could be from a previous leak but does not appear to be an active leak; recommend to be monitored. Missing trim in utility room. Uneven flooring transition from master bedroom to bath. Recommend further investigation by a qualified contractor.

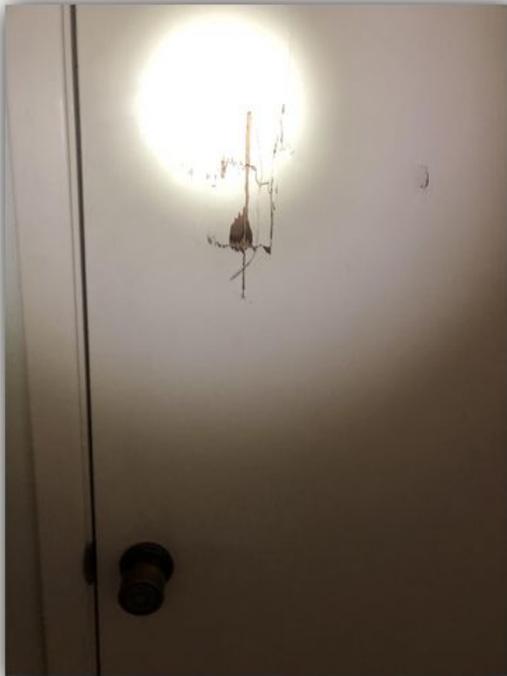
G. Doors (Interior and Exterior)

Comments: Damaged door from middle bedroom to hall. This is cosmetic.

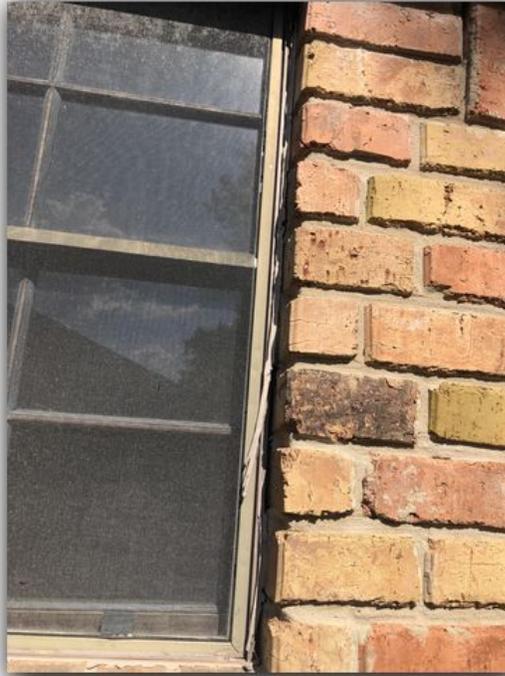
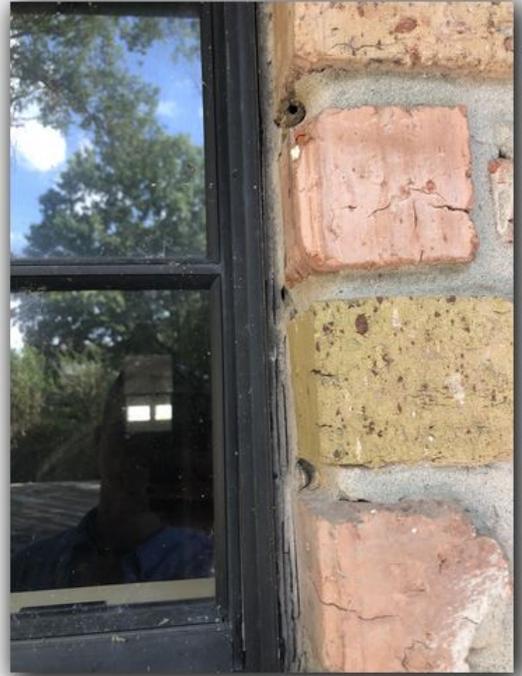
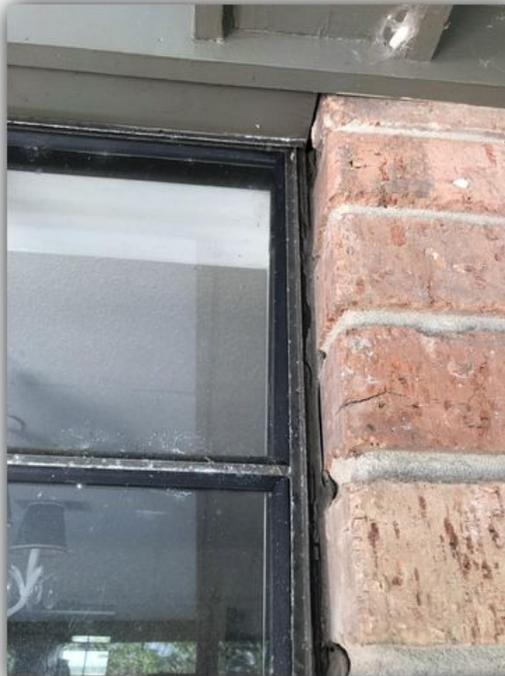
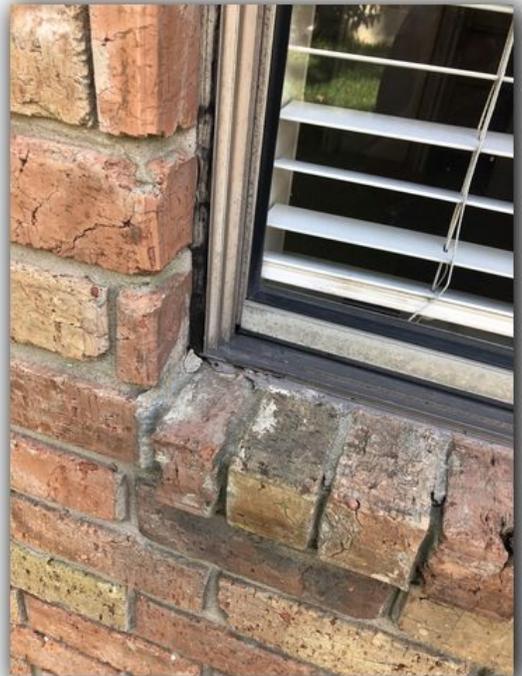
H. Windows

Comments: Multiple exterior window caulking is deteriorated. Recommend caulking windows. Windows hard to open in Front 2nd Bedroom.

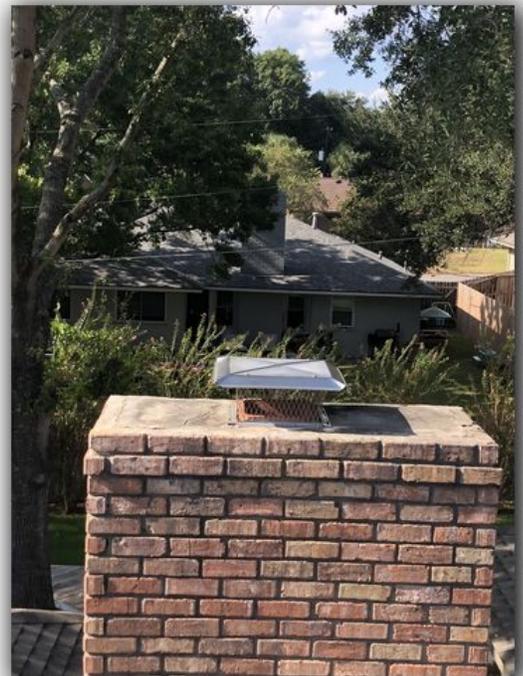
J. Fireplaces and Chimneys

Comments: Gas key located outside of the hearth but no gas lines were observed due to the firebox being full of ashes. Clean out located on exterior of fireplace is full and recommend cleaning. Recommend the padding on hearth be removed before using the fireplace (this is a fire safety issue). Damper operates properly. Chimney coping appears show signs of cracks and deterioration. Firebox screen framing loose against brick. The majority of the fireplace flue was not visible. A level II chimney inspection prior to closing is recommended for personal safety. Recommend to have the chimney cleaned and inspected every year by a qualified chimney sweep.

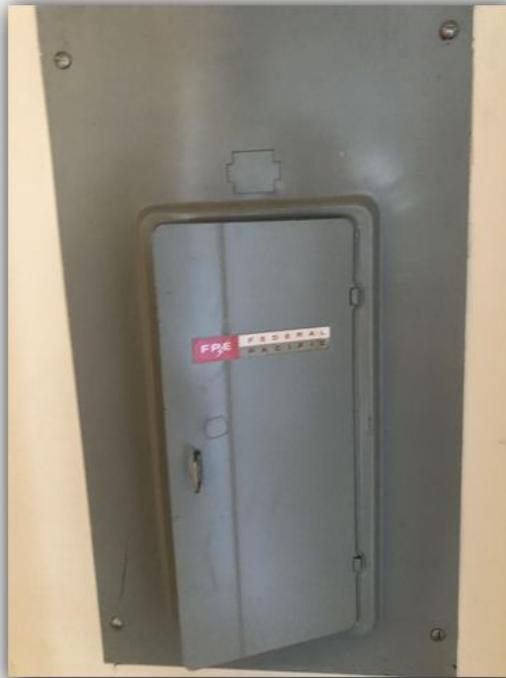
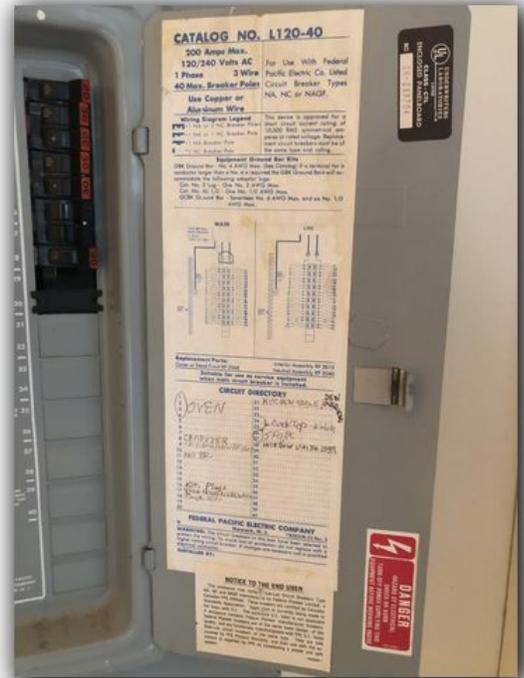
A. Service Entrance and Panels

Comments: Electrical panel located in master bedroom closet. Main disconnect located adjacent the electrical panel on the exterior of the wall. 200 amp Federal Pacific Stab-Lok panel. Breakers are known for failing to trip. Inadequate clearance around panel. Recommend removing and upgrading the panel by a qualified electrician. Add GFCI (Ground Fault Circuit Interrupter) and AFCI (Arc Fault Circuit Interrupter) breakers in the home to enhance electrical safety.

Removing and upgrading the electrical panel is recommended for electrical and fire safety. Federal Pacific panels are considered unsafe. Breakers that fail to trip could cause a fire. Having an electrician upgrade the panel is recommended.

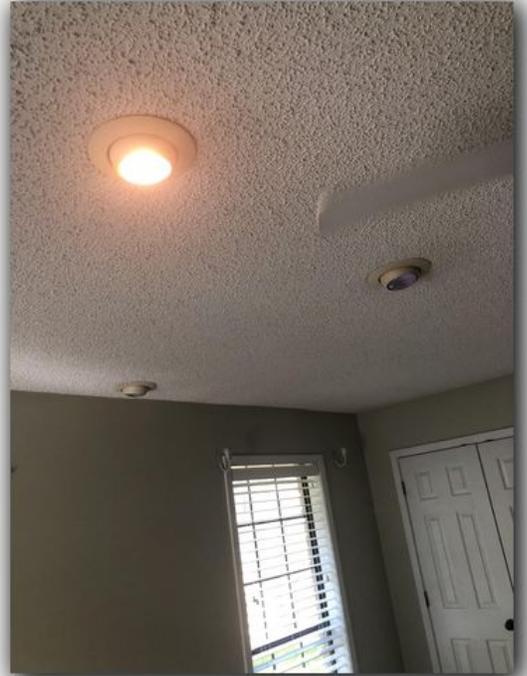
B. Branch Circuits, Connected Devices, and Fixtures

Comments: Wall plate missing. No GFCI outlets in kitchen, under kitchen sink for food waste disposer, hall bath, master bath, and exterior receptacles. Utility room light did not work. 1 light is not working, and 2 unknown light switch in the back master bedroom. Lights not working in at least 2 bedroom closets throughout home. Open receptacle on living room floor should be covered.

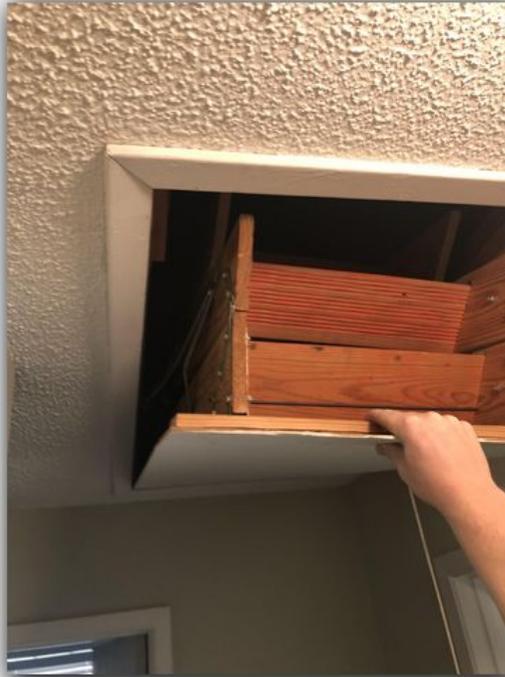
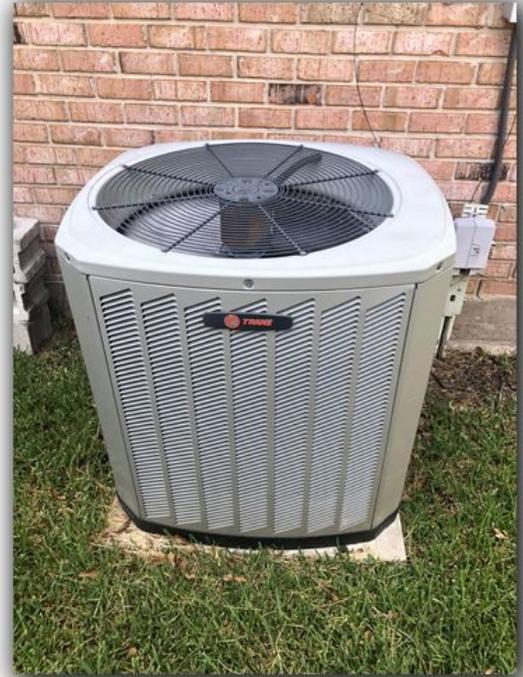
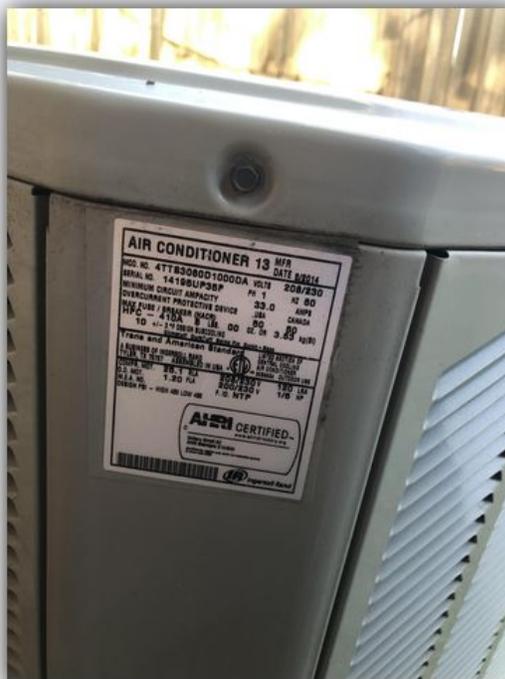
B. Cooling Equipment

Comments: 2.5 ton. Manufactured Date: 5/2014. Did not inspect evaporator unit; attic hatch ladder in hallway would not fold down. A/C set 72°F and measured 65°F on the supply and 76°F on the return. Condenser unit was inspected.
