Wittner Inspection Services

PROPERTY INSPECTION REPORT FORM

John Doe <i>Name of Client</i>	09/17/2024 <i>Date of Inspection</i>
12345 Anywhere Ct, Anytown, TX 77777 <i>Address of Inspected Property</i>	
Dauson Wittner <i>Name of Inspector</i>	TREC# 24364 <i>TREC License #</i>
<i>Name of Sponsor (if applicable)</i>	<i>TREC License #</i>

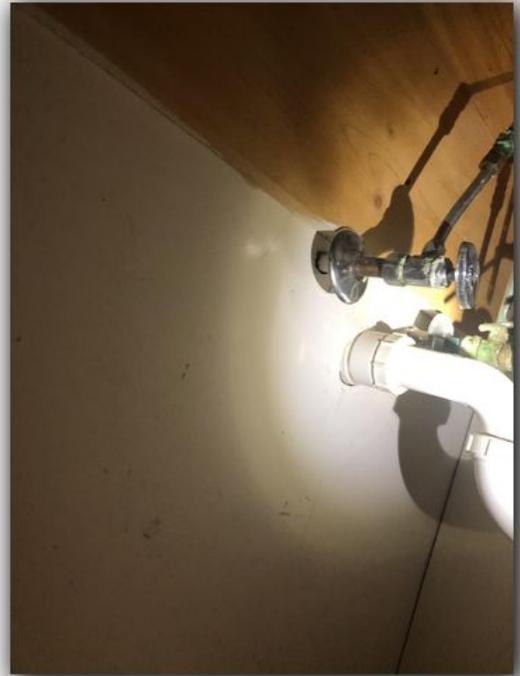
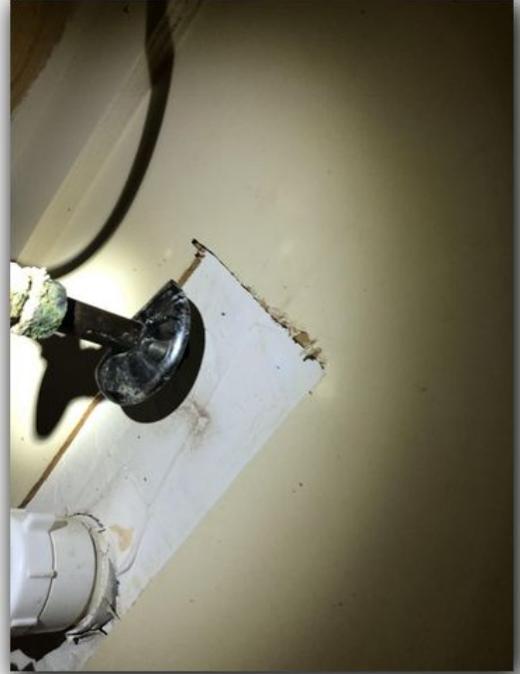
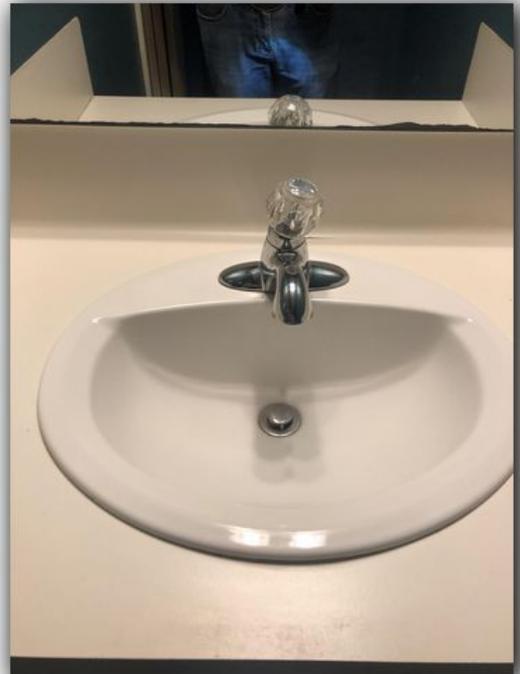
A. Plumbing Supply, Distribution Systems and Fixtures

Comments: Water faucet on left side exterior of the residence was leaking out of hose bib handle during testing. Water pressure exceeds 80 psi. Recommend a pressure reducing valve to be installed when the water pressure exceeds 80 psi by a qualified contractor. Washer connection has water around it possibly from disconnecting previous unit. Master bath sink fixture had no water. Tile cracked in hall bath and not enough caulking around bath tub. Hall bath shower fixture loose. Multiple bath sink faucet supply lines flange not properly attached to wall. Kitchen sink spray head leaking when main faucet was turned on.

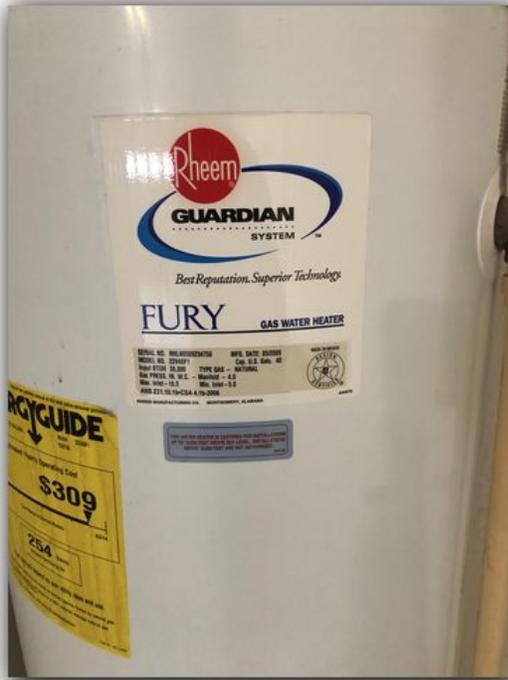
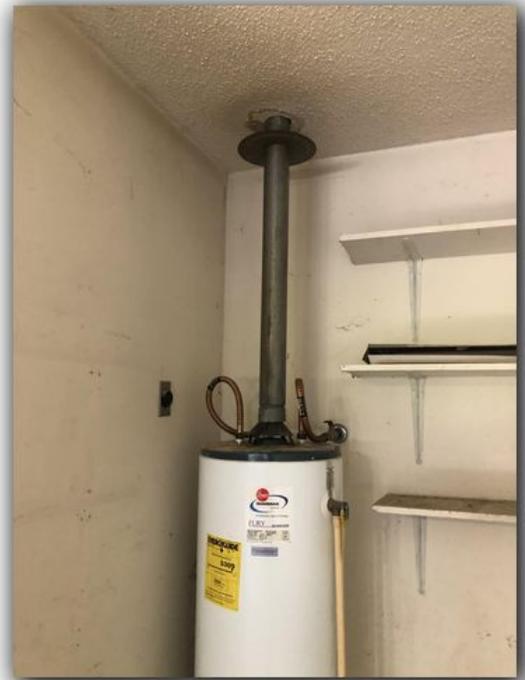
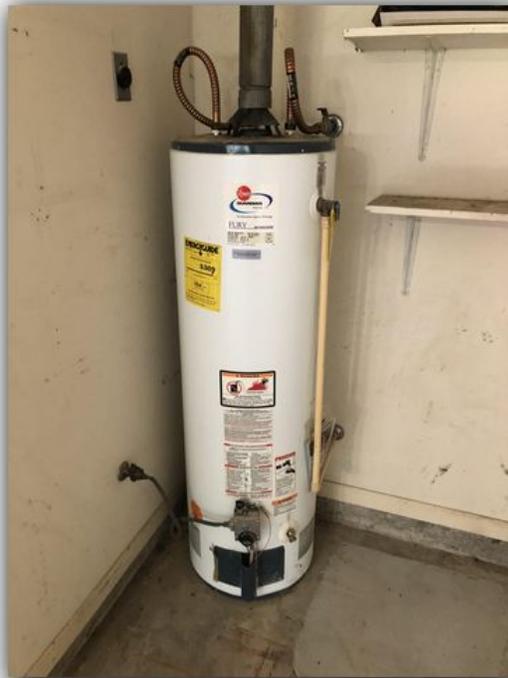
C. Water Heating Equipment

Comments: Located in the garage. Flue flange not properly connected.

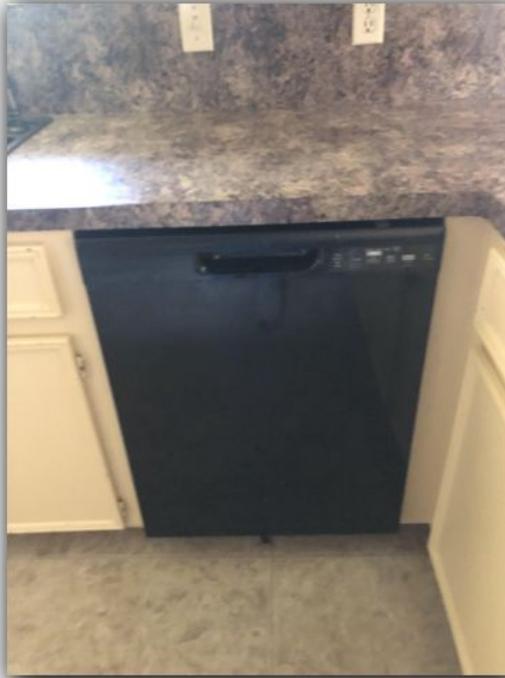
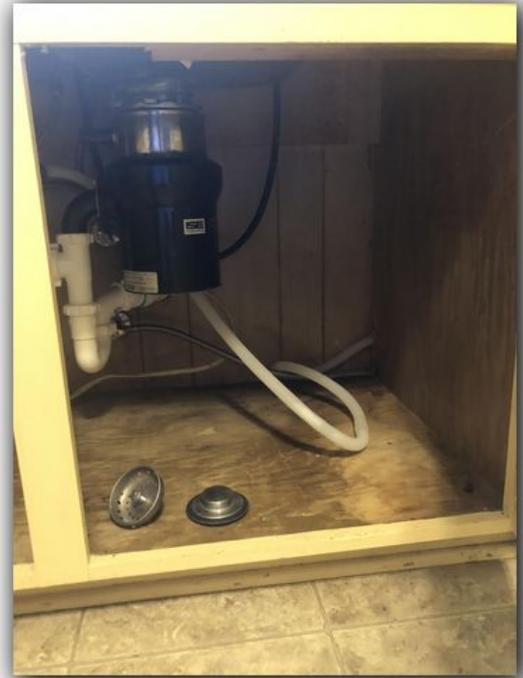
A. Dishwashers

Comments: No high loop to prevent backflow of wastewater. Dishwasher was operated for a few seconds for function. No leaks were found.
