HUD Engineering Evaluation

123 Sample Inspection, Sample, TX, 77303

PROPERTY INSPECTION REPORT

1234 Main Street
Magnolia TX 77354

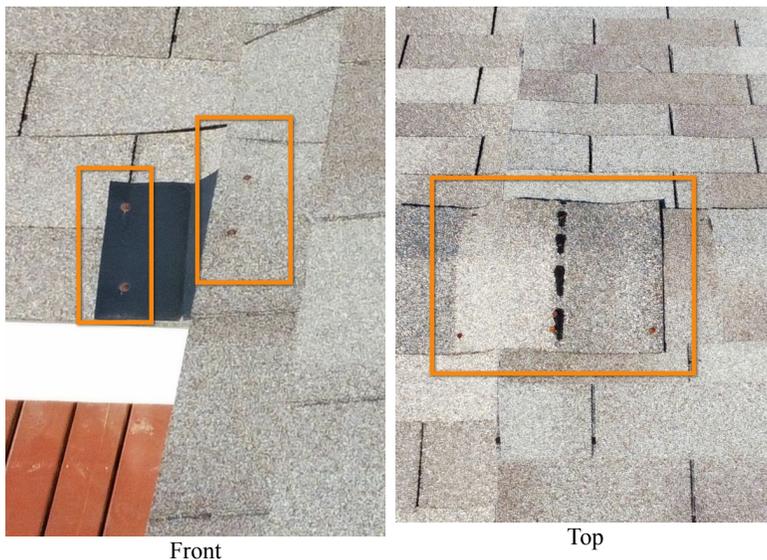
2: Lifted shingles

Areas of the roof show lifted shingles. This is typically caused by high gusts of wind. Lifted shingles will not seal with the lower shingles and allow for water intrusion. Recommend a roofing contractor to replace.

Recommendation: Contact a qualified roofing professional.

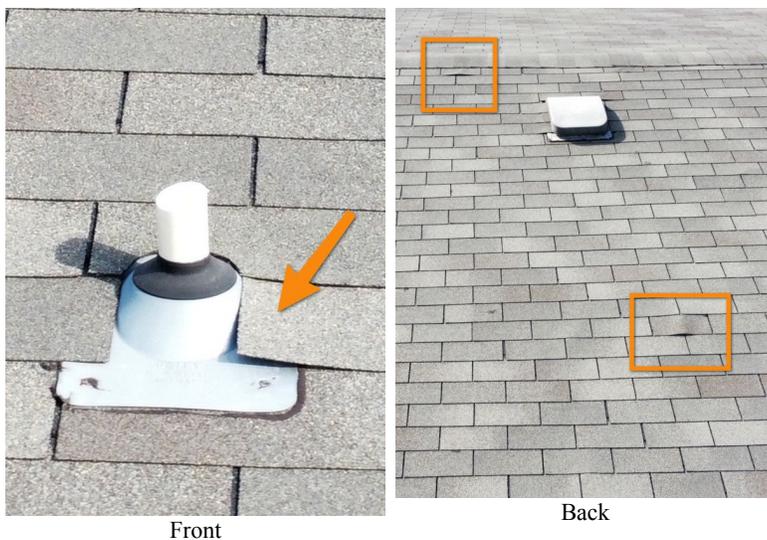
3: Lifted flashing

Areas of the roof show lifted flashing areas. Lifted flashing areas will not seal with the lower shingle areas or siding and can allow for water intrusion. Recommend a roofing contractor to replace.

Recommendation: Contact a qualified roofing professional.

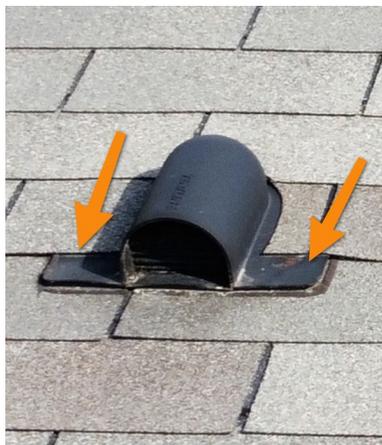
Front

4: Vent stack terminates short

Stack vents should terminate at least 6-inches above the roof. Recommend installation of a riser and/or a new boot, as necessary.

Recommendation: Contact a qualified plumbing contractor.

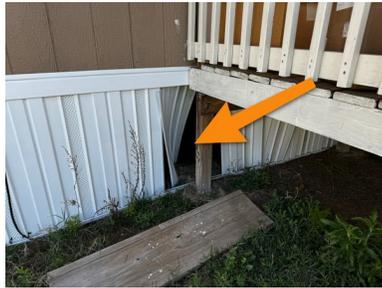
Front

1: Damaged skirting

The skirting was damaged around the home at various areas.

Recommendation: Contact a qualified general contractor.

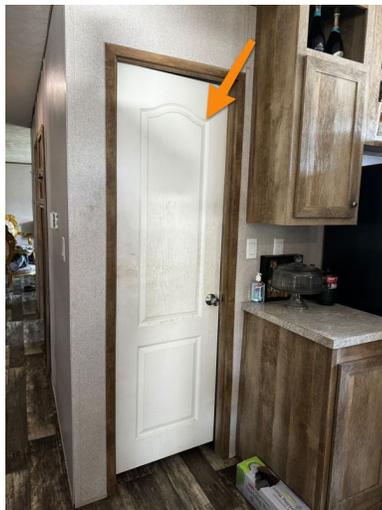
Kitchen pantry

Door sticks, rubs the frame, and is tough or impossible to open and/or close. The door is not aligning with the frame. Recommend hiring a door repair and installation contractor to realign the door or sanding down offending sides.

Recommendation: Contact a qualified door repair/installation contractor.

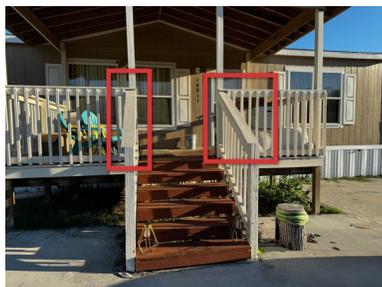
Front

Non-graspable handrails is a safety hazard. Handrails should be no wider than 2-1/4" so that a person can easily hold onto them.

Recommendation: Contact a qualified general contractor.

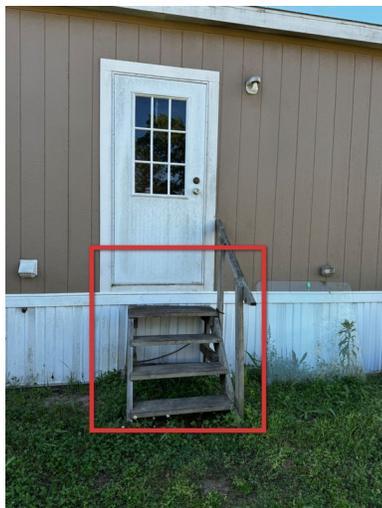
Back

The back door steps do not meet the safety standards required at this location. This is a safety hazard that could result in serious personal injury.

Recommendation: Contact a qualified general contractor.

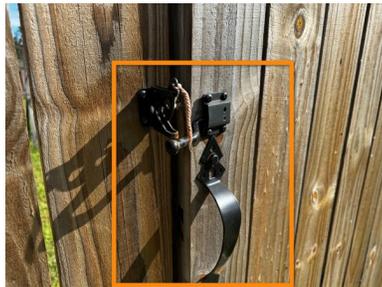
Right

Fence gate will not open, or is difficult to open/close and/or will not latch. This could be because of rot damage and/or support issues. Recommend a fencing contractor to resolve the gate issue.

Recommendation: Contact a qualified fencing contractor

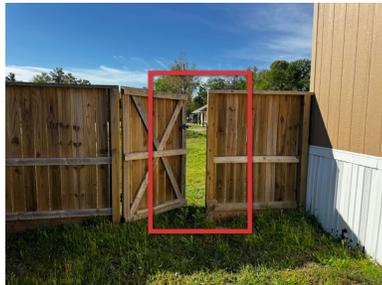
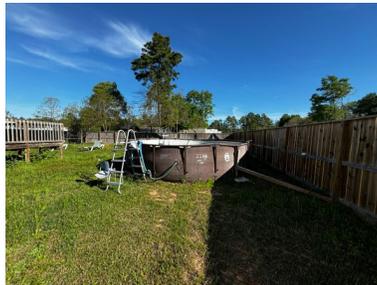
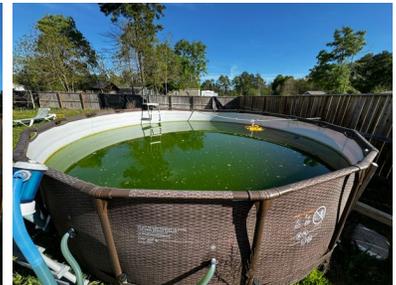
2: Pool gate

The gate that permits access to the pool does not auto close and auto latch. This is a requirement when a pool is located on the property. This is a safety hazard that could allow neighborhood children to access the pool without adult supervision. The latch should also be on the inside of the gate. This is a potential for drowning.

Does not auto close an auto latch

Recommendation: Contact a qualified general contractor.

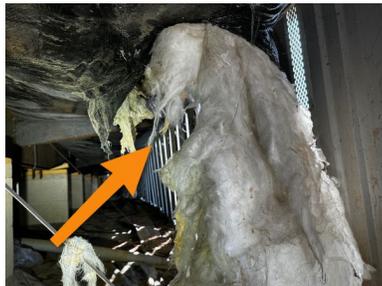
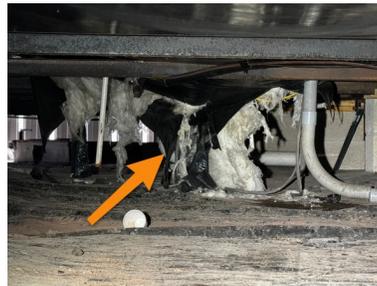
Under the house at various areas

4: Damaged insulation

Insulation under the home was damaged. This can allow damage to the flooring, electrical, and plumbing systems of the home, in addition to loss of cool and heated conditioned air in the house.

Damaged insulation

Recommendation: Contact a qualified insulation contractor.

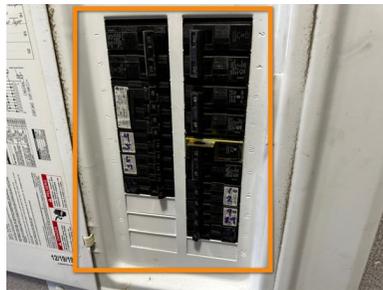
1: Panel missing AFCI breakers

Regulations in most states require inspectors, regardless of the structure's age, to mark as "deficient" where any (AFCI) protection is not installed in these areas.

Missing AFCI breakers

Recommendation: Contact a qualified electrical contractor.

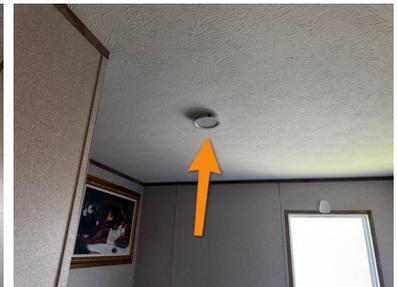
1: Fixture - light inoperable / bulb needs replacement

One or more lighting fixtures failed to illuminate (fixtures did not turn on when nearby switches were activated). It is advised to further evaluate by replacing bulbs and/or consulting with the property owner. If changing bulbs proves ineffective and/or no additional switch(es) can be found, then recommend that a qualified electrician examine and repair or replace light fixtures.

Lights did not work at several locations in the house

Recommendation: Contact a qualified electrical contractor.

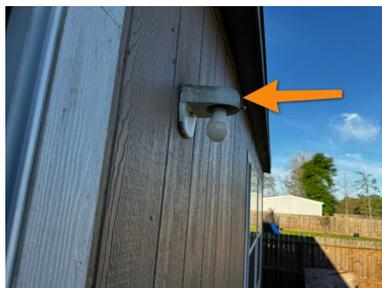
Back

2: Fixture - missing bulb cover

Lighting fixture is missing the bulb cover. This is considered a primarily cosmetic deficiency, but can provide some protection for the bulb. Recommend replacement of the bulb cover as necessary.

Recommendation: Contact a qualified electrical contractor.

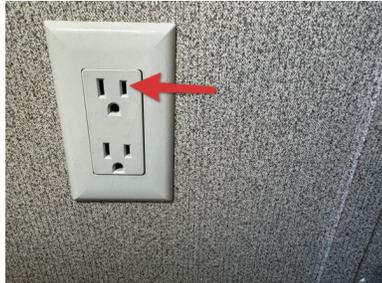
The state requires inspectors, regardless of the structure's age, to mark as "deficient" where tamper resistant protection is not installed.

Not tamper resistant, for child safety

Recommendation: Contact a qualified electrical contractor.

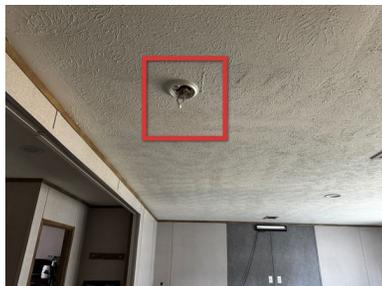
Please see recommendations provided by the National Fire Protection Association (NFPA) about smoke alarms and their recommended placement. All smoke detectors should be installed in accordance with the manufacturer's recommendation and be UL listed.

Smoke alarms missing at one or more locations around the house

Recommendation: Contact a qualified electrical contractor.

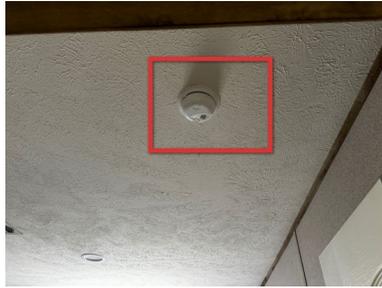
Middle Bedroom

2: Smoke alarm - inoperable

Recommendation: Contact a qualified Do It Yourself

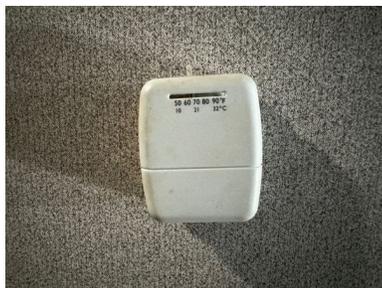
1: Thermostat not level

Thermostat not level

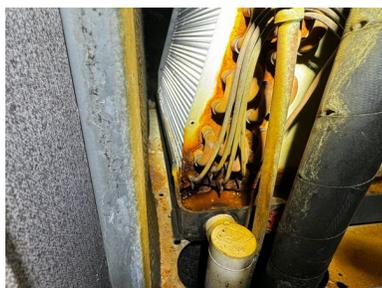
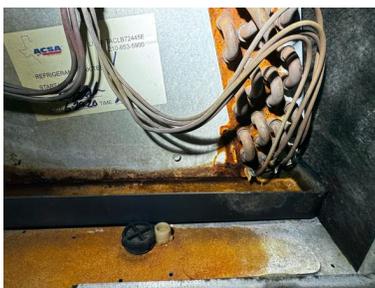
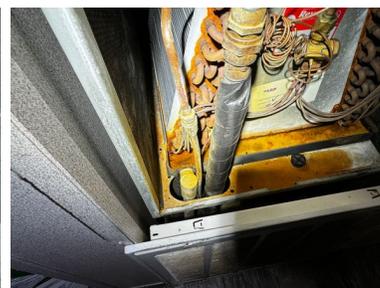
2: Rusted evaporator coil

Rusted coil

Recommendation: Contact a qualified HVAC professional.

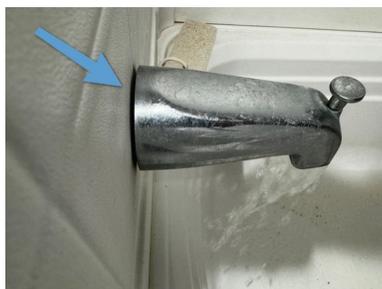
2: Tub/shower re-caulking necessary

Caulking needed

Recommendation: Contact a qualified Do It Yourself

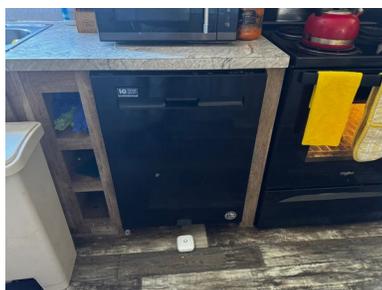
1: Dishwasher inoperable

Inoperable

Recommendation: Contact a qualified appliance repair professional.
