Executive Summary

Engineer's Foundation Evaluation

123 Sample Address, Your City, TX, 12345

On 4/1/2024 a foundation evaluation was performed at the property located at address 123 Sample Address, Your City, TX, 12345, which consists of a 2042 square-foot single family attached structure built in 2005 with a slab on grade foundation.

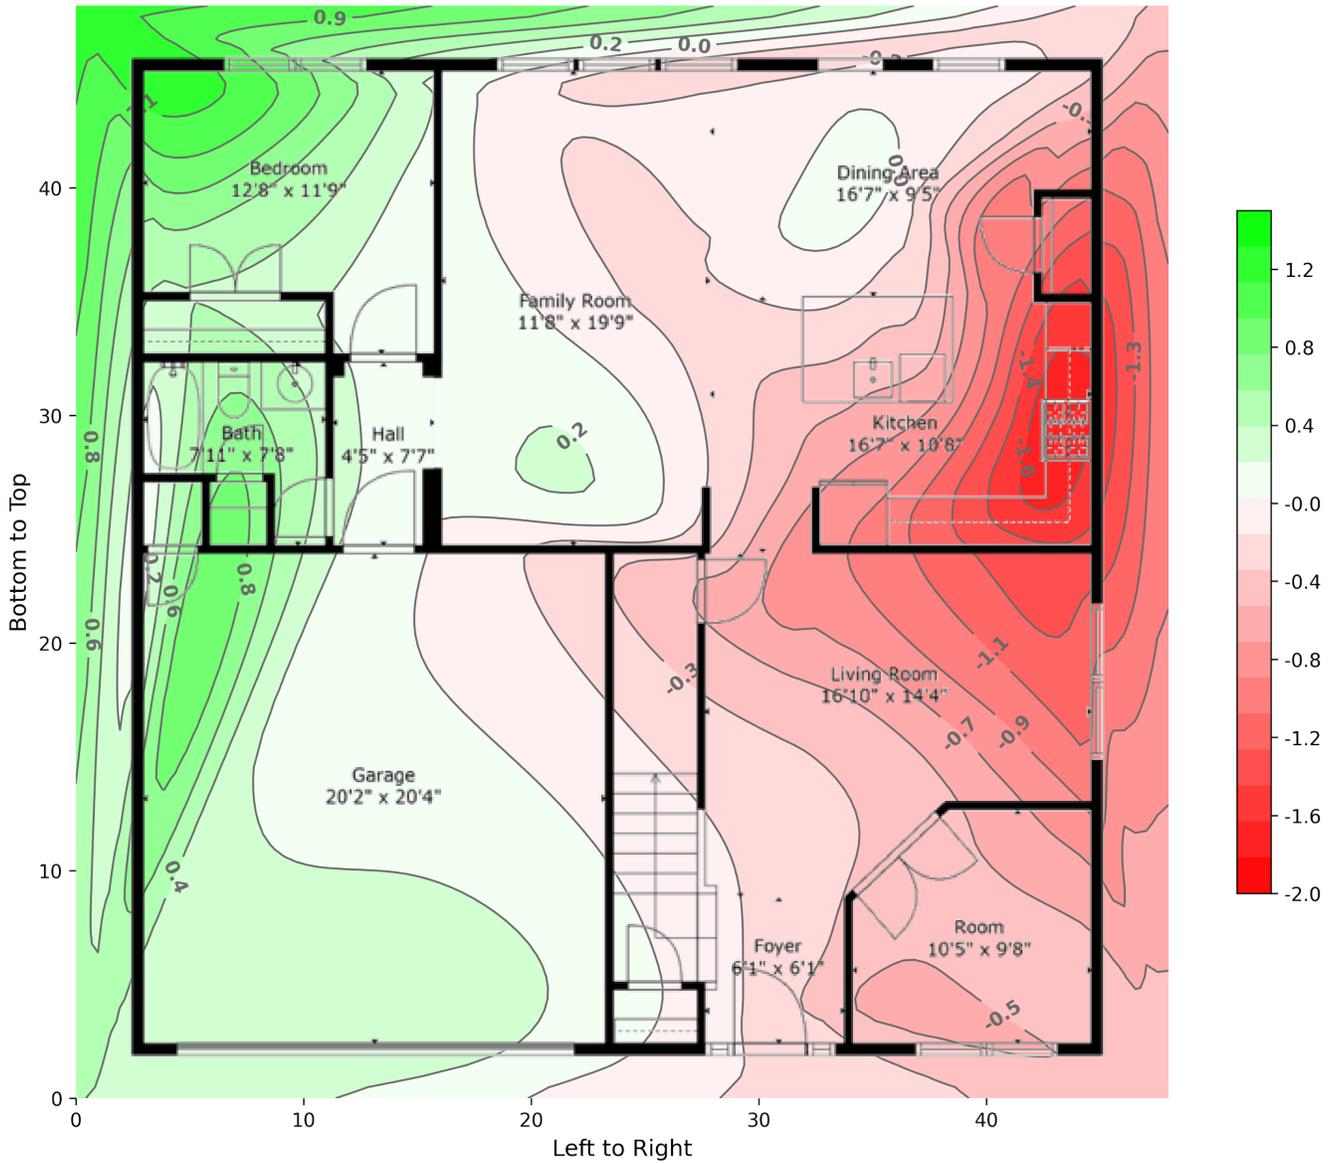
Mesh Contour Graphic (Figure B)

The mesh contours graphic depicted above in Figure B is similar to the elevation plot. The red, green, and white areas depict areas that are lower, higher, and equal to the base station elevation (0.0). The contour intervals are labeled.

As documented above, the maximum elevation point of this structure was determined to be 1.2 inches and the minimum was -1.7 inches, resulting in an elevation difference of 2.9 inches of difference across the structure. The elevation deflection across an entire structure should remain within 0.5 to 1-inch depending on the age of the structure. Measured differences approaching 2-inches are a sign of foundation fatigue. The maximum allowable elevation difference is subjective, depending on other factors such as the visual condition and age of the structure (19 year(s) old).

Based on observed elevations of the foundation from the elevation plot, the structure cannot be considered fully stable. Elevation differences do not fall within industry standards or tolerable limits. These findings indicate that the foundation does not have consistent and uniform elevation demonstrating continued movement of the foundation.

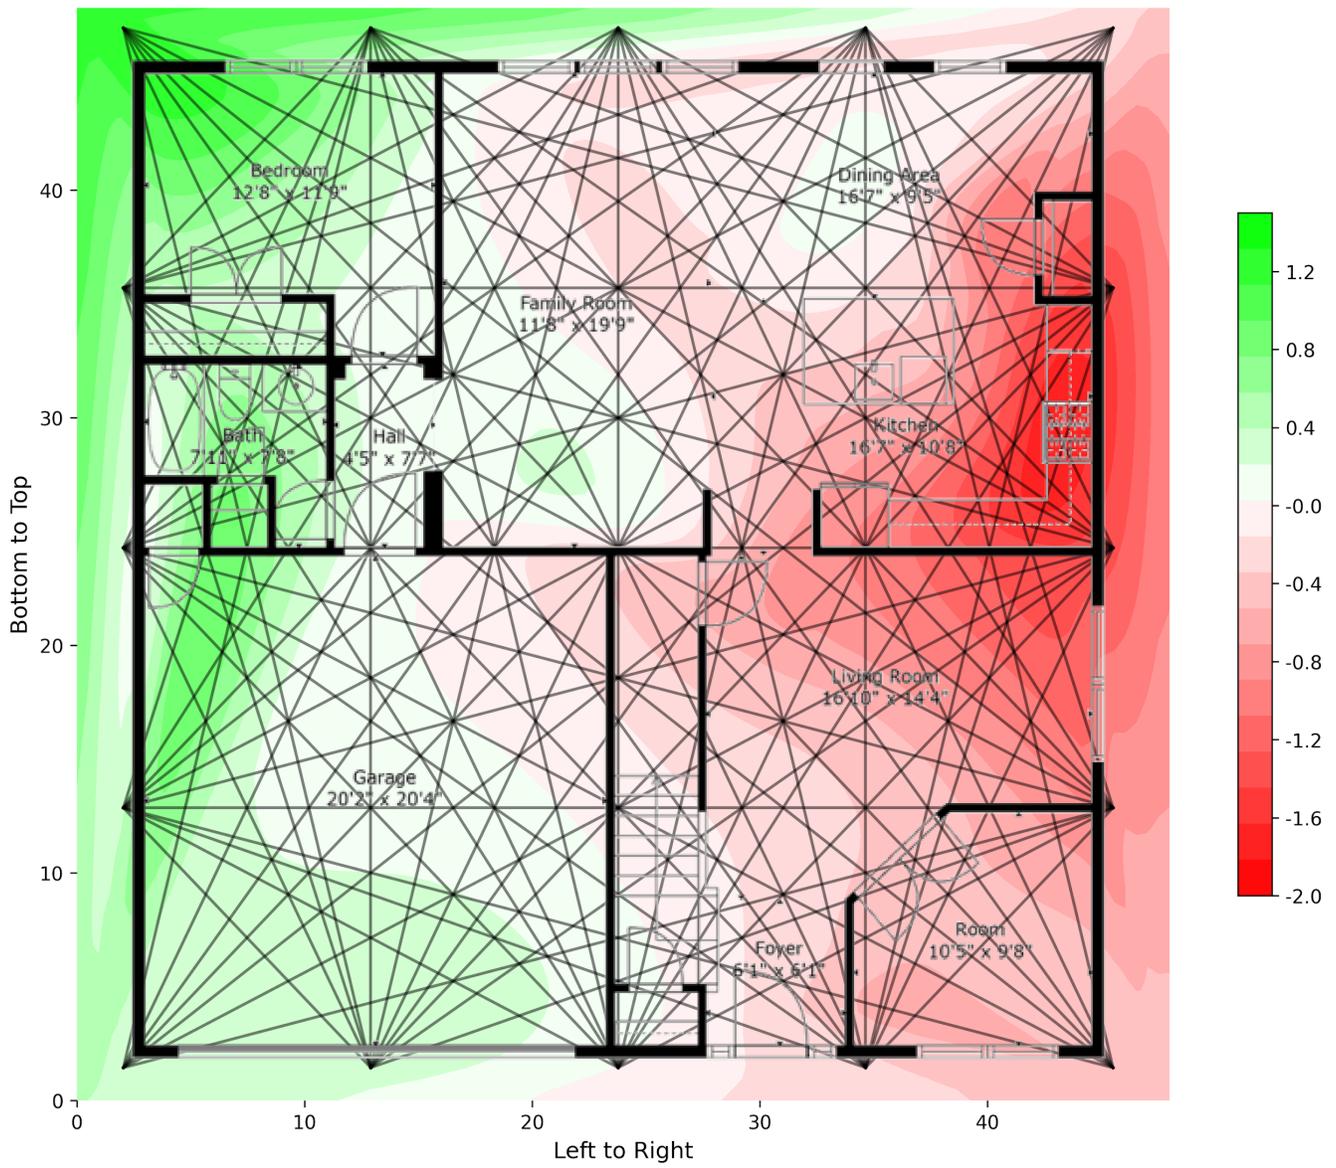
All Profiles Graphic (Figure C)

Below is a graphic that shows the locations of deflection and tilt profiles that were calculated. The total profiles calculated was 79 with a total usable profiles (above the effective length threshold) of 76.

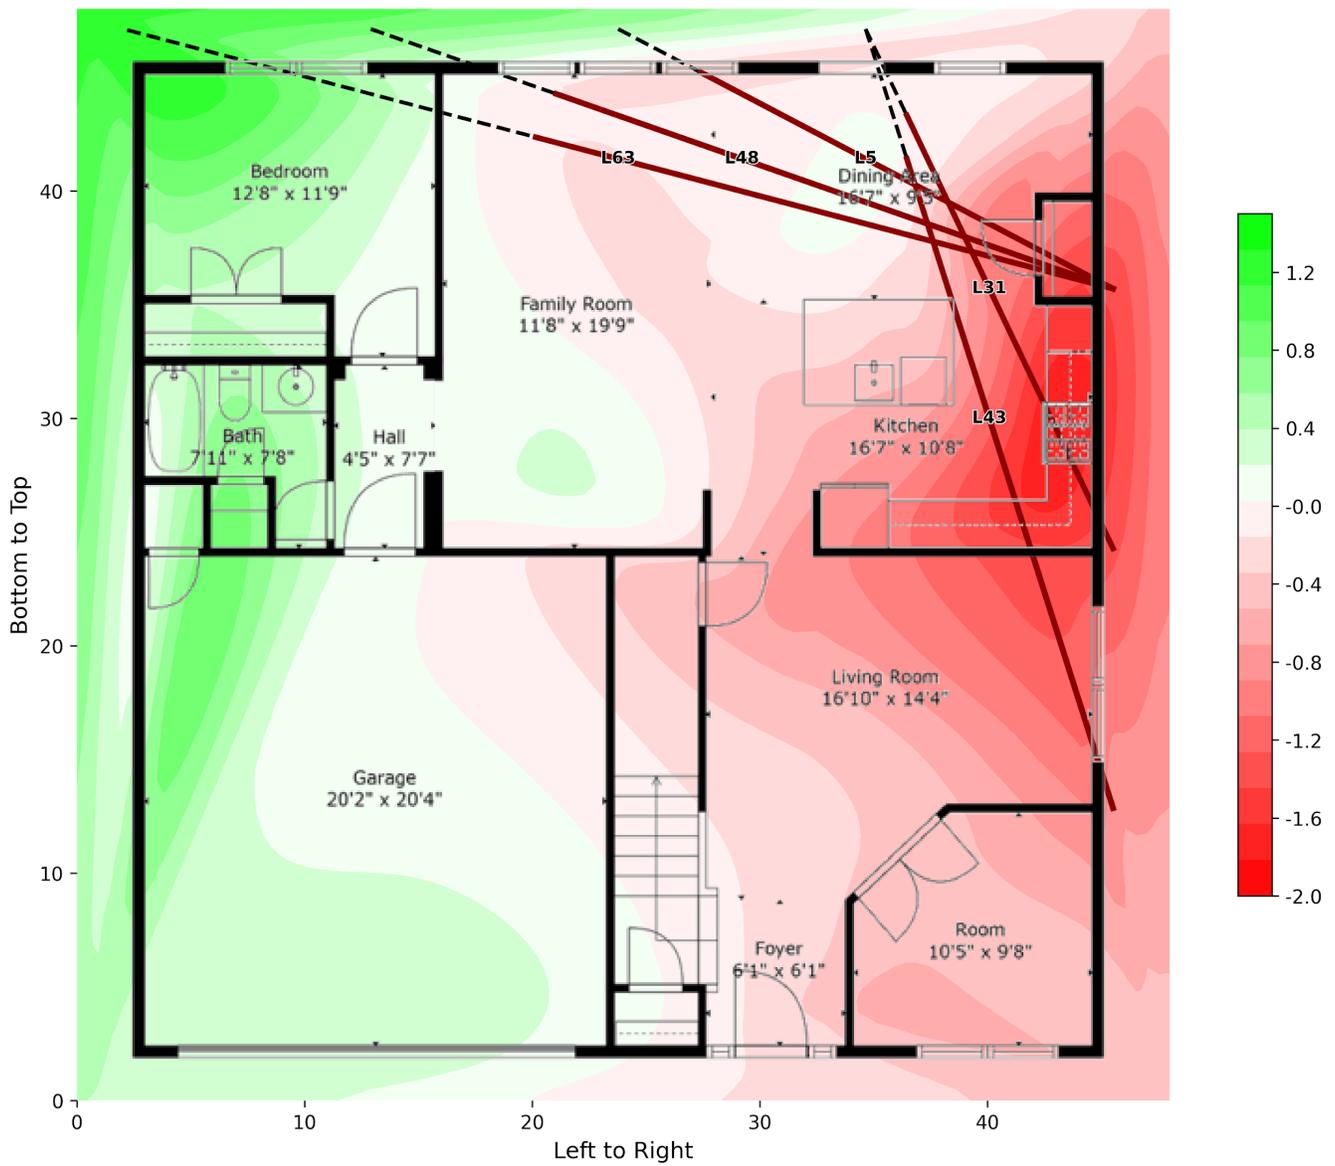
Deflection Failures Graphic (Figure D)

The above Figure D shows deflection failures along the foundation. Deflection failures can be considered localized failures in (sometimes) isolated portions of the foundation. The profile lines that were calculated are represented by a dashed black line and the areas that the deflection failures occur are represented by a dark red line segment. Of the 76 deflection profiles calculated, 5 profile failures were identified.

Deflection failures can be considered localized failures of the foundation in (sometimes) isolated portions of the foundation. Of the 76 deflection profiles calculated, 5 failures were identified.

Deflection failures are above standard acceptable limits; they exceed industry-standard thresholds and the structure should be considered actively moving/settling in areas where deflection failures are occurring.

To stabilize and lift the foundation, install and/or adjust perimeter and interior piles/piers as shown in the attached Exhibit C - Proposed Repair Plan. The underpinning may be concrete cylinders, steel pipe, helical screws, or drilled concrete piers – refer to Exhibits D, E, F, and G. Underpinning will not improve the performance of the foundation in non-underpinned areas. Note, any foundation movement, even corrective, can cause additional cosmetic distress. The contractor shall determine the amount of elevation correction needed based on the reaction of the structure during the adjustment in order to minimize stress and additional cosmetic damages.

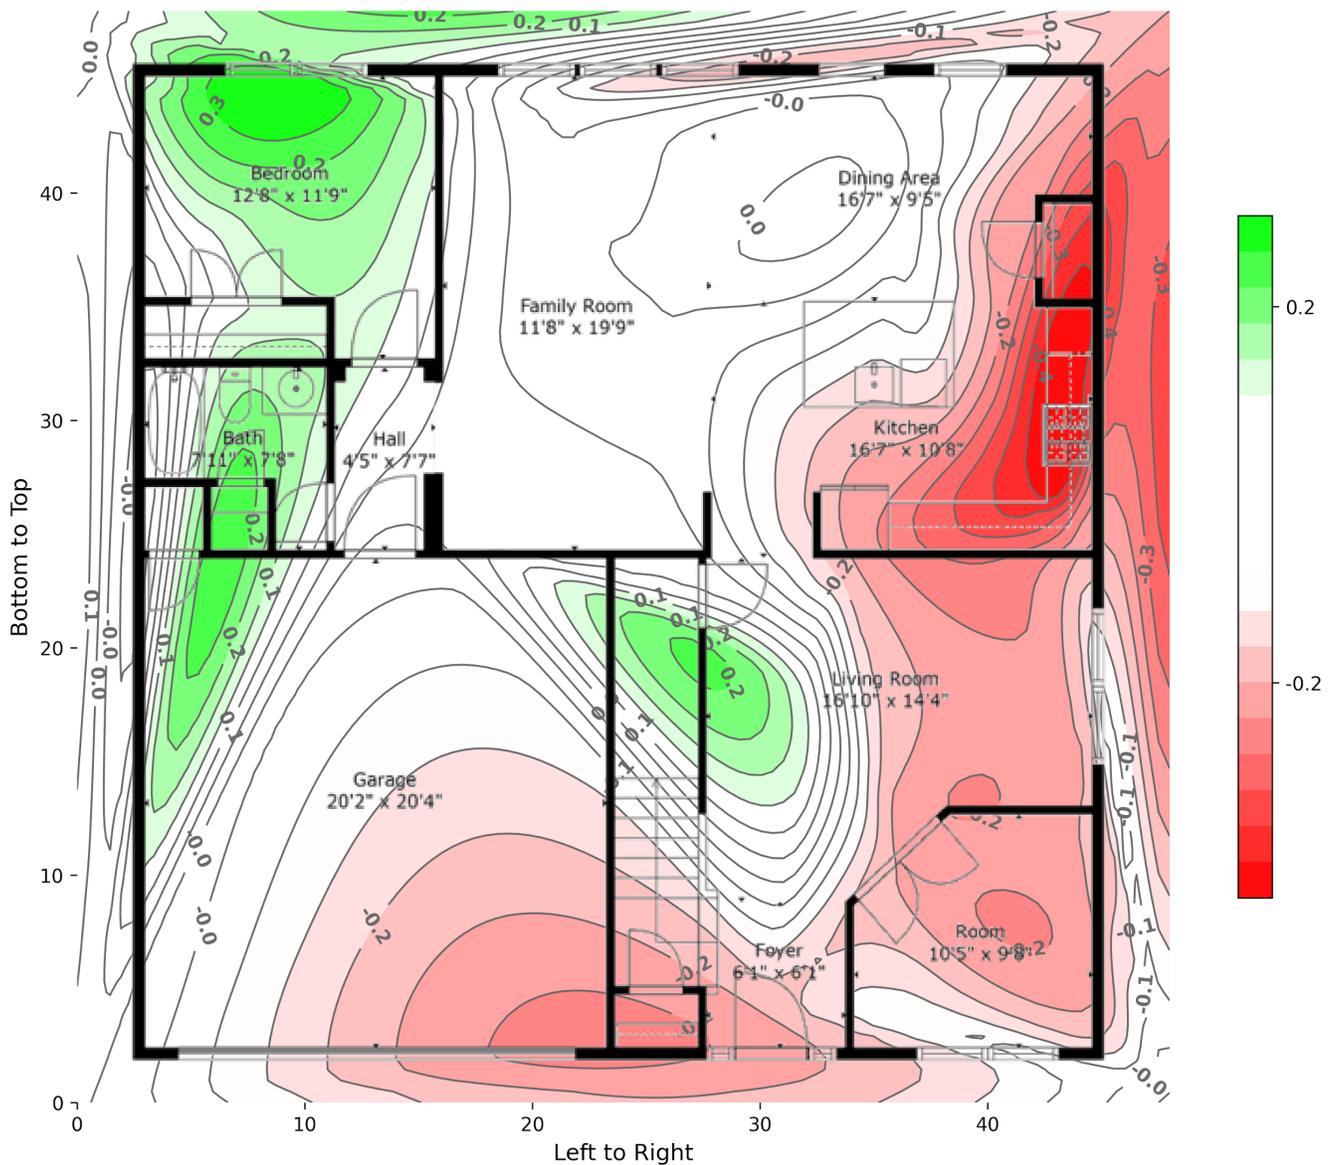
Elevation Plot Difference Graphic (Figure F)

The mesh contour graphic above in Figure F shows areas in red that are lower than the baseline elevation plot and areas of green that are higher than the baseline elevation plot (from the provided drawing completed in 1998). The darker the color (both red and green) the larger/smaller the elevation differences.

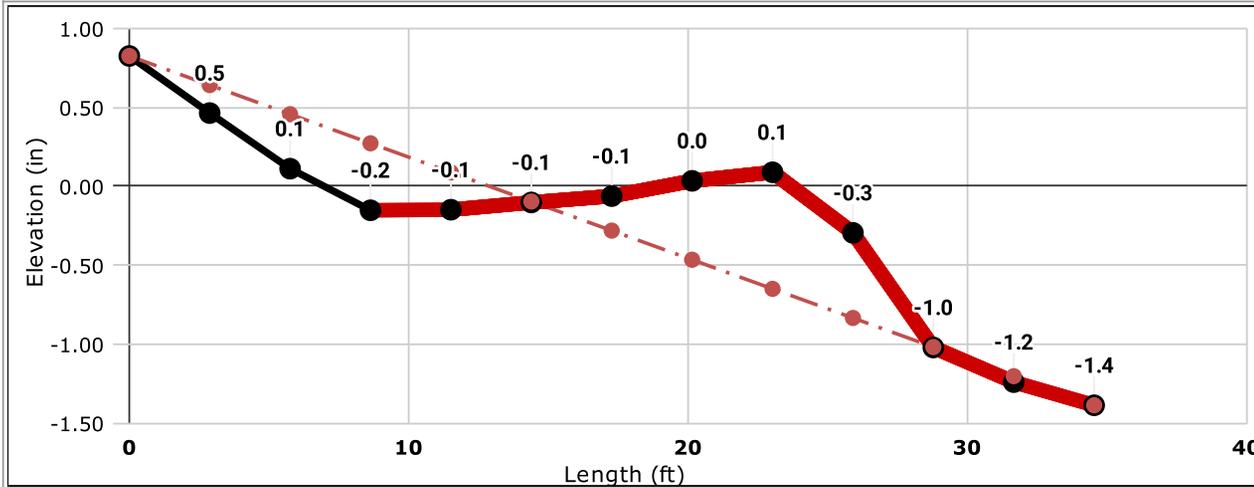
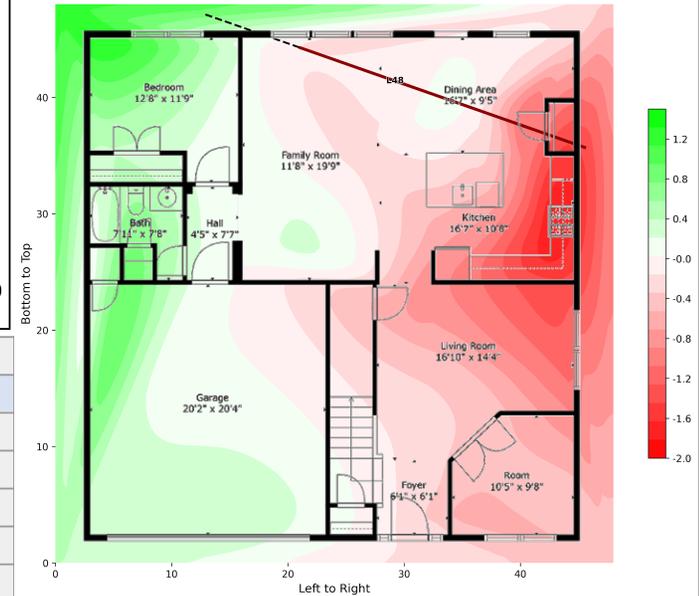
Exhibit A: Identified Deflection/Tilt Failure (L48)

Profile Data for L48		Actual Length (ft)						Effective Length (ft)					
Point (#)	1	2	3	4	5	6	7	8	9	10	11	12	13
Length (ft)	0	3	6	9	12	14	17	20	23	26	29	32	35
Tilt (in)	0.8	0.6	0.5	0.3	0.1	-0.1	-0.3	-0.5	-0.6	-0.8	-1.0	-1.2	-1.4
Z (in)	0.8	0.5	0.1	-0.2	-0.1	-0.1	-0.1	0.0	0.1	-0.3	-1.0	-1.2	-1.4
Deflection 1 (Failures)				-0.2	-0.1	-0.1	-0.1	0.0	0.1	-0.3	-1.0		
Deflection 2 (Failures)					-0.1	-0.1	-0.1	0.0	0.1	-0.3	-1.0	-1.2	
Deflection 3 (Failures)				-0.2	-0.1	-0.1	-0.1	0.0	0.1	-0.3	-1.0	-1.2	
Deflection 4 (Failures)					-0.1	-0.1	-0.1	0.0	0.1	-0.3	-1.0	-1.2	-1.4
Deflection 5 (Failures)						-0.1	-0.1	0.0	0.1	-0.3	-1.0	-1.2	-1.4

k-factor Calculation										
Start Position (x,y) (ft)	12.91	0.88	End Position (x,y) (ft)		45.52	12.3	k-factor (1.00 to 1.41)			1.06
Length (ft)	32.61		Width (ft)		11.42		Limit			L / 340

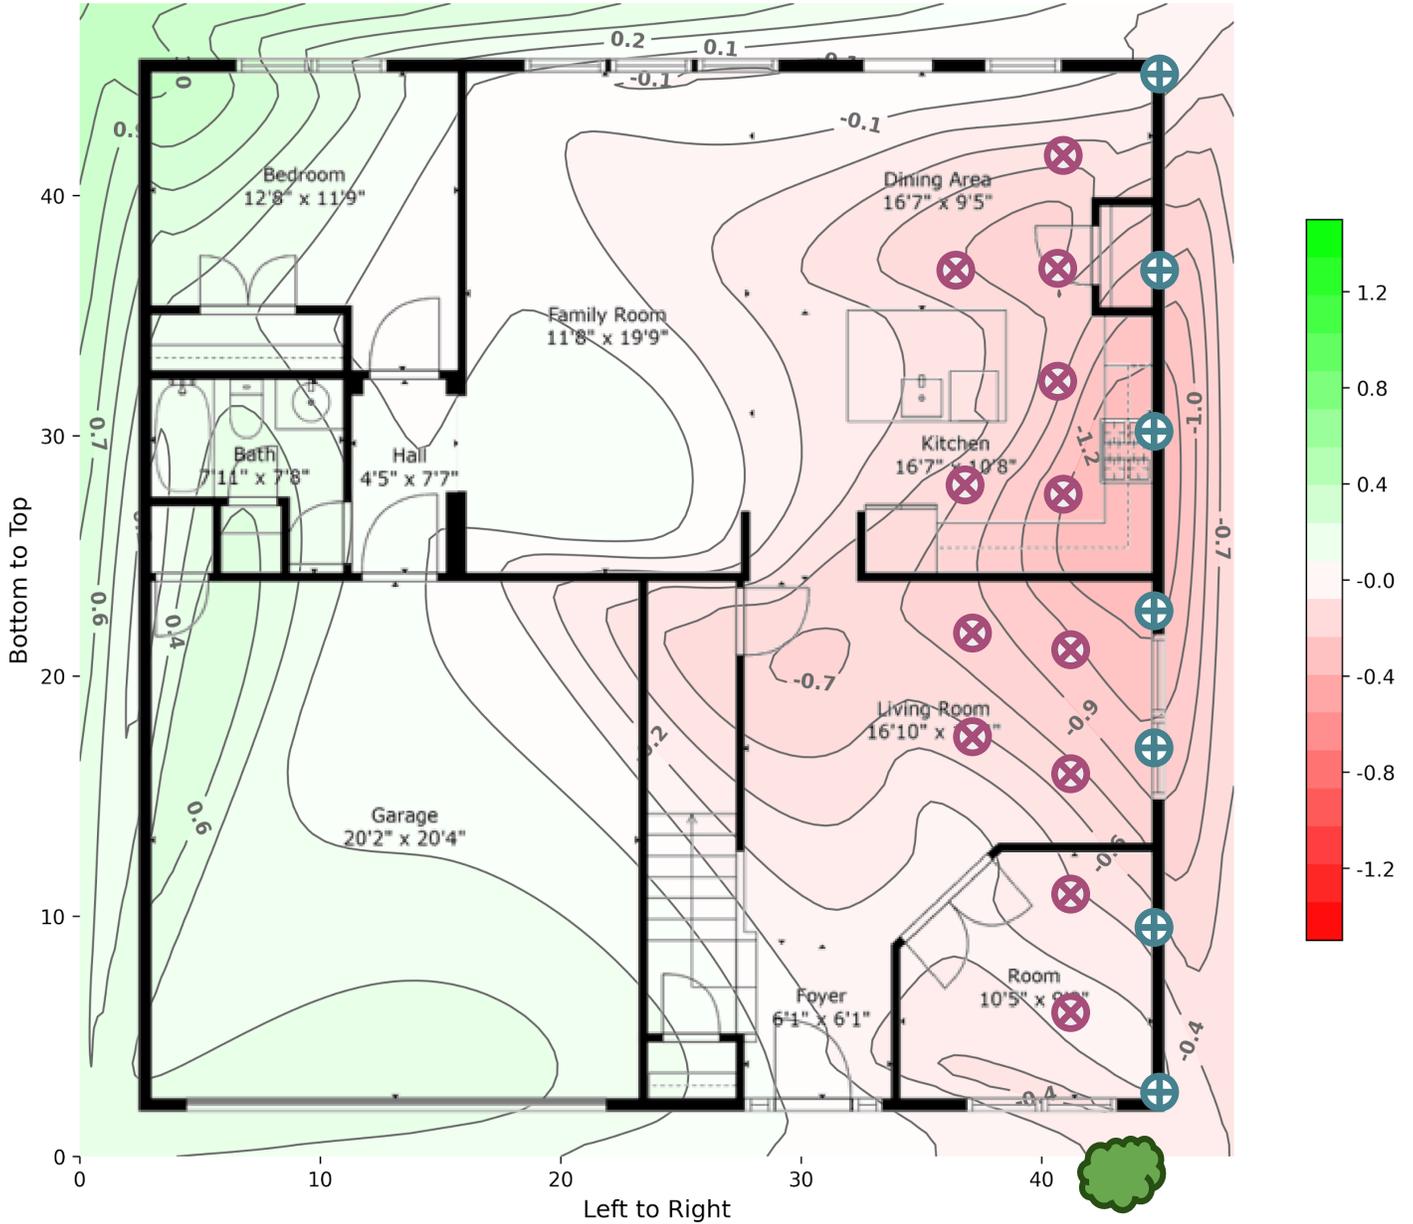
Exhibit C - Proposed Repair Plan

PROPOSED	
Contour Line and Elevation	Exterior Push Pile or Drilled Pier	7	<i>piers/pilings</i>
Base Station (0.0)	Interior Slab Pier	12	<i>piers/pilings</i>
Zero Elevation (0.0)	Existing Pile/Pier to be Adjusted	0	<i>piers/pilings</i>
Negative Elevation (-)	Existing Support Areas to be Adjusted	0	<i>square-feet</i>
Positive Elevation (+)	Trees to be Removed	0	<i>trees</i>

The repair plan we have provided may have been developed without location information on existing underpinning. If possible, we recommend locating documentation of any existing underpinning prior to implementation of the new underpinning. This documentation may be provided to us to analyze and adjust the repair plan as needed to maximize its effectiveness. Adjustment of the existing piers/piles that are in the same location as our recommended underpinning can be substituted for installation of new underpinning.

Following completion of the foundation underpinning installation, it is recommended that you obtain a final elevation survey to provide a post-repair elevation baseline. Review the performance of the foundation every 6 to 12 months. Compare all future foundation evaluations to the pre-repair and post-repair elevation baselines and to produce a final elevation survey with post-repair baseline and to ensure that the repairs have been performed in general accordance with our recommendations and in line with the Texas Section of the American Society of Civil Engineers (ASCE) guidelines.

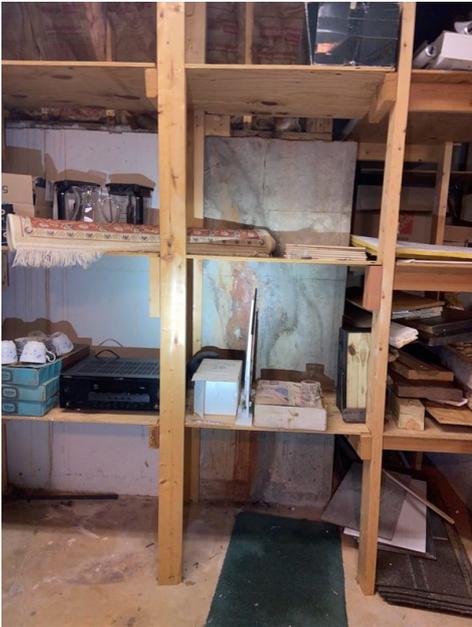
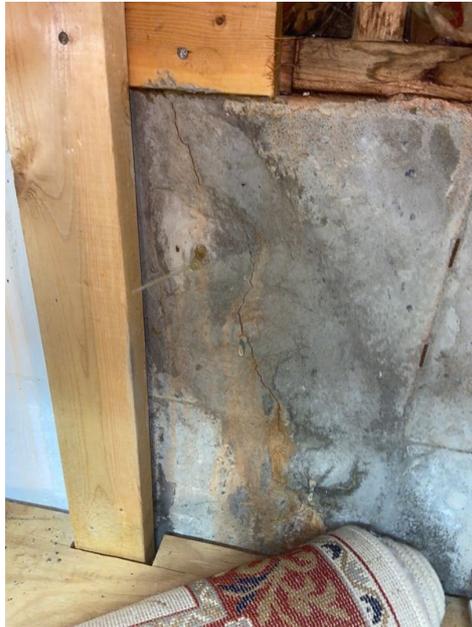
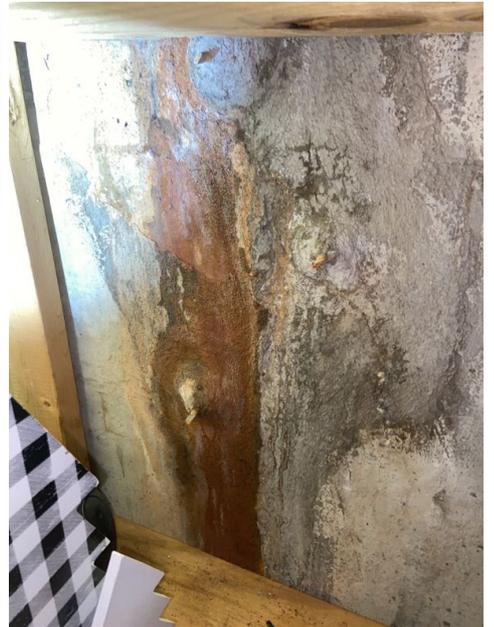
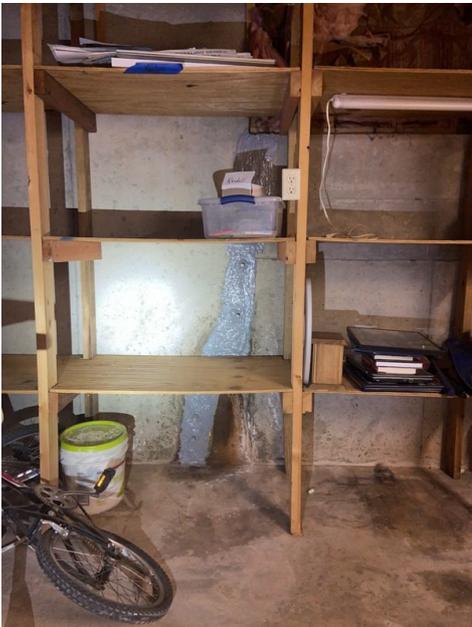
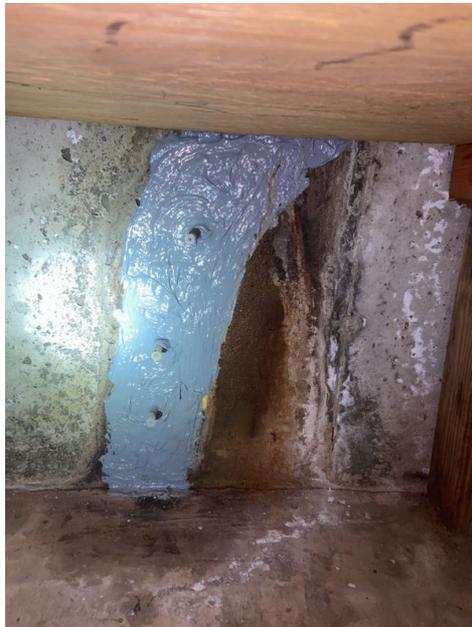
Assessment of true and present foundation deficiencies is difficult when foundation repair has been completed because inspector is unable to determine the extent of the stabilization and resolution of present foundation issues. Common indicators of foundation problems may be resolved or may continue to exhibit failure. It is difficult situation to fully understand without a timeline of events.

Recommend contacting the owner about the extent of the repairs to determine their validity as a true foundation stabilization, type of repair, and warranty. Recommend researching the previous foundation repair company to determine if they have quality reviews, have a long standing reputation, and if any warranty is transferable.

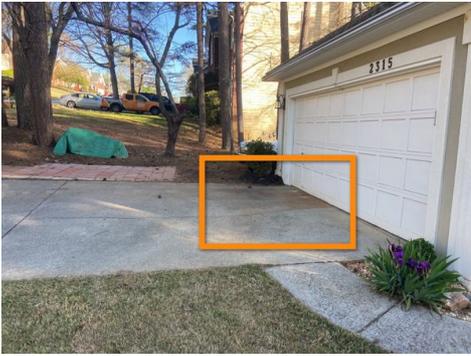
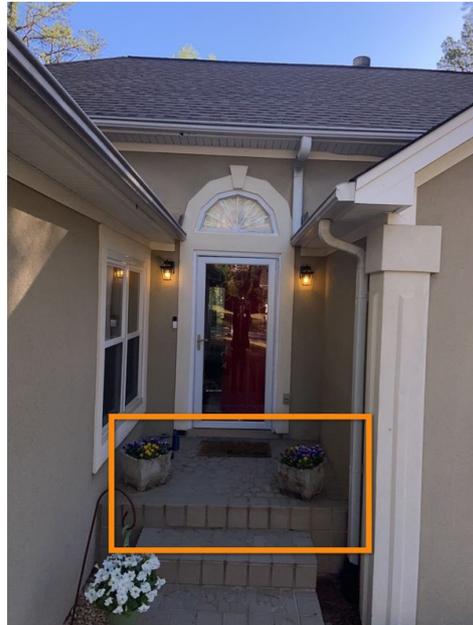
AREA WHERE WATER WILL STAND

Area where water can occur, which could indicate poor drainage and/or grading. Recommend monitor and/or have landscaper correct.

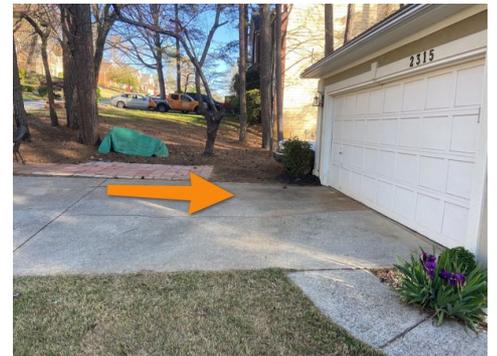
Front left of driveway

NEGATIVE GRADING SLOPE

Grading is sloping towards the structure in some areas. The slope away from the structure should be at least 0.5 inch per foot for 10 feet. This drainage slope could lead to water intrusion and foundation issues. Recommend qualified landscaper or foundation contractor regrade so water flows away from structure.

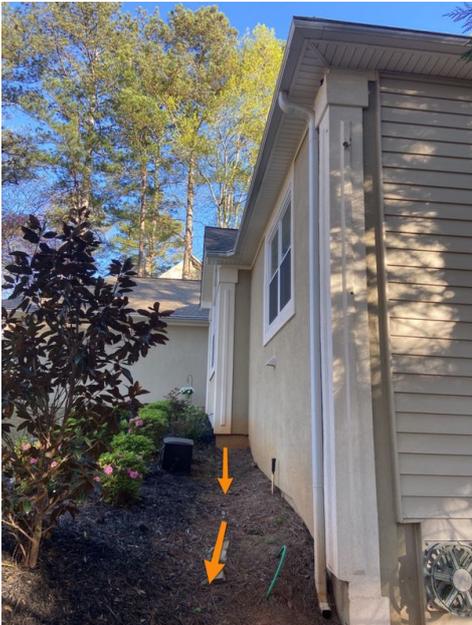
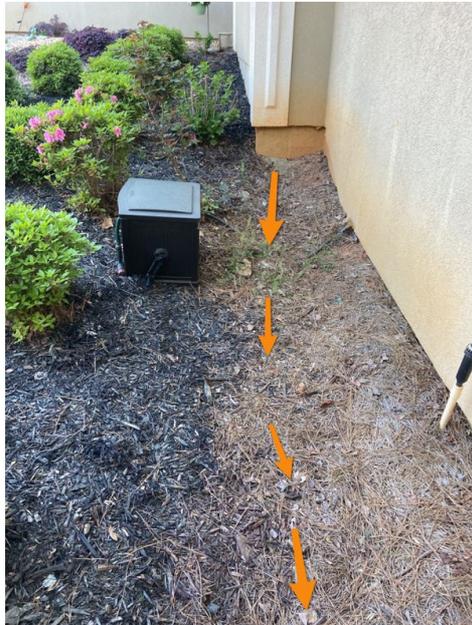
Erosion of soils is present. Erosion areas are significant to site drainage impact because they represent areas where stormwater velocities are high and water is "flowing." Erosive areas should be investigated and understood. Often these areas need above-average and more aggressive attention, such as concrete stabilization, re-grading, and/or drainage piping installation.

In this particular case, the erosion at the back right corner of the property appears to be due to a damaged landscape irrigation sprinkler.

Front right. From water skipping over gutter guards

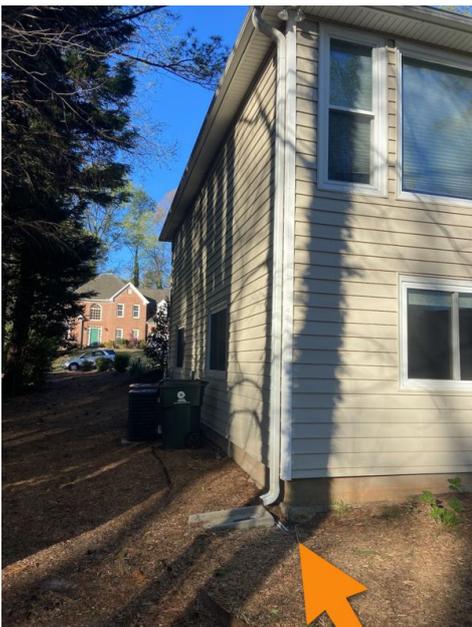
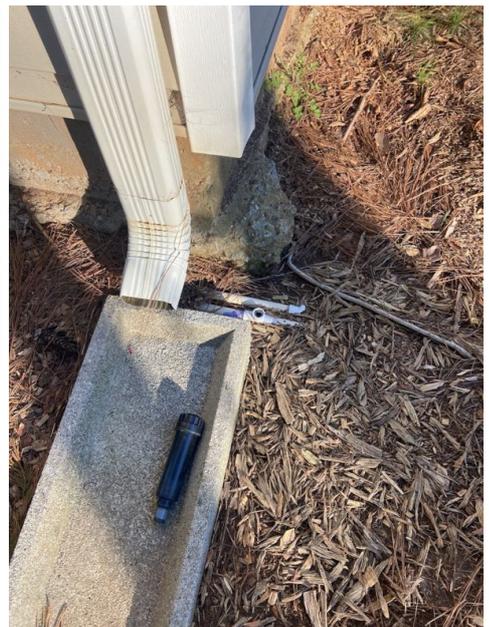
Erosion of soils is present. Erosion areas are significant to site drainage impact because they represent areas where stormwater velocities are high and water is "flowing." Erosive areas should be investigated and understood. Often these areas need above-average and more aggressive attention, such as concrete stabilization, re-grading, and/or drainage piping installation.

In this particular case, the erosion at the back right corner of the property appears to be due to a damaged landscape irrigation sprinkler.

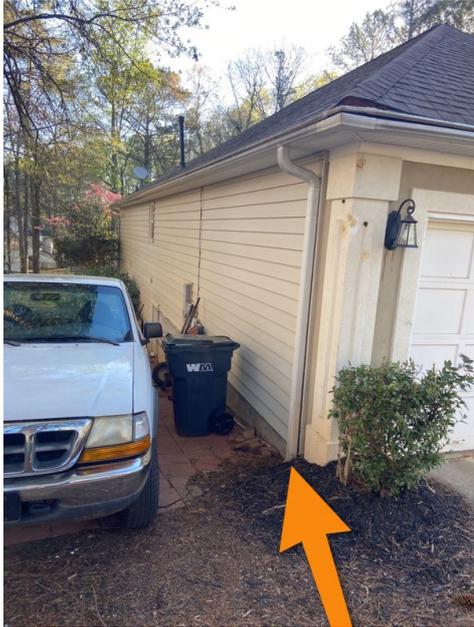
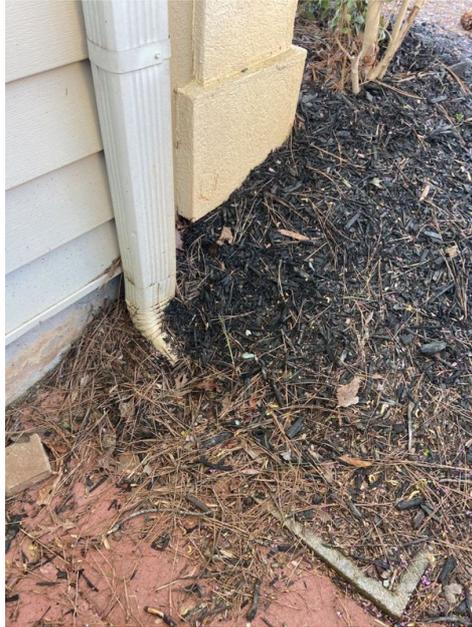
Front Left

DOWNSPOUT IS BLOCKED BY DEBRIS

The downspout is blocked by mulch and debris. Recommend cleaning of this area so water flows properly away from the structure.

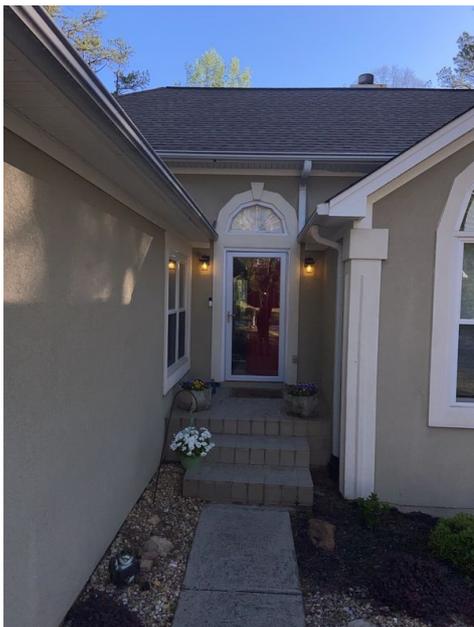
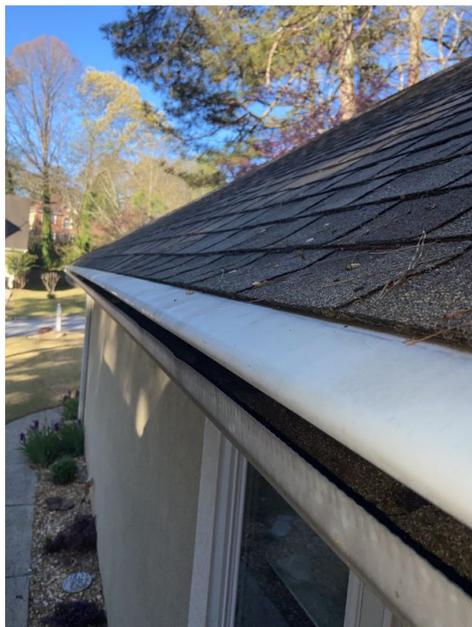
GUTTER GUARDS RESTRICT WATER FLOW

It appears that the gutter guards installed on the structure cause water to skip over them completely, and do not allow the water to flow into the gutters properly. Recommend installation of new gutters/gutter guards in problematic areas where water is standing next to the foundation

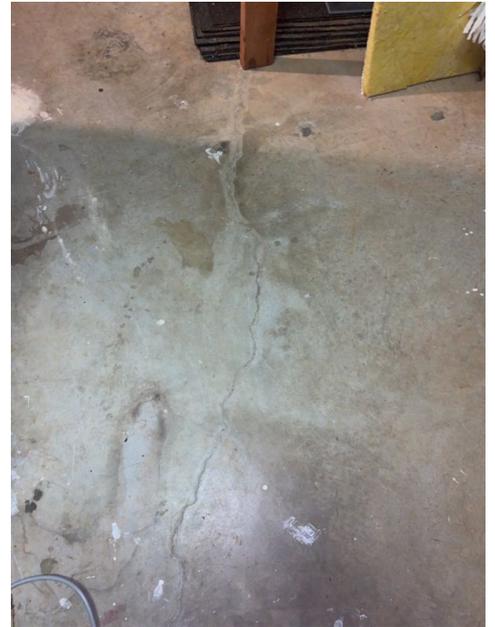
Areas of basement floor

FLOORING - CRACKS MINOR

Minor cracking observed on the flooring that is unlikely due to structural foundation issue. This is common in structures this age and is often determined to be cosmetic. Recommend patching the area and monitoring the cracking. The best way to monitor cracking is to patch it (with mortar, grout, calk, etc.) and see if it reappears.

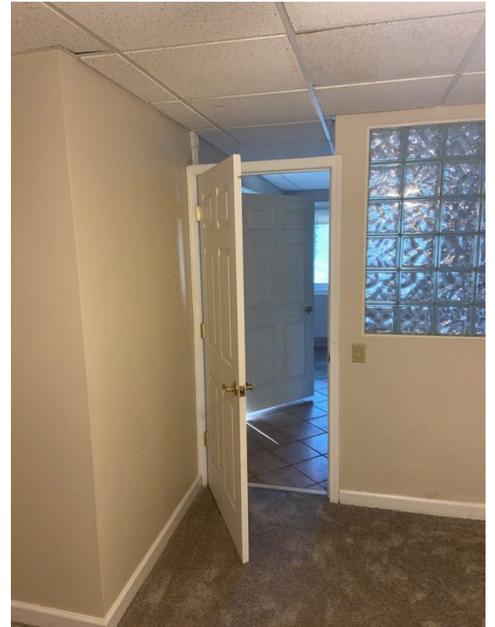
Basement bathroom door

DOOR DOESN'T LATCH TO CLOSE

Door doesn't latch to close properly. Recommend handyman repair door, latch, frame, and/or strike plate.

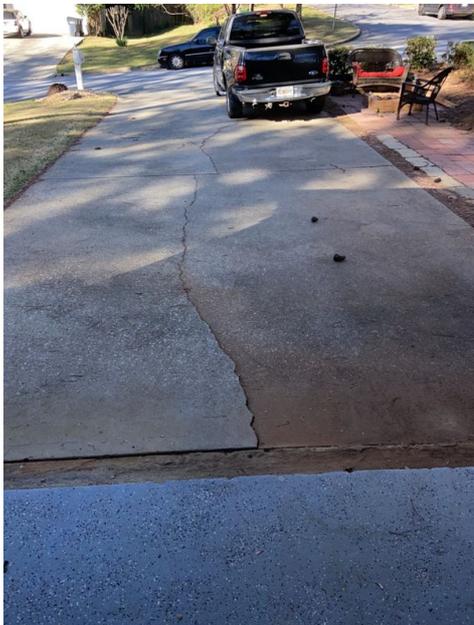
Driveway

OLD CONCRETE - CRACKS, SEPARATION, AND HEAVING

The driveway and/or sidewalks show signs of aged cracking, separation, heaving, and/or deterioration. This is common in areas of the state that have clay-based soils. Compromised concrete will continue to exhibit decay, failure, collapse, and uplift if not remediated. Recommend caulking larger cracks and applying a concrete sealer. Cracking can also be a safety hazard for pedestrians if it becomes (or is currently) a trip hazard.

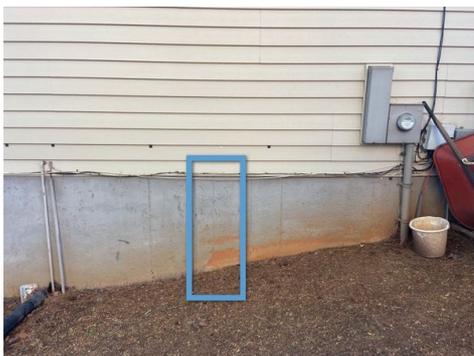
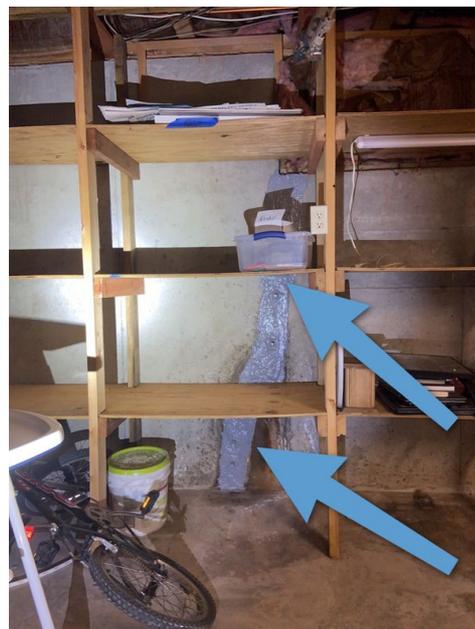
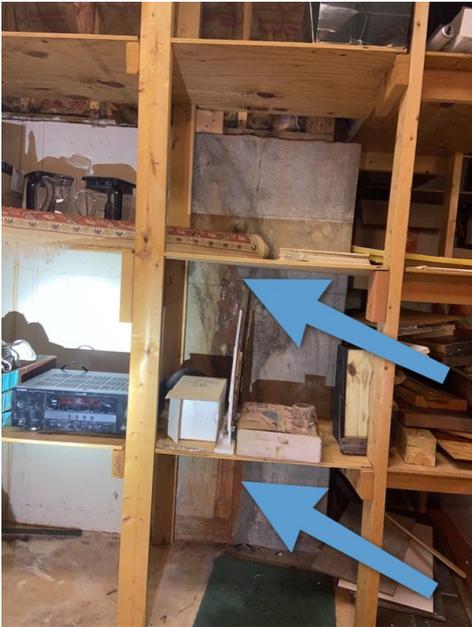
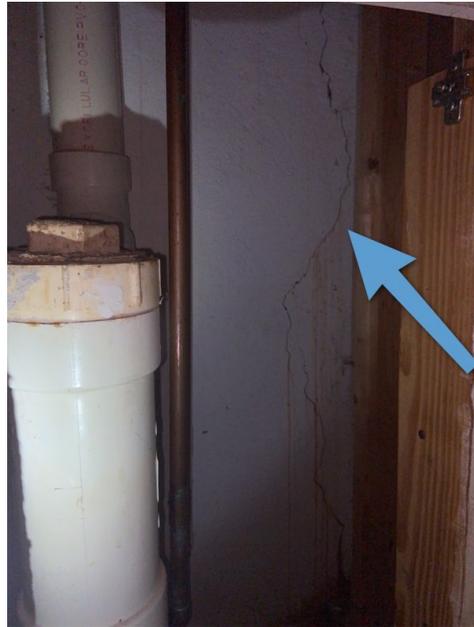
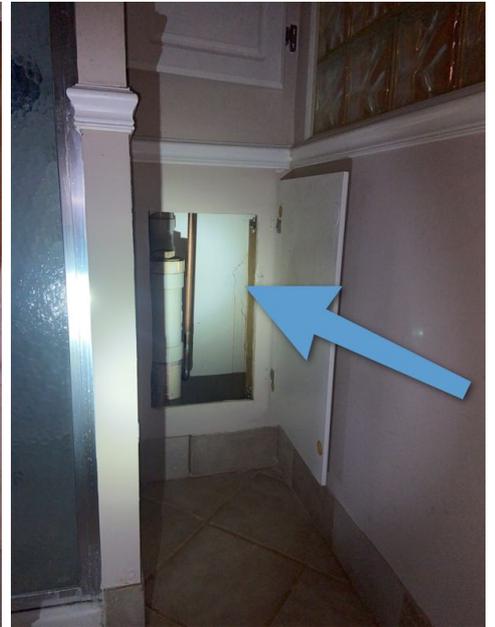
Vertical cracks can appear straight up and down or within 30 degrees of vertical, and are typically caused by settlement. In some cases, newly constructed homes can settle within the first few years, vertical cracks are common in both newly constructed and older homes.

Vertical cracks seldom indicate structural failure. That said, they can allow water to seep into a basement and allow for pest infestations to persist. Recommend sealing/caulking the vertical crack to prevent moisture intrusion and pests from entering the structure. This will also allow for the monitoring of the crack for possible foundation issues in the future.

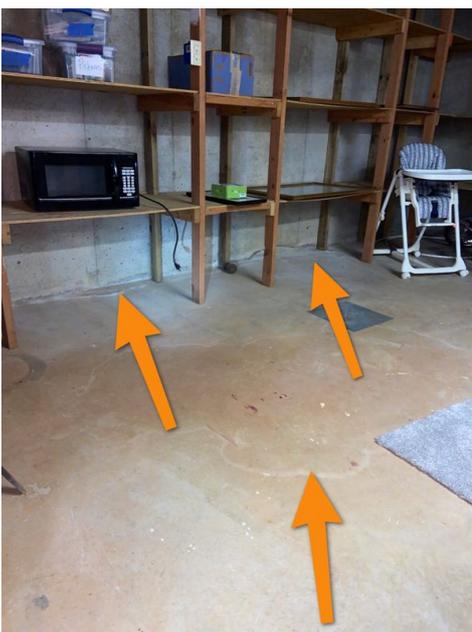
Basement walls and floor

Ultimately, efflorescence itself isn't dangerous. However, it can lead to potential moisture problems that can cause structural damage to building materials (particularly degradation of the internal rebar in concrete).

Recommend consulting with a concrete or foundation contractor that may apply a mild acid or efflorescence remover and seal the concrete. Monitor for future foundation issues.

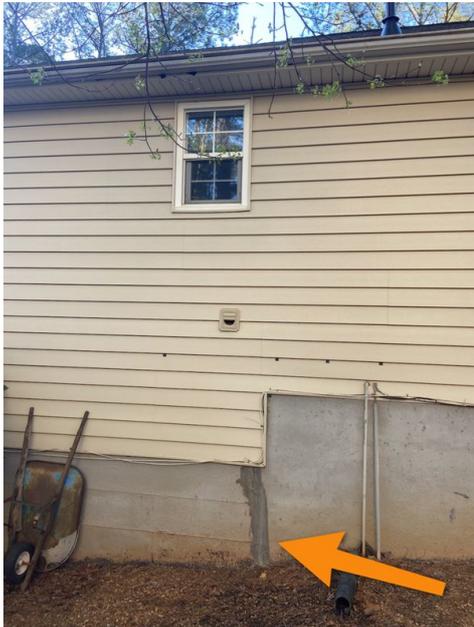
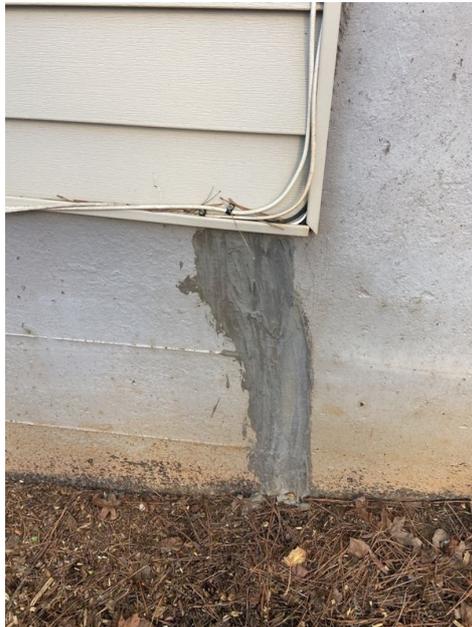
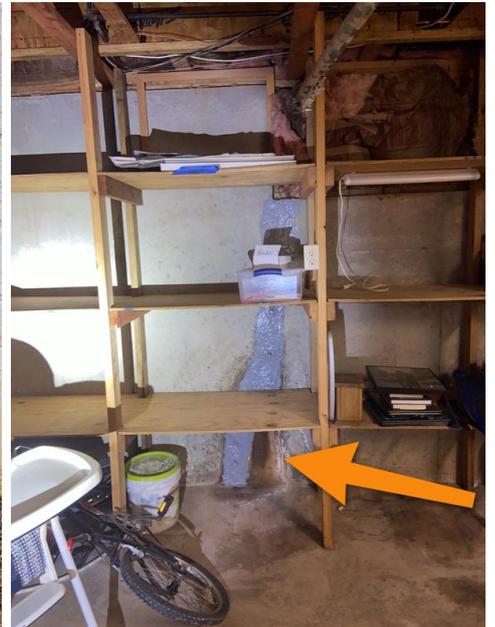
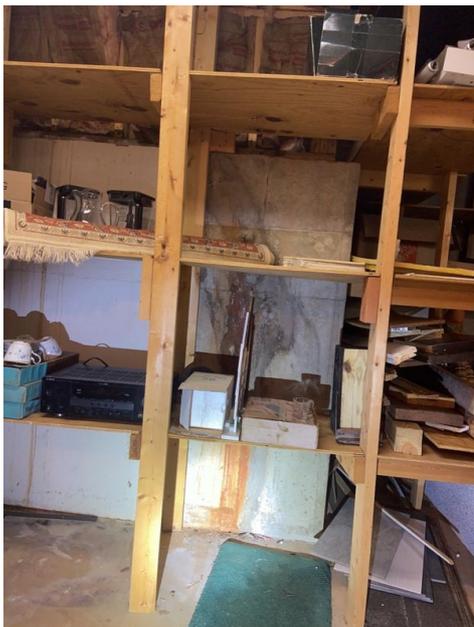
WALL - VERTICAL CRACK PATCHED

Hey patch was noted to a vertical crack on the basement wall To avoid water intrusion in the basement. Recommend monitoring this patch for further cracking.

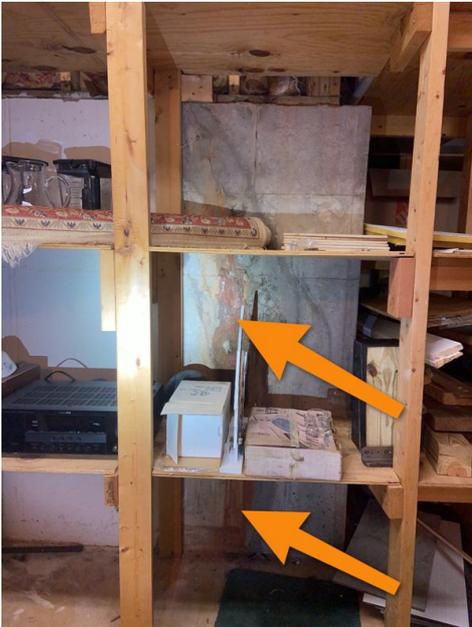
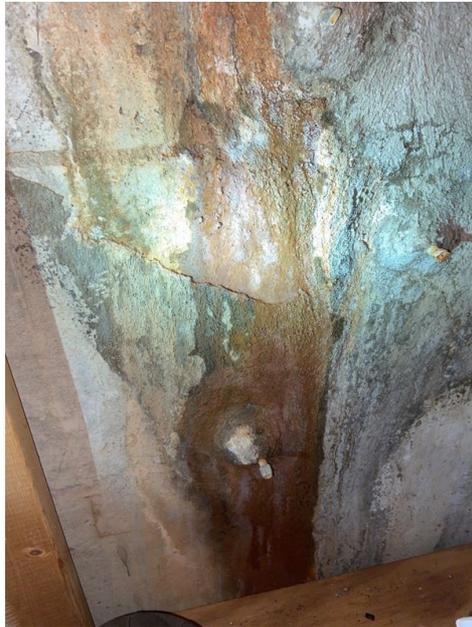
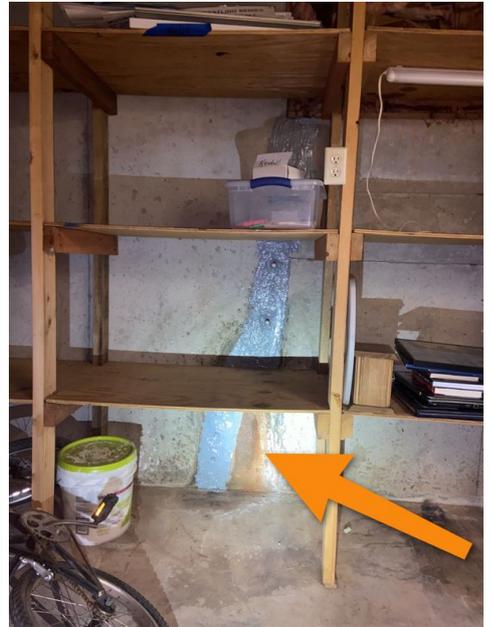
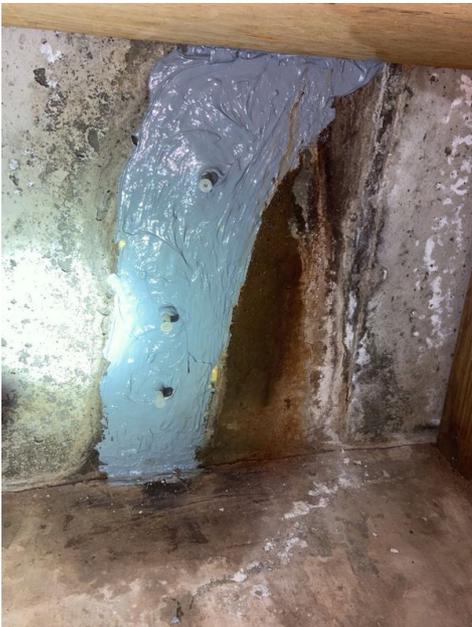
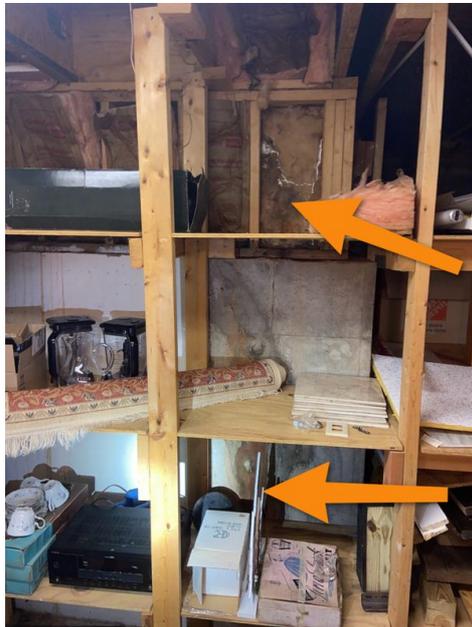
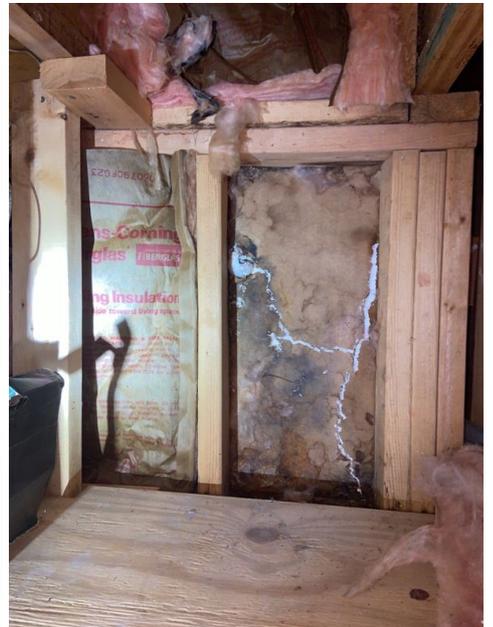
ACTIVE WATER INTRUSION IN BASEMENT

Active water intrusion was noted in the basement. Some of these areas have already been patched. Previously with a injectable epoxy sealant. It appears that settlement has continued since The repairs have been made allowing for more water intrusion. Recommend remediation by a waterproofing contractor.

Coming through stucco wall underneath the foyer

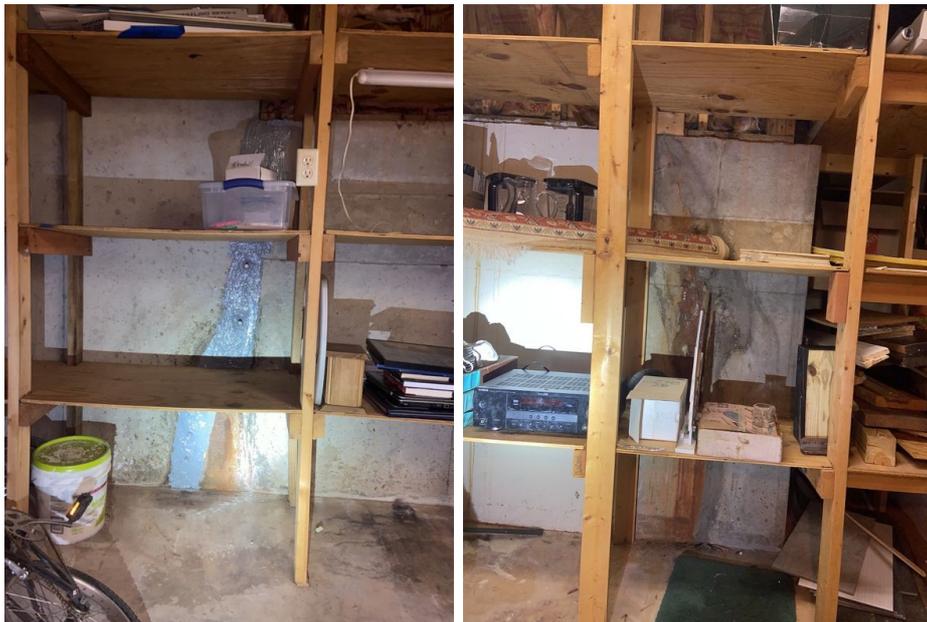
Visual Condition Assessment: Visual Discovery of Previous Foundation Work

There exist signs of previous foundation improvements that were completed to the structure. Refer to the inspection report for approximate locations of the improvements to the structure. The exact extent (depth, width, type, etc.) could not be field-verified (other than capped field-observations reported herein). Existing underpinning is typically concealed entirely below grade. No invasive or destructive investigation nor subgrade radar readings were performed to confirm the presence or absence of any existing foundation underpinning.
