ROOF MRI

OVERVIEW

ROOF TYPE: COATED PVC (DURO-LAST)

2209 S 24TH ST OMAHA NE 68108

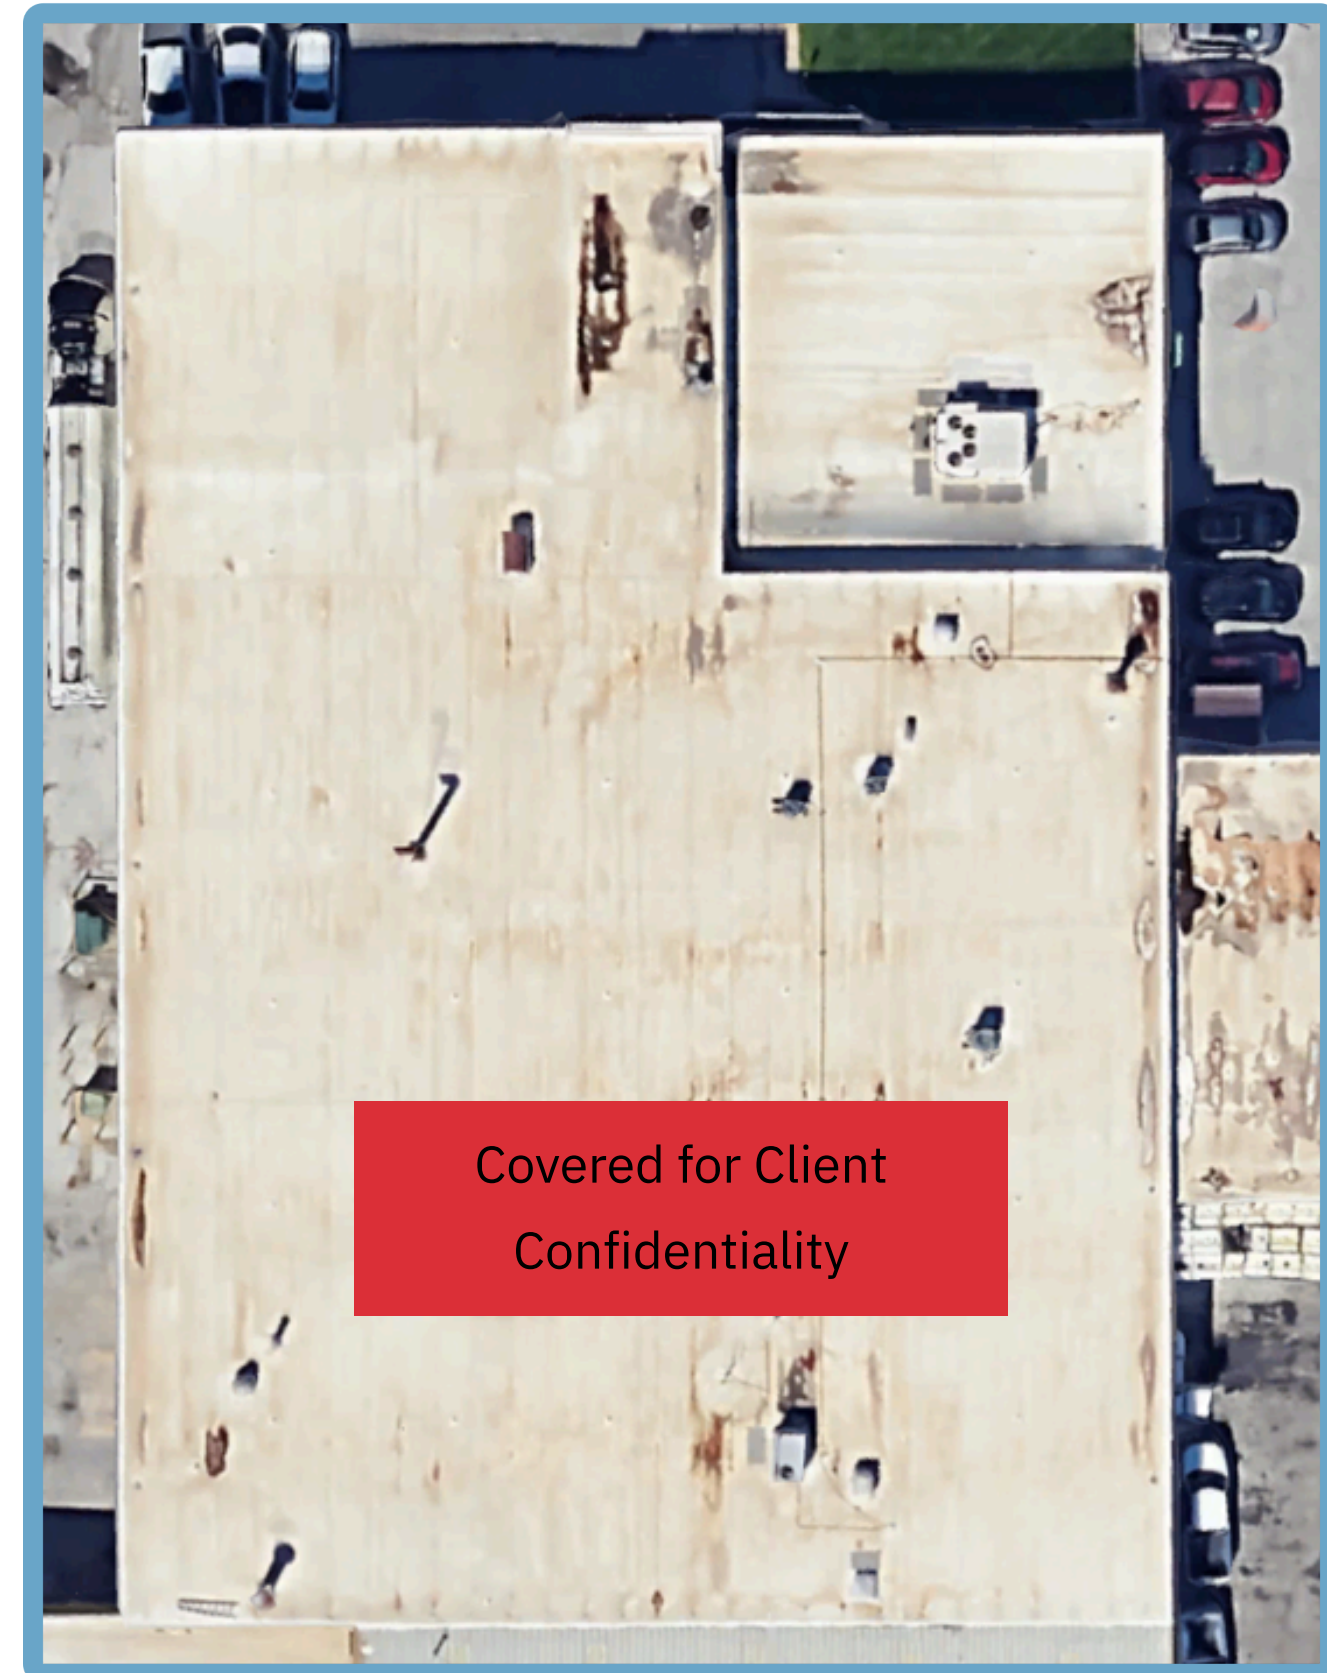
MOISTURE ANALYSIS:	WET	4000SF(13%)	<div></div>
	DAMP	10900SF(37%)	<div></div>
	DRY	14800SF(50%)	<div></div>
	UNDETERMINED	0SF (0%)	<div></div>

Dry-Out Progress Summary (May 2024 to May 2025) This roof has been under active dry-out using ReDry vents for the past year. The initial scan from May 2024 showed extensive saturation, with the vast majority of the grid reading in the 8–10 range, indicating fully saturated insulation. Only a few isolated areas registered in the dry (0–4) or moderate (5–7) range, and the system overall was holding a substantial volume of moisture throughout the field. **The May 2025 scan shows a dramatic improvement:**

- High saturation (8–10) zones have been significantly reduced and are now confined to a few isolated pockets
- Moderate moisture (5–7) has become the noticeable moisture reading range across the roof
- Dry readings (0–4) now make up the primary portion of the grid, particularly in the center and lower sections

This shift reflects consistent progress: trapped moisture has been successfully mobilized and ventilated over time, reducing saturation and promoting healthy drying. Based on the visual grid, more than 75% of the roof is now at or below moderate levels, a significant turnaround from the fully saturated starting condition. These results confirm that the dry-out process is well underway and trending toward completion with continued airflow.
