SLS Home Inspections

Property Inspection Report

, Bourbonnais, IL 60914
Inspection prepared for:
Real Estate Agent: -

Date of Inspection: 5/7/2025 Time: 4:00 PM
Age of Home: 1979 Size: 2292

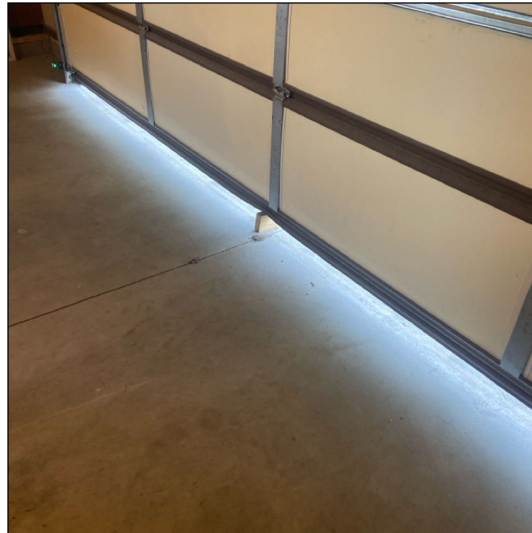
Page 14 Item: 5	Garage Condition	<ul style="list-style-type: none">The automatic retract feature of the overhead garage door motor is not operating. In my opinion this is an injury hazard and the door opener should be adjusted and/or serviced by a qualified garage door technician.
-----------------	------------------	--

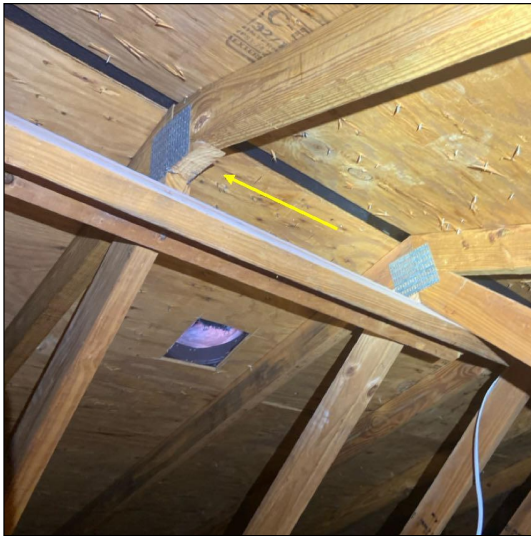
Page 17 Item: 5	Roof Framing Condition	<ul style="list-style-type: none">There are cut, modified or altered truss structural framing members. Truss framing is specifically engineered and should not be cut, modified or altered without the direction of a qualified design professional such as a structural engineer. This inspection cannot determine if these modifications were done under the watchful eye of a design professional. Evaluation is recommended by a design professional to determine if this poses any structural problems and/or to design a corrective solution. If correction is needed based on the design professional's opinion, corrective repair should be performed by a qualified contractor.
-----------------	------------------------	--

Cut truss

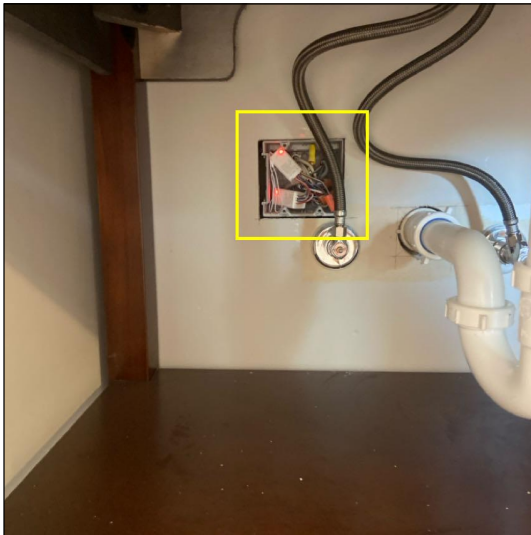
- Open wiring and splices are present and are not in appropriate junction boxes or enclosures in the bathroom, attic. This is an increased fire and shock hazard issue and needs to be corrected by a qualified electrician.

Under master bathroom sink

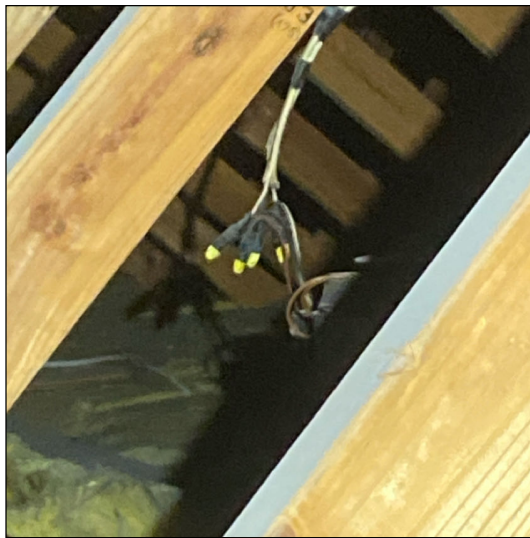
Wiring in attic

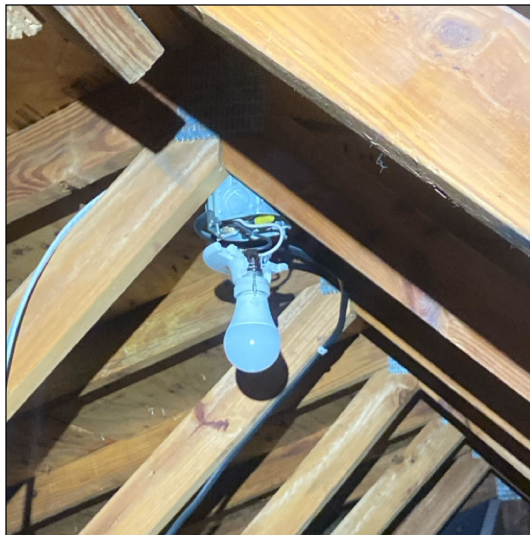
- Certain light fixtures do not appear properly secured. This is an increased electrical shock / fire hazard. Appropriate corrective action is recommended by a qualified electrician.

Loose light in attic

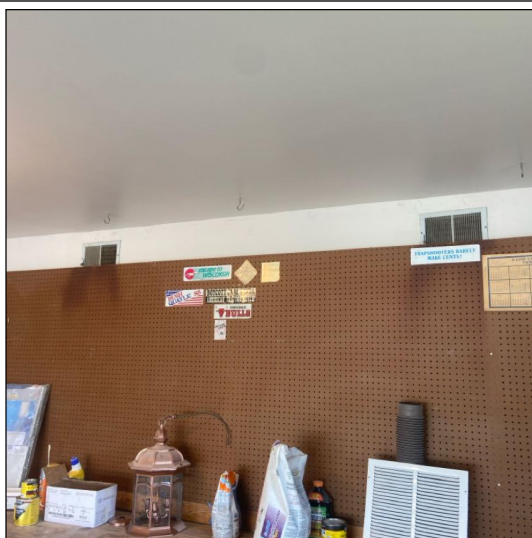
- HVAC ducts and/or registers are present in the garage. It is my opinion this is a fire / fume hazard due to the breach in the firewall and is a carbon monoxide hazard. Carbon monoxide poisoning can be deadly. I recommend you contact a qualified HVAC contractor for appropriate corrective action.

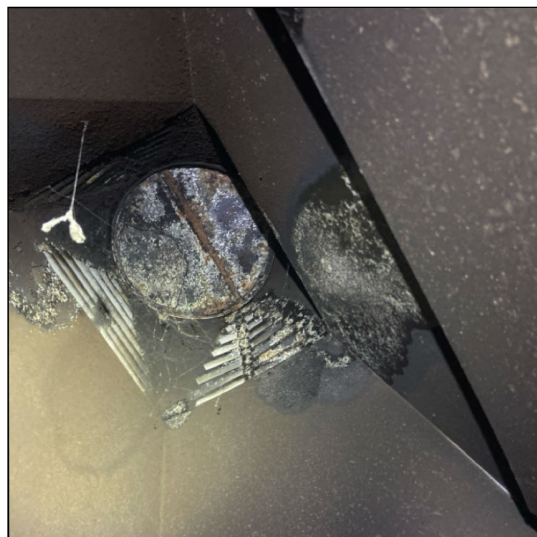
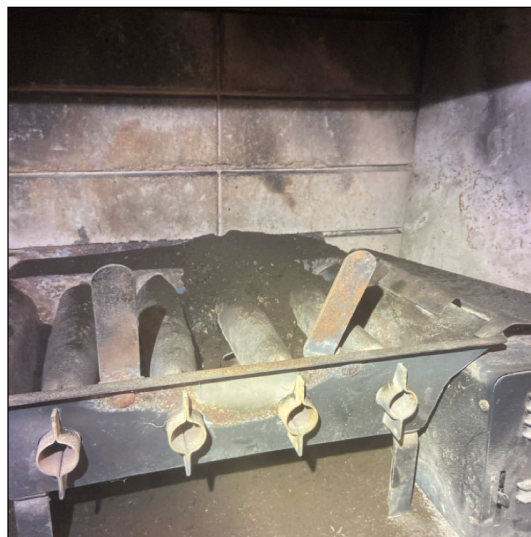
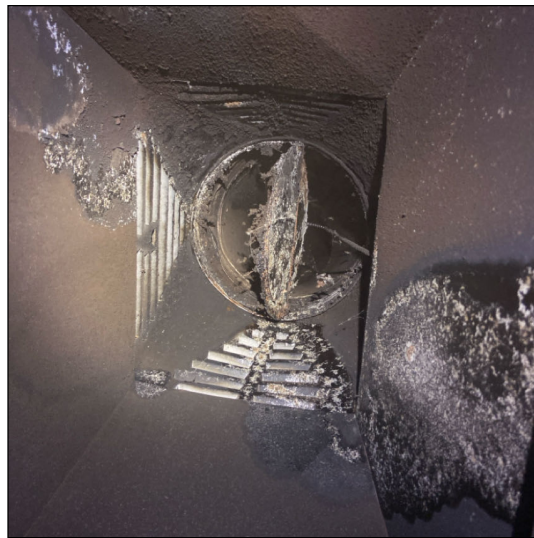
- **SAFETY** - There is a build up of creosote and debris in the fire box, smoke chamber or flue. In my opinion this is a fire hazard. Cleaning and servicing is needed by a qualified chimney sweep.

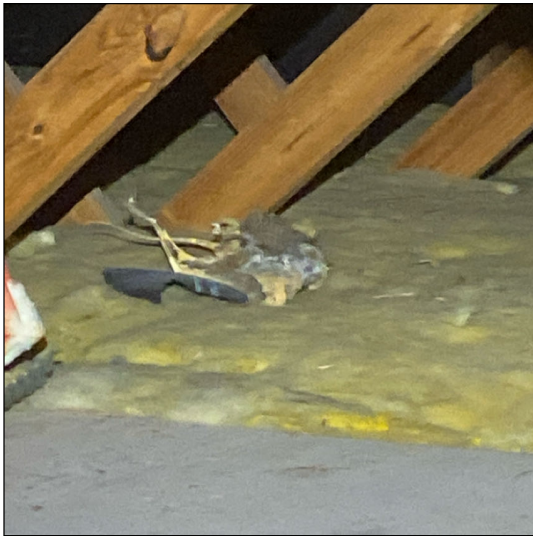
Page 33 Item: 1	Animal	<ul style="list-style-type: none">• SAFETY - This inspection excludes any and all conditions associated with pests and animal activity. However, there are indicators present in the attic that suggest animal and/or bird activity. This inspection cannot determine if they are active or if corrective measures have taken place. If corrective measures have been performed, its effectiveness is unknown. It is unknown how much damage is present to the home or structure. Contact a licensed pest control company for inspection and treatment.
-----------------	--------	--

Carcass in attic

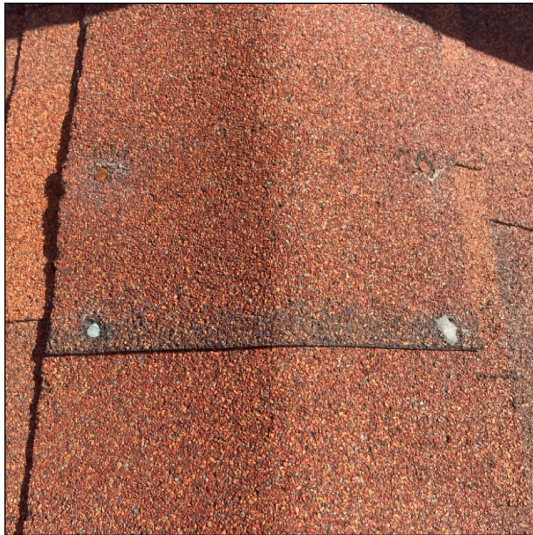
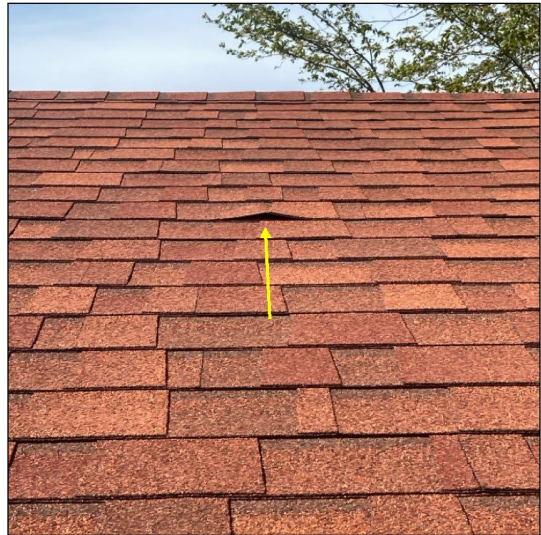
- Exposed nails on roofing material at hip/ridge. Recommend sealing all fastener heads with silicone.
- Sections of shingles are lifting. This can increase the chance of wind damage/shingles being blown off the roof. Recommend corrective action by qualified contractor.

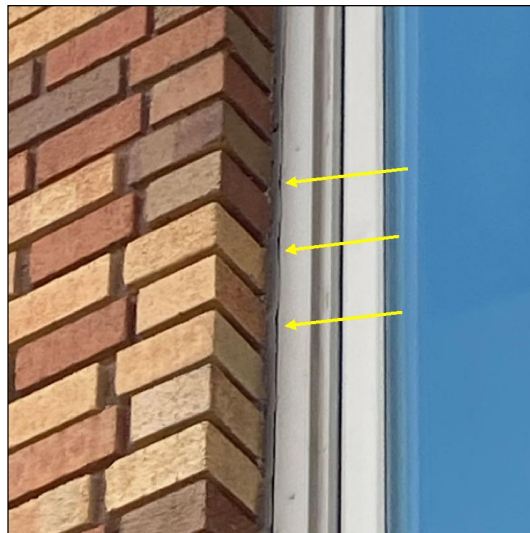
- Caulk, sealant, and/or flashing detail is deteriorated, damaged, or otherwise non-effective. In my opinion this can allow water leakage and water entry into the building, which can lead to various problems. I recommend you contact a qualified contractor for appropriate corrective action.

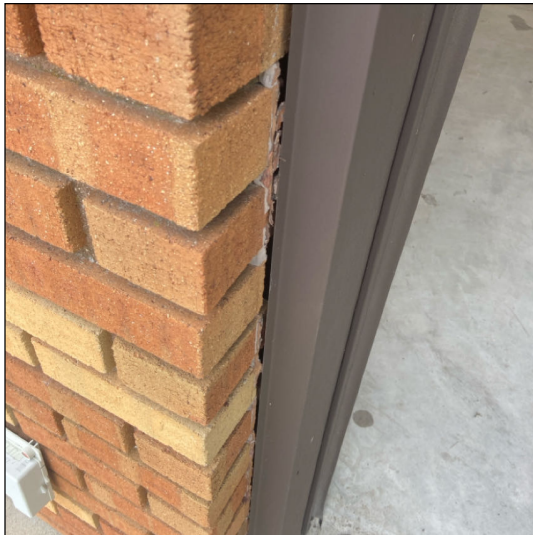
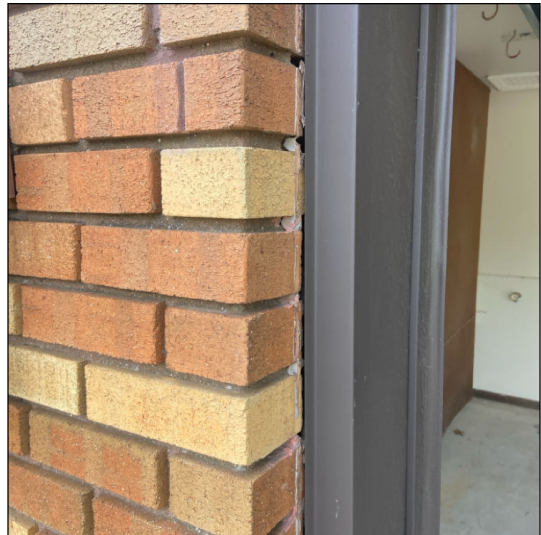
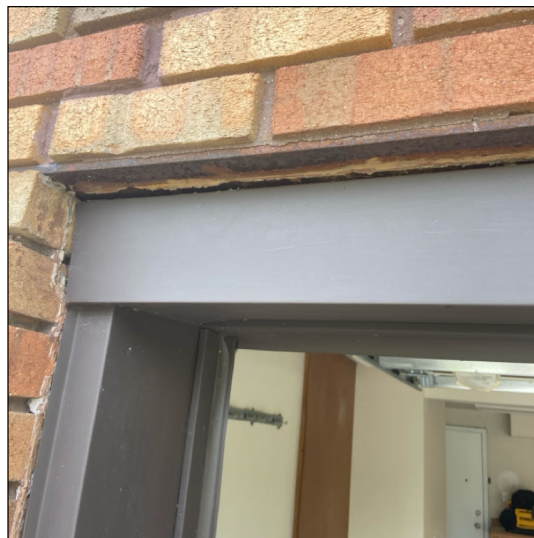
- Caulk, sealant, and/or flashing detail is deteriorated, damaged, or otherwise non-effective. In my opinion this can allow water leakage and water entry into the building, which can lead to various problems. I recommend you contact a qualified contractor for appropriate corrective action.

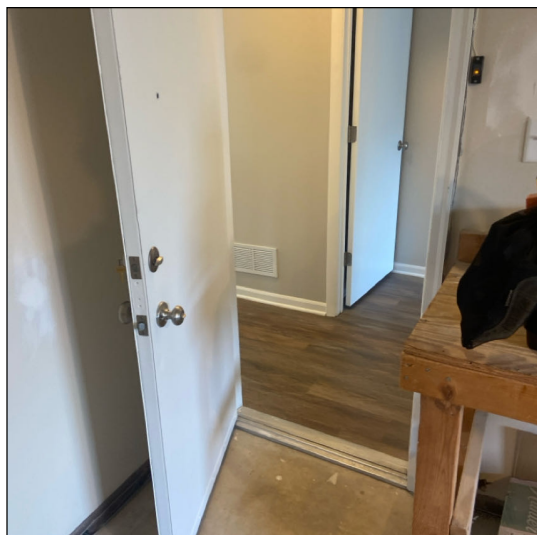
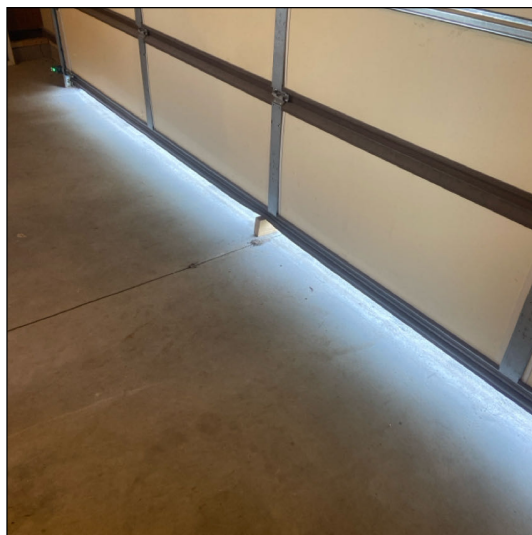
- The garage passage door into the house is not equipped with an automatic door closer mechanism. In my opinion this is unsafe and is considered a fire/fume hazard from the garage. Installation of appropriate door closer is recommended by a qualified contractor.
- The automatic retract feature of the overhead garage door motor is not operating. In my opinion this is an injury hazard and the door opener should be adjusted and/or serviced by a qualified garage door technician.

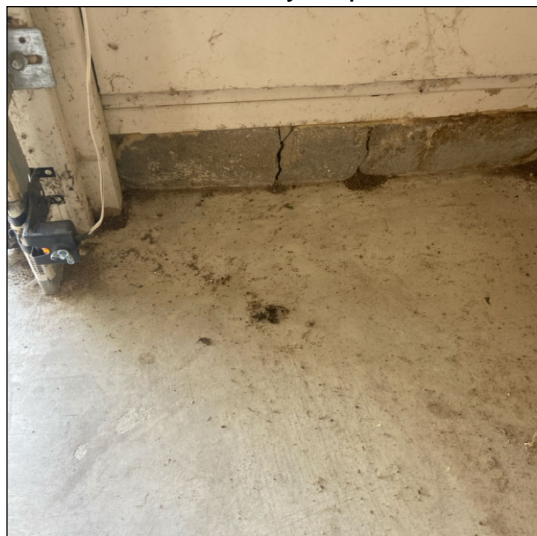
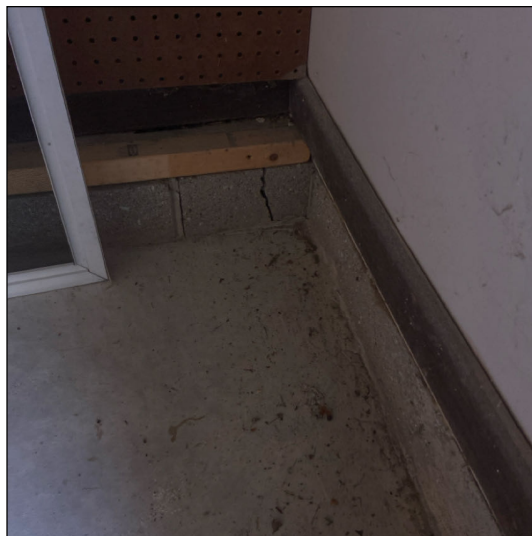
- Cracking observed in the foundation. Cracked foundations can lead to water seepage and related water damage which can lead to various problems and related damages. Cracking can be a symptom of structural issues. Appropriate corrective action is recommended by a qualified contractor.

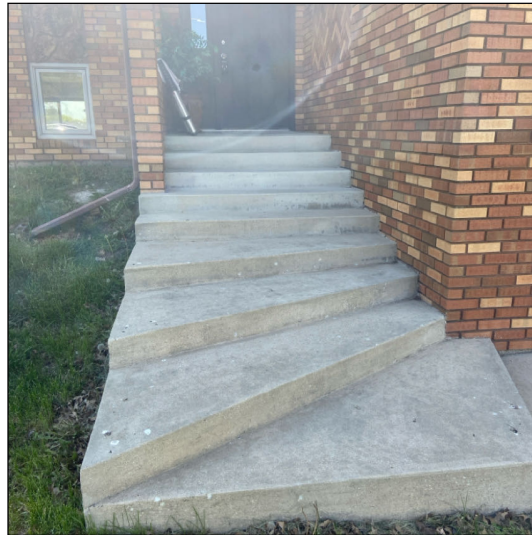
- There are no guard rails at porch. In my opinion this is a potential fall hazard. Recommend repair by qualified contractor.

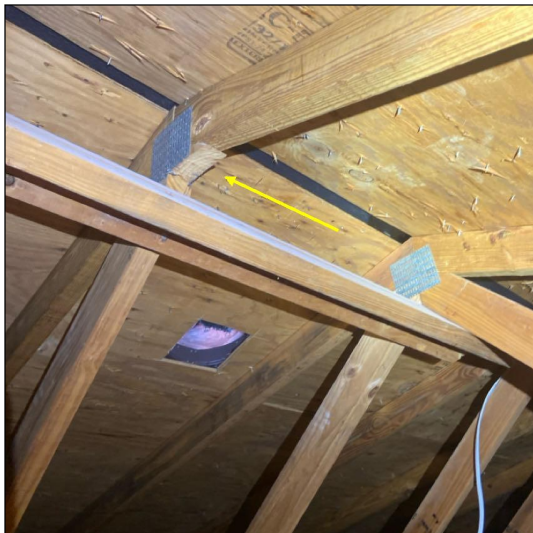
- There are cut, modified or altered truss structural framing members. Truss framing is specifically engineered and should not be cut, modified or altered without the direction of a qualified design professional such as a structural engineer. This inspection cannot determine if these modifications were done under the watchful eye of a design professional. Evaluation is recommended by a design professional to determine if this poses any structural problems and/or to design a corrective solution. If correction is needed based on the design professional's opinion, corrective repair should be performed by a qualified contractor.

Cut truss

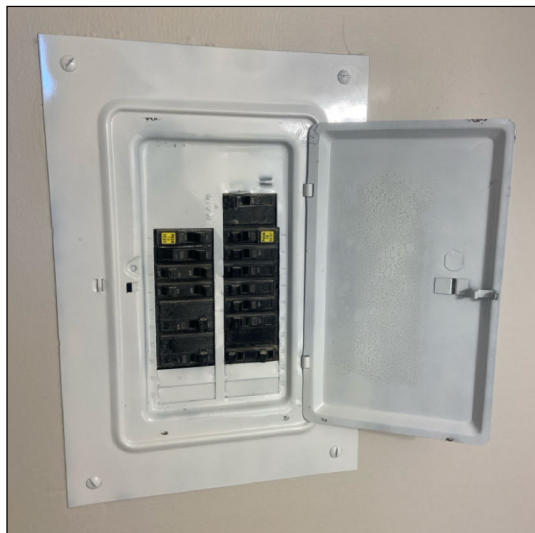
- There are missing knock-outs in the panel enclosure. Open knock outs pose certain potential hazards including fire and shock. Corrective action recommended by a qualified electrician.

Not labeled

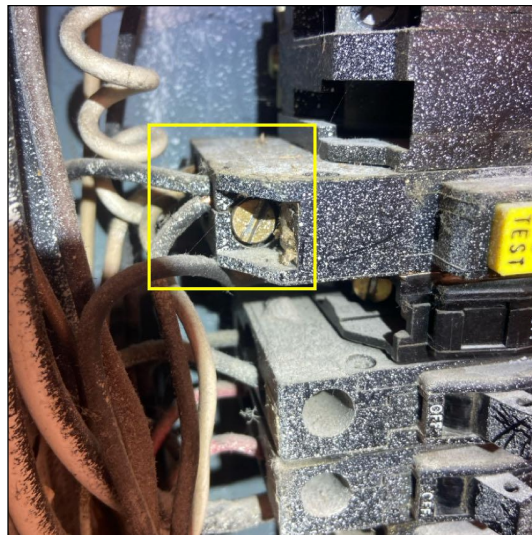
- There is double tapping at the circuit breakers (or fuses). Double tapping is an unsafe condition in which multiple conductors are placed under the set screw of a single breaker/fuse. This increases the risk of a loose connection, which can lead to overheating, arcing, and electrical fires. Although the repair is usually simple, a qualified electrician should be contacted for corrective action.

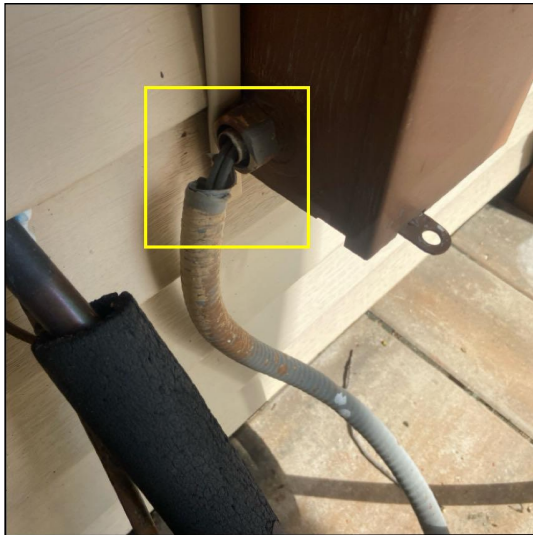
- Some of the electrical conduits are not properly or reasonably secured. This is an increased potential for various problems and electrical safety hazards. Appropriate corrective action is recommended by a qualified electrician.
- Open wiring and splices are present and are not in appropriate junction boxes or enclosures in the bathroom, attic. This is an increased fire and shock hazard issue and needs to be corrected by a qualified electrician.

Loose conduit at air conditioner wiring

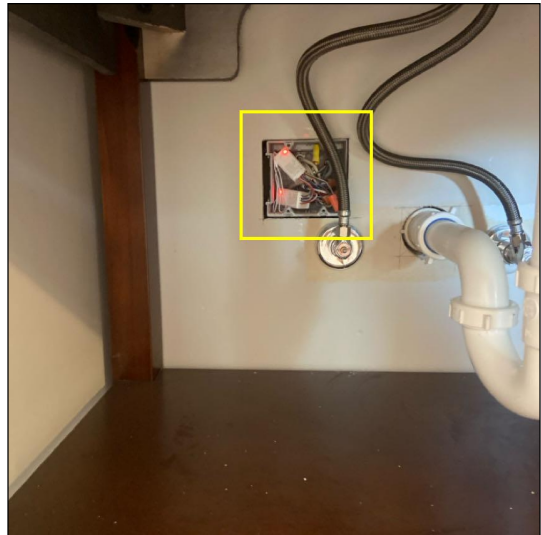
Under master bathroom sink

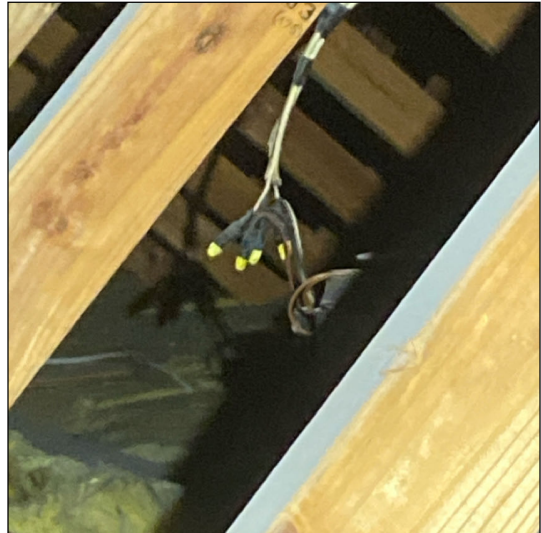
Wiring in attic

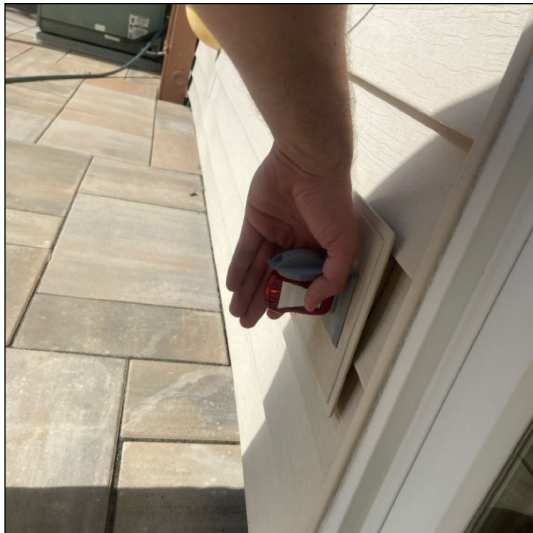
- One or more GFCI outlets at the exterior location did not respond properly when tested. A non functioning GFCI receptacle is considered to be an electrical shock / electrocution hazard. Corrective action by a qualified electrician is recommended.

- One or more of the receptacles at the exterior are not GFCI type. A lack of a GFCI receptacle in this location is considered to be an increased safety risk and an electrical shock / electrocution hazard. Upgrading and installation of GFCI receptacles for optimum safety is recommended.

- Of the representative sampling of wall receptacles, certain receptacles read on the test meter to be 'reverse polarity'. Reverse polarity is considered to be improperly wired and a potential electrical shock hazard. Corrective action is needed by a qualified electrician.

Patio receptacle not GFCI, reverse polarity

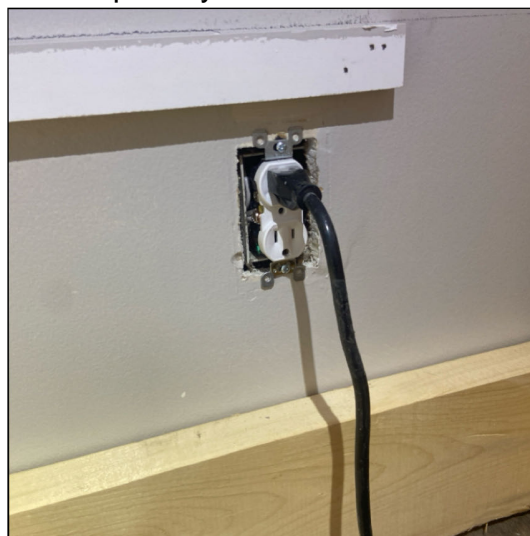
GFCI did not trip

Sump pump receptacle

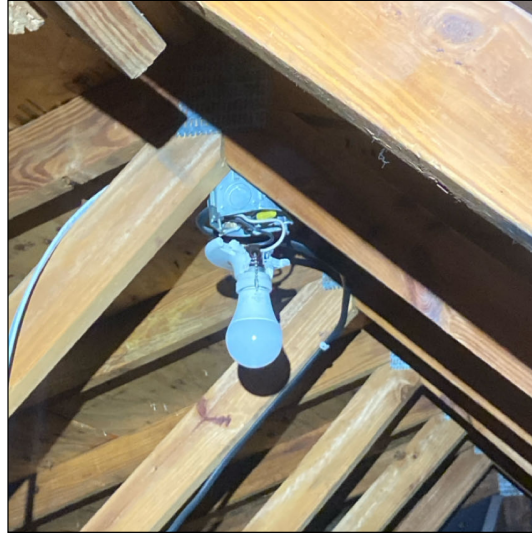
- Certain light fixtures do not appear properly secured. This is an increased electrical shock / fire hazard. Appropriate corrective action is recommended by a qualified electrician.

Loose light in attic

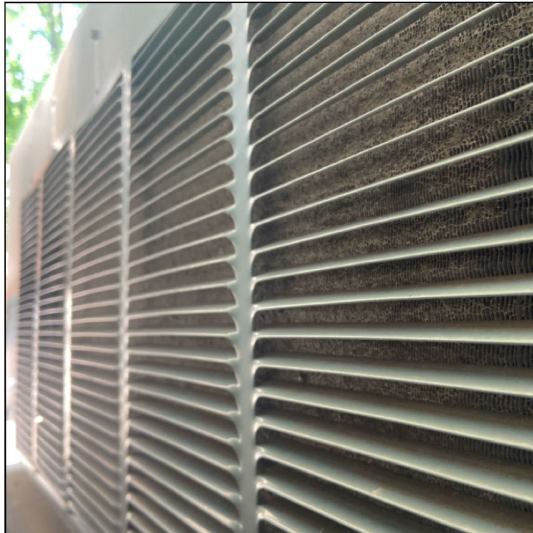
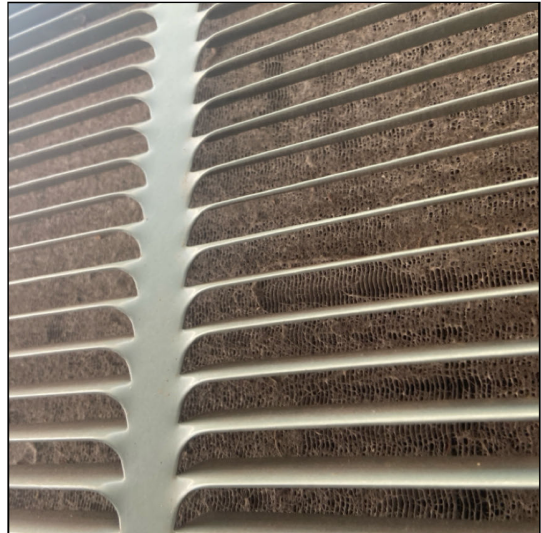
- As much as can be observed visually, the coil appears to be dirty. It is my opinion this can reduce air flow across the coil. This can reduce the efficiency of the air-conditioning system, cause performance problems, cause damages to the air-conditioning components and system, and lead to mechanical failure. Appropriate corrective action is needed by a qualified mechanical contractor.

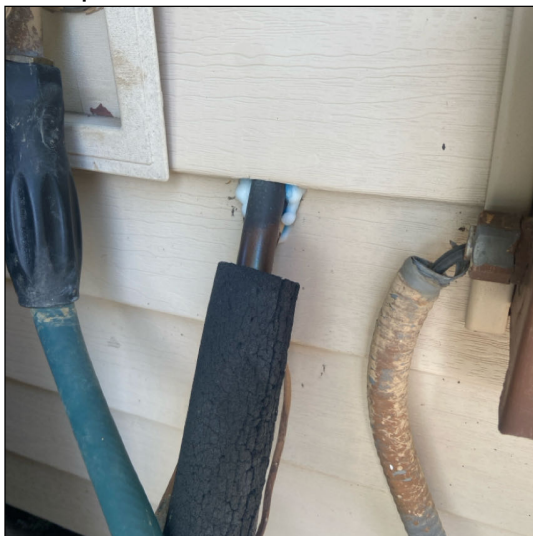
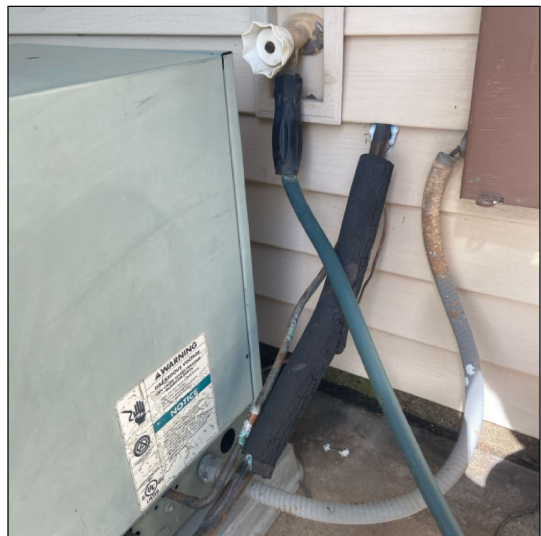
- The insulation of the **a/c** refrigerant (suction) line between the outdoor condensing unit and where it enters the house, is damaged or missing. As part of good maintenance, replacement of the insulation is recommended.

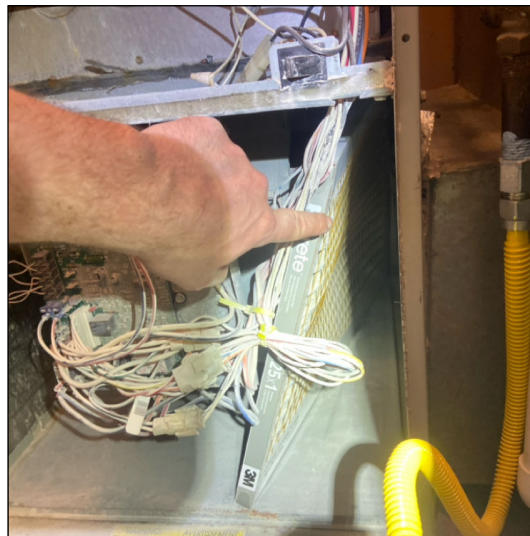
- The furnace filter is dirty. This can block airflow and affect indoor air quality. I recommend changing on a regular basis.

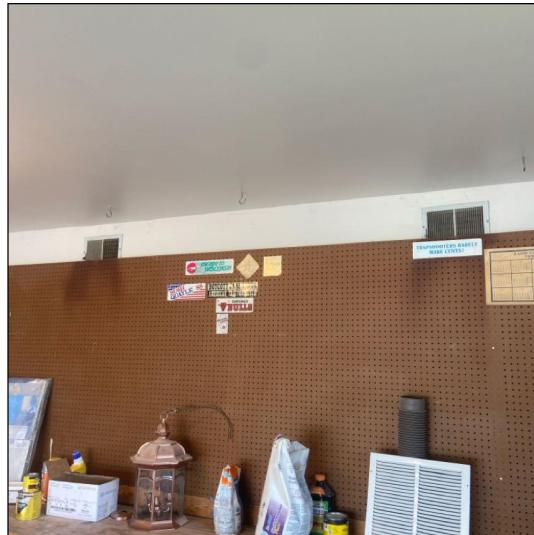
- HVAC ducts and/or registers are present in the garage. It is my opinion this is a fire / fume hazard due to the breach in the firewall and is a carbon monoxide hazard. Carbon monoxide poisoning can be deadly. I recommend you contact a qualified HVAC contractor for appropriate corrective action.

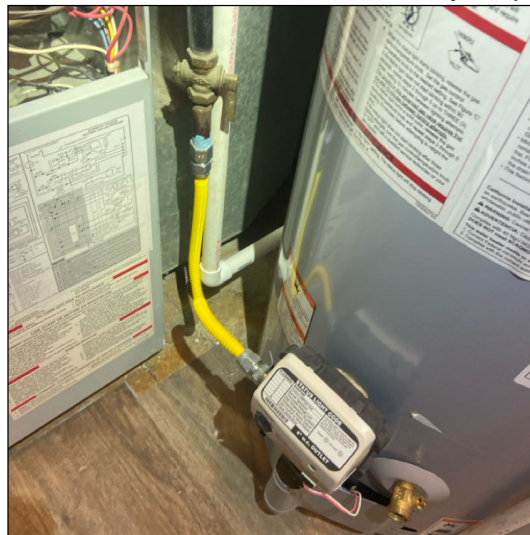
- The water heater is equipped with a flexible gas connector. In my opinion, in this area flexible gas connectors are not the preferred method and upgrading is recommended. Consultation and corrective action is recommended by a qualified mechanical contractor.

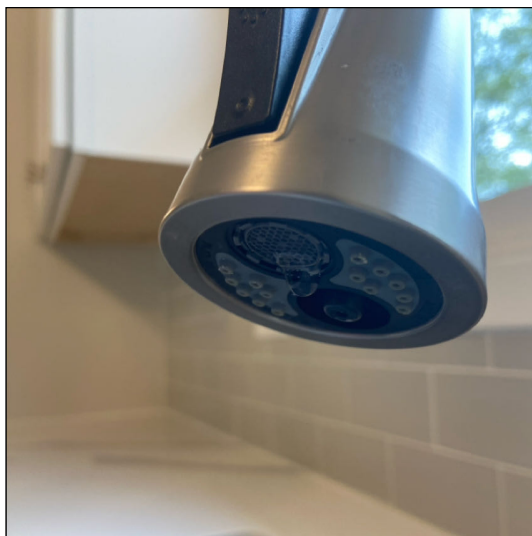
- The faucet is dripping when in the off position. A dripping faucet is not functioning as intended. This can lead to increased utility bills and wastes water. Recommend corrective action by qualified contractor.

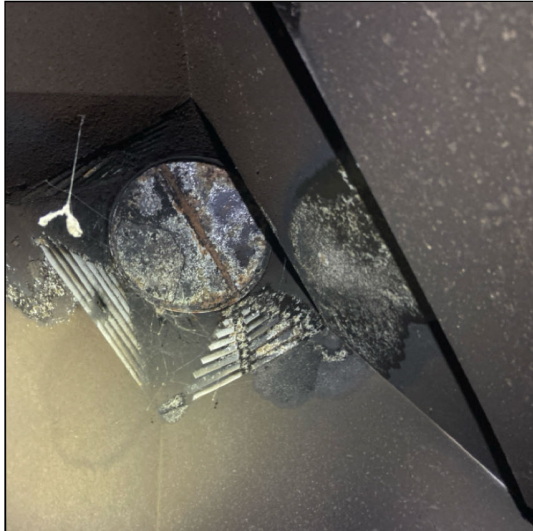
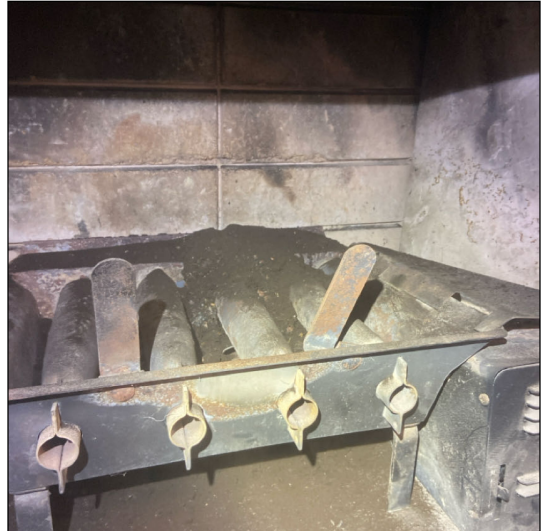
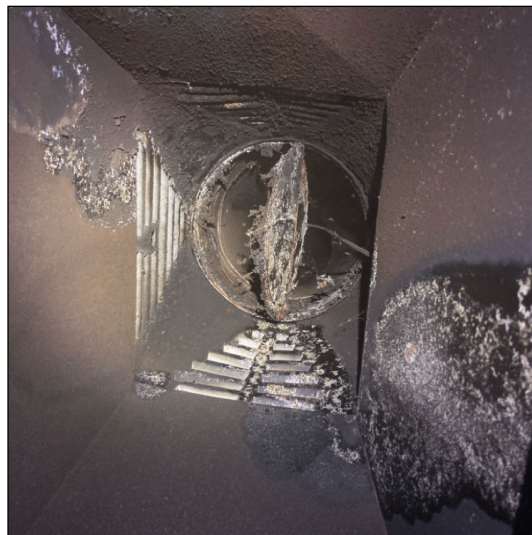
- **SAFETY** - There is a build up of creosote and debris in the fire box, smoke chamber or flue. In my opinion this is a fire hazard. Cleaning and servicing is needed by a qualified chimney sweep.

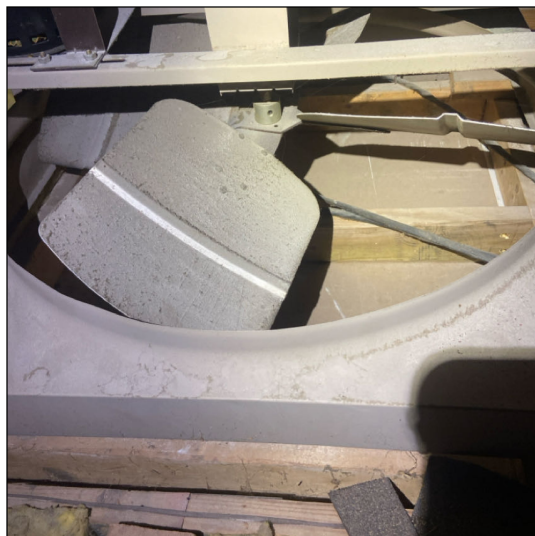
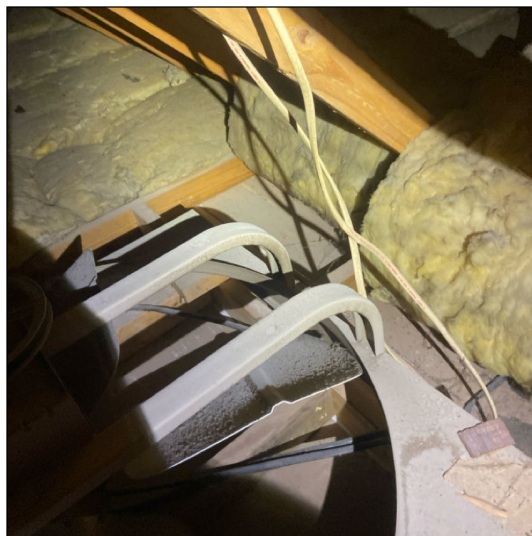
- There are indicators that suggest inadequate ventilation. Exhaust vents are present but not intake vents. No negative effects caused by this condition were noted. Inadequate ventilation can result in a variety of problems including energy efficiency and damaged building materials. Correction of the ventilation is recommended by a qualified contractor.
- Sections of insulation are loose or missing. This can affect energy efficiency and comfort levels. Recommend corrective action by qualified contractor.

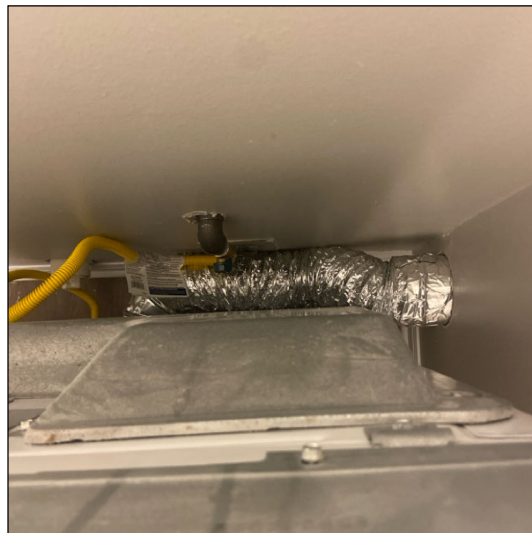
- The dryer vent is flexible type. In my opinion flexible dryer vents are a potential fire hazard. Replacement of the vent with rigid aluminum dryer vent is recommended.

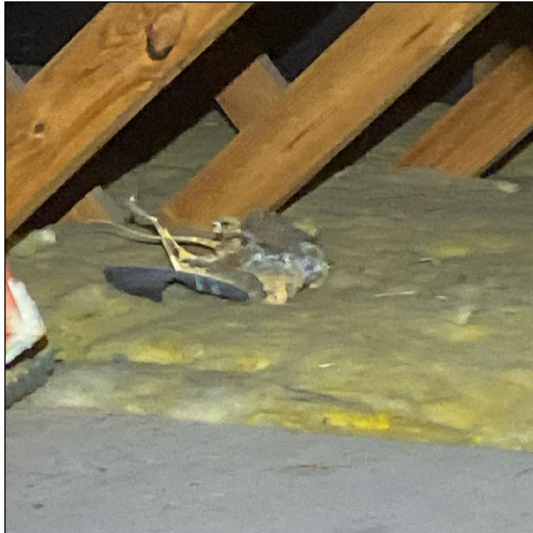
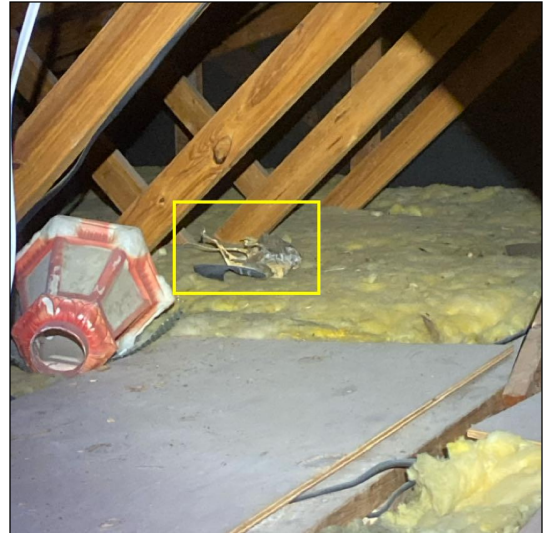
• **SAFETY** - This inspection excludes any and all conditions associated with pests and animal activity. However, there are indicators present in the attic that suggest animal and/or bird activity. This inspection cannot determine if they are active or if corrective measures have taken place. If corrective measures have been performed, its effectiveness is unknown. It is unknown how much damage is present to the home or structure. Contact a licensed pest control company for inspection and treatment.

Carcass in attic
