Site Map
Upper Shaker Lake Dam
File Number: 1314-002

Name of Dam: Upper Shaker Lake Dam File Number: 1314-002
 County: Cuyahoga Date: September 30, 2014 Engineer: DCB

Name of Dam: Upper Shaker Lake Dam
 Date of Inspection: 9-30-2014
 File Number: 1314-002
 Class: I
 Haz.: I, Height: III, Volume: III

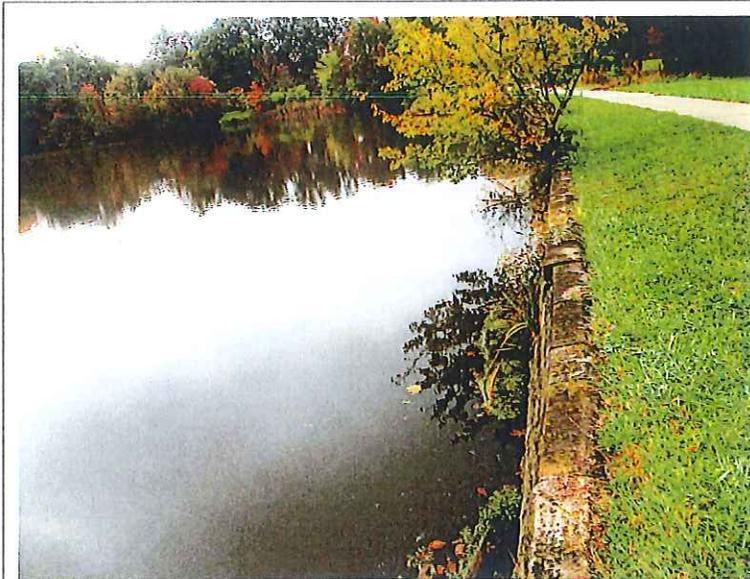
Photograph No. 1:

Stone wall along the upstream slope on the right side of the dam. Note the trees and vegetation growing through the wall.

Trees and brush located at the left and right ends. In addition, small trees & other vegetation growing through the masonry wall in places. The masonry wall had some missing stones, loss of mortar, and cracks. It appeared that the wall was leaning towards the lake on the left side of the dam.

Previous inspections noted erosion on the slope beyond the masonry wall. Due to dense vegetation, these areas could not be inspected. Add erosion control as needed.

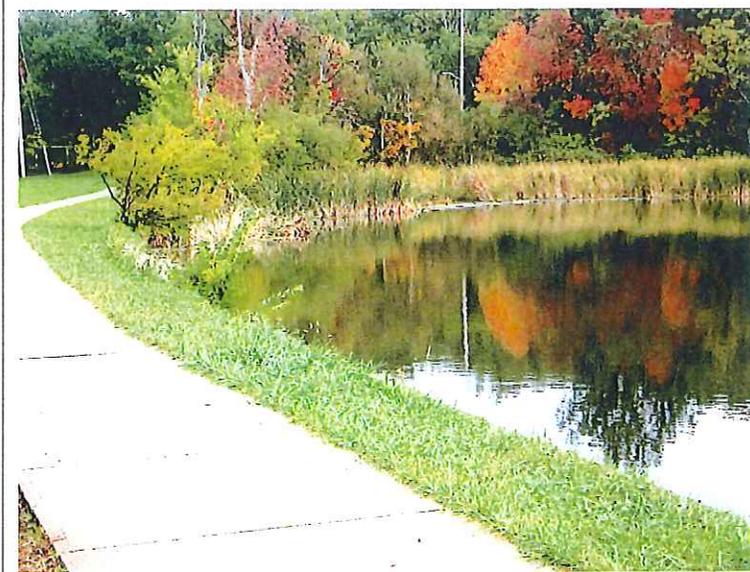
Photograph No. 2:

Crest looking towards the right end of the dam.

Concrete sidewalk. Mowed grass. No signs of rodent burrows, cracks, or erosion. It appeared that the right end and possibly the left end was lower than the center of the dam. The owner showed a video on his phone of the dam overtopping on either side of the principal spillway. Monitor the crest for depressions or sinkholes.

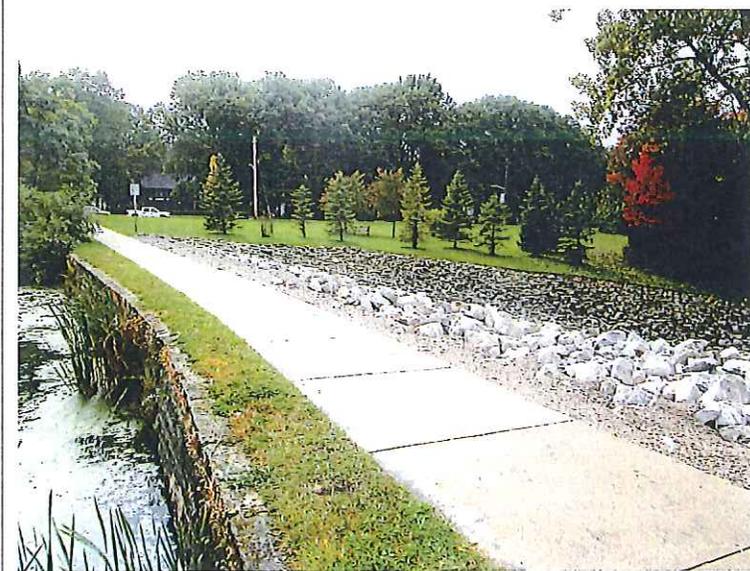
Photograph No. 3:

Stone wall and crest looking towards the left end of the dam. Note the new (lighter color) riprap on the downstream slope. The new riprap replaced riprap that had been displaced during an overtopping flood earlier in the year.

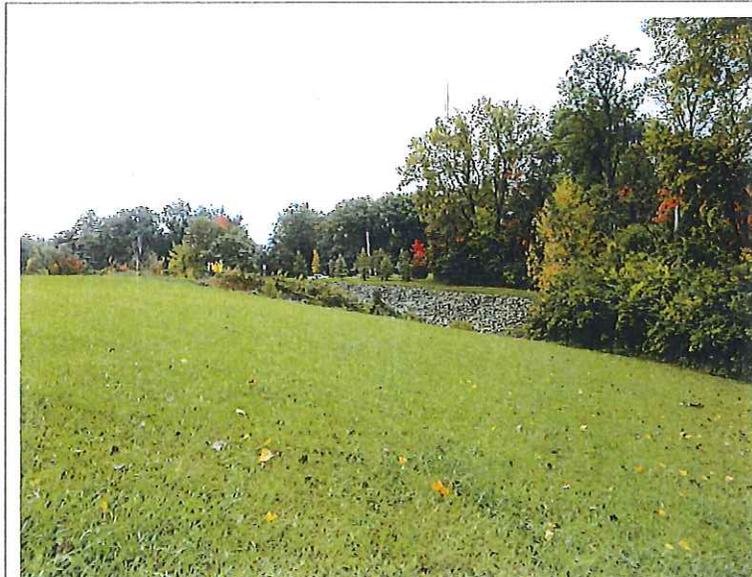
Photograph No. 4:

Downstream slope.

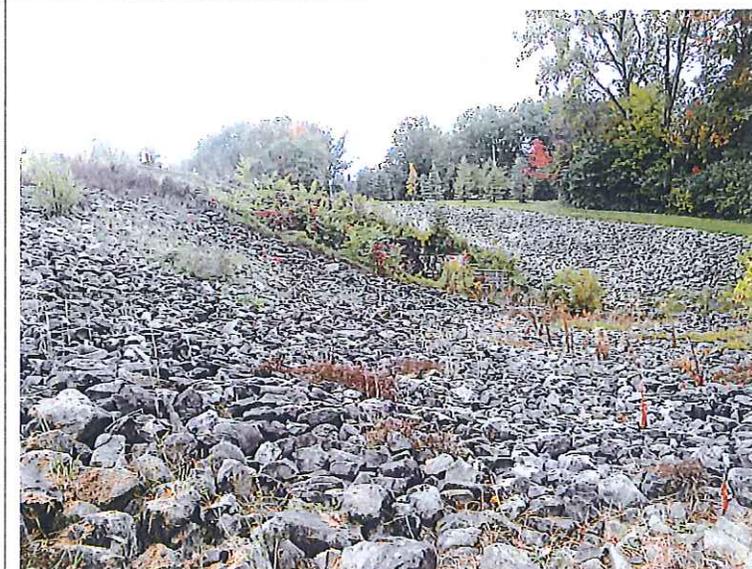
Photograph No. 5:

Riprap on the downstream slope around the principal spillway outlet.

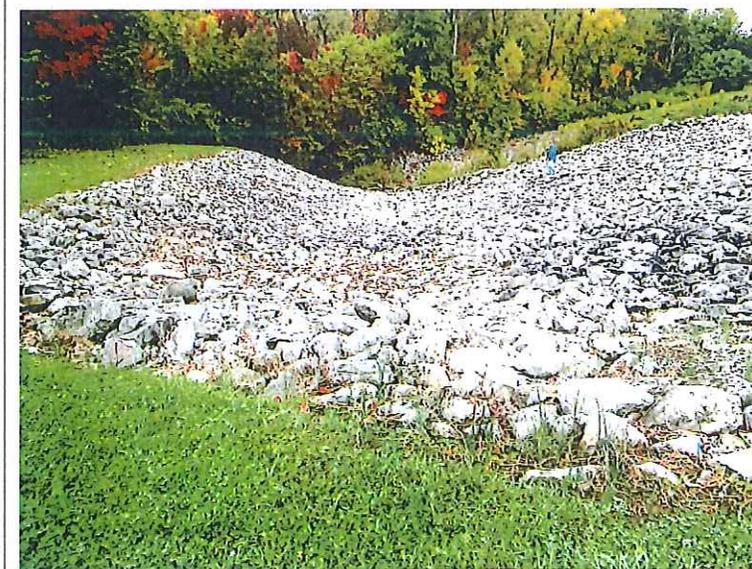
Photograph No. 6:

Riprap on the downstream slope to the left of the principal spillway outlet.

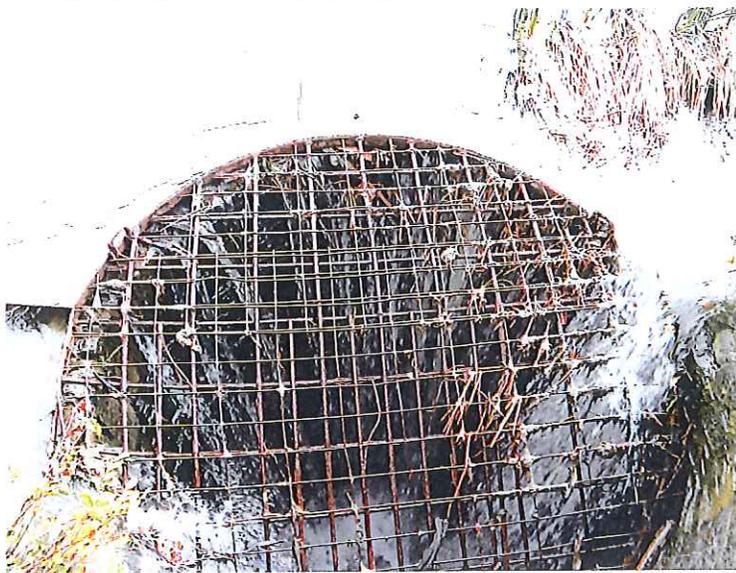
Photograph No. 7:

Principal spillway inlet. Note the flat trashrack and small openings.

Wire fencing has been added to the metal bars on the trashrack. The openings appeared to be < 6 inches which is too small & the trashrack is flat. Routinely gets blocked by debris.

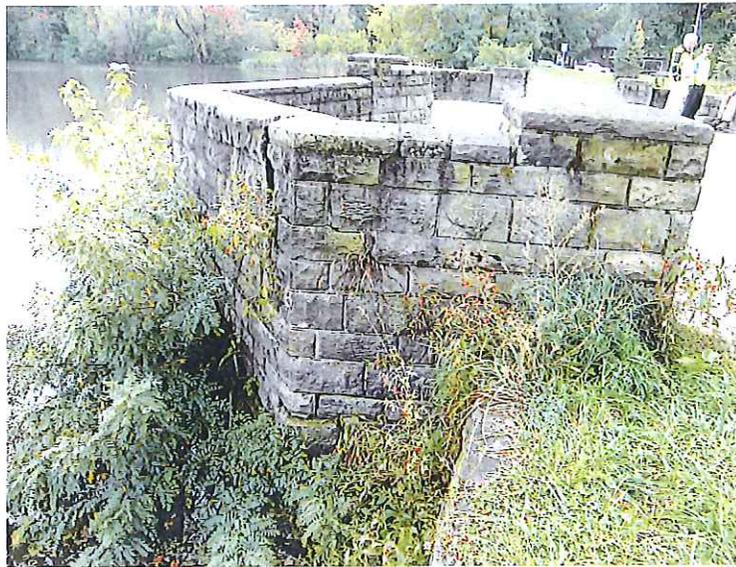
Photograph No. 8:

Note the cracks in the masonry wall above the principal spillway inlet.

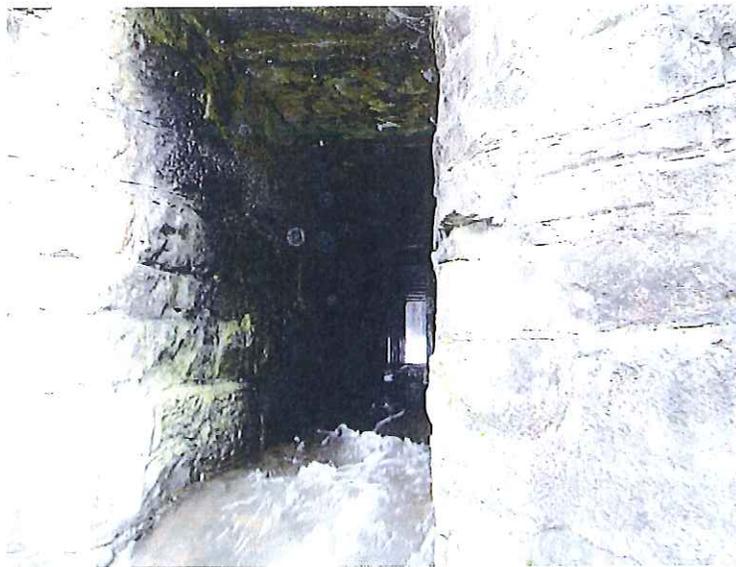
Photograph No. 9:

Interior of the principal spillway conduit.

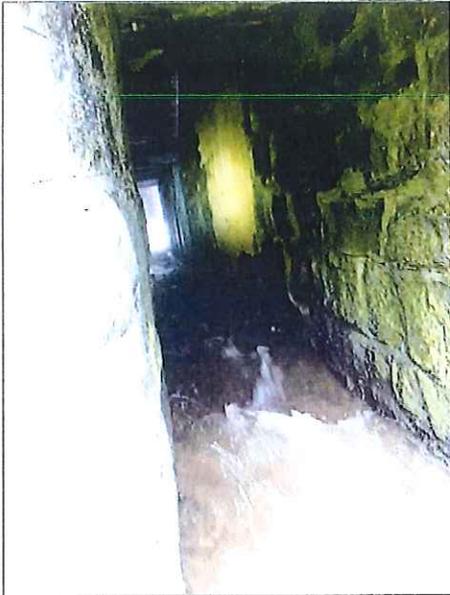
Photograph No. 10:

Interior of the principal spillway conduit. Note that portions of the conduit have been braced with steel I-beams due to concerns of roof stability.

The interior of the inlet and conduit could not be inspected due to flow. A consultant, G.P.D., designed and installed reinforcing inside the conduit due to stability concerns with the ceiling.

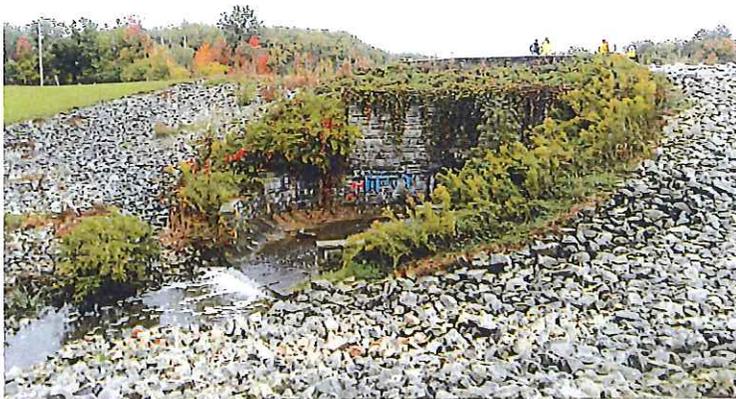
Photograph No. 11:

Overview of the principal spillway outlet. Note the trees, brush, and ivy growing around the spillway outlet.

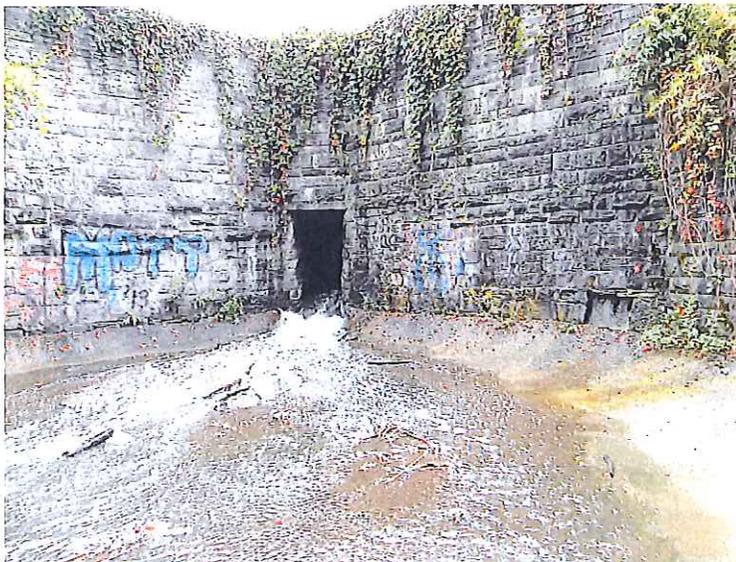
Photograph No. 12:

Principal spillway outlet basin.

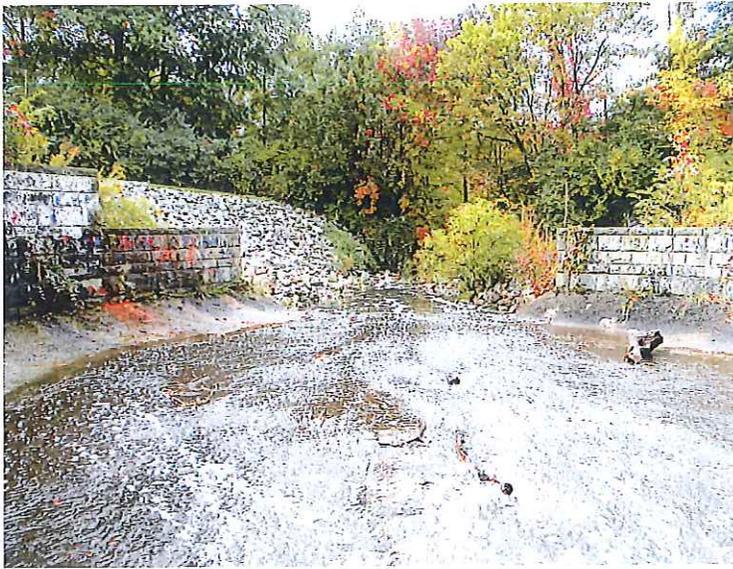
Photograph No. 13:

Principal spillway outlet basin looking downstream.

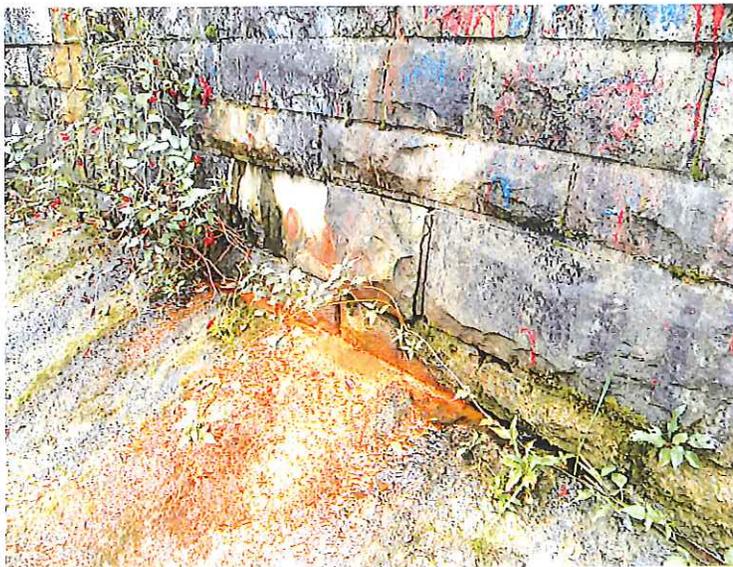
Photograph No. 14:

Note the seepage (orange-colored deposits) exiting through the left wall of the principal spillway outlet basin.

Seepage was observed on the slope on the left side of the spillway outlet wall. Seepage was also noted coming through the masonry wall and from the floor of the spillway outlet basin. Monitor the seepage and the embankment for sinkholes.

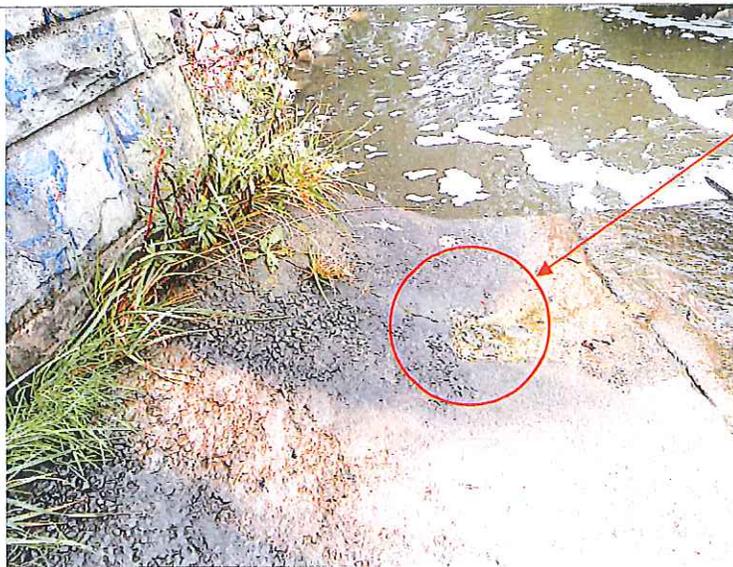
Photograph No. 15:

Seepage was observed coming from the floor of the principal spillway outlet basin.

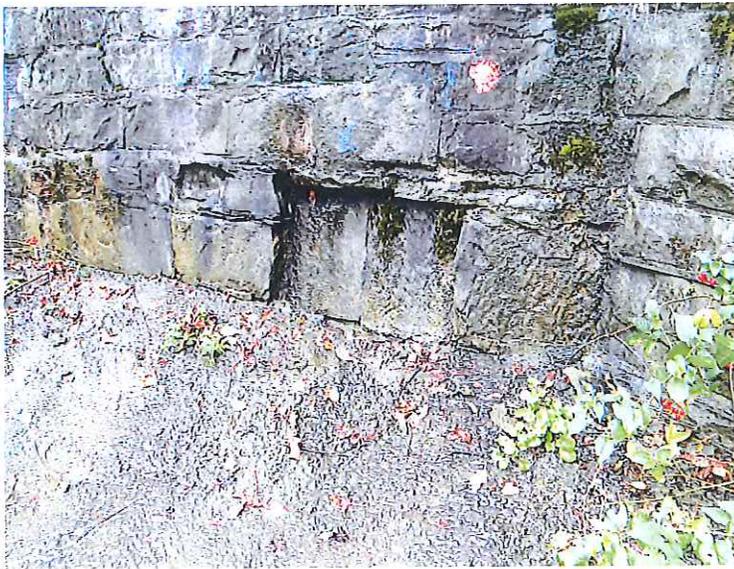
Photograph No. 16:

Seepage observed coming from the base of what appears to be a damaged stone block.

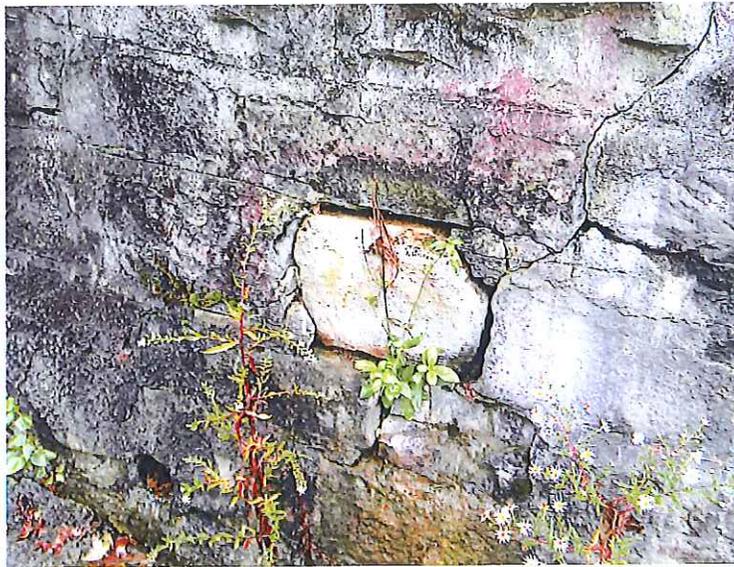
Photograph No. 17:

Note the crack in the wall, vegetation growing through the cracks, and missing mortar around the stone block.

There is a circular masonry wall w/ concrete floor at the outlet. Riprap is at the outlet of this basin. There was loss of mortar in the joints, cracking, and seepage through the walls and floors

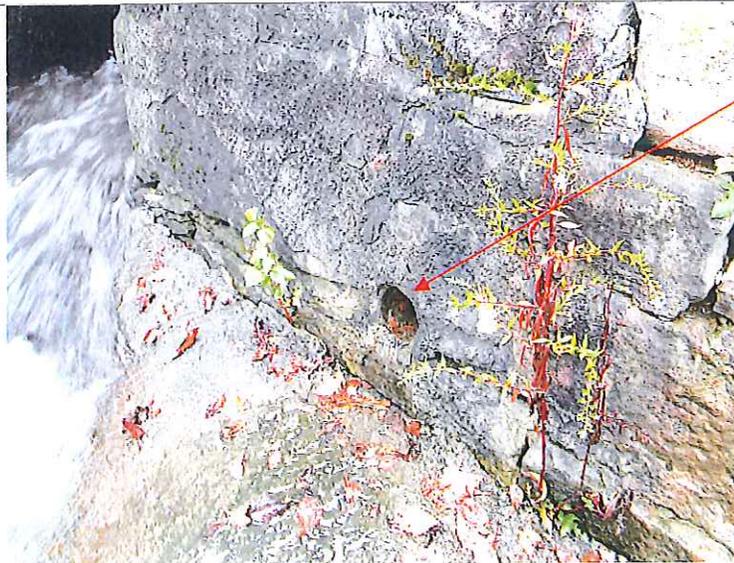
Photograph No. 18:

The 4-inch drain pipe was located just downstream of the principal spillway conduit outlet.

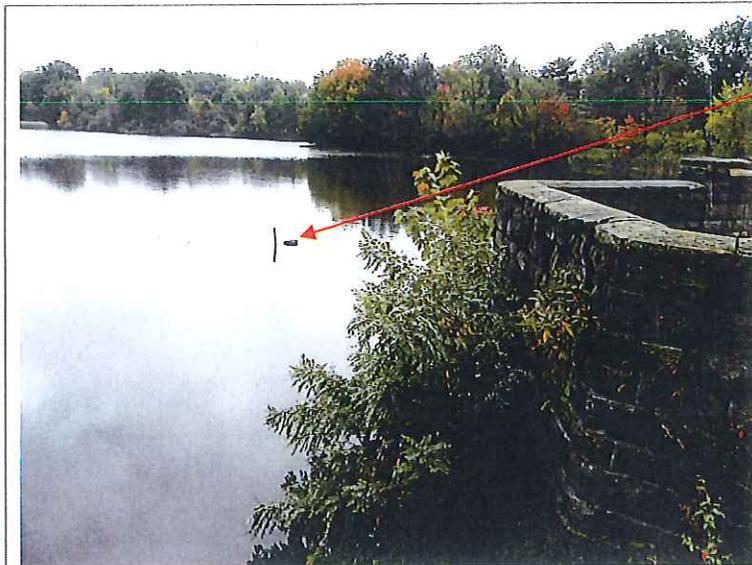
Photograph No. 19:

The lake drain is accessed from a riser pipe in the lake.

It is unclear whether the drain is operable. It can only be accessed by boat.
