Name of Dam: Lower Shaker Lake Dam File Number: 1314-001
 County: Cuyahoga Date: September 30, 2014 Engineer: DCB

Dam Safety Inspection Checklist

Name of Dam: Lower Shaker Lake Dam
 Date of Inspection: 9-30-14
 File Number: 1314-001
 Class: I
 Haz.: I, Height: IV, Volume: III

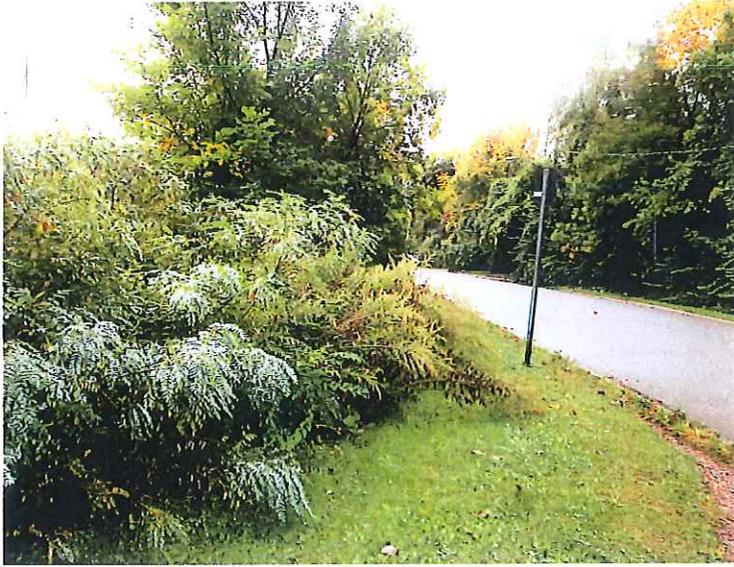
Photograph No. 1:

Upstream slope. Note the dense trees and brush.

Dense trees and brush entire slope. Vegetation was too dense to see the slope. Previous inspections noted erosion along the shoreline.

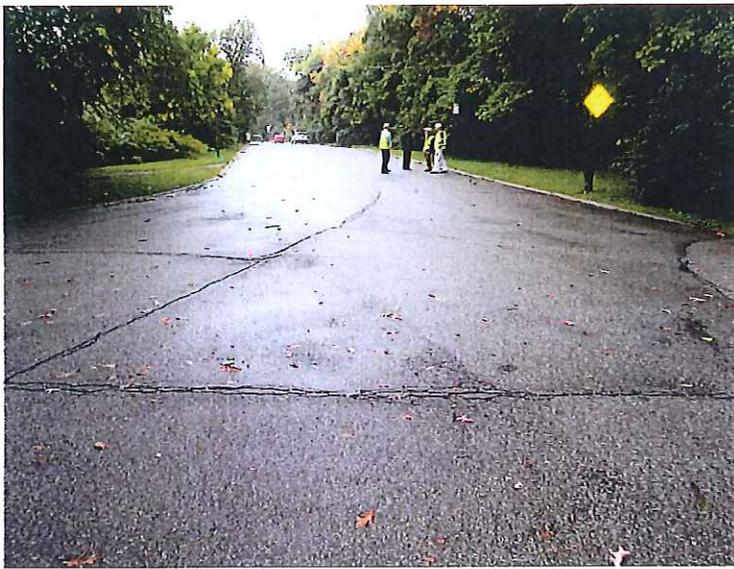
Photograph No. 2:

Crest. Photo taken from the right end of the dam looking toward the dam. Note that the right end of the dam is lower than the dam itself.

The right end of the dam is 2 to 3 feet lower than the rest of the dam. North Park Road floods above the 50-yr ~~err~~ flood according to owner. It was reported to have happened in July of this year.

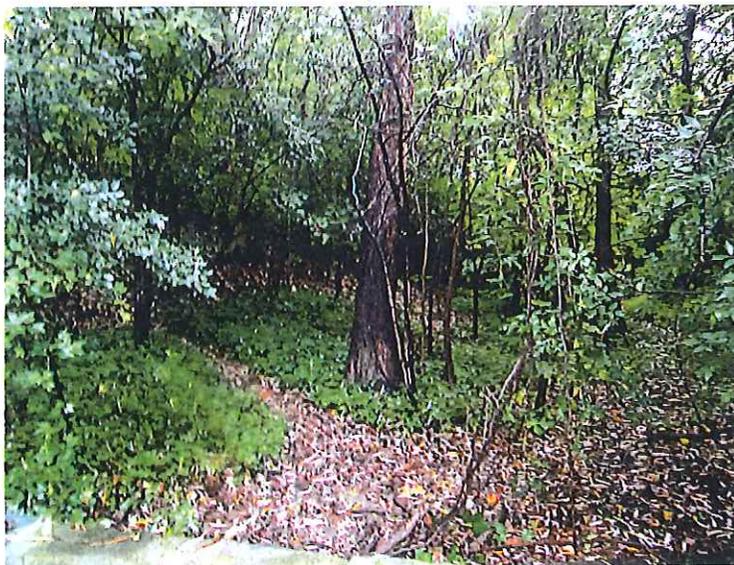
Photograph No. 3:

Downstream slope. Note the dense trees and brush.

Very dense trees and brush. The slope was hummocky with trails.

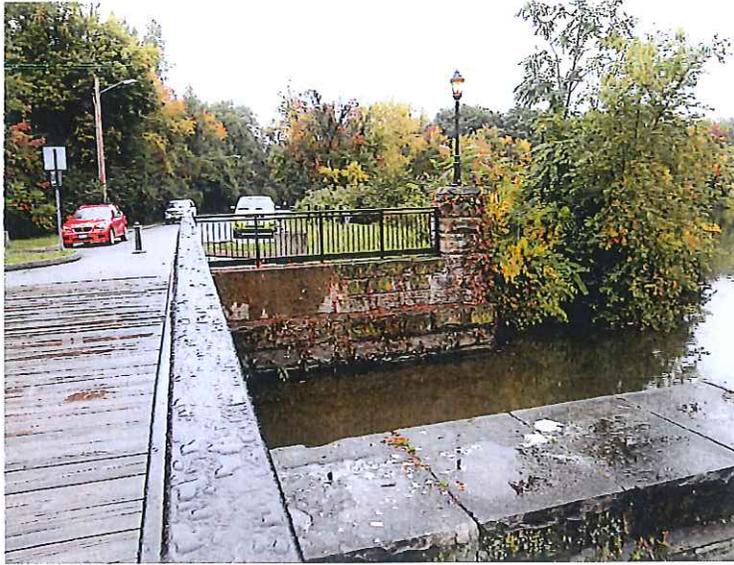
Photograph No. 4:

Right sidewall of the principal spillway inlet.

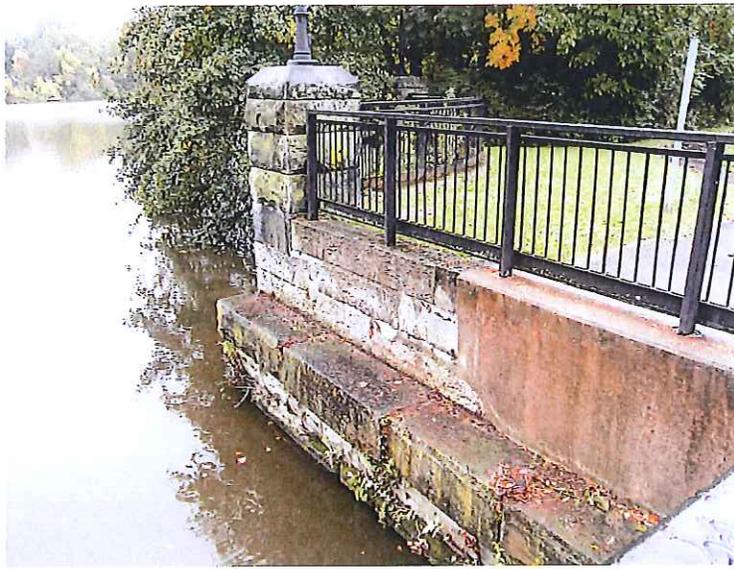
Photograph No. 5:

Left sidewall of the principal spillway inlet.

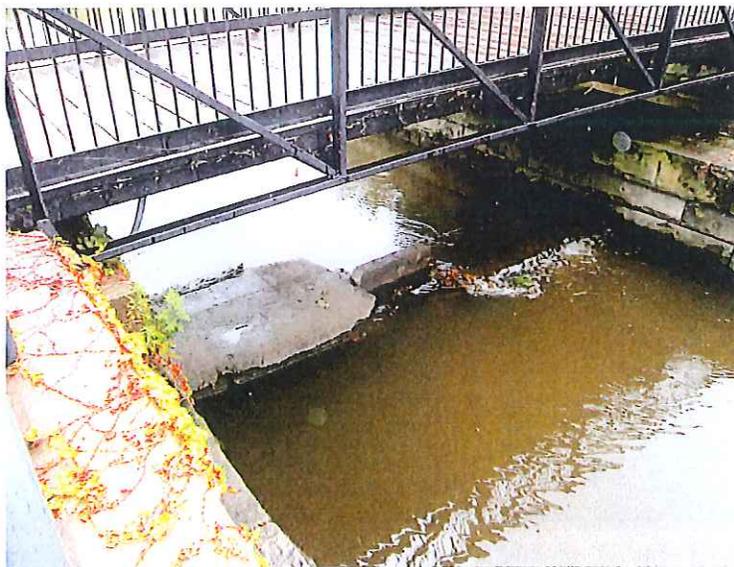
Photograph No. 6:

Concrete stop-logs in the principal spillway.

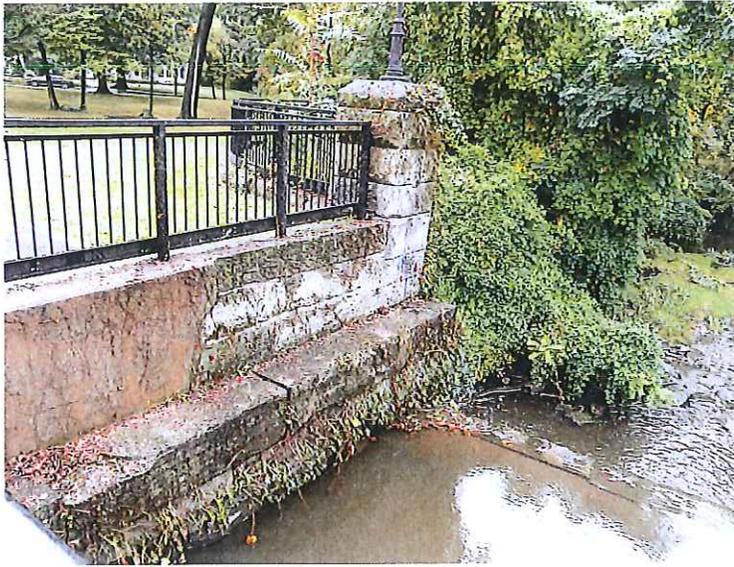
Photograph No. 7:

Left sidewall of the principal spillway outlet.

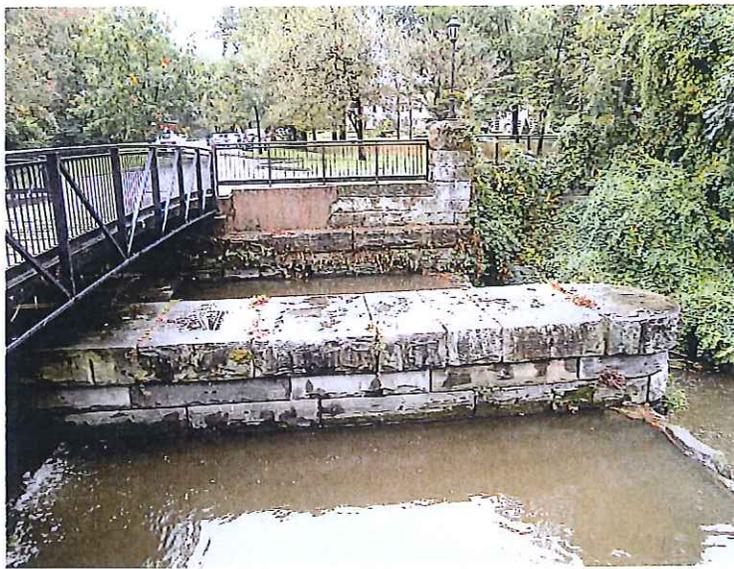
Photograph No. 8:

Center dividing wall and left sidewall of the principal spillway outlet.

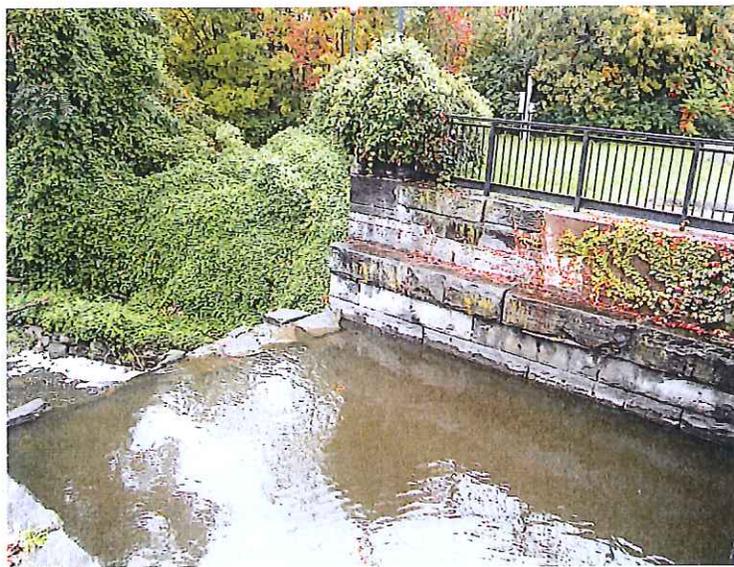
Photograph No. 9:

Right sidewall of the principal spillway outlet.

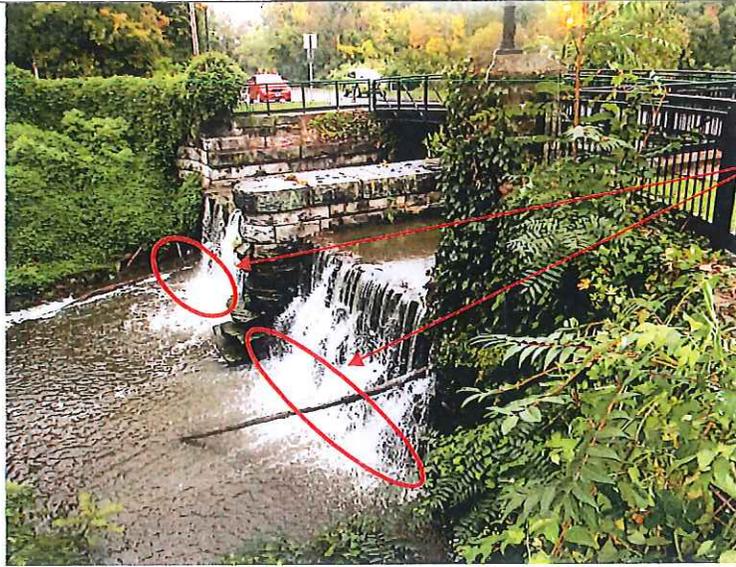
Photograph No. 10:

Principal spillway outlet.

Note that previous inspections noted that the spillway was undermined in these areas. The water was too deep and turbulent during this inspection to view these areas.

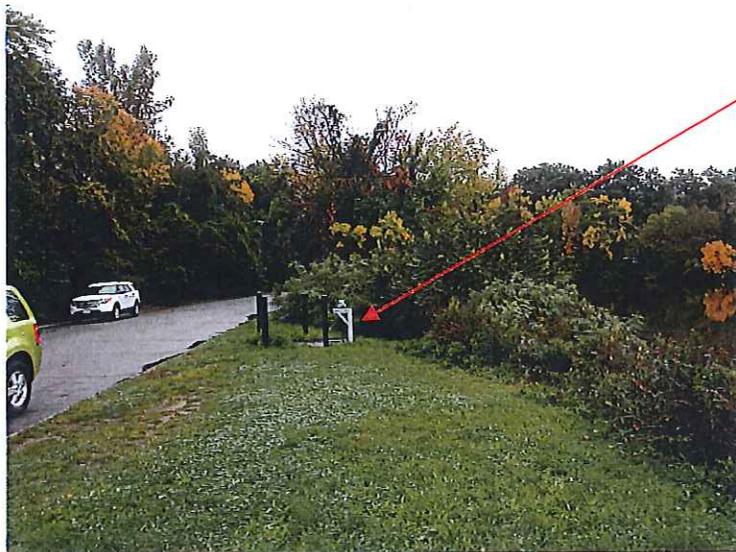
Photograph No. 11:

The lake drain is operated from the crest.

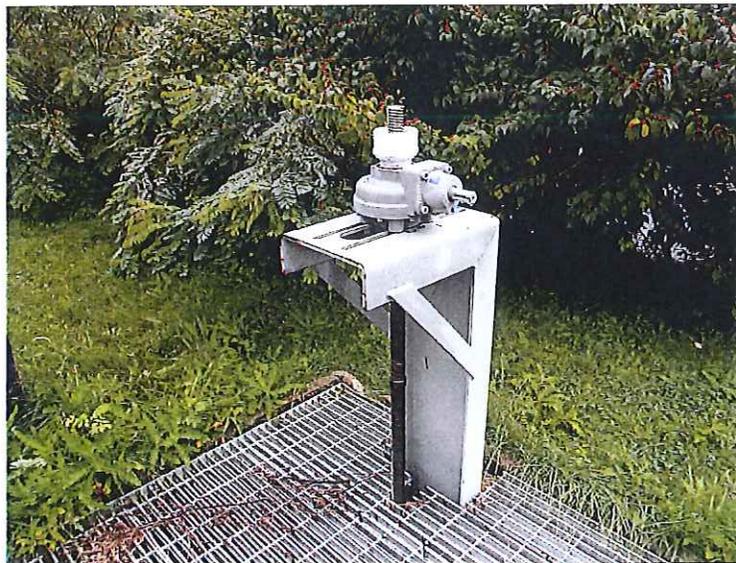
Photograph No. 12:

Lake drain.

Lake drain was reported to be operable. The components appeared to be in good condition.

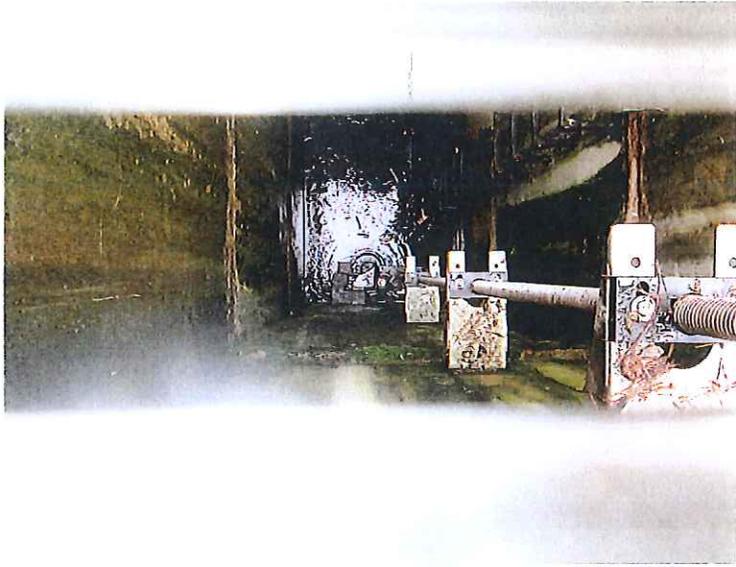
Photograph No. 13:

Interior of the lake drain vault. View of the gate stem.

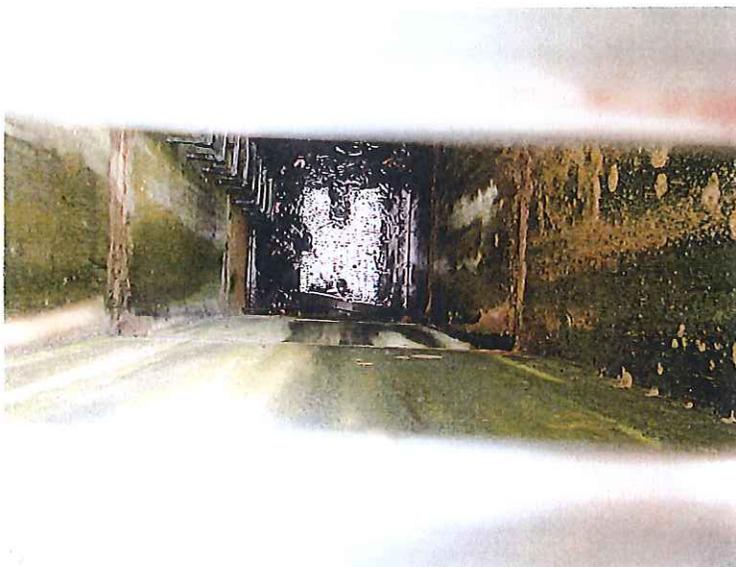
Photograph No. 14:

Interior of the lake drain vault. View of the lake drain discharge pipe.

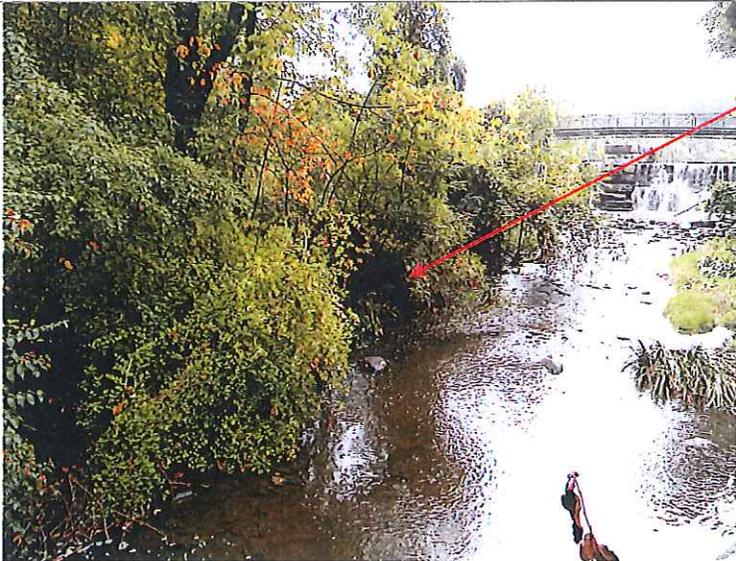
Photograph No. 15:

Lake drain outlet.
