INSPECTION REPORT

ROSEVILLE, CA 95747

Inspection Date: Thursday, August 15, 2024

A2Z Home Services
2351 Sunset Boulevard, Suite 170-444
Rocklin, CA 95765
916-256-4374

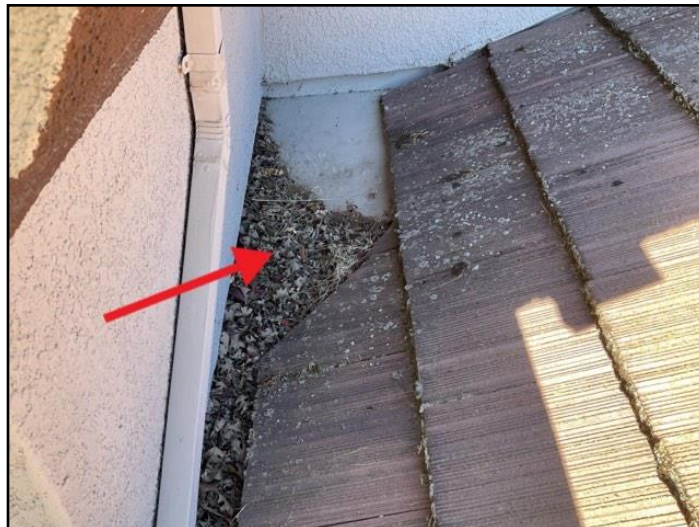
1. Debris Noted

Condition: • Debris Noted

There is a large amount of debris build up on the roof. Leaves, branches, and/or other material that should be removed at some time in the near future. The debris can clog gutters, down spouts and/or drains. Debris can hold moisture that can cause damage to the roof system if large accumulations develop. Debris should be cleaned off the roof surface on an annual basis as a proper care and maintenance recommendation. Roof valleys are a common place for debris build up which can result in roof leaks. Regular inspections for debris build up in the valley areas is recommend.

Task: Recommend further evaluation and repair by a licensed roofing contractor.

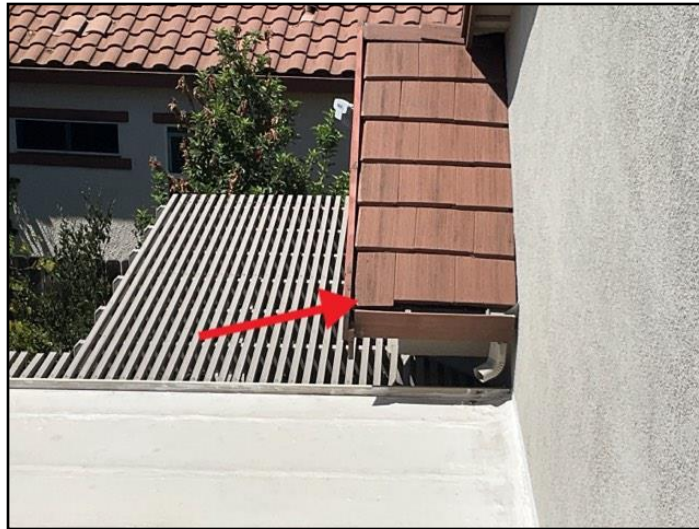
2. Slipped/Loose Tiles

Condition: • Slipped/Loose Tiles

There are one or more loose tiles that have slipped out of position. This may lead to early deterioration of the roofing paper.

Task: Recommend further evaluation and repair by a licensed roofing contractor.

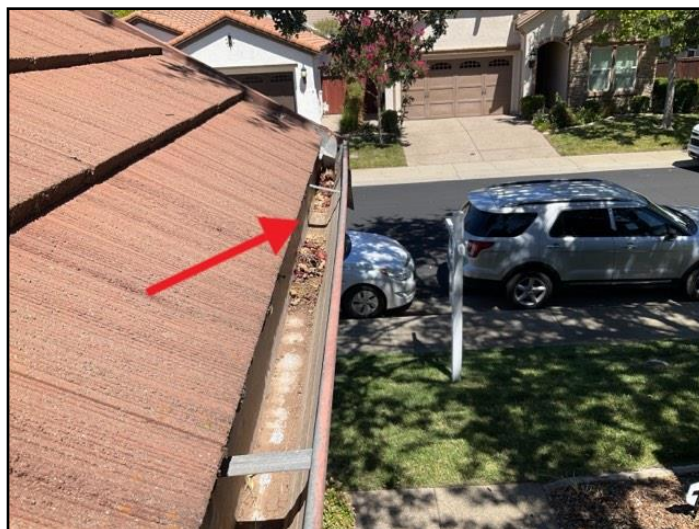
3. Debris/Water Build Up

Condition: • Debris/Water Build Up

There is debris or water build up in the gutters at this time. The inspector recommends cleaning the gutters for preventive maintenance considerations.

Any amount of debris can clog the gutters, down spouts, and/or drain system if not cleaned out. Cleaning the gutters on an annual basis is recommended for proper care and maintenance of the gutter system. This can also help reduce the spread of neighborhood and local wild fires. Installing gutter screen over the gutters will reduce the debris build up and the need for frequent cleaning in the fall and winter. Gutter screen can be purchased at your local hardware or home improvement center.

Task: Recommend further evaluation and repair by a qualified specialist.

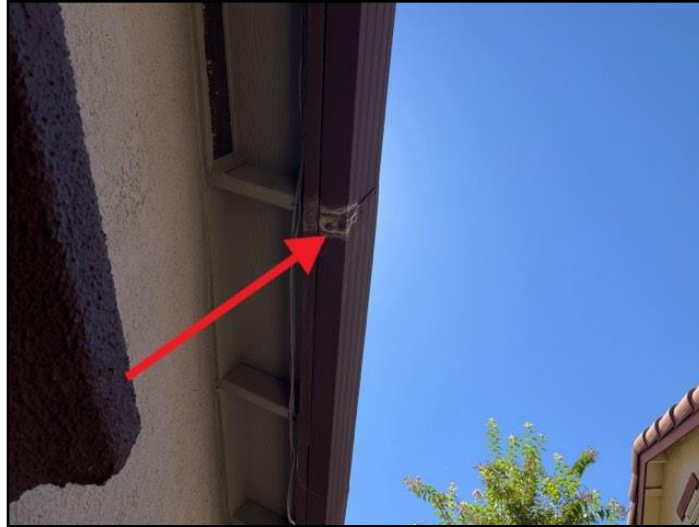
4. Leak at Seams

Condition: • Leak at Seams

There are one or more gutter or downspouts seams with evidence of past or current leaking.

Location: Right side of the home, Left side of the home,

Task: Recommend further evaluation and repair by a licensed roofing contractor.

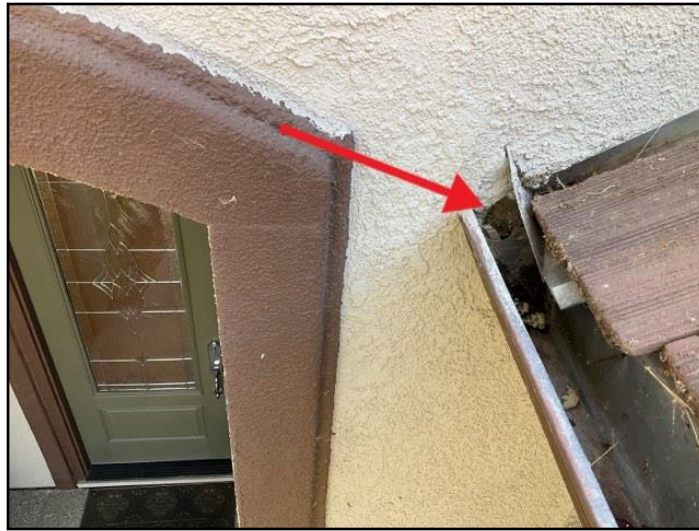
5. Gaps at Siding

Condition: • Gaps at Siding

The siding material is in need of attention. There are areas that have visible gaps and no caulking. Recommend sealing the gaps to prevent moisture intrusion.

Task: Recommend further evaluation of the siding material and repair by a qualified specialist.

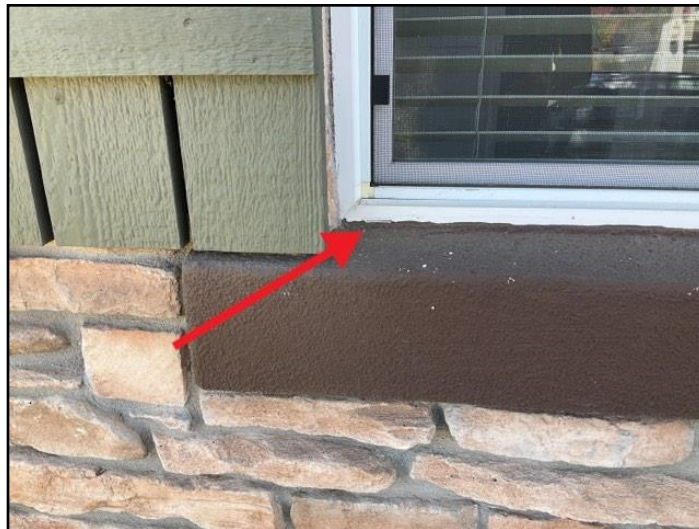
6. Weep Holes Plugged

Condition: • Weep Holes Plugged

There are one or more windows on the structure that appear to have blocked weep holes. Recommend further evaluation of all of the structure window weep holes and removal of any present stucco, caulking, paint, or debris by a qualified specialist. This will allow the windows to drain properly during the rainy season.

Location: Front of the home,

Task: Recommend further evaluation and repair by a qualified handyman.

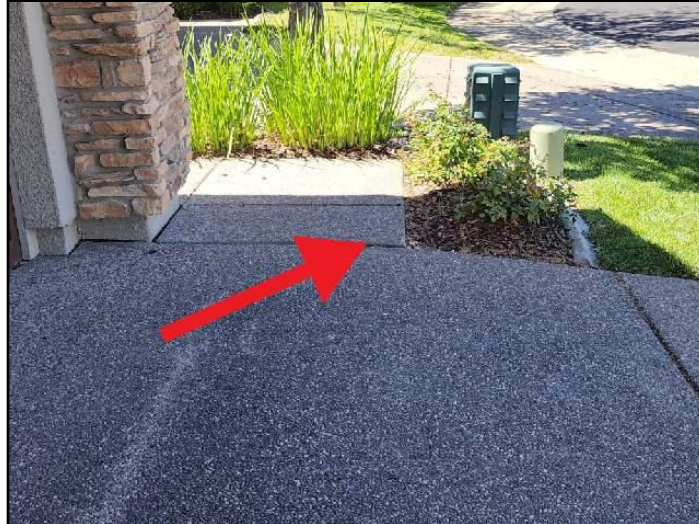
7. Cracks and Lifting at walkway

Condition: • Cracks and Lifting at walkway

There was visible lifting noted at one or more of the concrete walkways. Recommend sealing the cracks and monitoring over time. Repair as needed.

Location: Front of the home,

Task: Recommend further evaluation and repair by a qualified specialist.

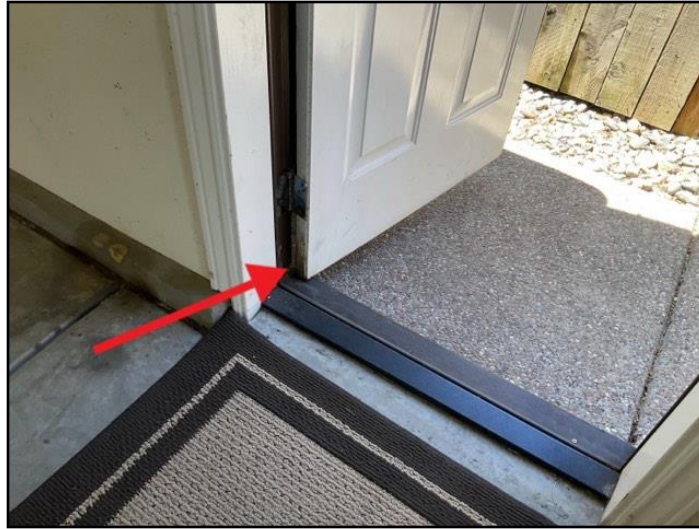
8. Attention

Condition: • Attention

The door, jamb, or trim at the door leading from the garage to the exterior is showing signs of wear and wood deterioration. Recommend checking with the most recent "Pest Report" for further evaluation and determinations.

Task: Recommend further evaluation and repair by a qualified specialist.

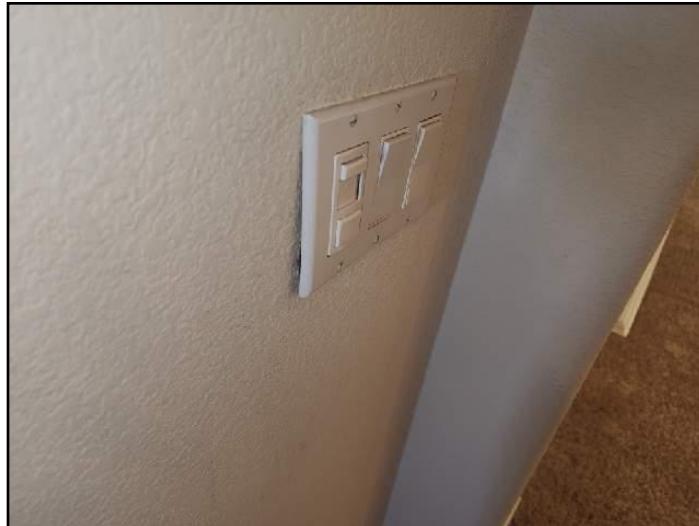
9.

Condition: • Ding room switch not mounted properly.

Location: Dining Room,

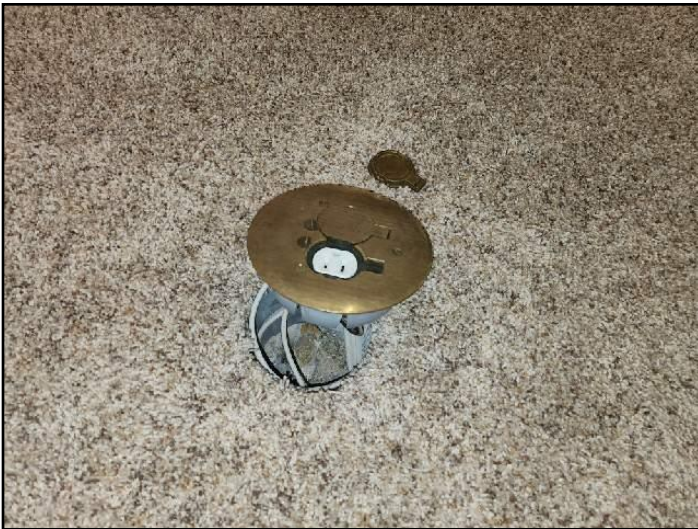
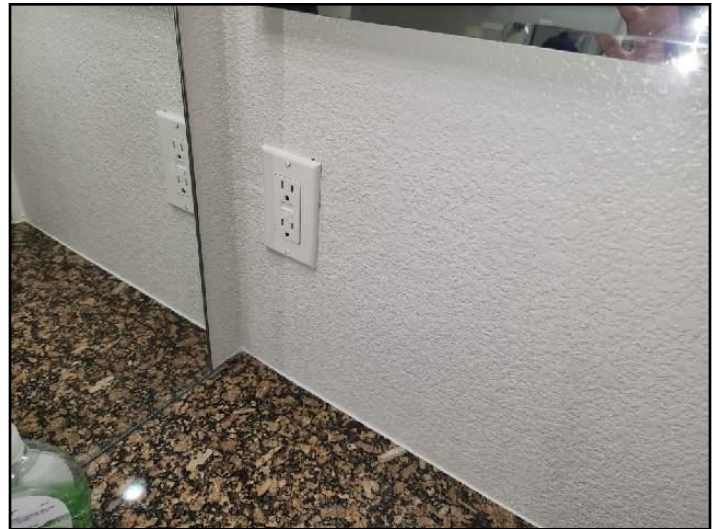
Condition: • Loose Outlet

There are one or more outlets at the interior/exterior of the home that are loosely mounted in the wall. Recommend re-mounting the outlet(s).

Location: Living Room, Master Bathroom,

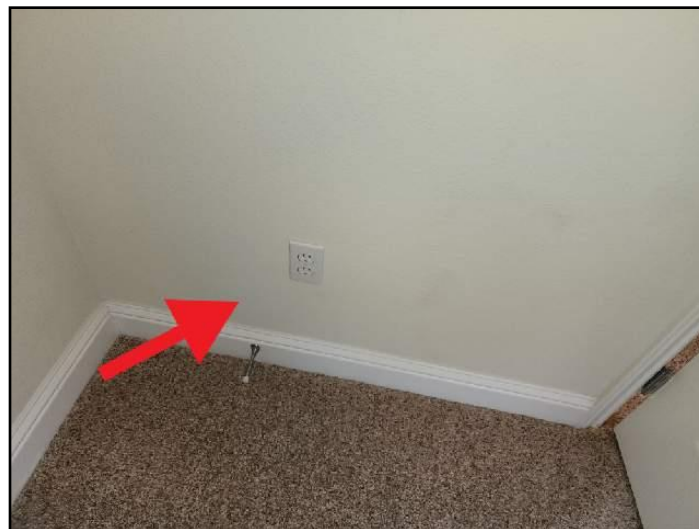
12. Broken Outlet Cover

Condition: • Broken Outlet Cover

There are one or more outlets located in the home that have broken safety covers. Recommend installation of approved covers.

Location: Bedroom Two,

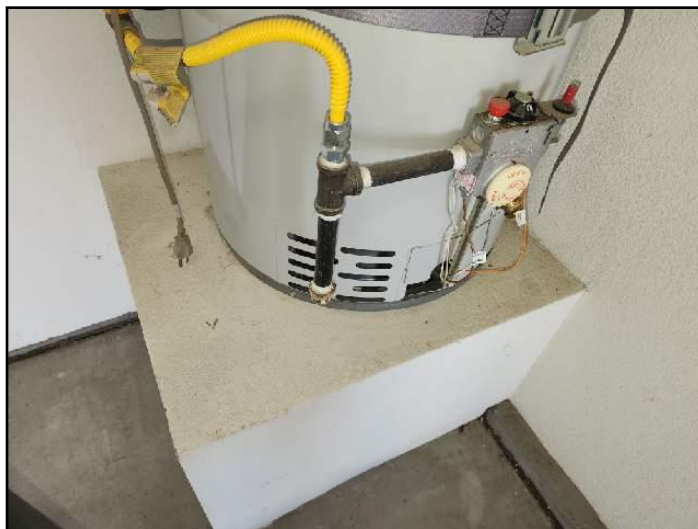
18. No Drip Pan

Condition: • No Drip Pan

There is no drip pan for the water heater. Modern building practices would require a water tight drip pan with drain line if a leak would cause damage. Future consideration should be given to adding a pan as a preventative maintenance upgrade.

Task: Recommend further evaluation and repair by a licensed plumber.

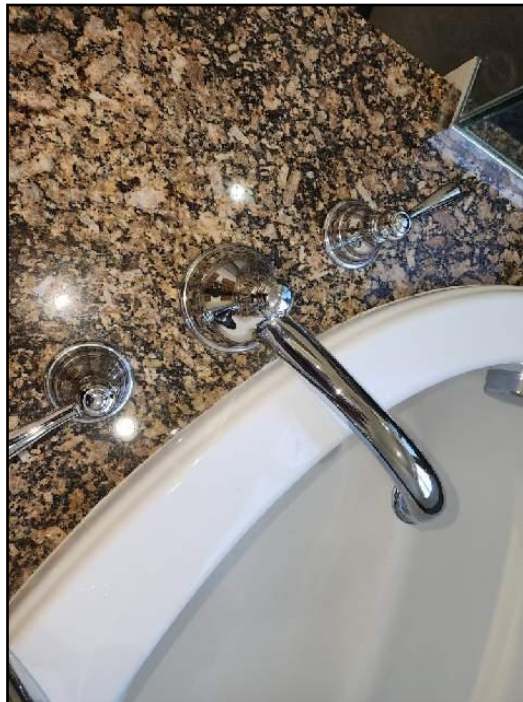
19. Loose Tub Spout

Condition: • Loose Tub Spout

There is a loose tub water spout that should be made secure so that a leak does not develop inside the wall. In addition, we recommend caulking and sealing any visible gaps between the spout and wall. No leak or evidence of moisture damage was noted by this visual inspection.

Task: Recommend further evaluation and repair by a licensed Plumber

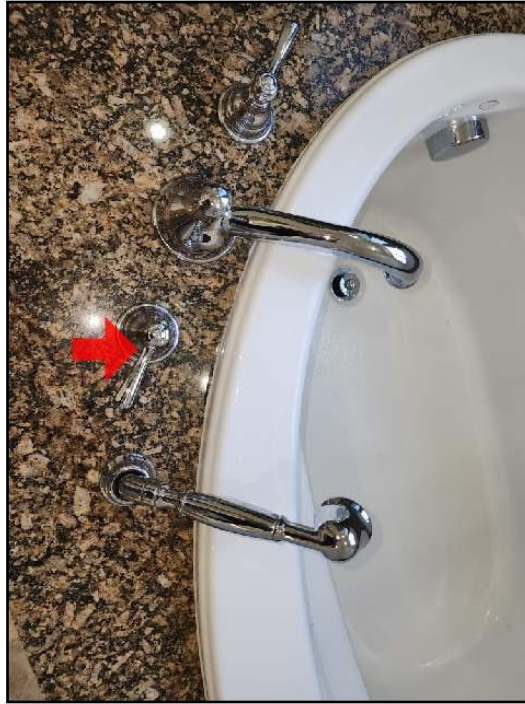
20. Weak Diverter

Condition: • Weak Diverter

Task: Recommend further evaluation and repair by a licensed Plumber

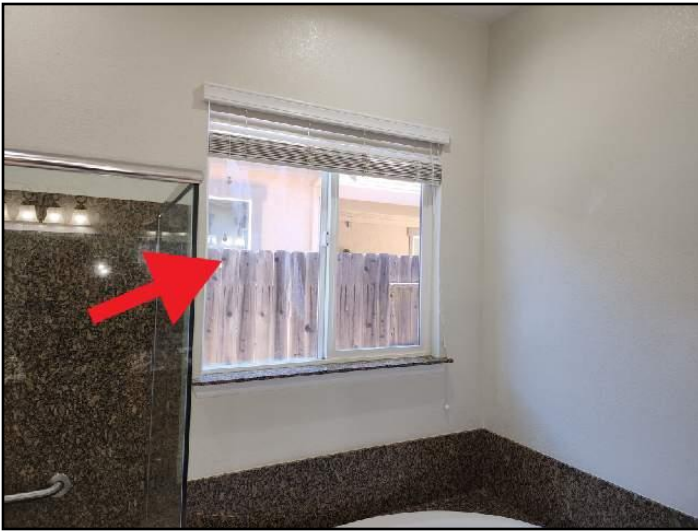
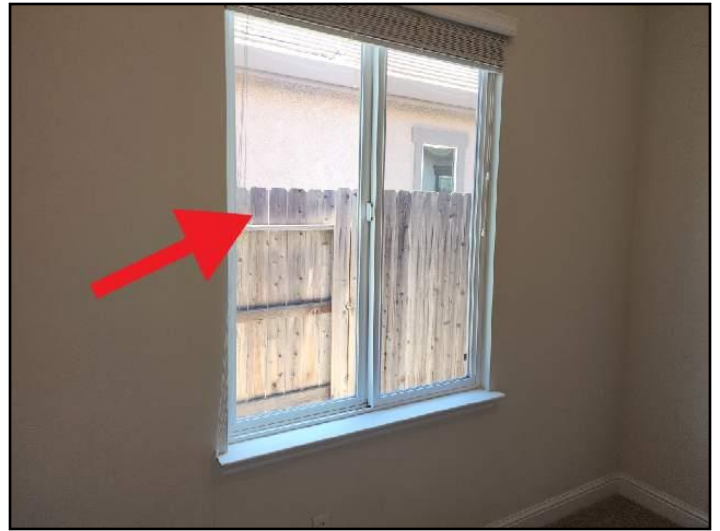
Condition: • Seal Fail(s) Noted

The inspector has noted that there are one or more dual pane insulating windows in the home that appear to have lost their vacuum seal between the panes of glass or have a low-E film failure. The condition is identified by signs of fogging, condensation build up in between the glass panes, or a colored metallic film failure. It is not a failure of the window, per se, since light is allowed in and weather is kept out. However, many clients feel it is not an attractive feature to live with and often choose to have the window replaced, resulting in expensive replacement costs. In regards to our service to you, we will note windows which have obvious low-E failure or seal failure, that is to say, the metallic sheen or fogging must be clearly obvious to the inspector in relation to the conditions of light, the cleanliness of the windows, and the accessibility to view the window(s) during the short time period we are inspecting the house. When low light levels are present, the windows are covered in grime, located on tall walls, or concealed by window coverings; a slightly faded millimeters thick coating may not be noted or reported. Therefore it is incumbent on the client to closely view the windows during their pre-closing walk-through to ensure the windows meet their satisfaction. Replacement of the dual pane glass unit is the only way to correct the condition.

Task: Recommend further evaluation and repair by a qualified specialist.

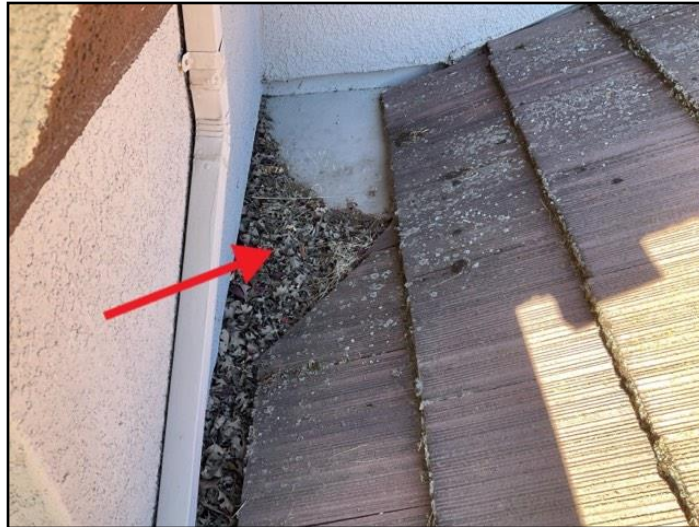
23. Debris Noted

There is a large amount of debris build up on the roof. Leaves, branches, and/or other material that should be removed at some time in the near future. The debris can clog gutters, down spouts and/or drains. Debris can hold moisture that can cause damage to the roof system if large accumulations develop. Debris should be cleaned off the roof surface on an annual basis as a proper care and maintenance recommendation. Roof valleys are a common place for debris build up which can result in roof leaks. Regular inspections for debris build up in the valley areas is recommend.

Task: Recommend further evaluation and repair by a licensed roofing contractor.

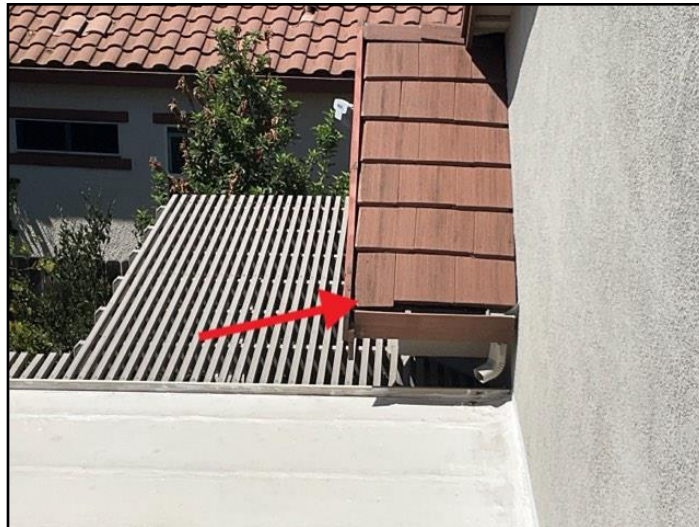
24. Slipped/Loose Tiles

There are one or more loose tiles that have slipped out of position. This may lead to early deterioration of the roofing paper.

Task: Recommend further evaluation and repair by a licensed roofing contractor.

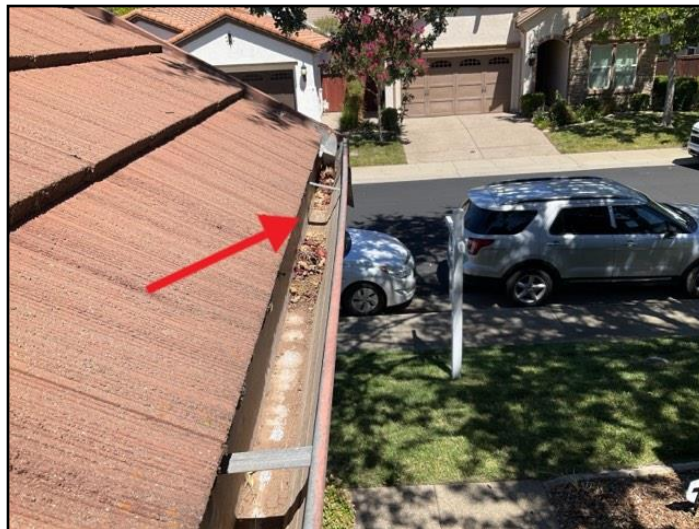
25. Debris/Water Build Up

Any amount of debris can clog the gutters, down spouts, and/or drain system if not cleaned out. Cleaning the gutters on an annual basis is recommended for proper care and maintenance of the gutter system. This can also help reduce the spread of neighborhood and local wild fires. Installing gutter screen over the gutters will reduce the debris build up and the need for frequent cleaning in the fall and winter. Gutter screen can be purchased at your local hardware or home improvement center.

Task: Recommend further evaluation and repair by a qualified specialist.

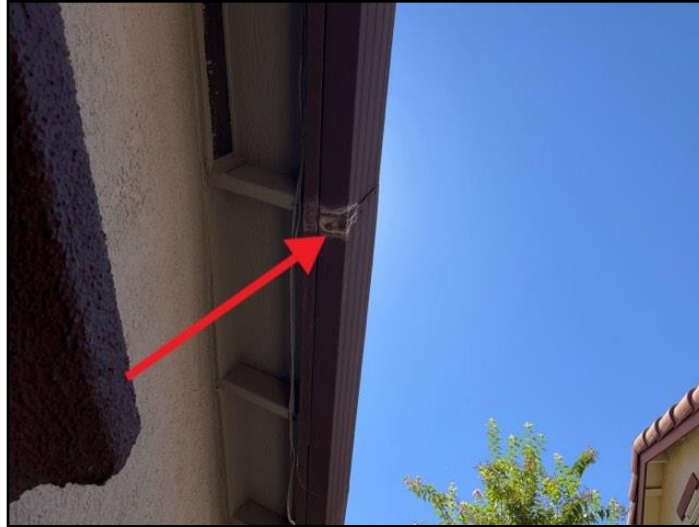
26. Leak at Seams

7. Condition: • Leak at Seams

Location: Right side of the home, Left side of the home,

Task: Recommend further evaluation and repair by a licensed roofing contractor.

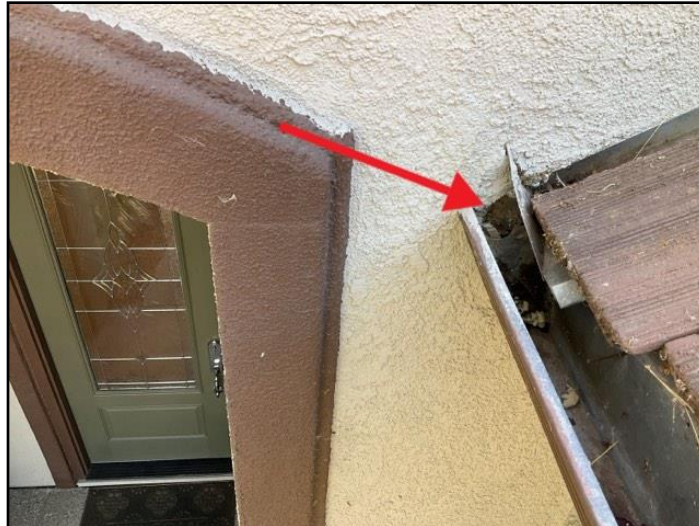
28. Gaps at Siding

Location: Front of the home,

Task: Recommend further evaluation of the siding material and repair by a qualified specialist.

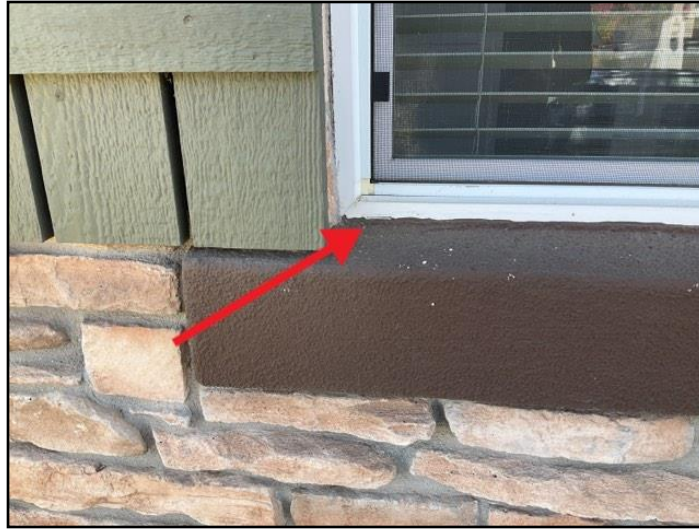
29. Weep Holes Plugged

Location: Front of the home,

Task: Recommend further evaluation and repair by a qualified handyman.

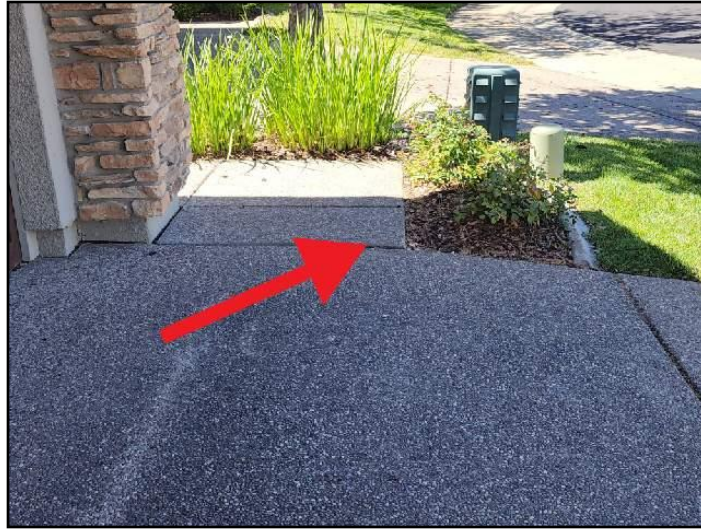
30. Cracks and Lifting at walkway

Location: Front of the home,

Task: Recommend further evaluation and repair by a qualified specialist.

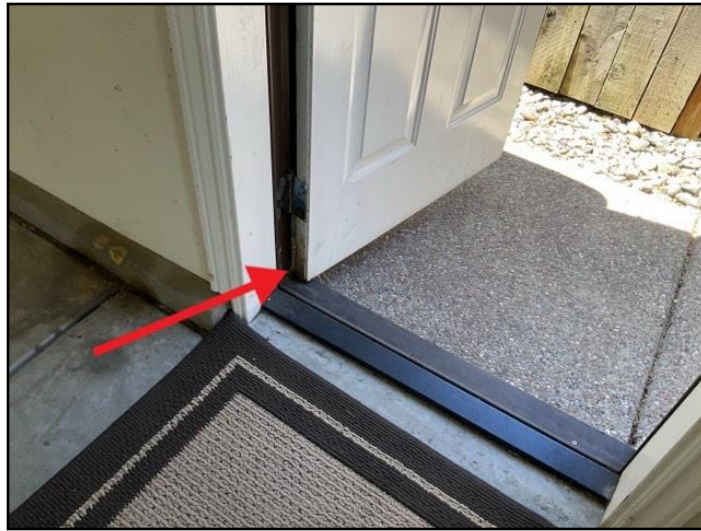
31. Attention

The door, jamb, or trim at the door leading from the garage to the exterior is showing signs of wear and wood deterioration. Recommend checking with the most recent "Pest Report" for further evaluation and determinations.

Task: Recommend further evaluation and repair by a qualified specialist.

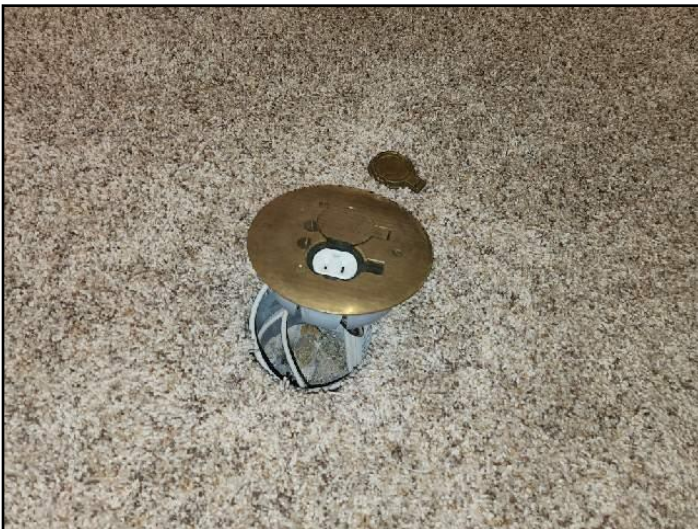
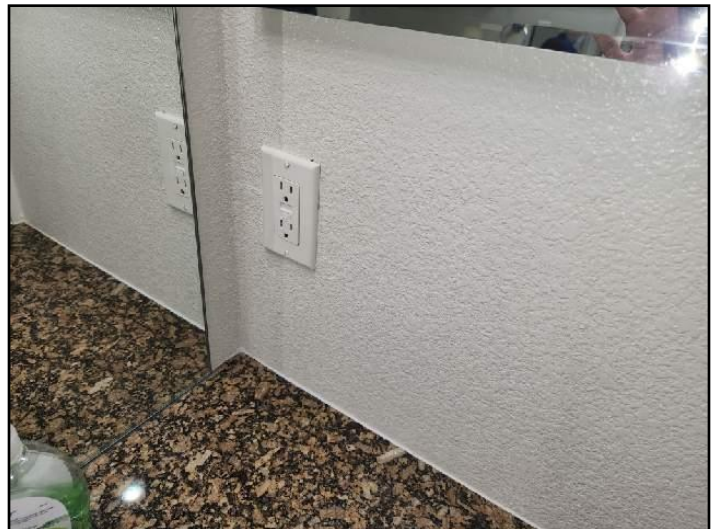
There are one or more outlets at the interior/exterior of the home that are loosely mounted in the wall. Recommend re-mounting the outlet(s).

Location: Living Room, Master Bathroom,

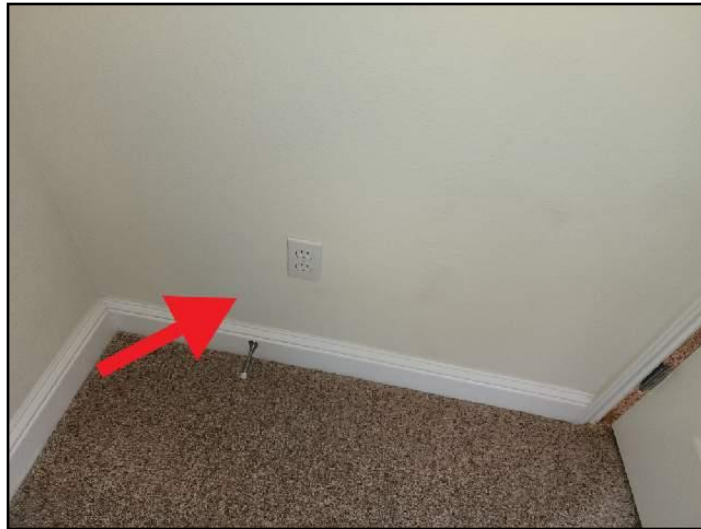
36. Broken Outlet Cover

66. Condition: • Broken Outlet Cover

Location: Bedroom Two,

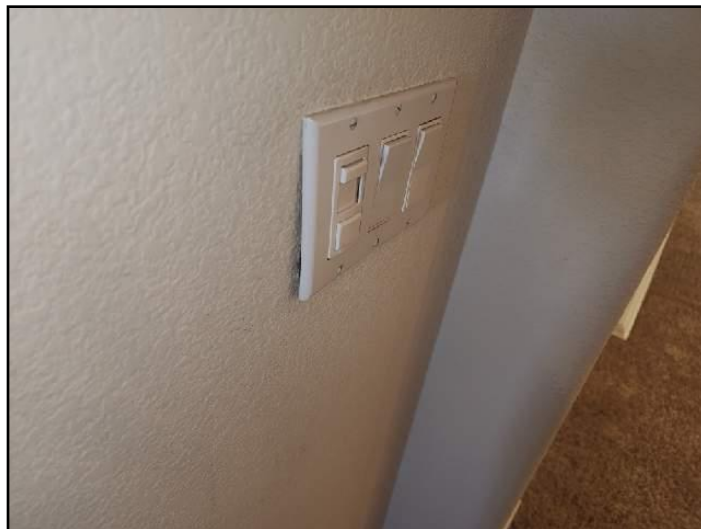
37.

67. Condition: • Ding room switch not mounted orperly.

Location: Dining Room,

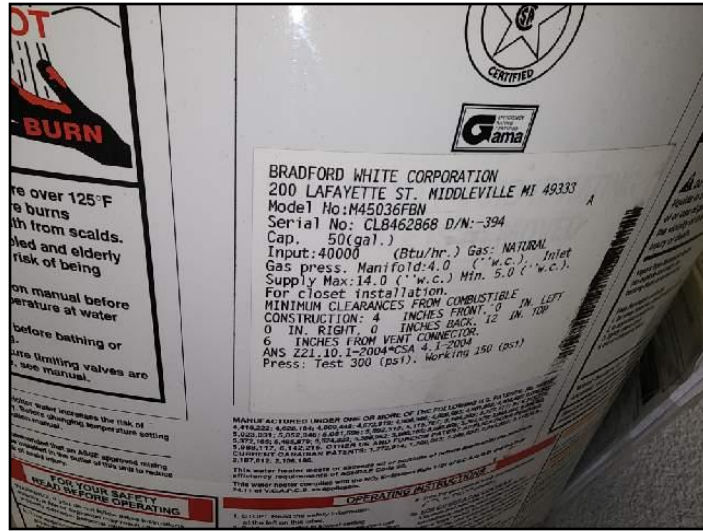
44. Type/Mfg/Age

Items should not be stored against gas or electric water heater. Providing at least two feet of clearance around the water heater is recommended.

Task: Recommend further evaluation and repair by a licensed Plumber

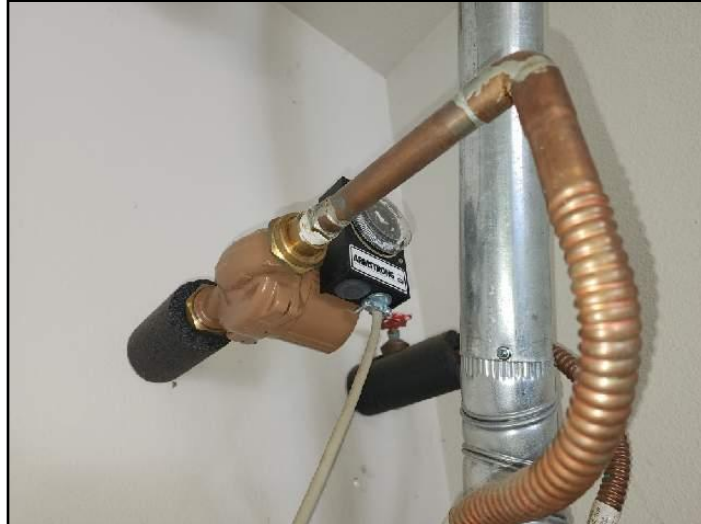
45. Recirc Pump Present

There is a re-circ pump installed at the water heater. The unit was found unplugged. This unit is outside the scope of the inspection. Recommend checking with the seller in this regard.

Task: Recommend further evaluation and repair by a licensed Plumber

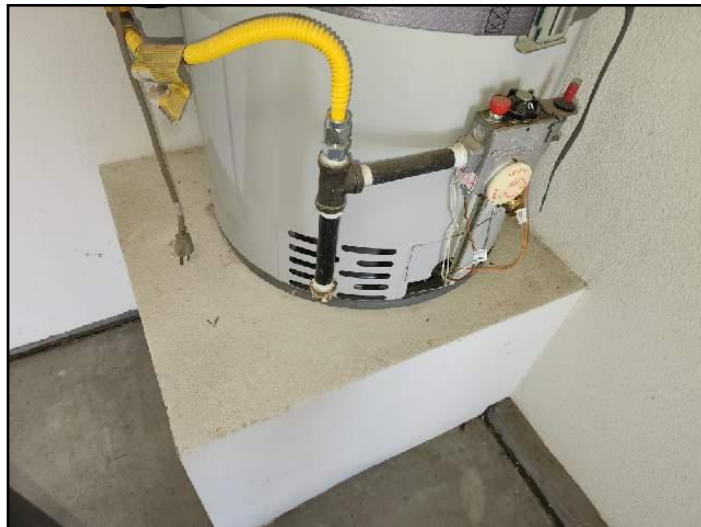
46. No Drip Pan

117. Condition: • No Drip Pan

There is no drip pan for the water heater. Modern building practices would require a water tight drip pan with drain line if a leak would cause damage. Future consideration should be given to adding a pan as a preventative maintenance upgrade.

Task: Recommend further evaluation and repair by a licensed plumber.

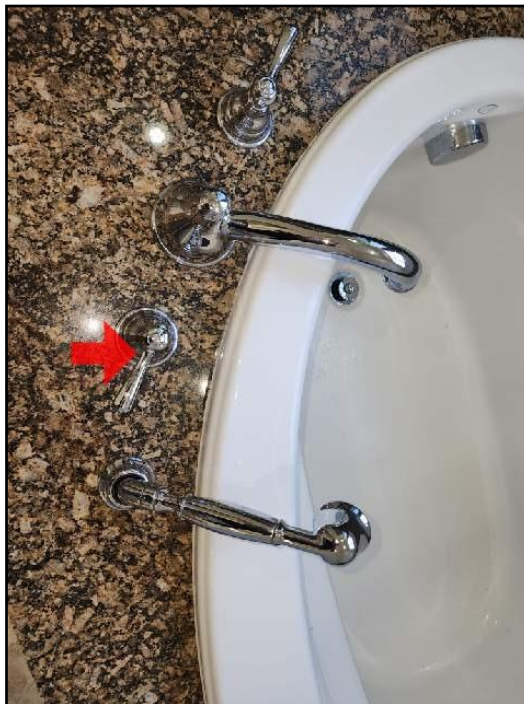
53. Weak Diverter

171. Condition: • Weak Diverter

Task: Recommend further evaluation and repair by a licensed Plumber
