MUV MARKETPLACE SDN BHD (253263-U)

VEHICLE INSPECTION REPORT

Registration Number	VAL8830	Vehicle Location	Seri Kembangan
Vehicle Model	Serena 2.0L CVT H/STAR S-HYBRID	Colour	Purple
Engine Type	Electric/Hybrid	Year Made	2013
Engine Capacity (C.C.)	1997	Mileage (KM)	124114
Gearbox Type	Automatic	Inspection Date	21/01/2020
Type of Usage	Individual Private	Body Type	MPV
Engine Number	MR20474421B	Chassis Number	HFC26166820
Key Set	1

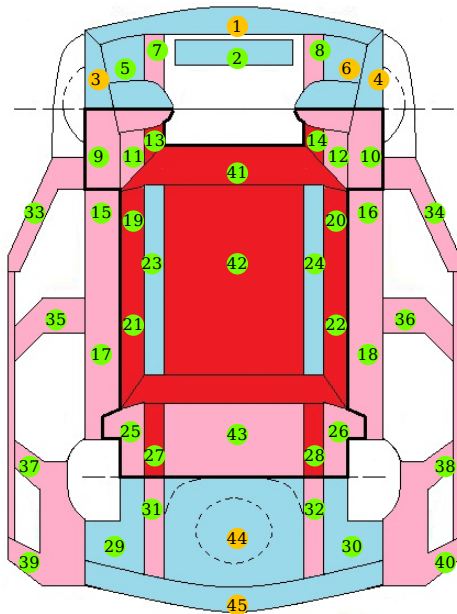
Structure (Bottom View)

1	Upper Radiator Support	Replaced	24	Right Center Rail	Normal
2	Radiator Support	Normal	25	Left Rear Wheel House - inner part	Normal
3	Left Inner Fender - front part	Dented (below 3cm)	26	Right Rear Wheel House - inner part	Normal
4	Right Inner Fender - front part	Rusted & Corrosion, Replaced	27	Left Rear Rail - inner part	Normal
5	Left Apron - front part	Normal	28	Right Rear Rail - inner part	Normal
6	Right Apron - front part	Dented (3cm - 6cm), Repaired, Rusted & Corrosion	29	Left Rear Wheel House - outer part	Normal
7	Left Front Rail - front part	Normal	30	Right Rear Wheel House - outer part	Normal
8	Right Front Rail - front part	Normal	31	Left Rear Rail - outer part	Normal
9	Left Inner Fender - rear part	Normal	32	Right Rear Rail - outer part	Normal
10	Right Inner Fender - rear part	Normal	33	Inner Left A-pillar	Normal
11	Left Apron - rear part	Normal	34	Inner Right A-pillar	Normal
12	Right Apron - rear part	Normal	35	Inner Left B-pillar	Normal

13	Left Front Rail - rear part	Normal	36	Inner Right B-pillar	Normal
14	Right Front Rail - rear part	Normal	37	Inner Left C-pillar	Normal
15	Left Front Inner Rocker - front part	Normal	38	Inner Right C-pillar	Normal
16	Right Front Inner Rocker - front part	Normal	39	Inner Left D-pillar	Normal
17	Left Rear Inner Rocker - rear part	Normal	40	Inner Right D-pillar	Normal
18	Right Rear Inner Rocker - rear part	Normal	41	Front Firewall	Normal
19	Left Front Side Floor Plan	Normal	42	Center Floor Plan	Normal
20	Right Front Side Floor Plan	Normal	43	Rear Floor Plan - inner part	Normal
21	Left Rear Side Floor Plan	Normal	44	Rear Floor Plan - outer part	Dented (below 3cm)
22	Right Rear Side Floor Plan	Normal	45	Rear Panel	Dented (3cm - 6cm), Repaired
23	Left Center Rail	Normal

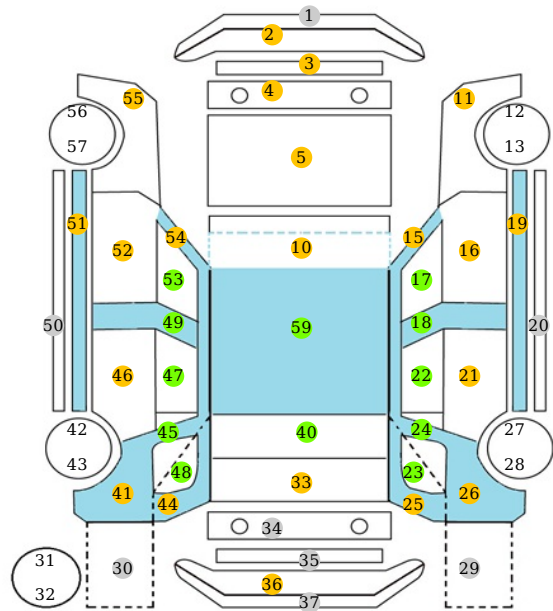
Exterior (Top View)

1	Front Skirt	N/A	32	Spare Tyre Brand, Size and Year Make	
2	Front Bumper	Scratched (3cm - 6cm), Replaced	33	Rear Trunk	Dented (below 3cm), Scratched (above 6cm), Repaired
3	Front Reinforcement	Replaced	34	Rear Lighting Panel	N/A
4	Front Grille	Replaced	35	Rear Reinforcement	N/A
5	Front Bonnet	Scratched (below 3cm), Repaired	36	Rear Bumper	Scratched (3cm - 6cm), Replaced
6	Headlamp (Right)	Scratched	37	Rear Skirt	N/A
7	Hazard/Signal Lamp (Right)	Normal	38	Rear Combination Lamp (Right)	Scratched
8	Headlamp (Left)	Scratched	39	Rear Combination Lamp (Left)	Scratched
9	Hazard/Signal Lamp (Left)	Normal	40	Rear Windscreen	Normal
10	Front Windscreen	Broken / Cracked	41	Rear Left Fender	Re-sprayed, Dented (below 3cm)
11	Front Right Fender	Scratched (below 3cm), Replaced	42	Rear Left Tyre Tread	2.6 mm
12	Front Right Tyre Tread	2.5 mm	43	Rear Left Tyre Brand, Size and Year Make	Bridgestone, 195/60R16, 0617
13	Front Right Tyre Brand, Size and Year Make	Bridgestone, 195/60R16	44	Left D-pillar	Re-sprayed, Scratched (below 3cm)

14	Side Mirror (Right)	Scratched	45	Left C-pillar	Normal
15	Right A-pillar	Re-sprayed	46	Rear Left Door	Re-sprayed
16	Front Right Door	Re-sprayed, Dented (below 3cm)	47	Rear Left Door Window	Normal
17	Front Right Door Window	Normal	48	Left Quarter Glass	Normal
18	Right B-pillar	Normal	49	Left B-pillar	Normal
19	Right Side Sill	Scratched (3cm - 6cm)	50	Left Side Skirt	N/A
20	Right Side Skirt	N/A	51	Left Side Sill	Dented (above 6cm), Scratched (above 6cm)
21	Rear Right Door	Scratched (below 3cm), Dented (3cm - 6cm)	52	Front Left Door	Repaired
22	Rear Right Door Window	Normal	53	Front Left Door Window	Normal
23	Right Quarter Glass	Normal	54	Left A-pillar	Scratched (below 3cm)
24	Right C-pillar	Normal	55	Front Left Fender	Scratched (below 3cm), Repaired
25	Right D-pillar	Scratched (below 3cm)	56	Front Left Tyre Tread	2.4 mm
26	Rear Right Fender	Re-sprayed	57	Front Left Tyre Brand, Size and Year Make	Bridgestone, 195/60R16, 1117

27	Rear Right Tyre Tread	2.8 mm	58	Side Mirror (Left)	Scratched
28	Rear Right Tyre Brand, Size and Year Make	Bridgestone, 195/60R16, 0617	59	Roof Top	Normal
29	Rear Right Cargo Panel	N/A	60	Antenna	N/A
30	Rear Left Cargo Panel	N/A	61	Vehicle Paint Condition

Front and rear bumper not align. Wheel scratches and repaired. Door moulding loose and repaired. Spare tire not available.
