# MUV MARKETPLACE SDN BHD (253263-U)

## VEHICLE INSPECTION REPORT

| Registration Number | <b>W5494R</b> | Vehicle Location | - |
| Vehicle Model | <b>SUPRIMA S PREMIUM</b> | Colour | <b>Blue</b> |

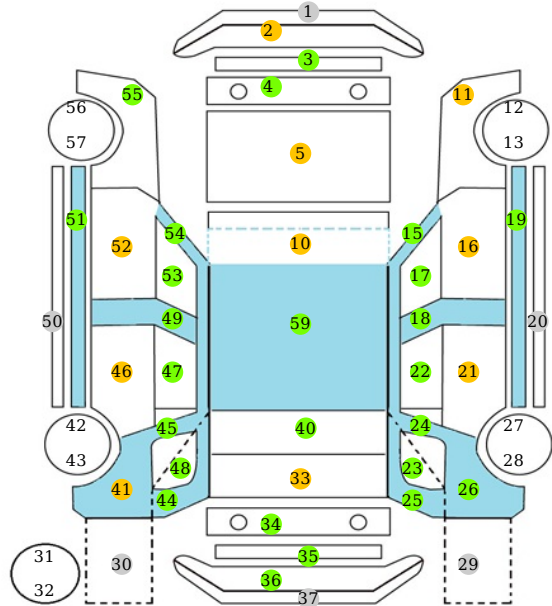
Exterior (Top View)

| 2 | Front Bumper | Replaced | 33 | Rear Trunk | Dented (below 3cm), Scratched (above 6cm) |
| 5 | Front Bonnet | Dented (below 3cm), Scratched (above 6cm), Broken / Damaged / Cracked, Rusted & Corrosion, Re-sprayed | 36 | Rear Bumper | Normal |
| 10 | Front Windscreen | Stone Chip | 41 | Rear Left Fender | Dented (below 3cm), Scratched (above 6cm) |
| 11 | Front Right Fender | Scratched (above 6cm) | 42 | Rear Left Tyre Tread | 60 mm |
| 16 | Front Right Door | Dented (below 3cm), Scratched (above 6cm) | 47 | Rear Left Door Window | Normal |
| 21 | Rear Right Door | Dented (below 3cm), Scratched (above 6cm) | 52 | Front Left Door | Dented (below 3cm), Scratched (above 6cm) |

-Need touch up.  
-Front windscreen stone chipped.  
-Front section impact.
