# MUV MARKETPLACE SDN BHD (253263-U)

## VEHICLE INSPECTION REPORT

Registration Number	<b>WYB4119</b>	Vehicle Location	-
Vehicle Model	<b>SAGA 1.3 FLX STANDARD (M)</b>	Colour	<b>Brown</b>
Engine Type	<b>Petrol</b>	Year Made	<b>2013</b>
Engine Capacity (C.C.)	<b>1332</b>	Mileage (KM)	<b>99378</b>
Gearbox Type	<b>Manual</b>	Assessment Date	<b>28/02/2020</b>
Type of Usage	<b>Individual Private</b>	Body Type	<b>Sedan</b>
Engine Number	<b>S4PETL5597</b>	Chassis Number	<b>PL1BT3SNRDB372147</b>
Key Set	<b>1</b>

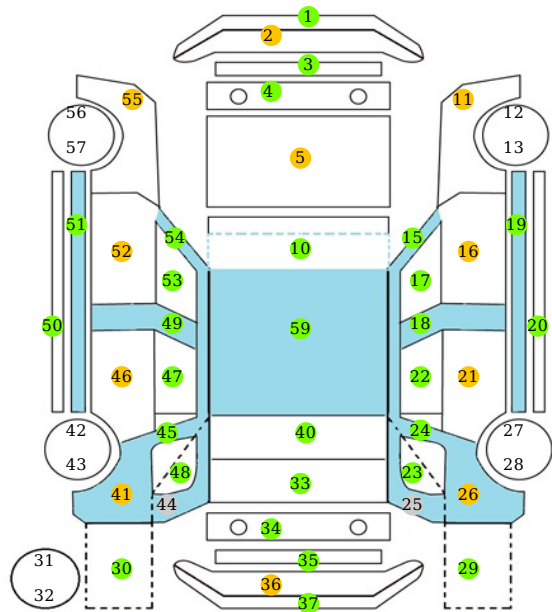
Exterior (Top View)

1	Front Skirt	Normal	32	Spare Tyre Brand, Size and Year Make	
2	Front Bumper	Scratched (above 6cm)	33	Rear Trunk	Normal
3	Front Reinforcement	Normal	34	Rear Lighting Panel	Normal
4	Front Grille	Normal	35	Rear Reinforcement	Normal
5	Front Bonnet	Scratched (above 6cm)	36	Rear Bumper	Scratched (above 6cm)
6	Headlamp (Right)	Normal	37	Rear Skirt	Normal
7	Hazard/Signal Lamp (Right)	Normal	38	Rear Combination Lamp (Right)	Normal
8	Headlamp (Left)	Normal	39	Rear Combination Lamp (Left)	Normal
9	Hazard/Signal Lamp (Left)	Normal	40	Rear Windscreen	Normal
10	Front Windscreen	Normal	41	Rear Left Fender	Scratched (above 6cm)
11	Front Right Fender	Scratched (above 6cm)	42	Rear Left Tyre Tread	3 mm
12	Front Right Tyre Tread	3 mm	43	Rear Left Tyre Brand, Size and Year Make	Leao, 175/70/R13
13	Front Right Tyre Brand, Size and Year Make	Leao, 175/70/R13	44	Left D-pillar	N/A
14	Side Mirror (Right)	Normal	45	Left C-pillar	Normal

15	Right A-pillar	Normal	46	Rear Left Door	Scratched (above 6cm)
16	Front Right Door	Scratched (above 6cm)	47	Rear Left Door Window	Normal
17	Front Right Door Window	Normal	48	Left Quarter Glass	Normal
18	Right B-pillar	Normal	49	Left B-pillar	Normal
19	Right Side Sill	Normal	50	Left Side Skirt	Normal
20	Right Side Skirt	Normal	51	Left Side Sill	Normal
21	Rear Right Door	Scratched (above 6cm)	52	Front Left Door	Scratched (above 6cm)
22	Rear Right Door Window	Normal	53	Front Left Door Window	Normal
23	Right Quarter Glass	Normal	54	Left A-pillar	Normal
24	Right C-pillar	Normal	55	Front Left Fender	Scratched (above 6cm)
25	Right D-pillar	N/A	56	Front Left Tyre Tread	3 mm
26	Rear Right Fender	Scratched (above 6cm)	57	Front Left Tyre Brand, Size and Year Make	Leao, 175/70/R13
27	Rear Right Tyre Tread	3 mm	58	Side Mirror (Left)	Normal
28	Rear Right Tyre Brand, Size and Year Make	Leao, 175/70/R13	59	Roof Top	Normal

29	Rear Right Cargo Panel	Normal	60	Antenna	Normal
30	Rear Left Cargo Panel	Normal	61	Vehicle Paint Condition	1 Layer Paint
31	Spare Tyre Tread	0 mm

1 layer paint.

Power door lock malfunction.  
Engine oil leaking.
