MUV MARKETPLACE SDN BHD (253263-U)

VEHICLE INSPECTION REPORT

Registration Number	WBL7040	Vehicle Location	-
Vehicle Model	COROLLA 1.3 (M)	Colour	Silver
Engine Type	Petrol	Year Made	1987
Engine Capacity (C.C.)	1295	Mileage (KM)	461266
Gearbox Type	Manual	Assessment Date	09/03/2020
Type of Usage	Individual Private	Body Type	Sedan
Engine Number	2E0941767	Chassis Number	EE909000368
Key Set	1

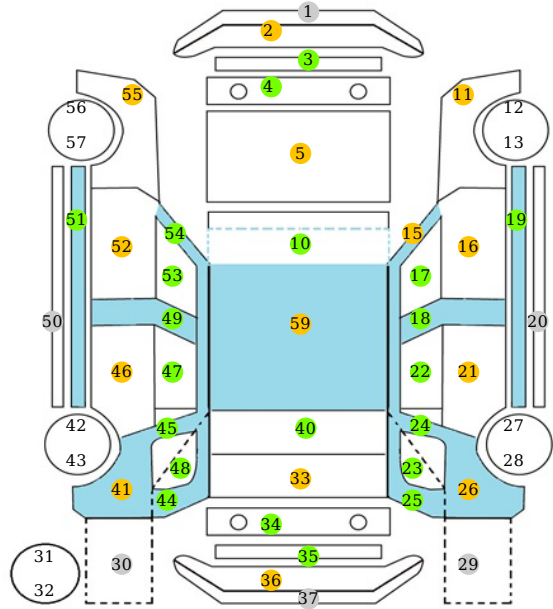
Exterior (Top View)

1	Front Skirt	N/A	32	Spare Tyre Brand, Size and Year Make	Dunlop 175/70R13
2	Front Bumper	Dented (below 3cm), Scratched (above 6cm), Broken / Damaged / Cracked, Rusted & Corrosion, Repaired	33	Rear Trunk	Dented (below 3cm), Scratched (above 6cm), Broken / Damaged / Cracked, Rusted & Corrosion
3	Front Reinforcement	Normal	34	Rear Lighting Panel	Normal
4	Front Grille	Normal	35	Rear Reinforcement	Normal
5	Front Bonnet	Dented (below 3cm), Scratched (above 6cm), Broken / Damaged / Cracked, Rusted & Corrosion	36	Rear Bumper	Dented (below 3cm), Scratched (above 6cm), Broken / Damaged / Cracked, Rusted & Corrosion
6	Headlamp (Right)	Normal	37	Rear Skirt	N/A
7	Hazard/Signal Lamp (Right)	Normal	38	Rear Combination Lamp (Right)	Scratched, Damaged
8	Headlamp (Left)	Normal	39	Rear Combination Lamp (Left)	Normal
9	Hazard/Signal Lamp (Left)	Normal	40	Rear Windscreen	Normal
10	Front Windscreen	Normal	41	Rear Left Fender	Dented (below 3cm), Scratched (above 6cm), Broken / Damaged / Cracked, Rusted & Corrosion

11	Front Right Fender	Scratched (above 6cm), Rusted & Corrosion	42	Rear Left Tyre Tread	30 mm
12	Front Right Tyre Tread	40 mm	43	Rear Left Tyre Brand, Size and Year Make	Dunlop 175/70R13
13	Front Right Tyre Brand, Size and Year Make	Silverstone 175/70R13	44	Left D-pillar	Normal
14	Side Mirror (Right)	Normal	45	Left C-pillar	Normal
15	Right A-pillar	Rusted & Corrosion, Repaired	46	Rear Left Door	Dented (below 3cm), Scratched (above 6cm), Rusted & Corrosion
16	Front Right Door	Dented (below 3cm), Scratched (above 6cm), Broken / Damaged / Cracked, Rusted & Corrosion, Repaired	47	Rear Left Door Window	Normal
17	Front Right Door Window	Normal	48	Left Quarter Glass	Normal
18	Right B-pillar	Normal	49	Left B-pillar	Normal
19	Right Side Sill	Normal	50	Left Side Skirt	N/A
20	Right Side Skirt	N/A	51	Left Side Sill	Normal
21	Rear Right Door	Dented (below 3cm), Scratched (above 6cm), Broken / Damaged / Cracked, Rusted & Corrosion	52	Front Left Door	Dented (below 3cm), Scratched (above 6cm), Rusted & Corrosion

24	Right C-pillar	Normal	55	Front Left Fender	Dented (above 6cm), Scratched (above 6cm), Broken / Damaged / Cracked, Rusted & Corrosion
25	Right D-pillar	Normal	56	Front Left Tyre Tread	40 mm
26	Rear Right Fender	Dented (below 3cm), Scratched (above 6cm), Broken / Damaged / Cracked, Rusted & Corrosion, Repaired	57	Front Left Tyre Brand, Size and Year Make	Silverstone 175/70R13
27	Rear Right Tyre Tread	30 mm	58	Side Mirror (Left)	Normal
28	Rear Right Tyre Brand, Size and Year Make	Dunlop 175/70R13	59	Roof Top	Dented (below 3cm), Scratched (above 6cm), Broken / Damaged / Cracked, Rusted & Corrosion
29	Rear Right Cargo Panel	N/A	60	Antenna	Normal
30	Rear Left Cargo Panel	N/A	61	Vehicle Paint Condition	2 Layer Paint
31	Spare Tyre Tread	50 mm

-wholebody need repaint.
-rear trunk impact.
