# MUV MARKETPLACE SDN BHD (253263-U)

## VEHICLE INSPECTION REPORT

| Registration Number | <b>WSP1496</b> | Vehicle Location | - |
| Vehicle Model | <b>VIOS S 1.5 (A)</b> | Colour | <b>Black</b> |

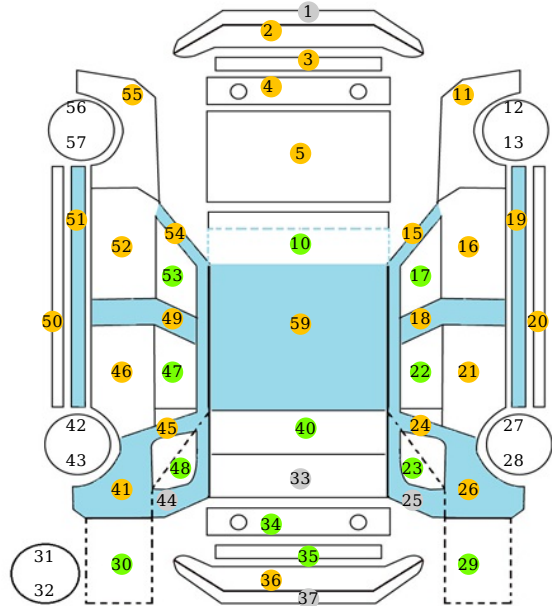
Exterior (Top View)

| 2 | Front Bumper | Scratched (3cm - 6cm) | 33 | Rear Trunk | N/A |
| 3 | Front Reinforcement | Scratched (3cm - 6cm) | 34 | Rear Lighting Panel | Normal |
| 4 | Front Grille | Scratched (3cm - 6cm) | 35 | Rear Reinforcement | Normal |
| 5 | Front Bonnet | Scratched (3cm - 6cm) | 36 | Rear Bumper | Scratched (3cm - 6cm) |
| 6 | Headlamp (Right) | Yellowish | 37 | Rear Skirt | N/A |
| 8 | Headlamp (Left) | Yellowish | 39 | Rear Combination Lamp (Left) | Normal |
| 10 | Front Windscreen | Normal | 41 | Rear Left Fender | Scratched (3cm - 6cm) |
| 11 | Front Right Fender | Scratched (3cm - 6cm) | 42 | Rear Left Tyre Tread | 0 mm |
| 15 | Right A-pillar | Scratched (below 3cm) | 46 | Rear Left Door | Scratched (3cm - 6cm) |
| 16 | Front Right Door | Scratched (3cm - 6cm) | 47 | Rear Left Door Window | Normal |
| 19 | Right Side Sill | Scratched (3cm - 6cm) | 50 | Left Side Skirt | Scratched (3cm - 6cm) |
| 20 | Right Side Skirt | Scratched (3cm - 6cm) | 51 | Left Side Sill | Scratched (3cm - 6cm) |
| 21 | Rear Right Door | Scratched (3cm - 6cm) | 52 | Front Left Door | Scratched (3cm - 6cm) |
| 24 | Right C-pillar | Scratched (below 3cm) | 55 | Front Left Fender | Scratched (3cm - 6cm) |
| 26 | Rear Right Fender | Scratched (3cm - 6cm) | 57 | Front Left Tyre Brand, Size and Year Make | Continental, 195/60R15 |
| 28 | Rear Right Tyre Brand, Size and Year Make | Continental, 195/60R15 | 59 | Roof Top | Scratched (3cm - 6cm) |
