Detect and Inspect LLC

189 Michigan Street , Van, Texas 75790

House | 2034 sqft | 4 bedrooms | 2 bathrooms | Year Built 1973

PROPERTY INSPECTION REPORT FORM

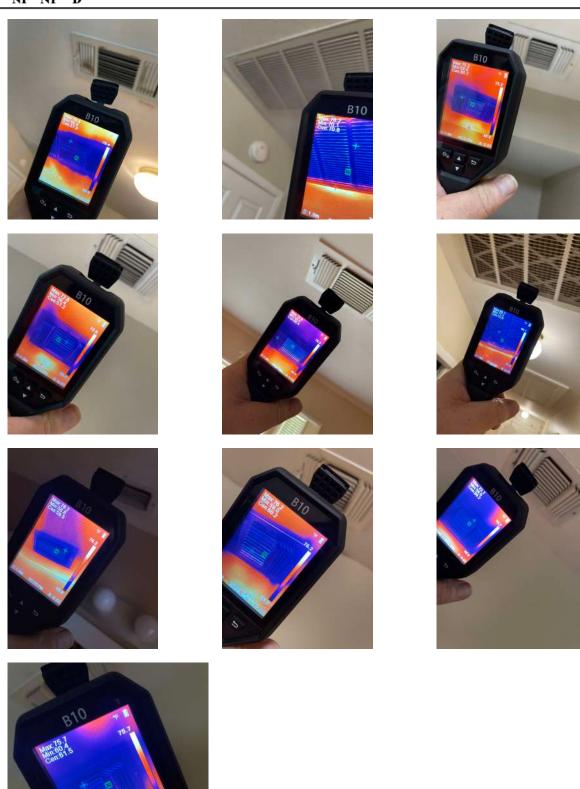
Note all numbers are approximate. Probing from a certified technician can give exact results: Normal differential is between 15 and 22 degrees. Average Delta T of 12-14 is not within rage. Suggest a Profession HVAC tech for further review and or correction.
