Detect and Inspect LLC

36 Oak Creek Ridge Drive , Longview, Texas 75605

House | 2251 sqft | 3 bedrooms | 2 bathrooms | Year Built 1995

PROPERTY INSPECTION REPORT FORM

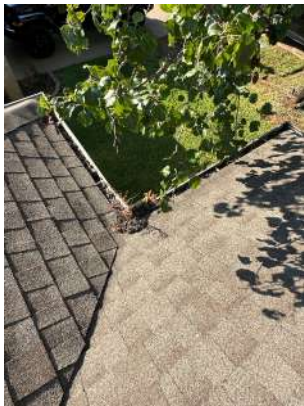
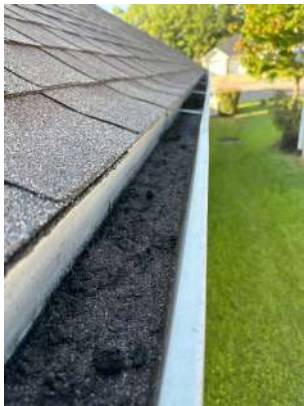
The gutters and down spouts were observed to be in need of cleaning. Excess debris can hide possible defects.

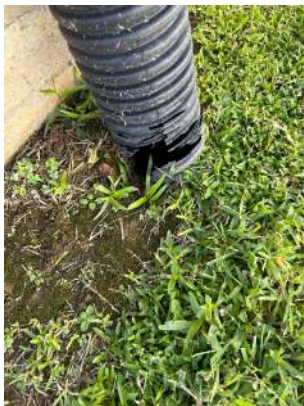
Downspouts and gutters were observed to be damaged. Damage, gutters and downspouts result in restricted flow.

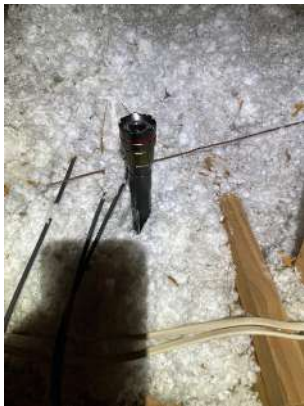
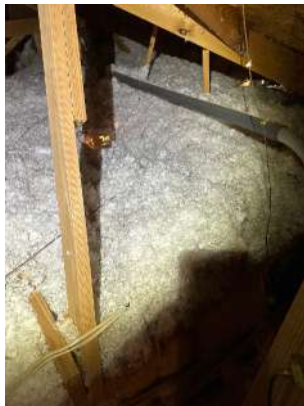
Unable to determine IC rating for canned lights. IC ratings allow insulation to be next to the canned lights. If the canned light is not IC rated insulation must be removed at least 3 inches from each canned light. IC rating will be labeled inside the canister. Consider using LED lighting because they do not carry as much heat as a Incandescent or halogen bulb. Usually canisters with openings or slits are not IC rated and the openings all for heat to disapeate.

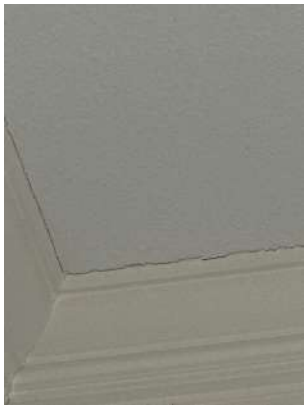
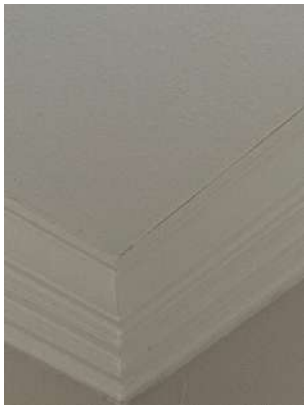
Trim and celing separation noted in various areas. Maybe due to expansion and should be corrected by a qualified professional of a DIY project.

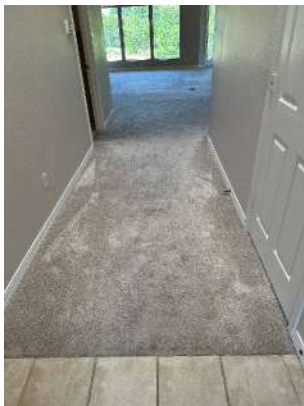
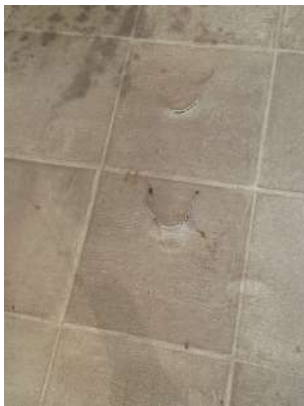
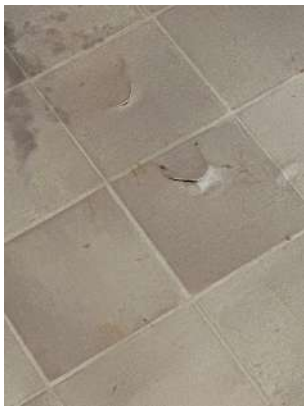
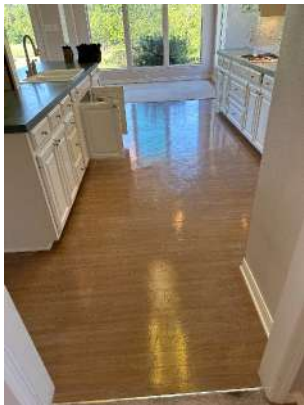
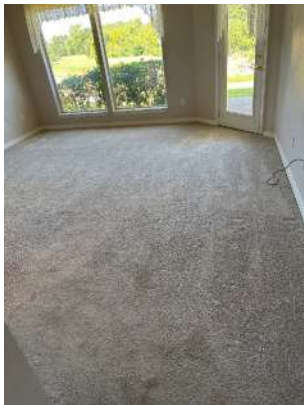
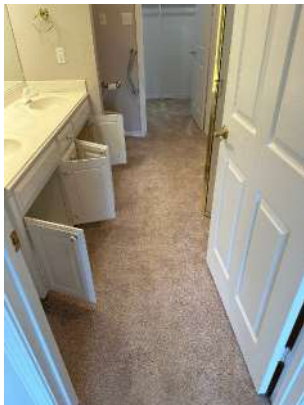
Normal wear and tear on flooring
 Laundry floor covering has multiple rips and tears. Consider repair or replacement as deemed necessary

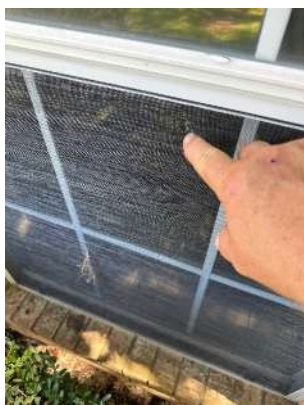
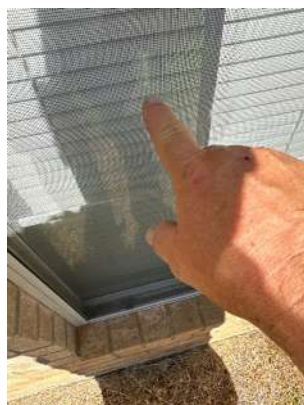
Caulking: X
 Clear
 Hazed X
 Screens in place X
 Screens missing
 Screen Damage X observed multiple damaged screens at more than one window

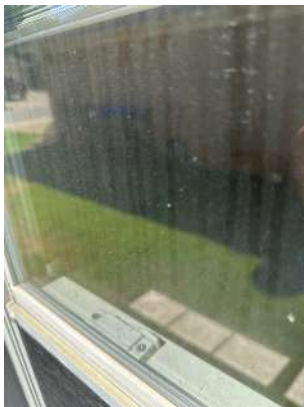
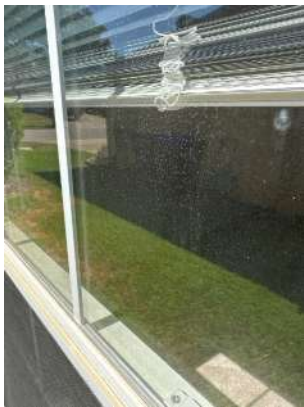
South east side windows show signs of broken seals, condensation lines within the window panes condensation was not showing at the time of inspection, however, previous lines show possible broken seals. Suggest correction from a window expert

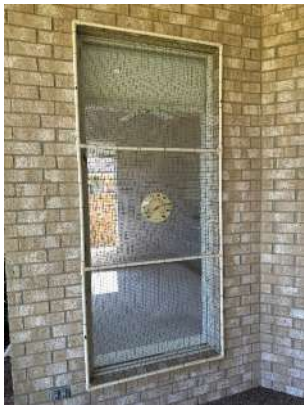
Back porch window is covered due to unskilled golfers like me!

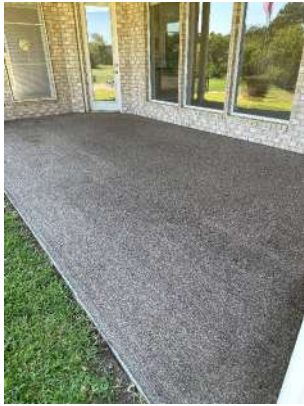
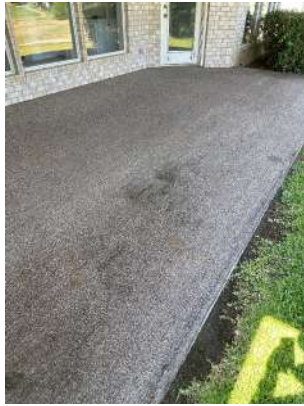
Unable to determine concrete condition due to back porch being covered with outdoor carpet

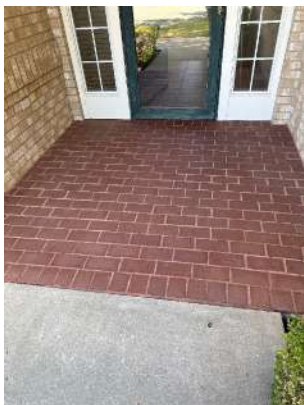
Monitor grouting to keep from water erosion

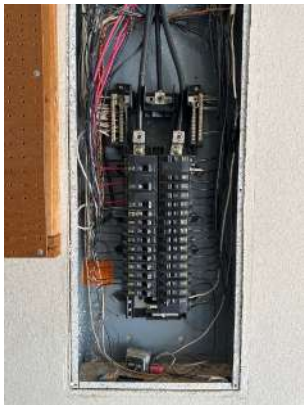
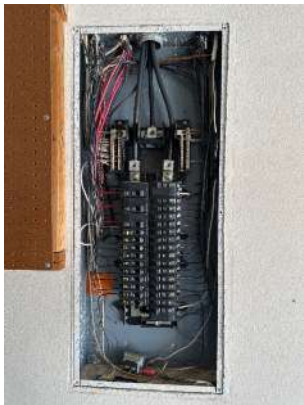
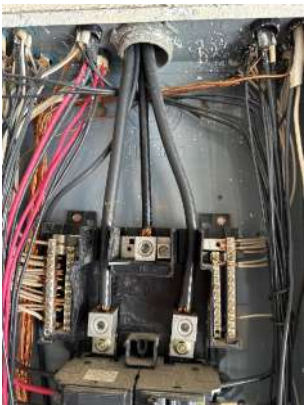
Service panel amperage is 200 amps. Unable to determine ground connection. NOTE Service panel disconnect is on the outside of the home.

White wire is being used as a hot wire and is not properly marked. This is for the water heater in the attic. Suggest correction from a licensed electrician.

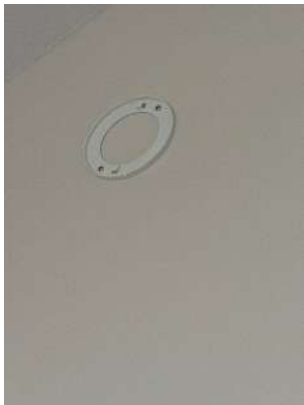
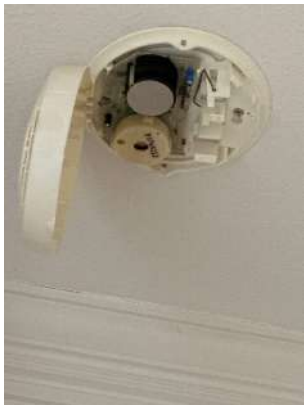
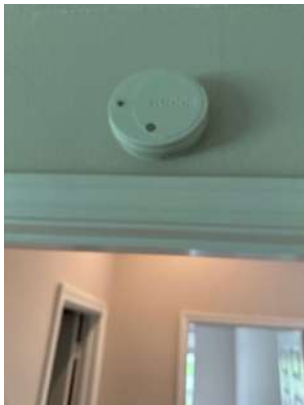
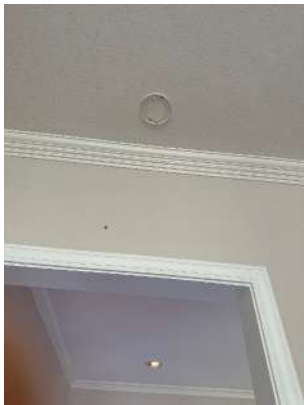
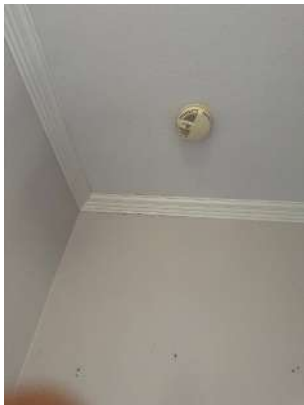
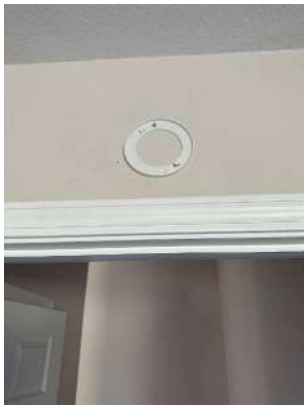
Inadequate smoke alarm coverage was observed. It is recommended additional smoke detectors and CO2 detectors be installed in accordance with current building standards. The NFPA {National Fire and Protection Agency} recommends one smoke alarm on each level, every bedroom and adjoining hallway, above stairwells and a CO2 detector in the garage and outside each bedroom with fuel fired appliances.
Recommendation Contact a handyman or DIY project.

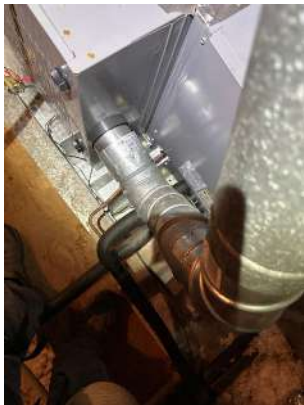
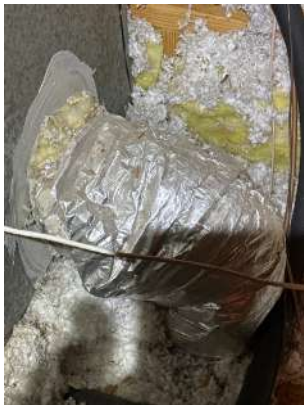
Ducks should be supported and not laying on rafters. Working as intended.

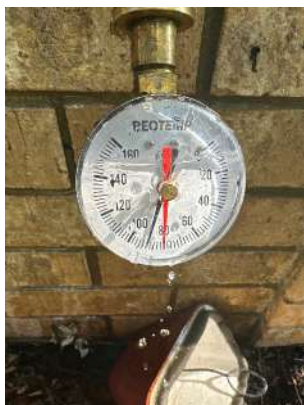
Hose bib at front and side of house leaks suggest correction by qualified professional. Side hose bib is loose and handle is broken. suggest correction by qualified professional.

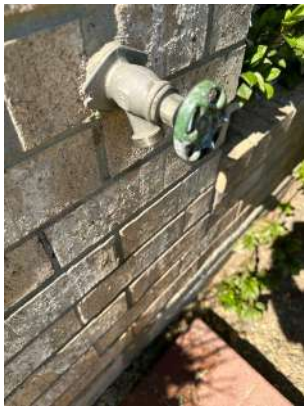
Hose bibs did not have anti-siphon device

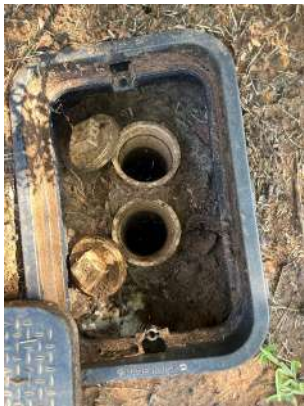
Sewer, drain inspection, and clean out location. Not properly covered Suggest correction to keep rain water or backwash going into city sewer or back up into the house.

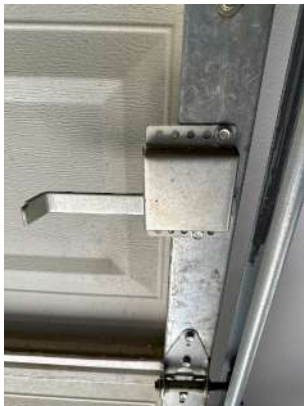
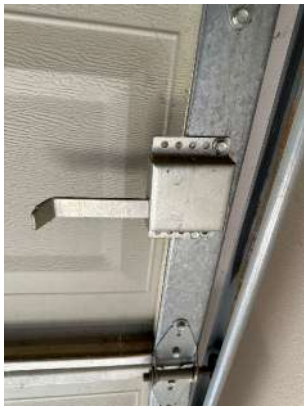
Remove door locking mechanism to ensure accidental damage when lifting the door. Considered a safety item.
Garage door is working as intended the day of inspection

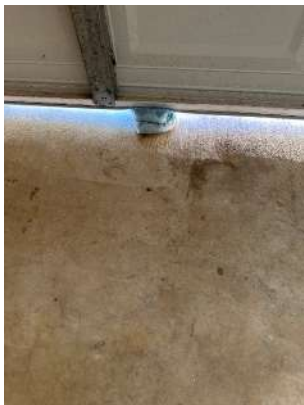
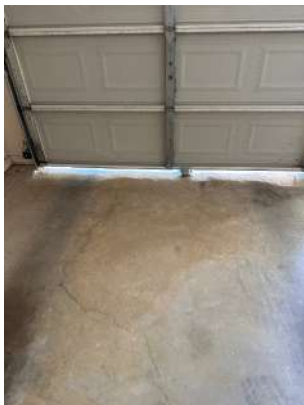
Garage door did not have required safety stickers in place. Safety stickers at the sensors were not install.

Garage door did not automatically reverse potential crushing situation. Garage door should since something in the Way and reverse. Suggest correction by qualified overhead door, professional.
