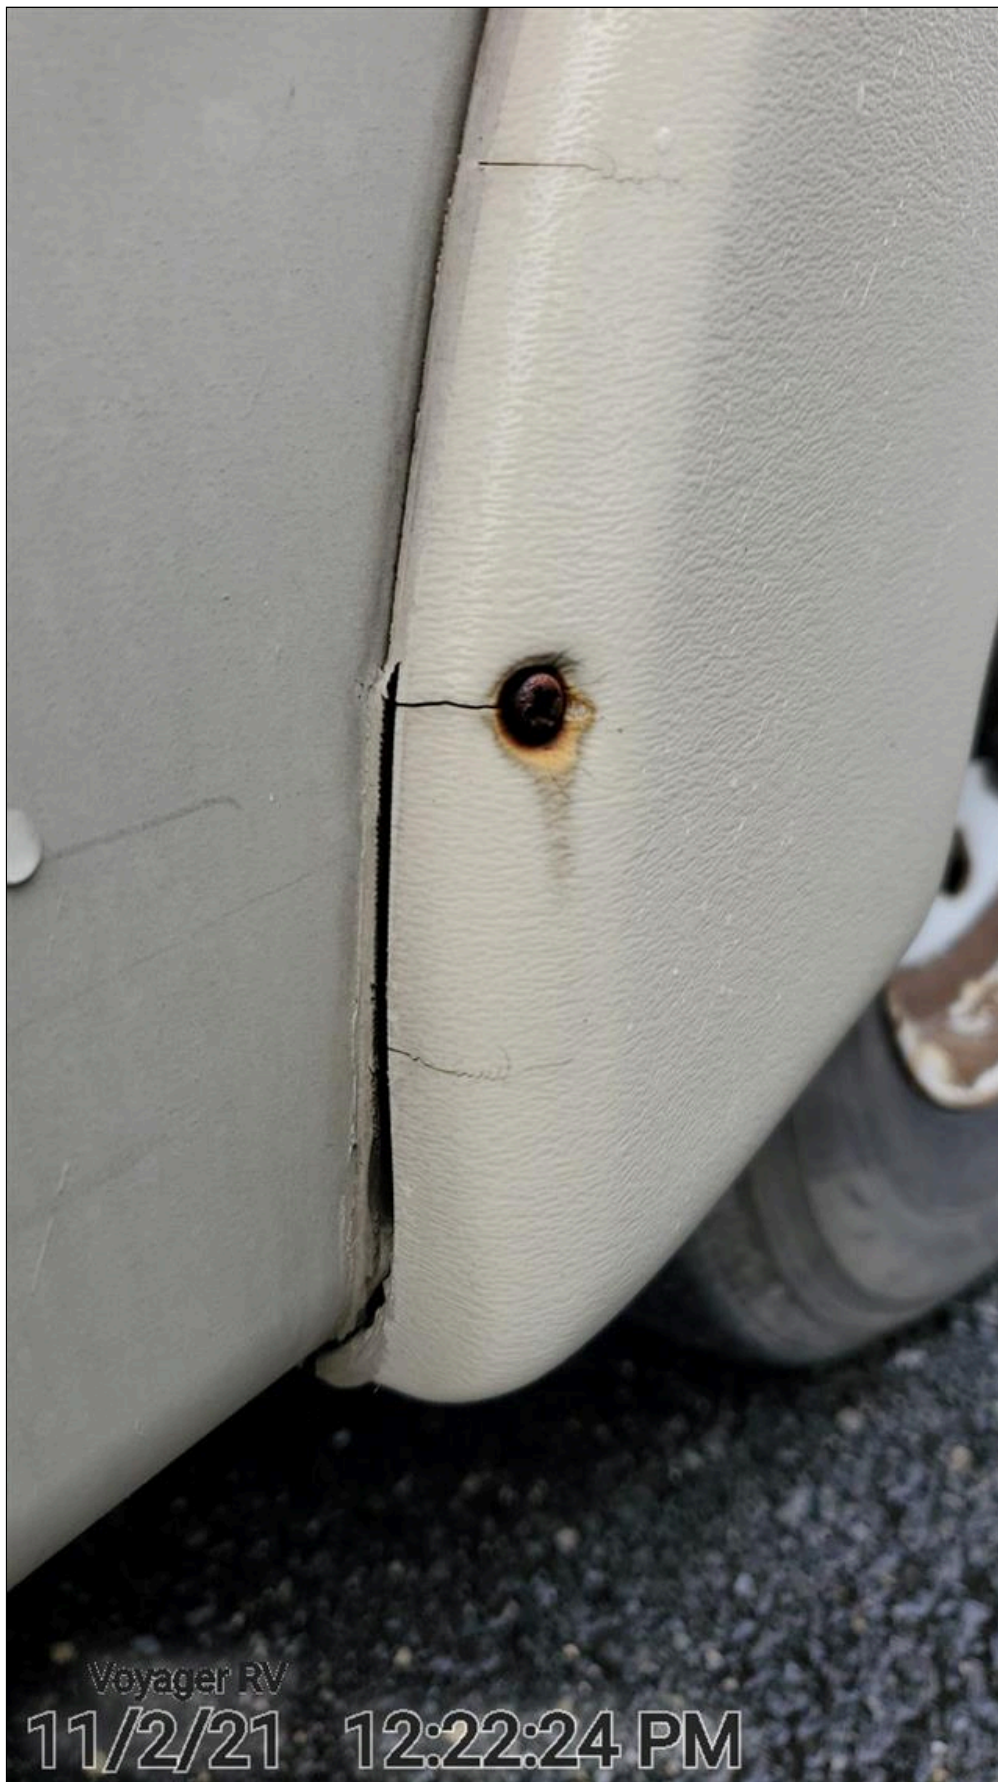
(3) Observed cracks and separation of wheel skirt. Recommend repair by a qualified RV technician to prevent detachment while in transit.

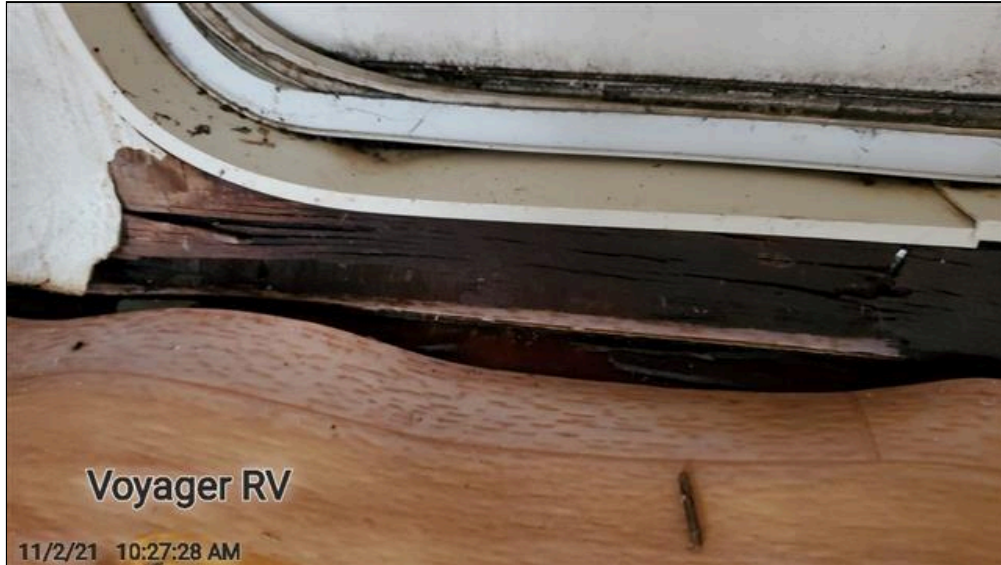
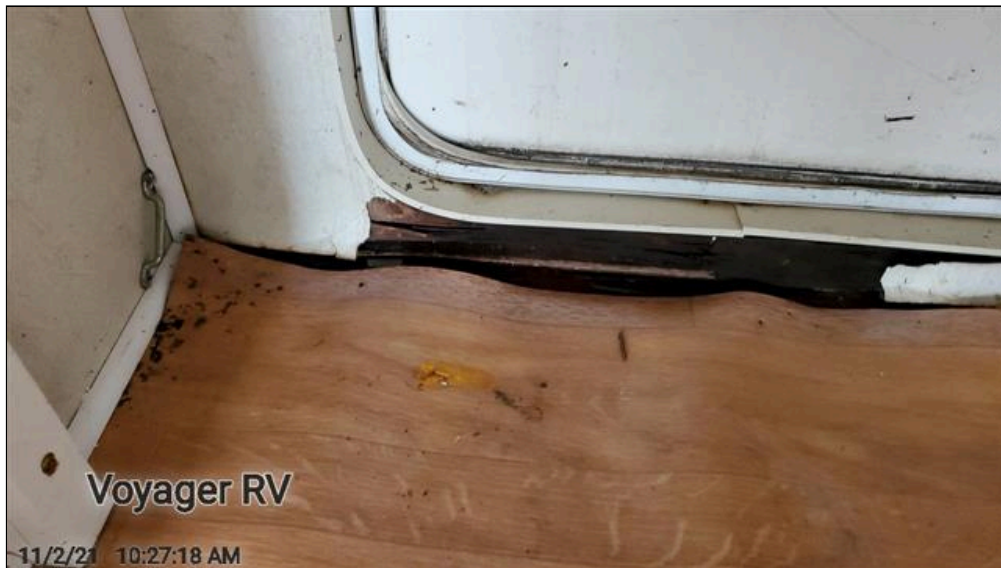
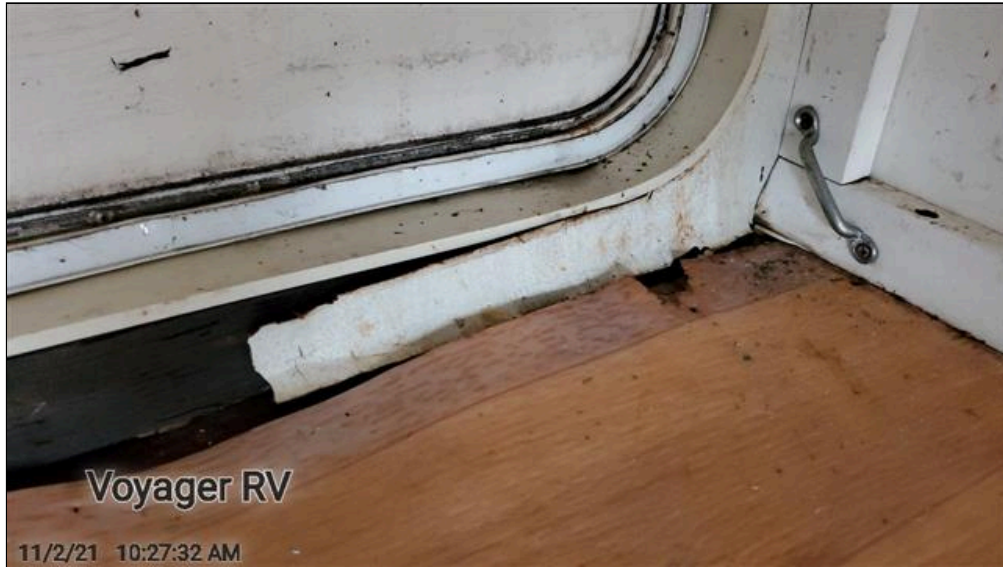
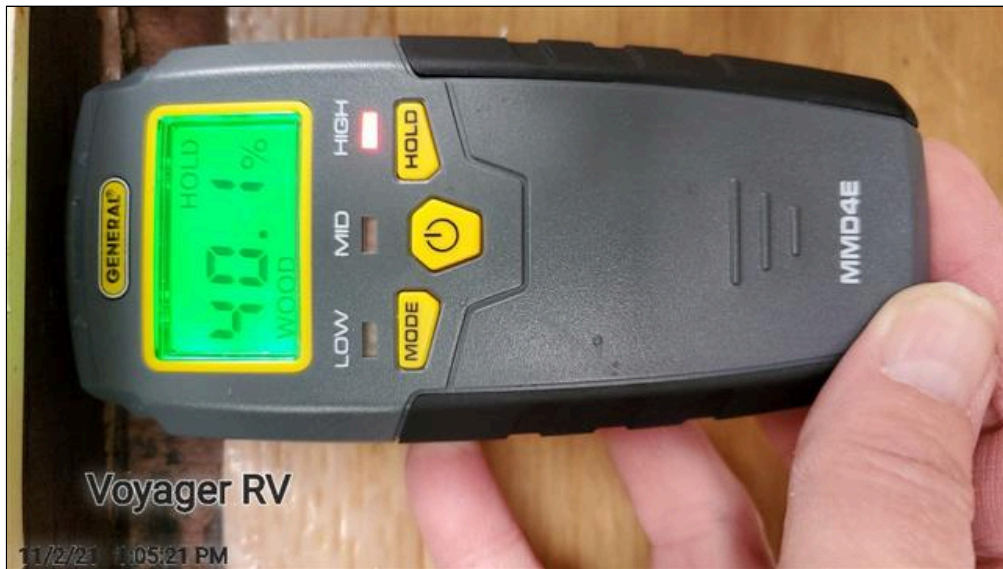
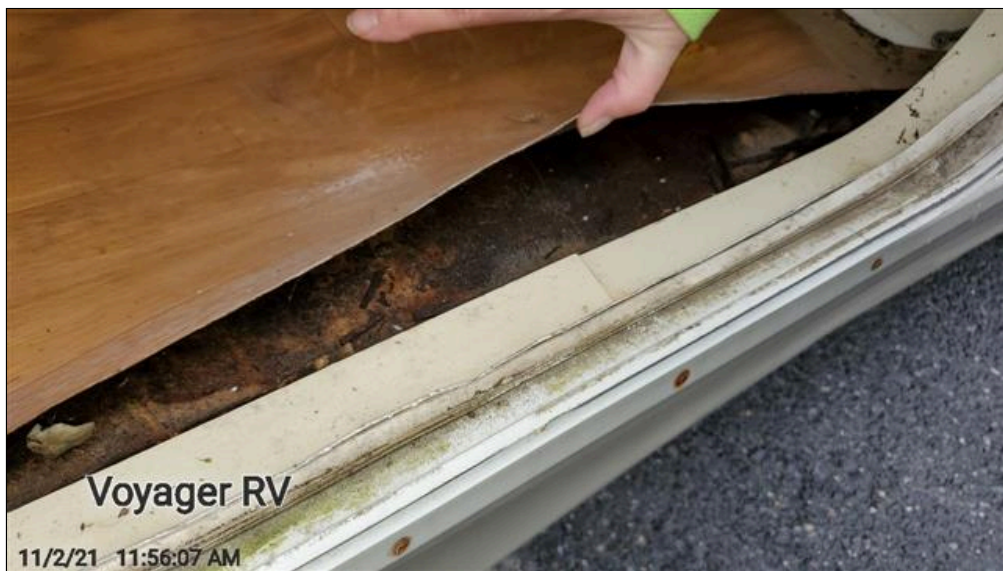
(1) Observed significant water damage and high moisture content on lower framing of front access door. Floor laminate is warped and wall covering missing. Wood is wet to the touch indicating recent wetting. Recommend repair by a qualified RV technician.

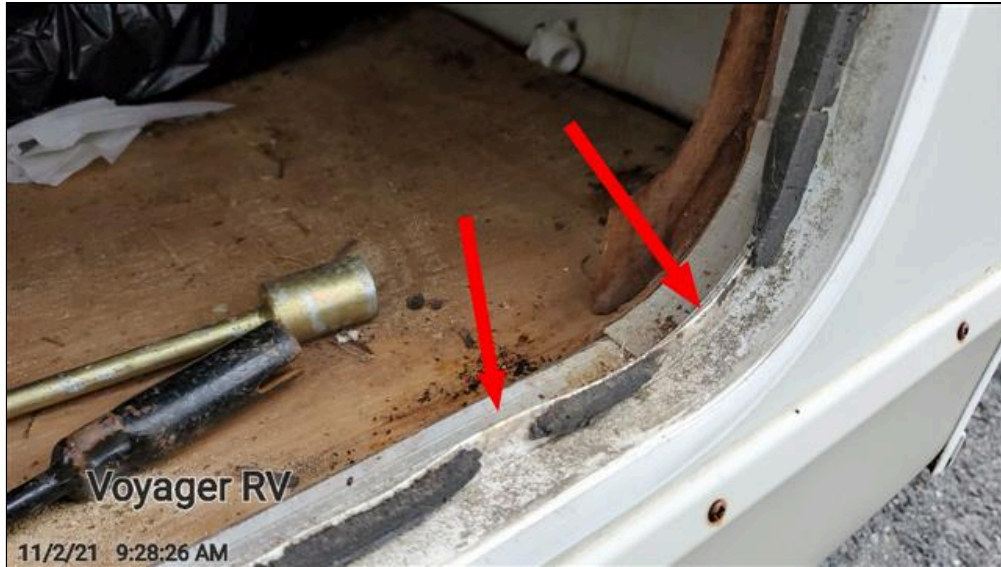
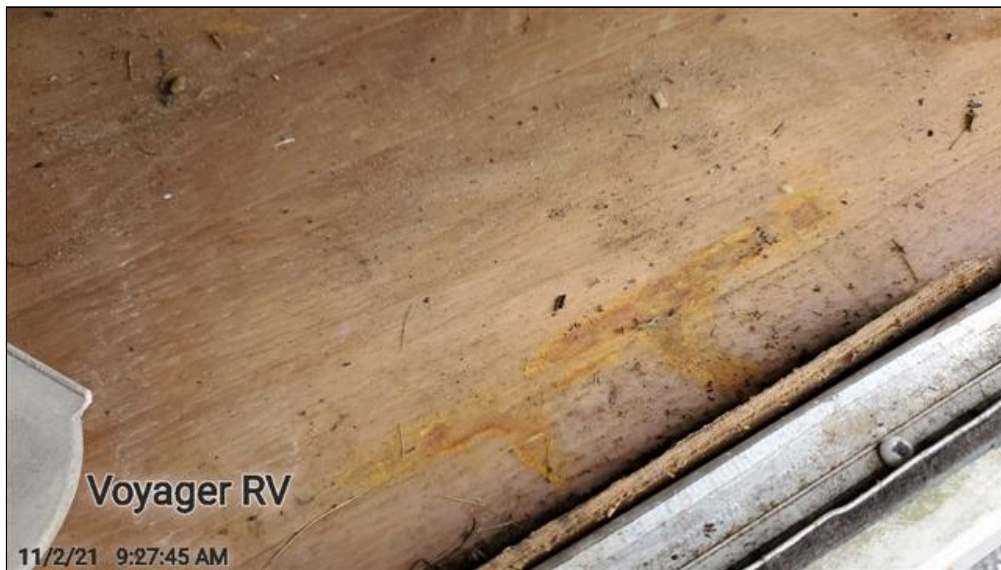
(2) Observed deteriorated seals on rear cargo door and evidence of water intrusion inside cargo area. Recommend repair by a qualified RV technician to prevent future water intrusion.

NOTE: Door seal material missing or degraded on all access doors and entrance door.
